Housing Health and Safety Rating System (HHSRS)

Hazard B15
Asbestos and
Manufactured
Mineral Fibres

Example B15.3
1946–1979
Terraced
House

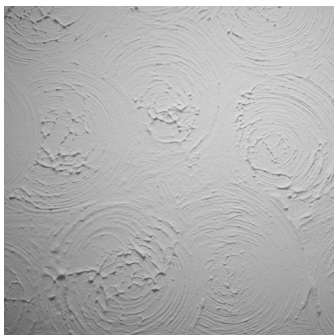
The living room and kitchen/dining room ceilings have an Artex finish that probably contain asbestos. These ceilings are in sound condition: the only cracks or damage is to the ceiling roses, evident when the light fittings are removed.

2
Artex ceiling

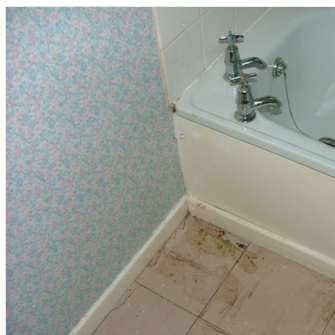
The bath panel also contains asbestos.

3
Bath panel
Photo credit: UKATA.

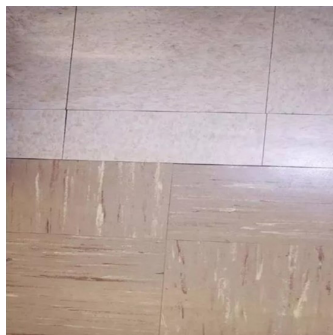
The floor tiles covering the dining room/kitchen and entrance hall on the ground floor and the bathroom upstairs all appear to be of a type and age to have some asbestos content (no test results are available to confirm this). The tiles appear in good condition and are securely stuck to the floors.

4
Floor tiles with possible
asbestos content

A full asbestos survey should be carried out, including sampling of the floor tiles. Once the type of asbestos is confirmed, a licensed contractor should be employed to prepare and undertake a suitable remedial action plan, including removal of any friable or damaged asbestos-containing materials and making good areas disturbed. Any remaining asbestos must be listed in an asbestos register which is provided to the building owner.

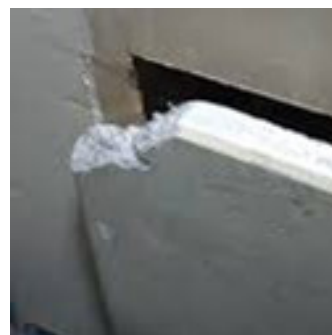
In the kitchen, the panelling/boxing-in around the soil vent pipe from the bathroom is asbestos sheet that has been damaged around the four screws that secure the access panel, exposing some fibres.

5
Damaged asbestos
boxing-in

The main concern relates to the panelling in the kitchen, particularly that used for access. The corners of this panel have broken off and asbestos fibres are exposed. The main exposure risk is that if removing the panel, its condition is such that it would continue to present an elevated risk to occupants, through inhalation of asbestos fibres, made more likely on account of kitchen being a frequent-use room.
