Report on the investigation of
the serious injury to a crew member on board the
scallop dredger

Jacoba (BM77)

29 nautical miles south-south-east of
Beachy Head, England
on 10 May 2025

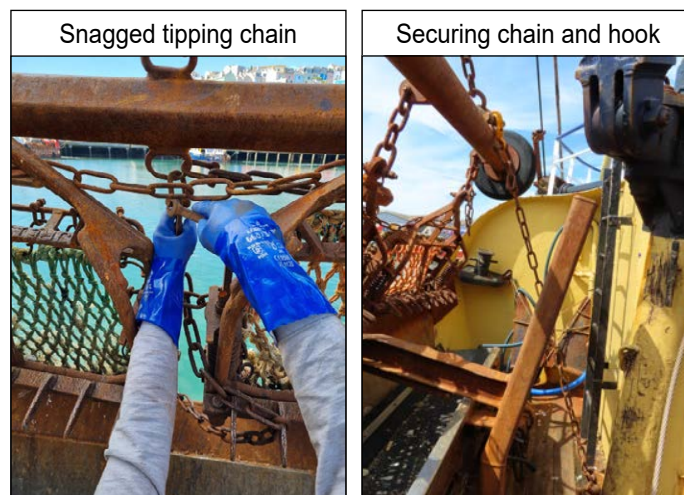
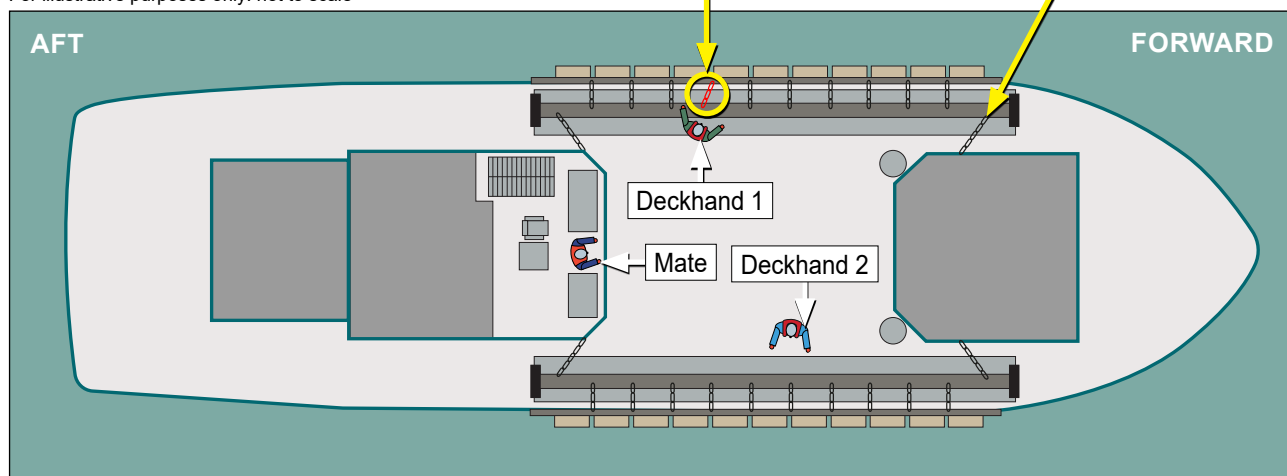
At midnight on 10 May 2025, the mate took over the watch from the skipper in the wheelhouse and deckhand 1 and deckhand 2 started their watch. At 0227, the mate began hauling the second dredge of their watch. The deckhands heard the winches operating and proceeded onto the main deck. Deckhand 1 went to the port side and deckhand 2 to the starboard side (**Figure 2**).

Figure 2: *Jacoba*'s working deck, showing key equipment and deckhand positions at the time of the accident

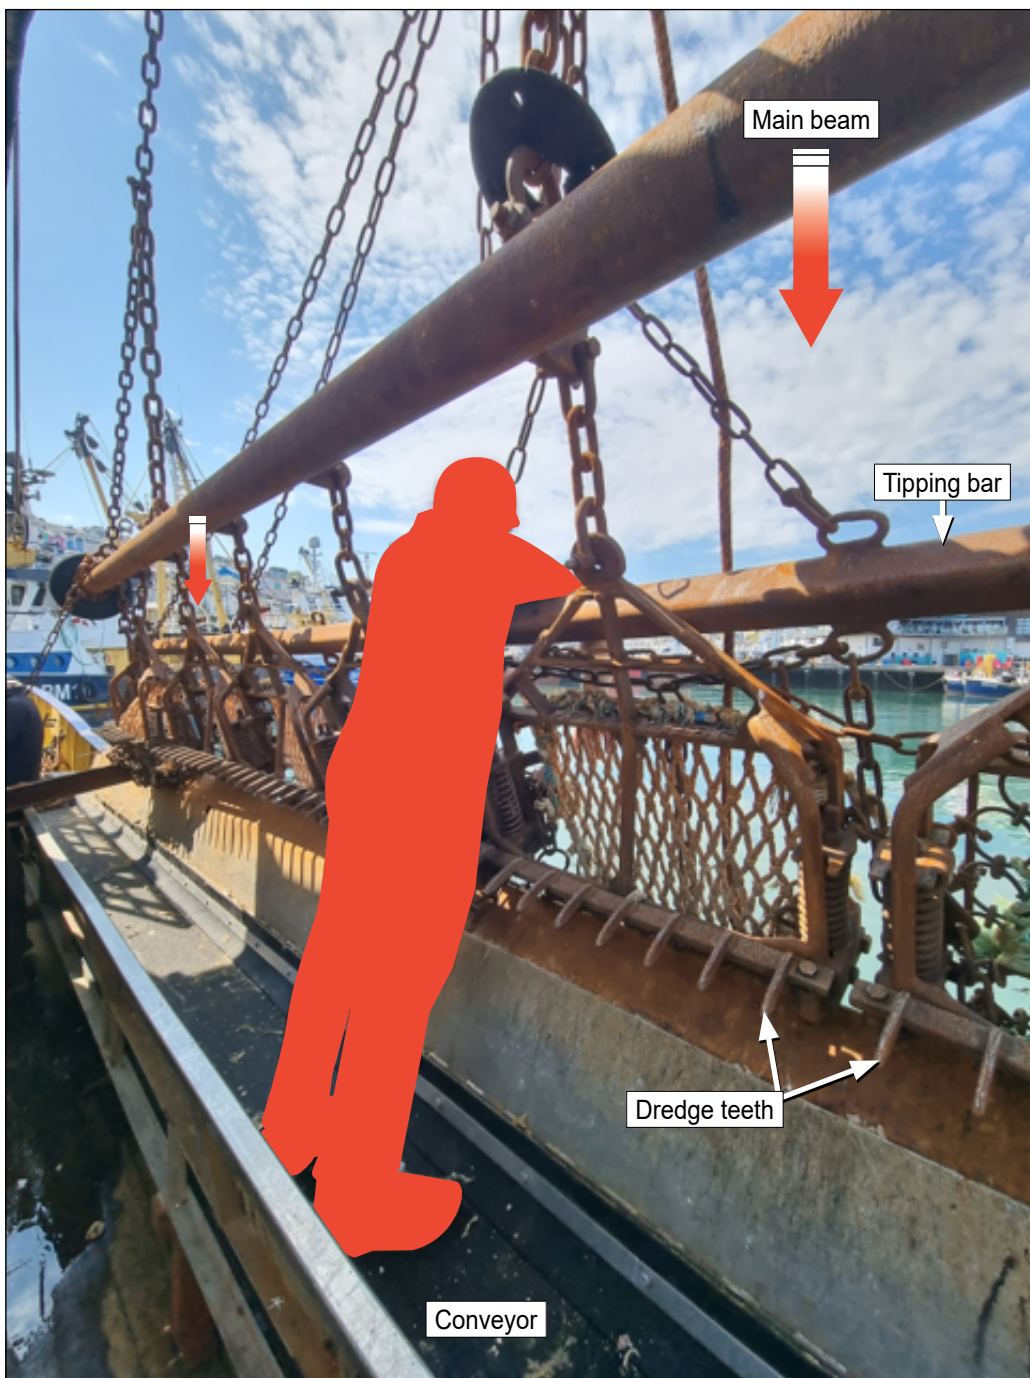
As the main beam on the port side was heaved tight against the chains, the chain connecting the bottom of the chain link dredge bag to the tipping bar became caught on the teeth of one of the dredge frames. The mate adjusted the main beam by lowering and heaving it slightly while deckhand 1 reached across the conveyor to try to manually free the chain from the teeth.

The mate again lowered and raised the port side main beam slightly to try and dislodge the chain as deckhand 1 sat on the inner edge of the conveyor. Deckhand 1 then stepped up onto the outer edge of the conveyor to access the shackle connecting the chain to the tipping bar, intending to undo the shackle to allow the chain to be removed and freed. Deckhand 1 then stepped back to the middle of the conveyor and leaned forward between the main beam and tipping bar.

At 0236, the mate again slackened the port side main beam to help deckhand 1 undo the shackle. As the mate operated the winch control both the port and starboard main beams lowered. The port side main beam struck deckhand 1 on the back, lifting them off the conveyor and pinning them between the main beam and tipping bar (**Figure 3**). The mate immediately raised the main beams and deckhand 1 fell onto the conveyor and rolled onto the deck, kicking and writhing in pain.

Figure 3: *Jacoba's* port dredging equipment, showing the position of deckhand 1 at the time of the accident

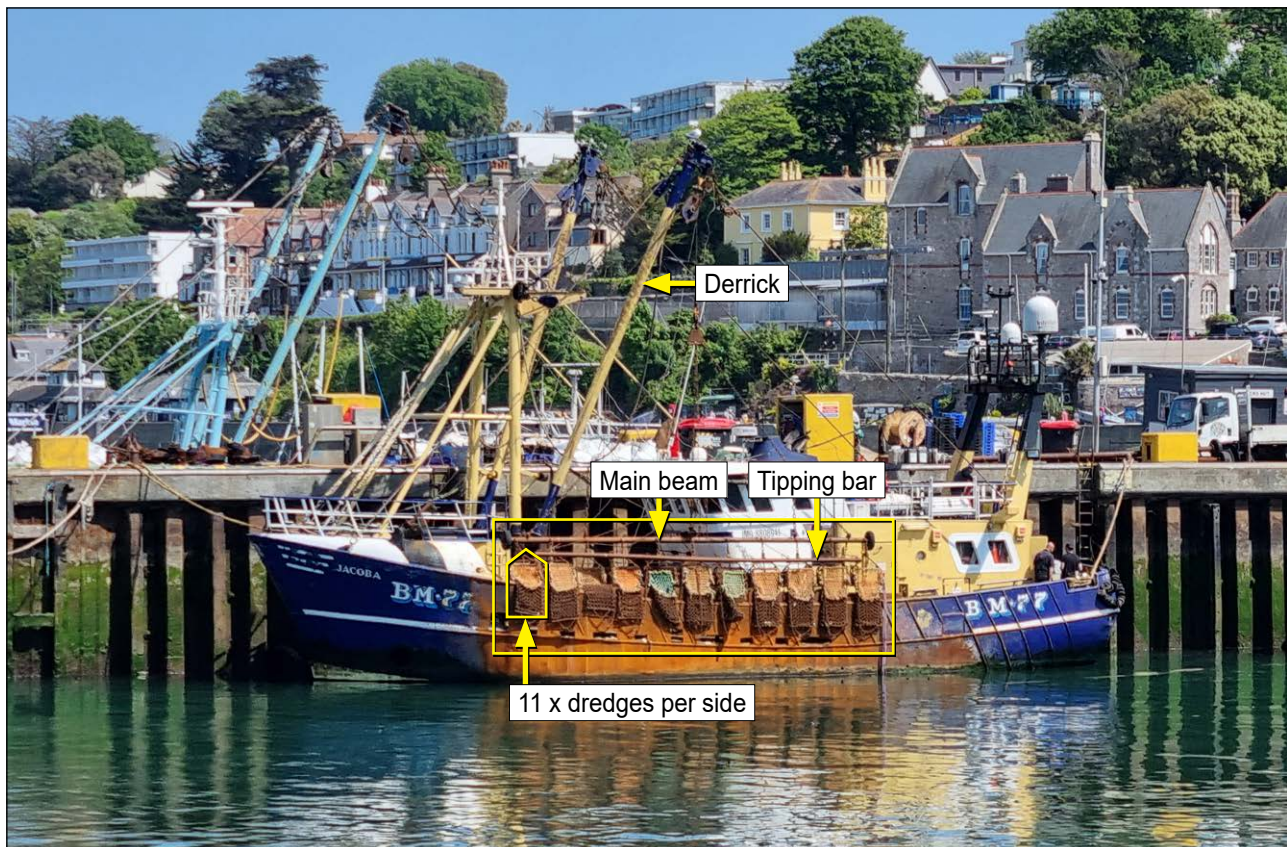
Jacoba carried two sets of scallop dredges, one on either side of the vessel. Each set comprised 11 dredges (**Figure 4**). The dredges comprised triangular steel frames fitted with bars lined with metal teeth and chain link dredge bags for collecting scallops. The upper end of the dredge frame was attached to a main beam, while the dredge bags were connected by short lengths of chain to a secondary beam known as the tipping bar. During fishing operations the dredges were towed along the seabed behind the main beam. As the dredges moved across the seabed the teeth disturbed the sediment and dislodged scallops, which were collected in the chain link bags. The vessel's winches hauled in the towing warps connected to the main beams to recover the dredges. As the gear reached the surface, the derricks were raised to bowse the dredges alongside the vessel. The crew then secured each main beam with chains at the forward and aft ends to hold the gear in position.

Figure 4: *Jacoba* alongside, showing the configuration of the scallop dredges

There had been several previous incidents on *Jacoba* of the chains connecting the dredge bags with the tipping bar becoming caught in the teeth of the dredges, requiring the crew to free the dredge bags before their contents could be tipped. To free these snags, the crew unpinned the shackle connecting the chain to the tipping bar with the main beam suspended.

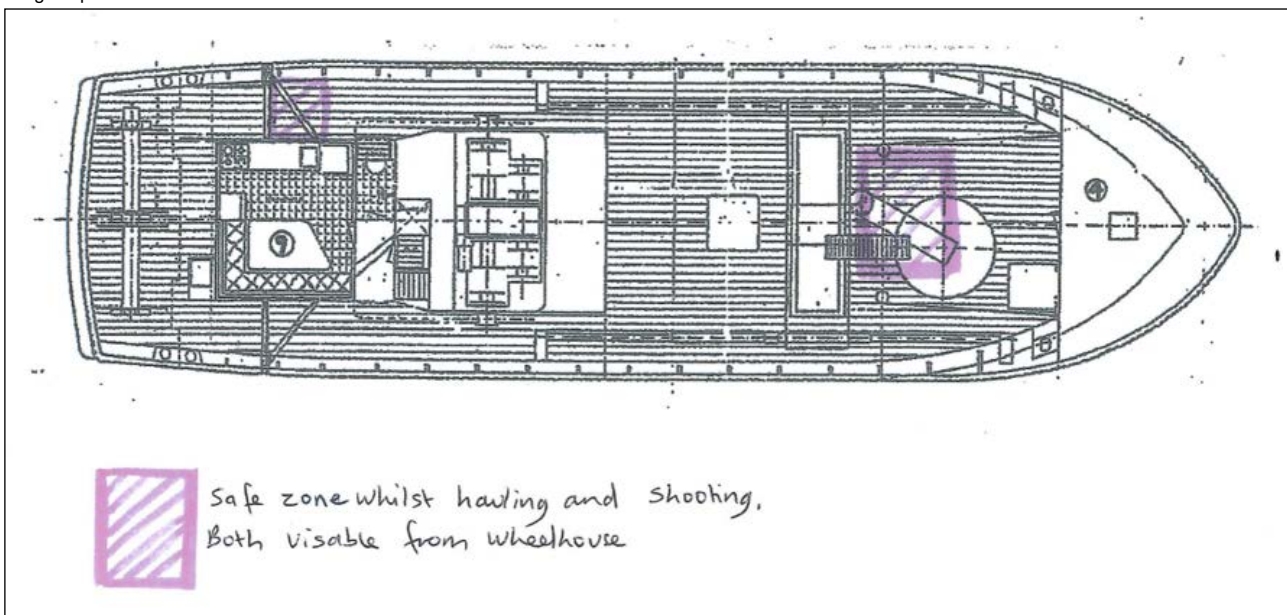
Figure 6: Jacoba's deck plan, showing identified safe zones

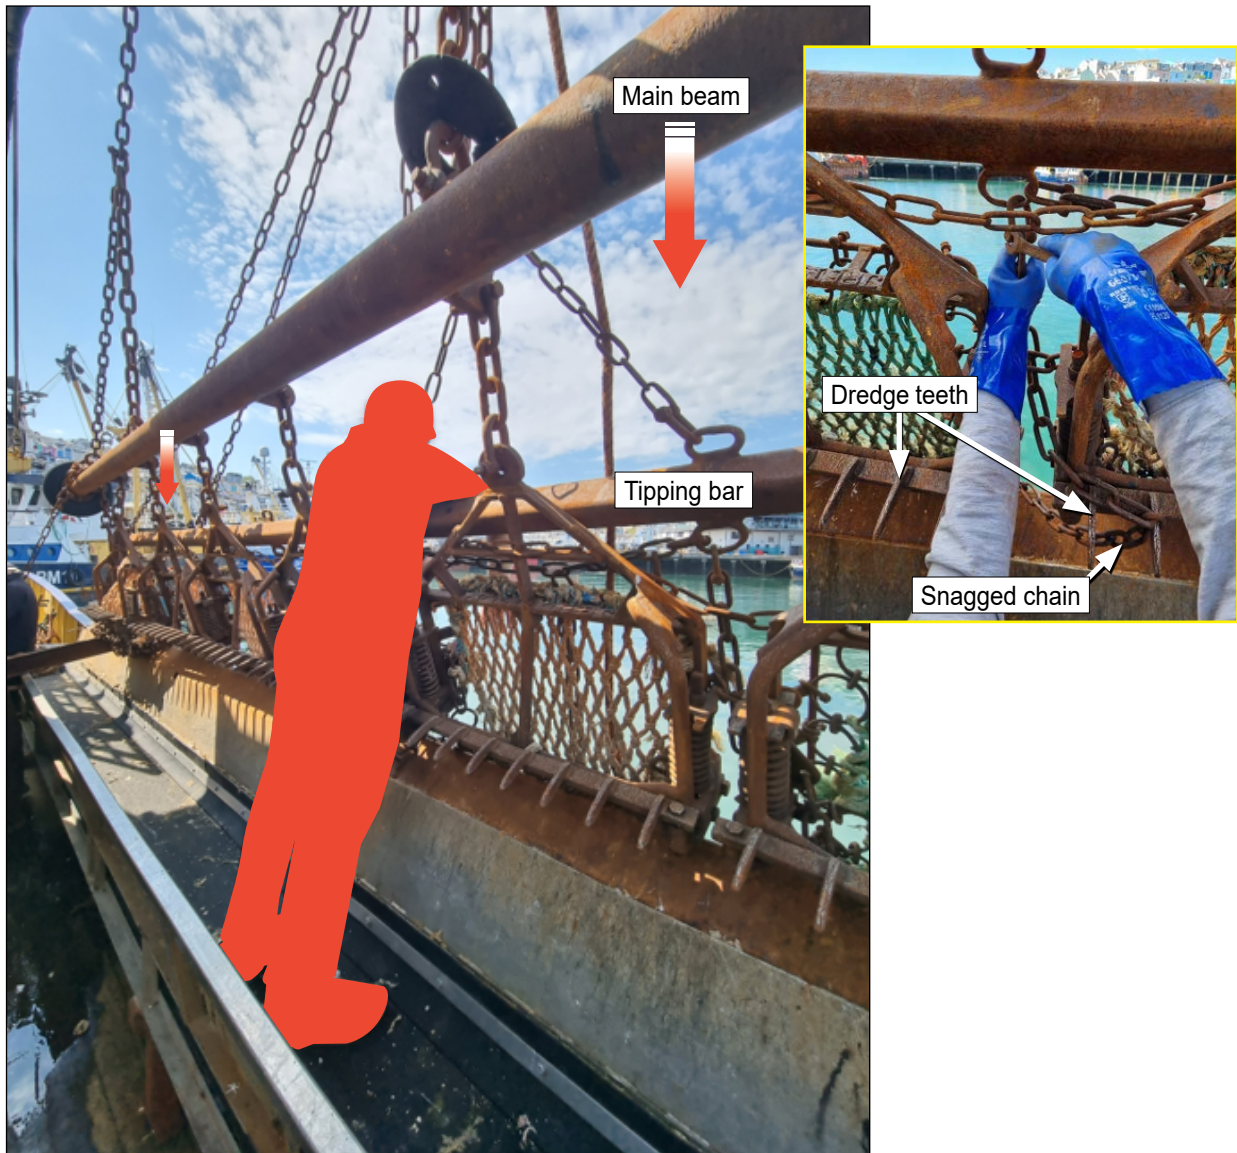
Figure: The accident

The investigation found that the accident happened because the main beam was lowered while a deckhand was positioned beneath suspended gear. The absence of documented procedures for dealing with snagged dredging gear and an incomplete understanding of the vessel's risk assessment meant that the risks associated with this task were not fully appreciated. Unsafe working practices were therefore able to develop during routine operations.

2. Owners and skippers should ensure all crew receive mandatory training and that on board familiarisation includes clear explanation of hazardous operations, safe working positions and agreed responses to regularly encountered problems such as snagged or fouled gear. Structured familiarisation and training specific to a vessel and its fishing method prevent informal practices or assumptions becoming accepted as routine practice, reducing the likelihood of unsafe actions that put crew at risk.
