# Rail Accident Report

## **Dangerous occurrence involving a portable access ramp at Norwood Junction station 1 July 2025**

Report 09/2026  
June 2026

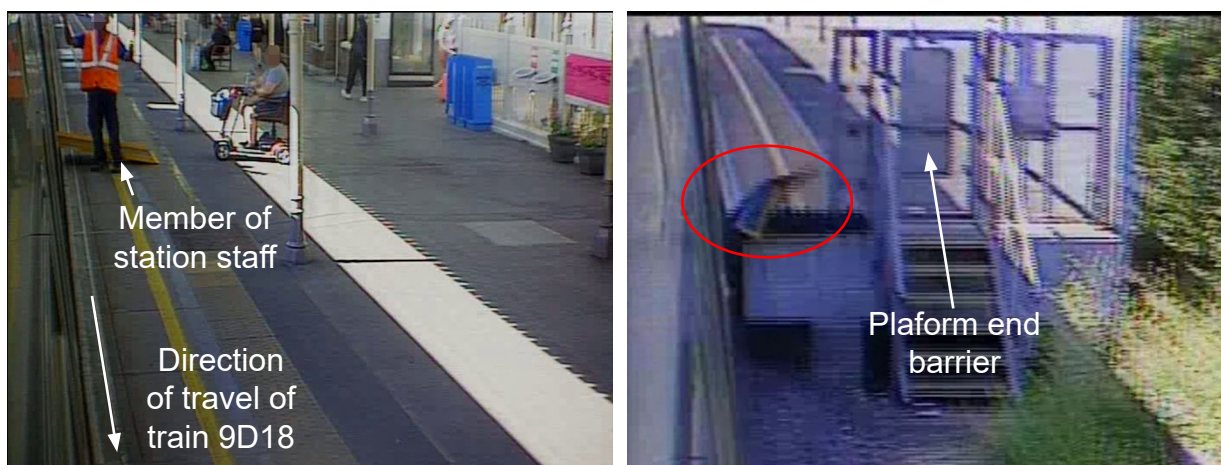
Figure 2: Portable access ramp attached to train 9D18 as it departed Norwood Junction station (left), ramp (circled in red) impacting the barrier at the end of the platform (right). Images are derived from the bodyside CCTV cameras fitted to the train (courtesy of ARL).

- 26 The ramp collided with the end-of-platform barrier and landed in the cess (the area between the running lines and the railway boundary) beyond the platform end.

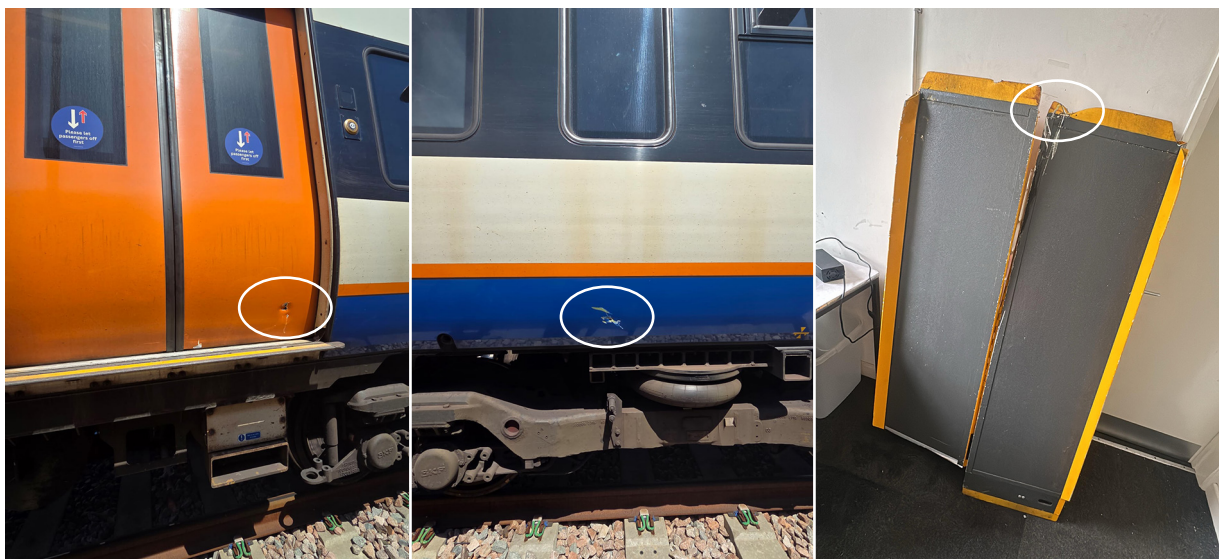
Figure 3: Damage (circled) to a door on train 9D18 (left), to side panelling (middle) and the portable access ramp (right) (courtesy of ARL).

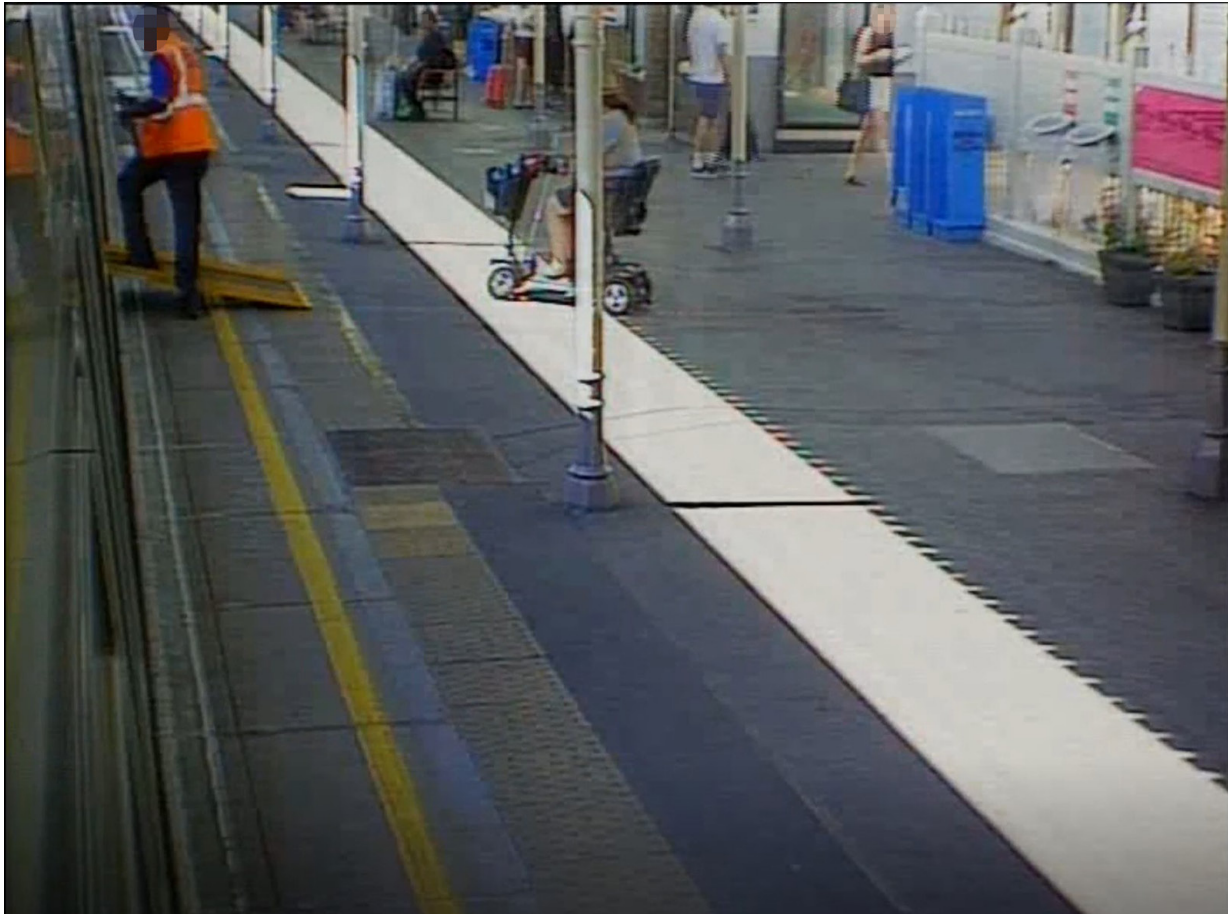
- 22 Train 9D18 arrived at platform 1 at Norwood Junction station at 09:51:35. After allowing passengers to disembark, the SAD made their way to the accessible door on the third vehicle (located in the centre of the train adjacent to the designated wheelchair space) and fitted the portable access ramp. The SAD then stood on the ramp to test that it was securely fixed to the train (figure 5).

Figure 5: SAD testing fitment of the portable access ramp (courtesy of ARL).

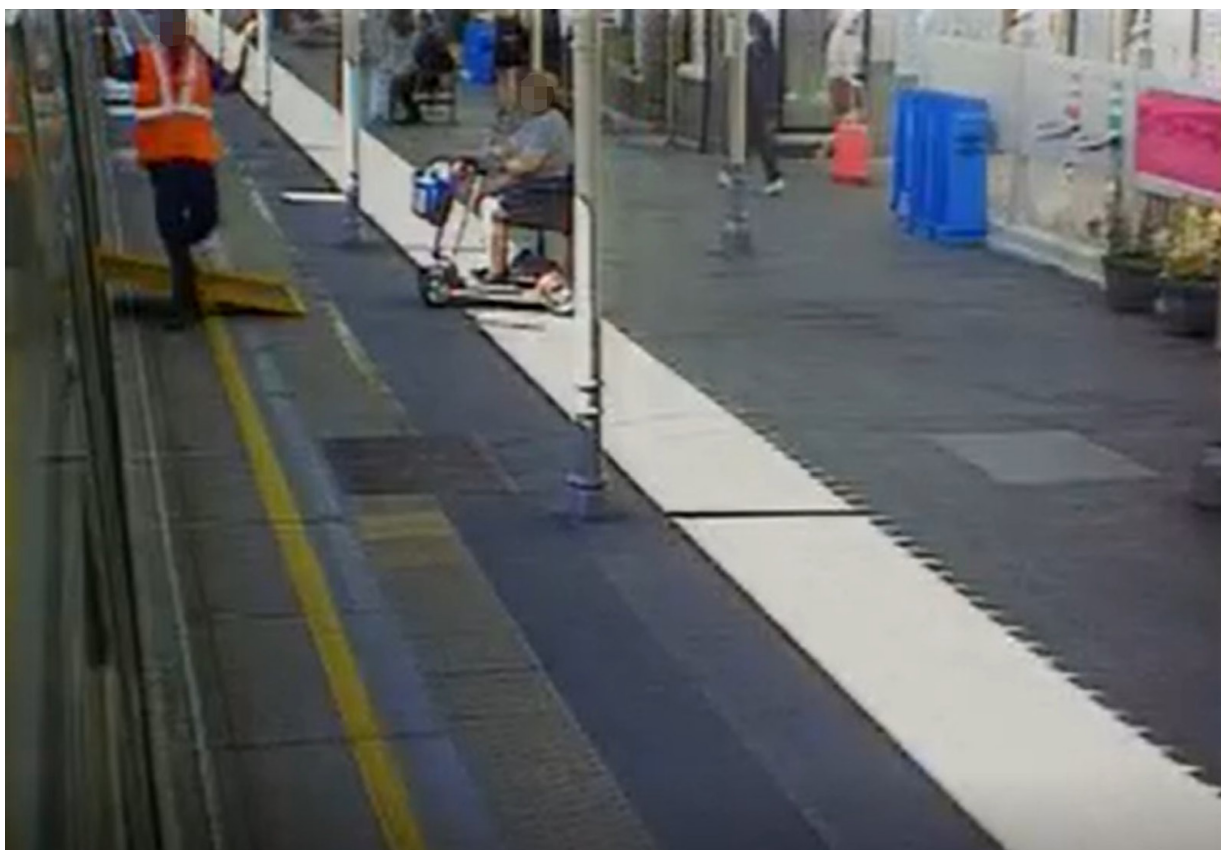
- 24 As the train started to move, the SAD stepped off the portable access ramp and attempted to use their dispatch baton to send a further visual emergency signal to the driver to stop the train.

Figure 6: SAD signalling to the driver to stop train 9D18 (courtesy of ARL).

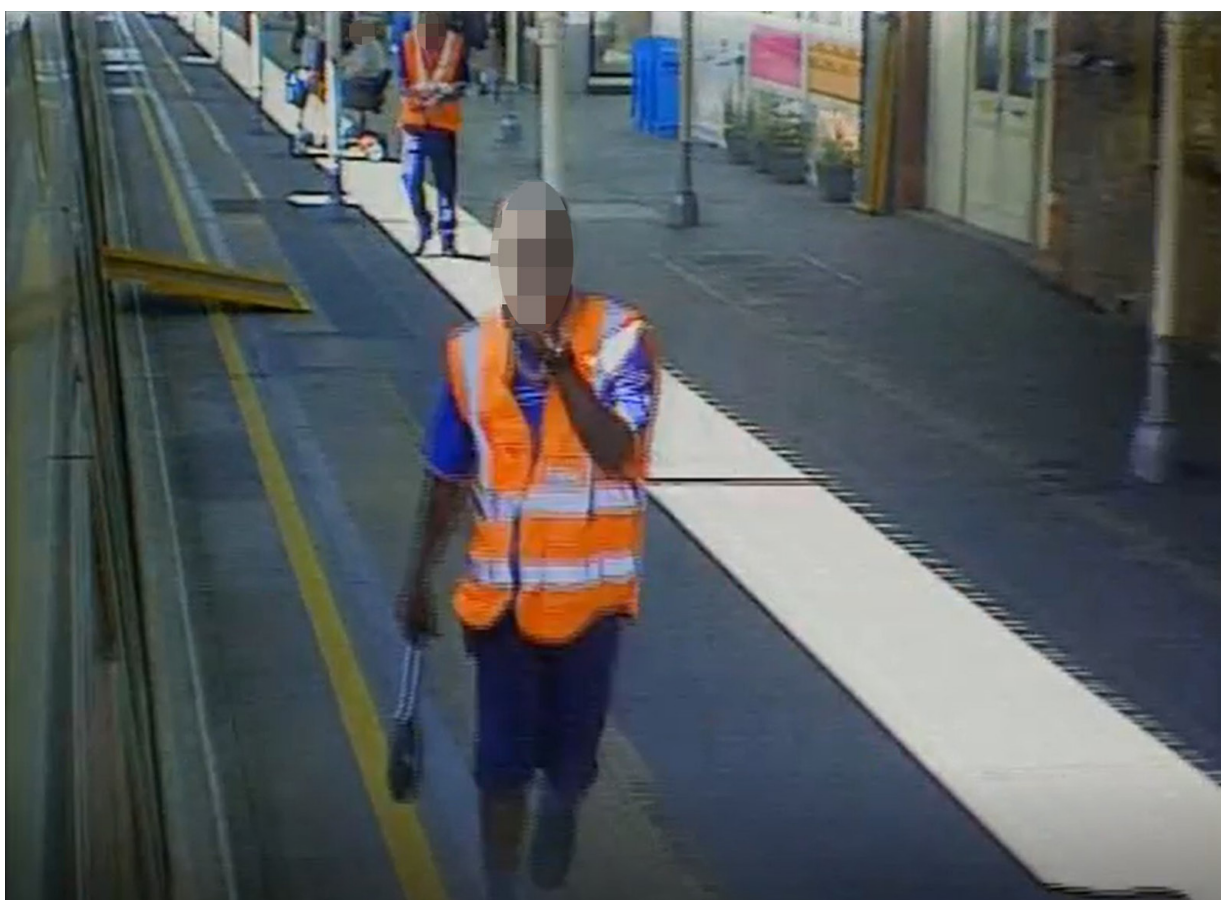
- 25 The TD was positioned further along the platform in the direction of departure. They noticed a passenger, sat on a bench along the platform, and blew their whistle to warn the passenger of the ramp being dragged by the train (figure 7). The passenger moved their legs out of the way before the ramp reached their location (figure 8).

Figure 7: TD using their whistle to warn a passenger further along the platform in the direction of travel of the approaching ramp (courtesy of ARL).

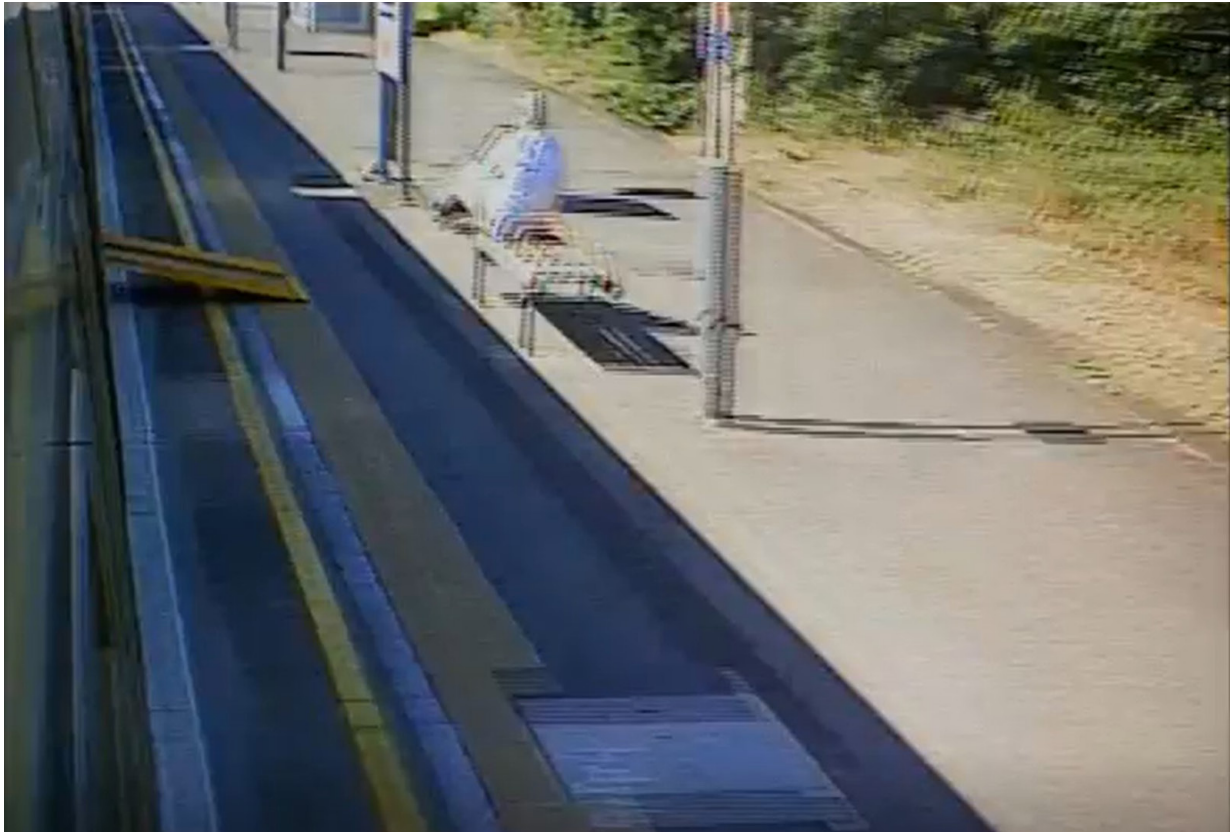
Figure 8: Member of public having moved their legs out of the way of the moving portable access ramp (courtesy of ARL).

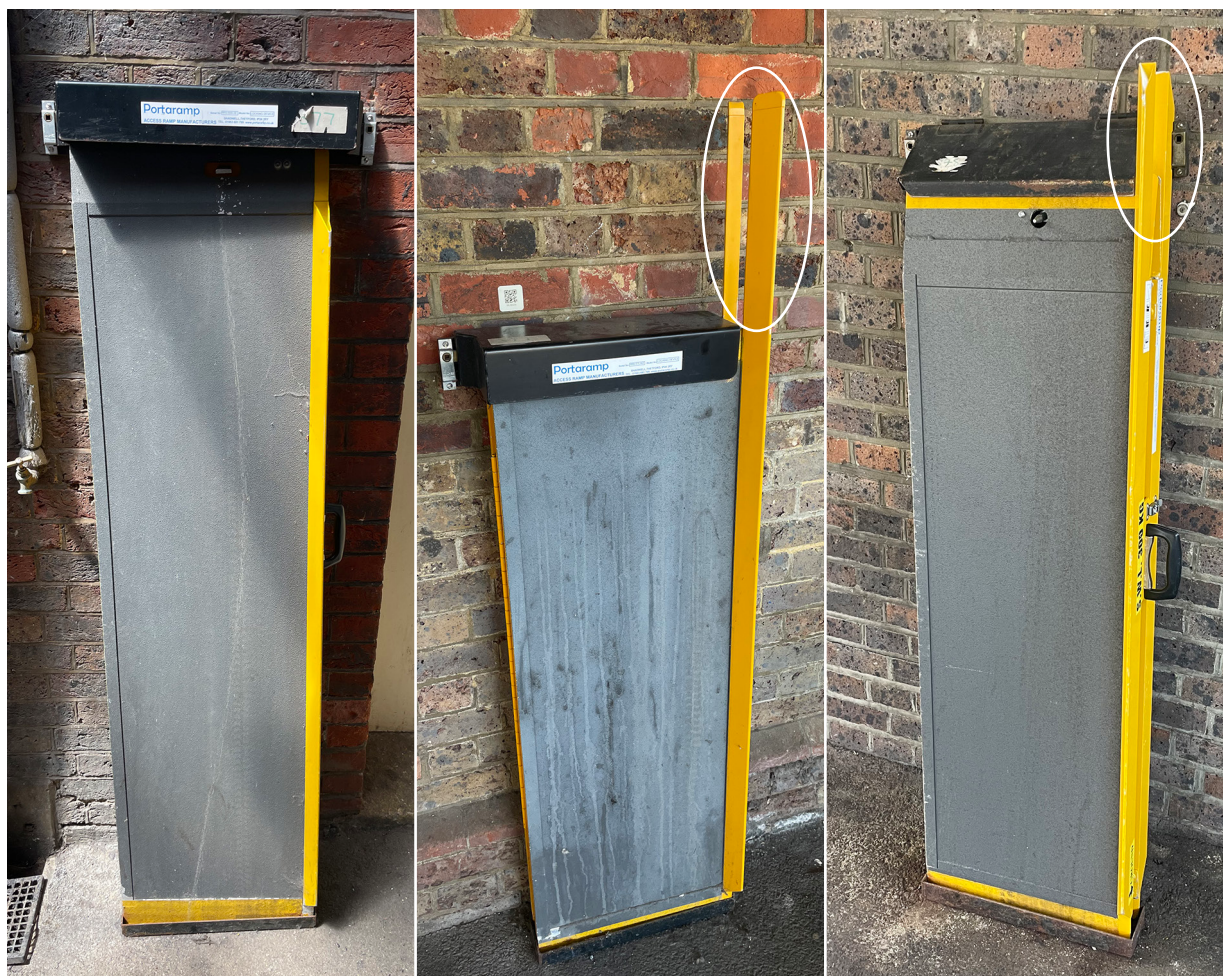
- 49 The ramp specified for a class 378 unit has location lugs that are designed to fit in holes cut in the train's step boards. As the class 378 unit has doors that open by sliding into pockets in the train's bodyside, the class 378 portable access ramp has been specified with extended arms that prevent the doors from closing if the ramp remains in place (figures 13 and 14).

Figure 13: Portable access ramps shown stored in their folded condition, on the left for a class 377 (which was also designed to work on class 455 trains that are now out of service), in the middle for a class 700 (door closure prevention arms circled), and on the right for a class 378 (door closure prevention arms circled).

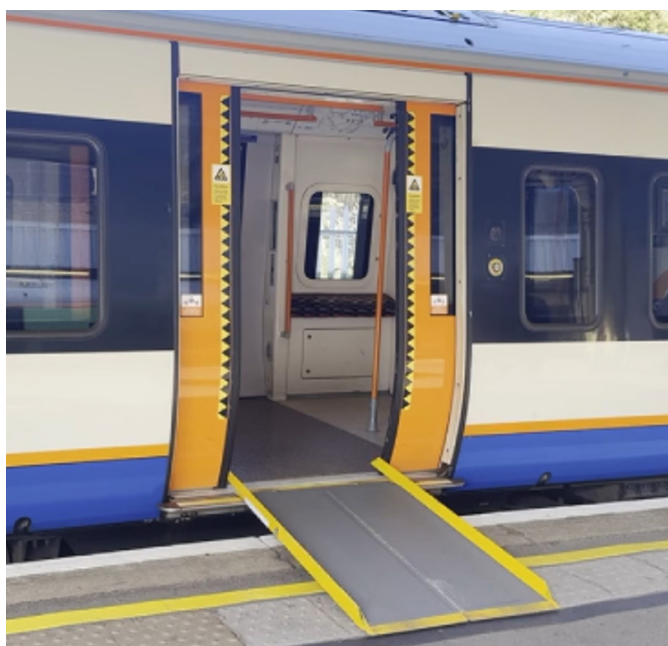
Figure 14: Door closure prevention on a class 378 electric multiple unit with correctly specified portable access ramp (courtesy of ARL).

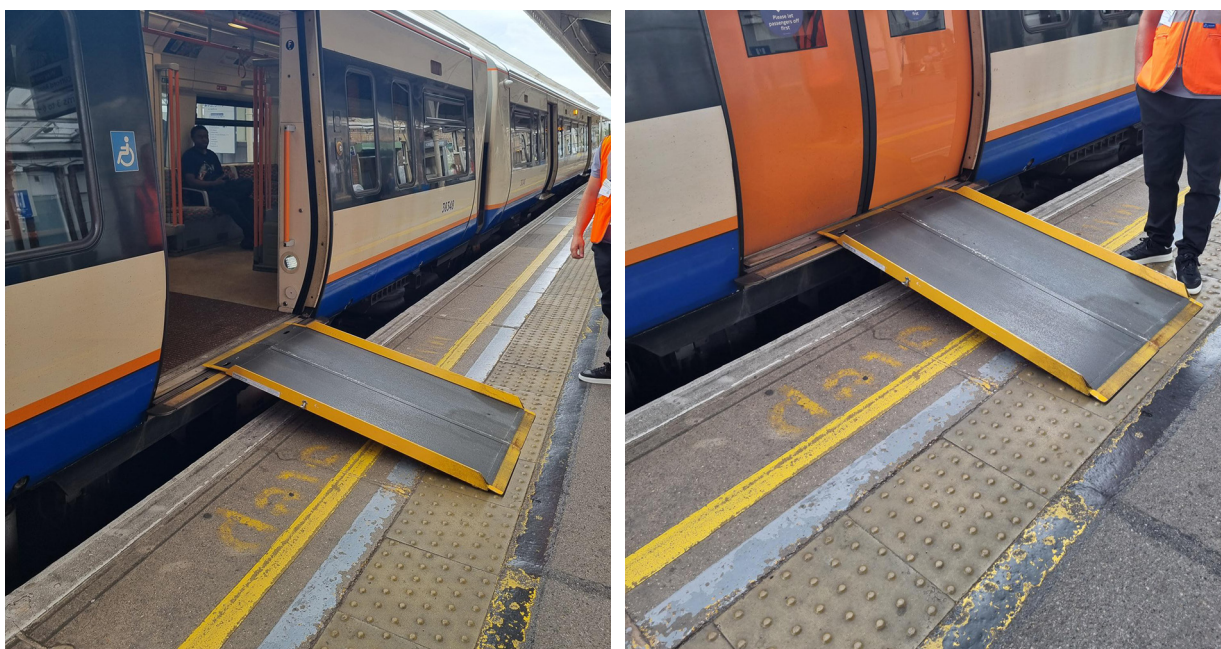
- 51 Although GTR, the operator of class 377 units, confirmed that ramps for a class 377 should not be used on a class 378 unit, the portable access ramp specified for a class 377 can nevertheless be physically attached to a class 378 using its location lugs. This means that a person of reduced mobility can be assisted to board a class 378 train using a class 377 ramp. However, as in the case of this accident, the use of a class 377 ramp on a class 378 train introduces the risk that the doors can be closed with the ramp still in place because the class 377 ramp lacks the extended arms needed to prevent this (figure 15). The train will, therefore, be able to gain door interlock and depart from the station.

Figure 15: Reconstruction of the fitment of a class 377 portable access ramp to a class 378 unit (courtesy of ARL).

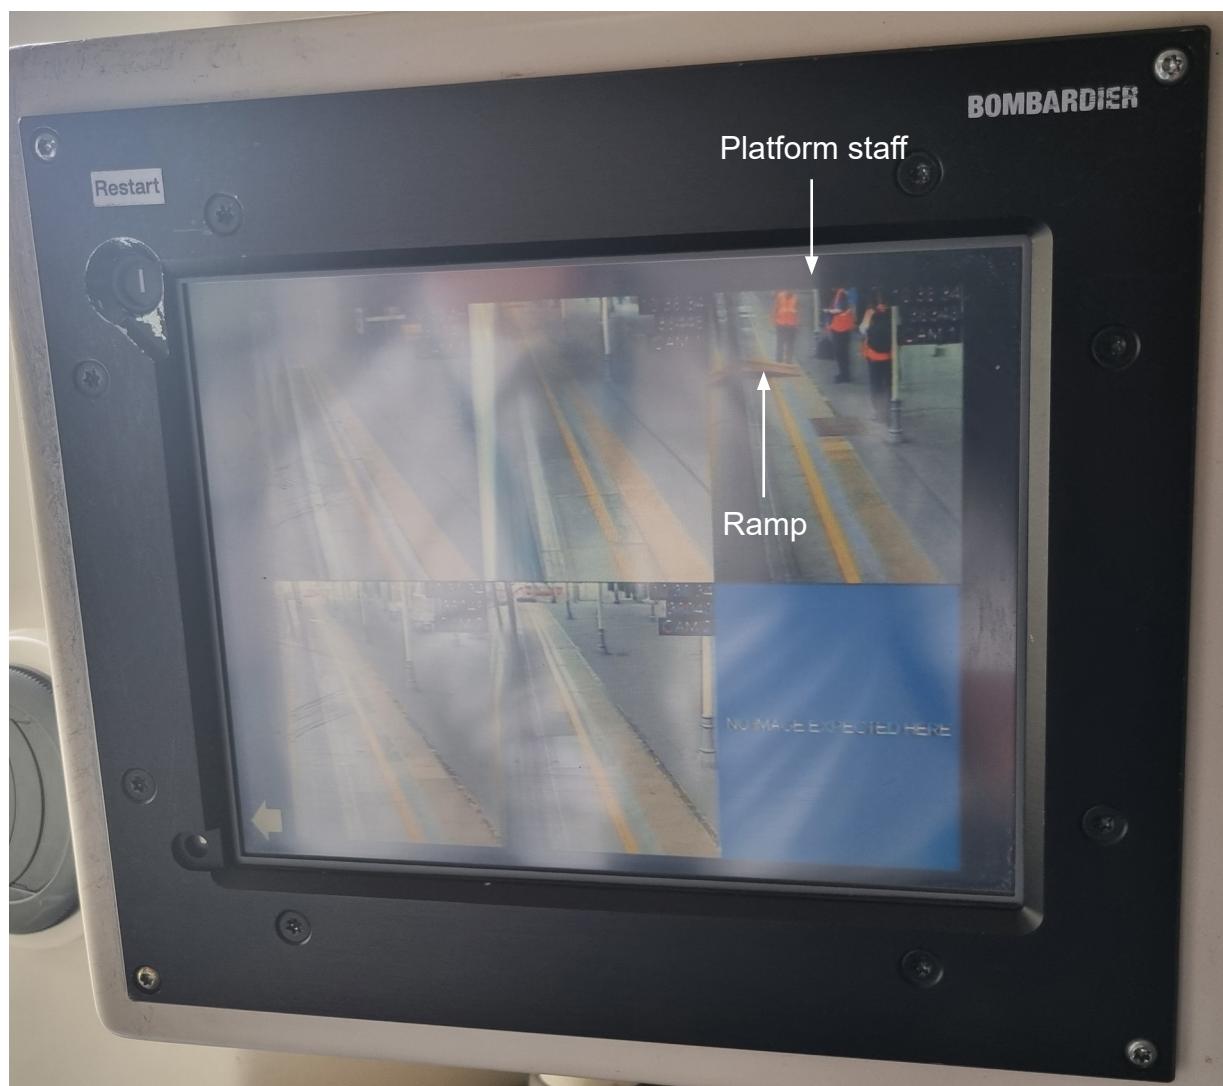
- 89 With assistance from ARL, RAIB undertook a reconstruction using a class 378 unit and a portable access ramp of the type involved in the accident. A ramp and staff in high-visibility vests can be seen on the monitors (figure 24) as they would have been during the accident. Reflections can be seen on the screens from the driver's shirt reflecting sunlight entering the driving cab. Operational drivers wear darker shirts (which the driver was wearing at the time of the accident) to combat this effect, but reflections of clothing can still be evident. There was, however, no evidence to suggest that any such reflections were a factor in this accident.

Figure 24: DOO monitor in cab of a class 378 unit from a reconstruction at Norwood Junction station showing a portable access ramp attached to car 3 and platform staff.

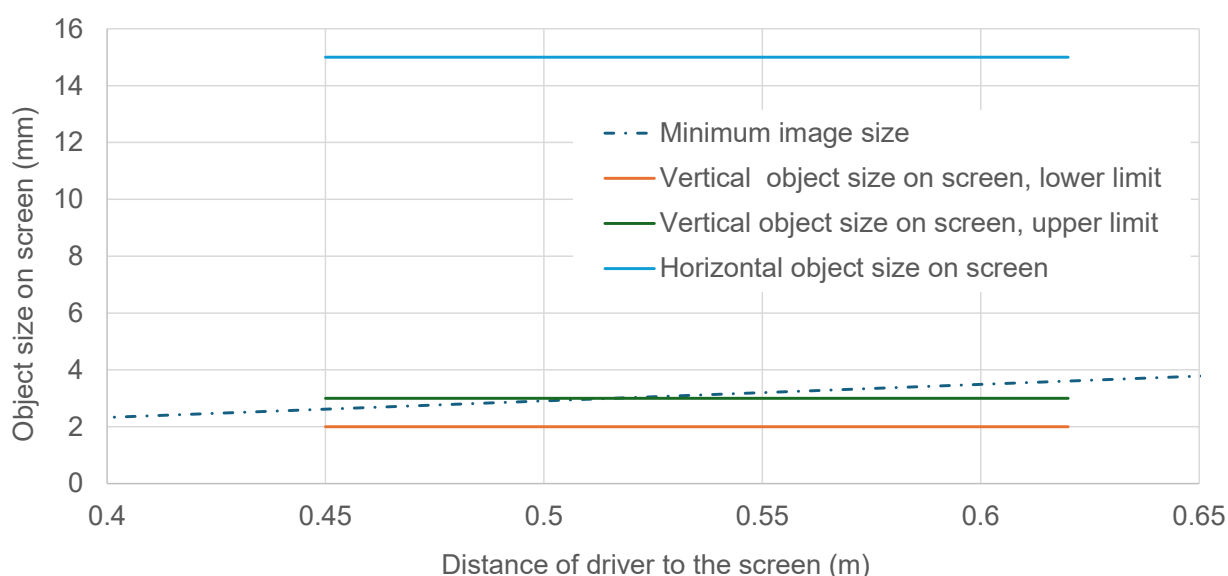
- 92 Measurements were taken of images on the screen. The image size of the portable access ramp on the screen was compliant in the horizontal plane, measuring 15 mm. However, the image was found to be marginally non-compliant in the vertical plane, measuring between 2 mm and 3 mm (figure 25). While it is possible that this reduced the conspicuity of the ramp, it was found to be clearly visible in the monitors during the reconstruction. Individuals wearing high-visibility clothing were present adjacent to the ramp, as they were during the accident, and RAIB observed that this drew further attention to the ramp.

Figure 25: Dimensions of portable access ramp in the horizontal and vertical directions for seating position limits relative to limits from RIS-2703-RST.

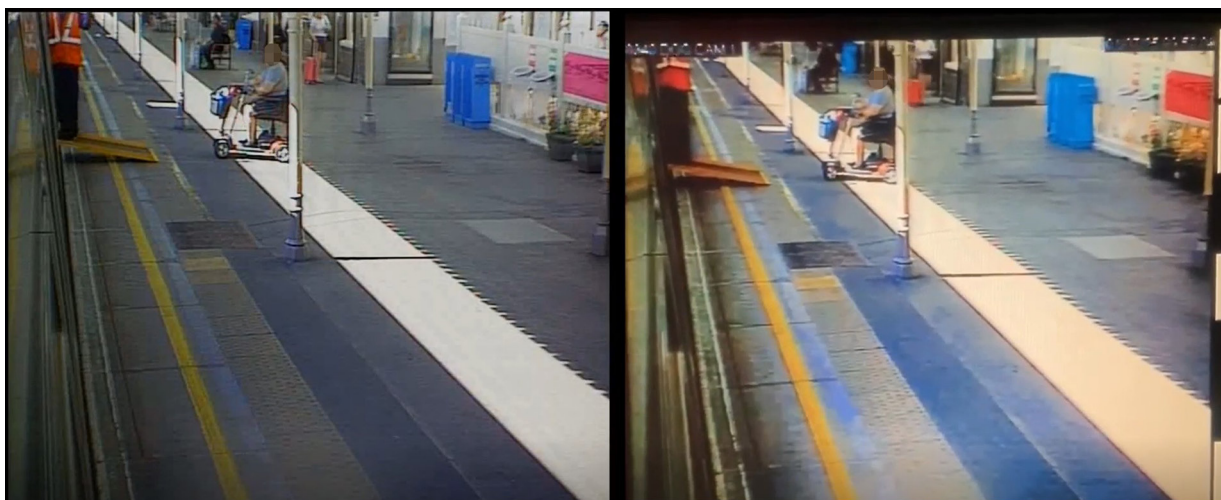
- 98 As the doors of train 9D18 closed, the SAD attempted to use an emergency hand signal. This is to raise both hands directly above the head. The SAD's hand signal does not exactly accord with the requirements of their training and operational rules, as their arms are bent at the elbow. RAIB considers that it is likely that this hand signal was not seen by the driver as the image on the in-cab monitor cropped the view of the SAD towards the top of their torso, meaning their raised arms were not visible (figure 26).

Figure 26: SAD attempting to use hand signals to stop train 9D18: to the left is the full image, to the right is the cropped image with time stamp as would be seen on the in-cab monitor (courtesy of ARL).

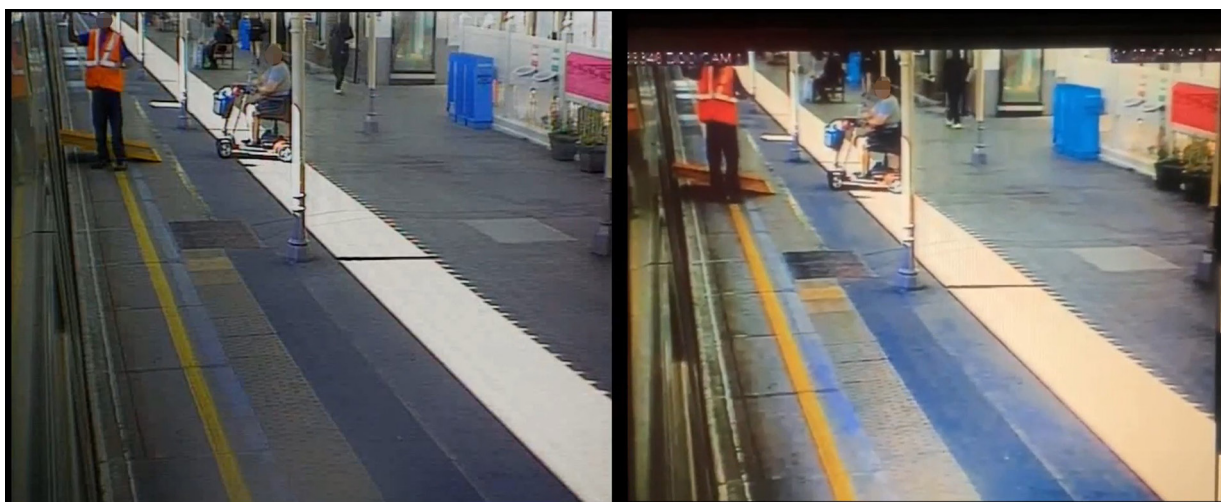
- 99 As train 9D18 began to move, the SAD stepped off the moving portable access ramp and attempted to use their dispatch baton (paragraph 40) to attract the driver's attention. This action was also cropped in the image presented to the driver (figure 27). Because ARL class 378 trains are driver dispatched, drivers are not trained to recognise a warning provided by a dispatch baton in this way and so this was also not effective in alerting the driver to the unfolding accident.

Figure 27: SAD attempting to use their dispatch baton to stop train 9D18: to the left is the full image, to the right is the cropped image with time stamp as would be seen on the in-cab monitor (courtesy of ARL).
