AAIB Bulletin

6/2026

Aircraft Type and Registration:	Leonardo AW139, G-CIMU	
No & Type of Engines:	2 Pratt & Whitney Canada PT6C-67C turboshaft engines	
Year of Manufacture:	2015 (Serial no: 31583)	
Date & Time (UTC):	13 June 2022 at 1801 hrs	
Location:	Norwich Airport	
Type of Flight:	N/A found during maintenance inspection	
Persons on Board:	Crew - None	Passengers - None
Injuries:	Crew - N/A	Passengers - N/A
Nature of Damage:	Bearing failure	
Commander's Licence:	N/A	
Commander's Age:	N/A	
Commander's Flying Experience:	N/A	
Information Source:	AAIB Field Investigation

The failure of an AW139 tail rotor duplex bearing was identified during a post-flight maintenance check from wear damage on the bearing/actuator cover. The extent of the damage to the bearing confirmed that a loss of tail rotor control event would likely have occurred had the helicopter continued to operate with the bearing fitted. The bearing is defined as a critical part and failure of a similar design of bearing fitted to an AW169 helicopter resulted in a fatal accident in 2018. Despite a full forensic assessment, the bearing was too badly damaged to determine the cause of failure. Three Safety Recommendation

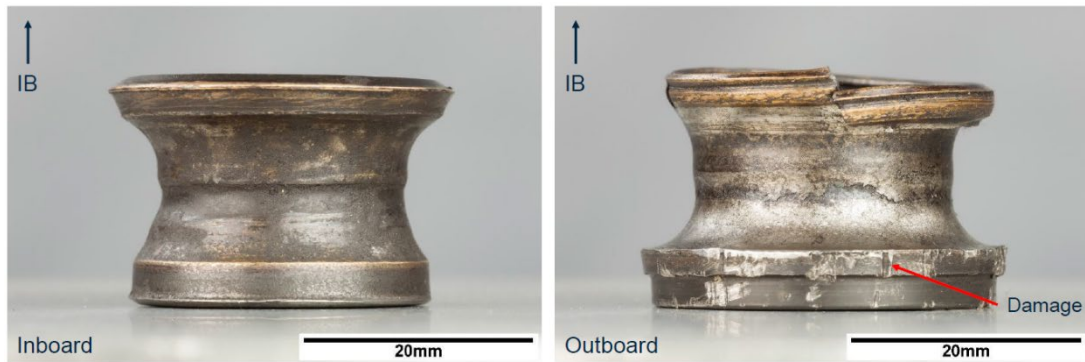
Figure 7

Both inner races were heavily worn and distorted (Figure 7). Some damage had also occurred when the operator was removing the damaged bearing from the control shaft using pliers (Figure 7). The race surfaces showed evidence of cracking and material deposition, notably copper from the cages. This layer of deposited material was approximately 10 µm thick on the inner race, but areas up to 25 µm were also observed.

Hardness testing of the inboard inner race material, resulted in hardness measurements approximately half to a third of the specified value for a new race. Etching of cross-sectional samples of the race material showed evidence of microstructural change due to heating.

Inboard and outboard inner races

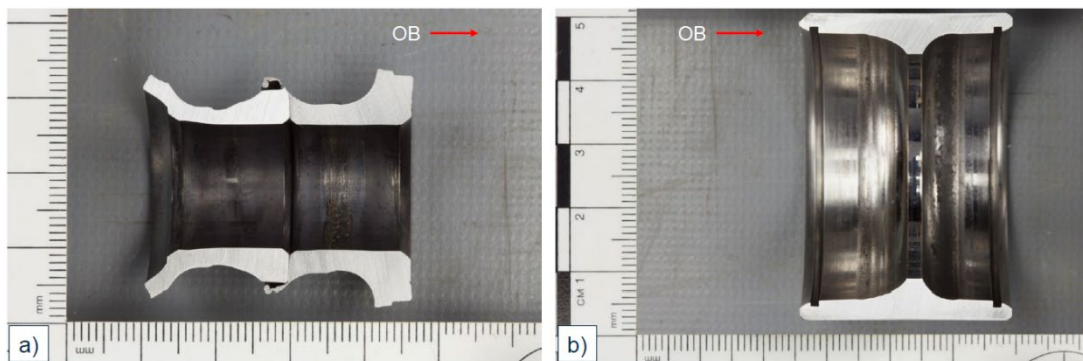
Cross sections of both inner races and the outer race in Figure 8 show the severe level of damage and distortion.

Cross section of the inner and outer races

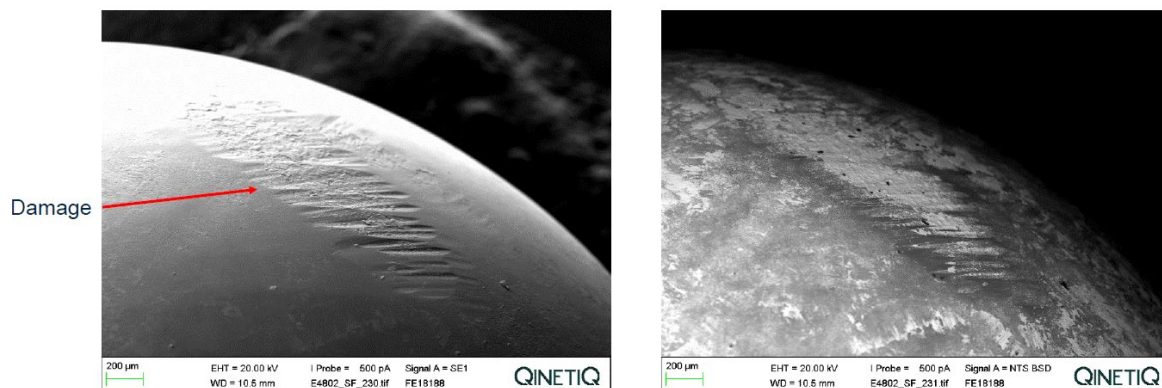
Figure 11

Assessment of the balls identified surface deposits consistent with wear material from the cages and races. The surface of one of the balls displayed damage marks indicative of sliding rather than rolling (Figure 11).

Damage marks on a ball, indicative of sliding rather than rolling
