Serious Incident

Aircraft Type and Registration:	Boeing 737-8, G-CRUX	
No & Type of Engines:	2 CFM International SA LEAP-1B27G05 turbofan engines	
Year of Manufacture:	2018 (Serial no: 44863)	
Date & Time (UTC):	22 April 2025 at 0630 hrs	
Location:	London Luton Airport	
Type of Flight:	Commercial Air Transport (Passenger)	
Persons on Board:	Crew - 6	Passengers - 162
Injuries:	Crew - None	Passengers - None
Nature of Damage:	None reported	
Commander's Licence:	Airline Transport Pilot's Licence	
Commander's Age:	61 years	
Commander's Flying Experience:	10,000 hours (of which 3,000 were on type) Last 90 days - not known Last 28 days - not known	
Information Source:	Aircraft Accident Report Form submitted by the pilot

Synopsis

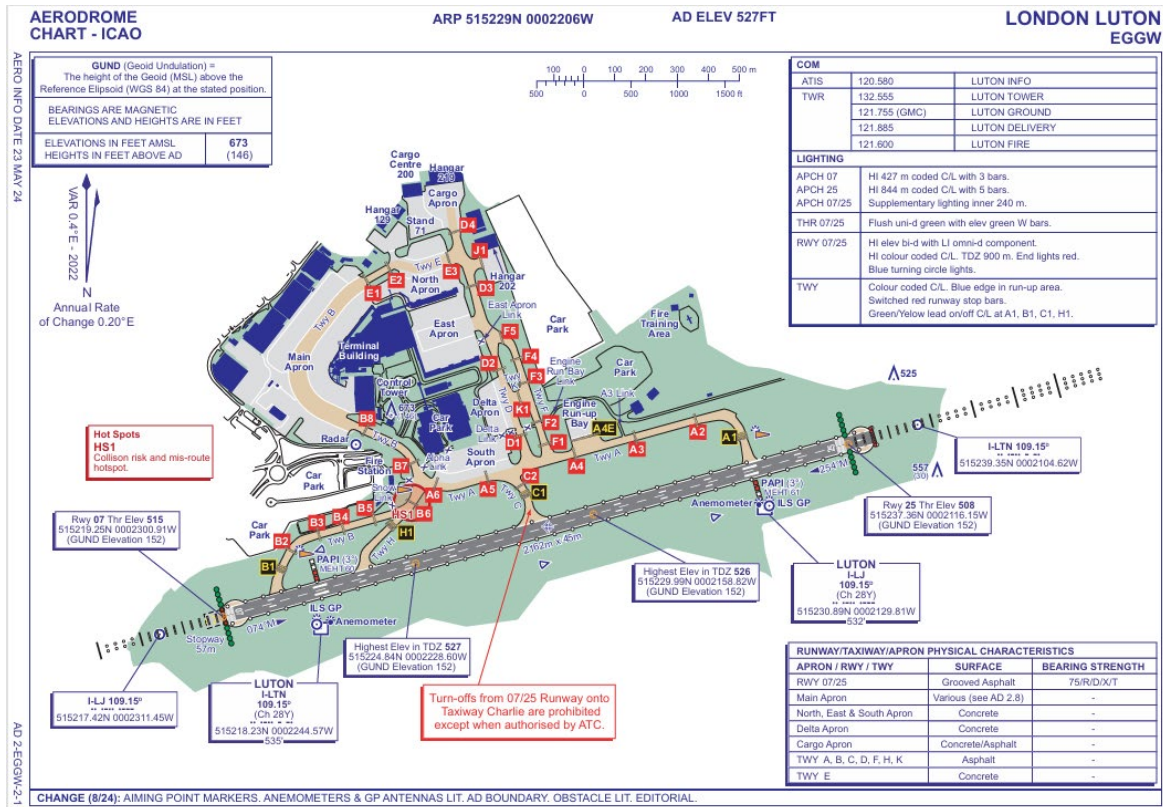
Figure 3
 London Luton Aerodrome Chart (correct Apr 2025)

The declared TORA³ from A was 1,771 m and the calculated required thrust was 85.2%.

Full length TORA was 2,116 m and the calculated required thrust was 81.4%.
