**Accident**

| <b>Aircraft Type and Registration:</b> | Jodel D18, G-BODT | |

**Synopsis**

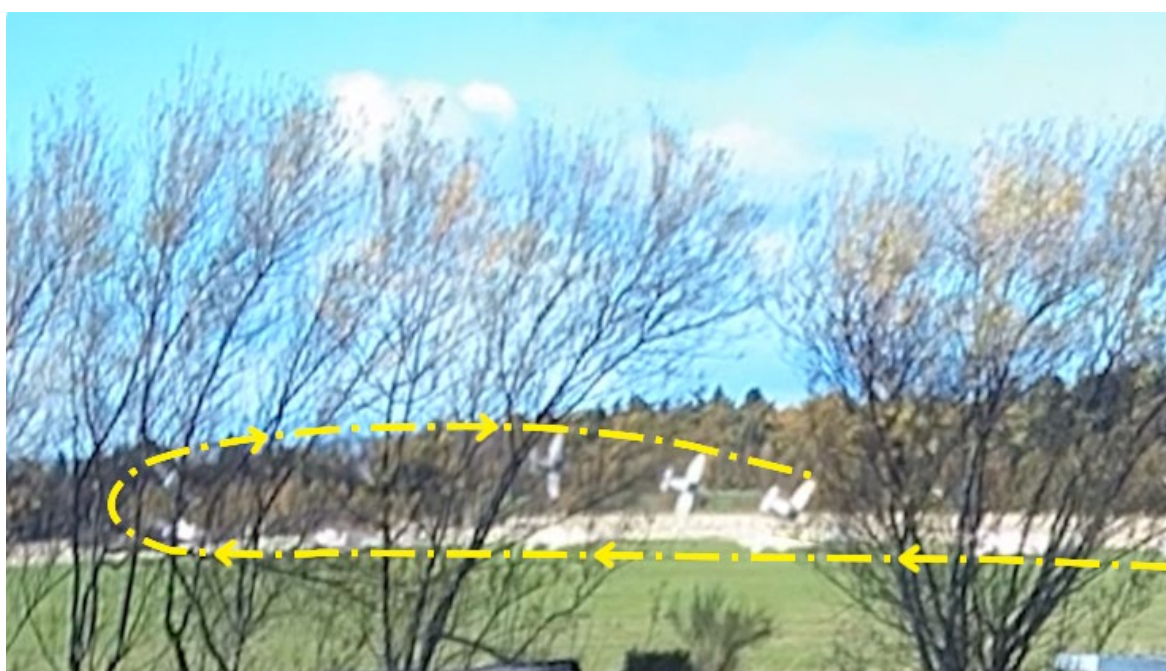
**Figure 1**

checks before lining up on the runway. It then commenced its takeoff roll. The tailwheel lifts off from the ground and a few seconds later appears to make contact with the ground again. During the final section of the ground roll, the aircraft deviated sharply to the right. Despite the deviation, the aircraft continued to accelerate and became airborne. Immediately after lifting off, the aircraft continued to yaw to the right and did not realign with the original takeoff heading. Within seconds the aircraft began to roll to the right while climbing only slightly. The rate of roll then increased rapidly, and the aircraft descended in a tightening right turn. Approximately six seconds after leaving the ground the right wingtip struck the ground followed by the nose of the aircraft. Figure 1 shows a composite photo taken from the CCTV footage.

Composite CCTV image G-BODT, arrow shows flight direction

The CCTV showed that immediately before leaving the ground, the aircraft yawed to the right which continued after the aircraft became airborne. This yaw resulted in the aircraft beginning to roll to the right with an increasing angle of bank and the nose dropping. Although it is not possible to observe the control surfaces due to the aircraft being some distance from the CCTV camera, there is no evidence on the footage of the aircraft beginning to recover from the high angle of bank before it struck the ground.
