## 11. Overspeeding

# Important areas for safety learning

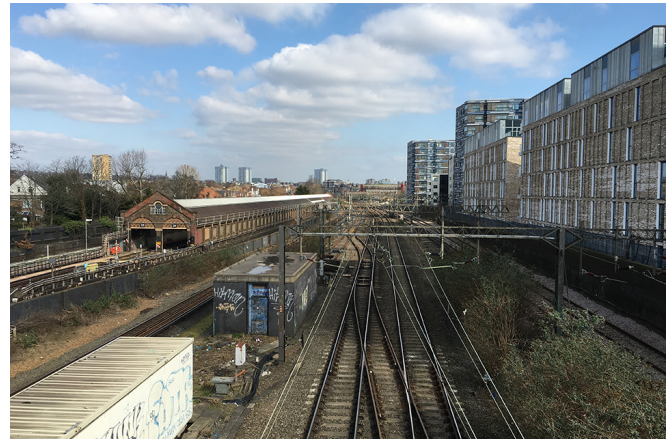
At Queen's Park (north London) on 5 January 2016, a driver manager who was being assessed by another driver manager travelled through a 5 mph (8 km/h) ESR at 75 mph. During its investigation ([report 19/2016](#)), RAIB found that the driver manager who was being assessed did not slow the train for the emergency speed restriction due to misunderstanding details of the restriction given in an email.

*Location of the incident at Queen's Park.*
