**Incident**

| <b>Aircraft Type and Registration:</b> | Embraer 190AR, ZS-YAD | |
| <b>Date &amp; Time (UTC):</b> | 17 June 2023 at 1235 hrs | |
| <b>Location:</b> | St Helena Airport | |

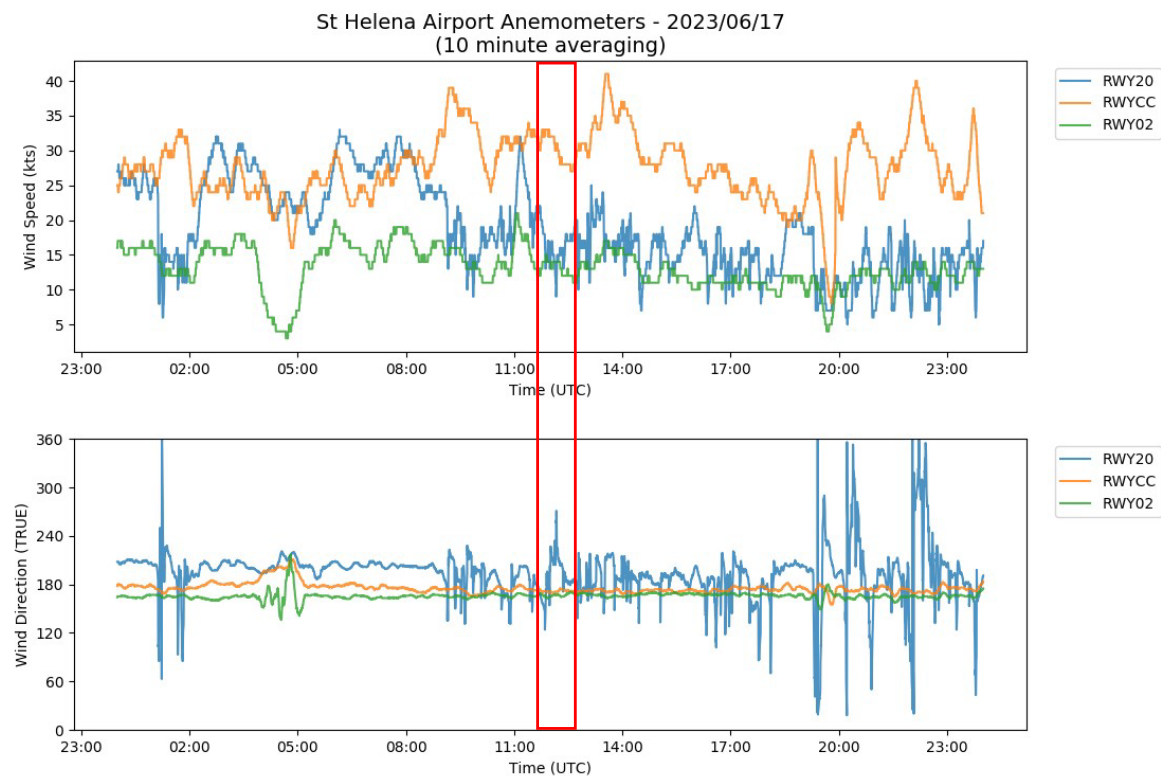
**Figure 1**

The Met Office provided recordings of the actual wind conditions at St Helena Airport for both 17 June and 10 September 2023. On 17 June, at the aircraft's planned arrival time of 1325 hrs, the 10-minute average wind speed at the mid-point reached 40 kt. The general wind direction was around 180° true at the Runway 19 mid-point and 180°/160V220 for the Runway 19 threshold.

St Helena Airport Wind Recordings - 17 June 2023

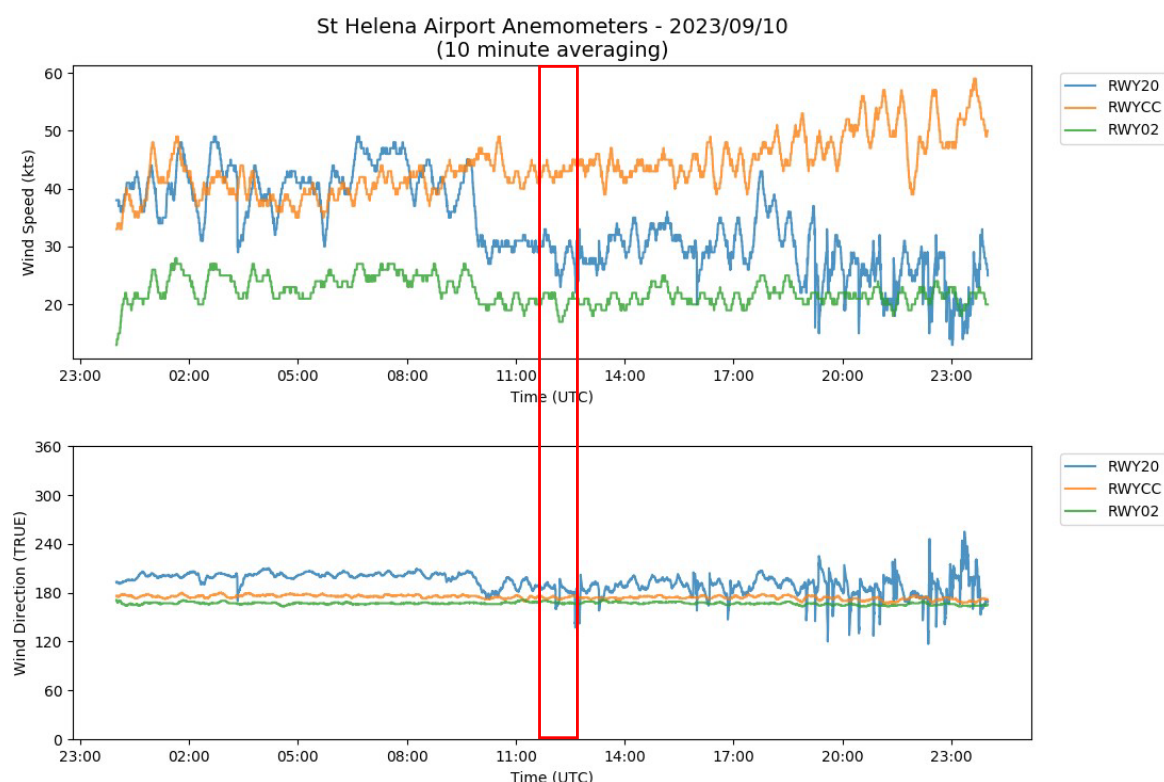
**Figure 2**

On 10 September, the 10-minute average wind speed at the Runway 19 mid-point was consistently 40 kt and above, and at the threshold around 30 kt. The wind direction gave a general head wind along Runway 19.

St Helena Airport Wind Recordings - 10 September 2023
