# ***AAIB Bulletin***

***7/2026***

Published: 9 July 2026.

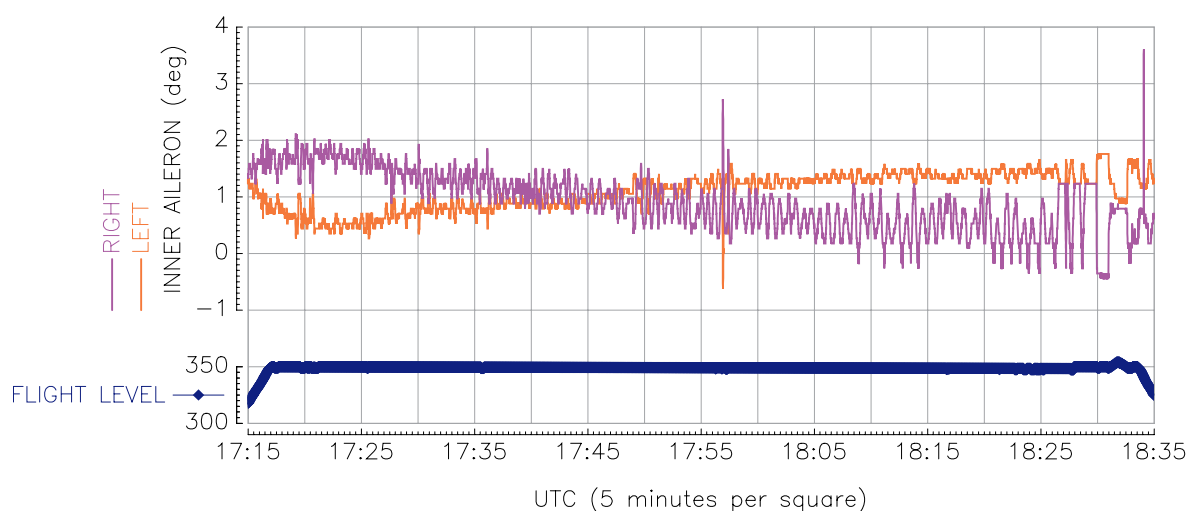
**Figure 1**

Figure 1 plots the inner aileron deflection, with the autopilot on, recorded on the flight data recorder, for the 75 minutes the aircraft was at FL350. Prior to this period and during the 52 hours of recorded data from the previous 22 flights, both ailerons moved in equal but opposite amounts about a nominal position. However, Figure 1 shows that at the beginning of this period, the right aileron was starting to move more than the left aileron, and this differential in movement grew to over four times the amount by the end.

Inner aileron deflection during flight while at FL350

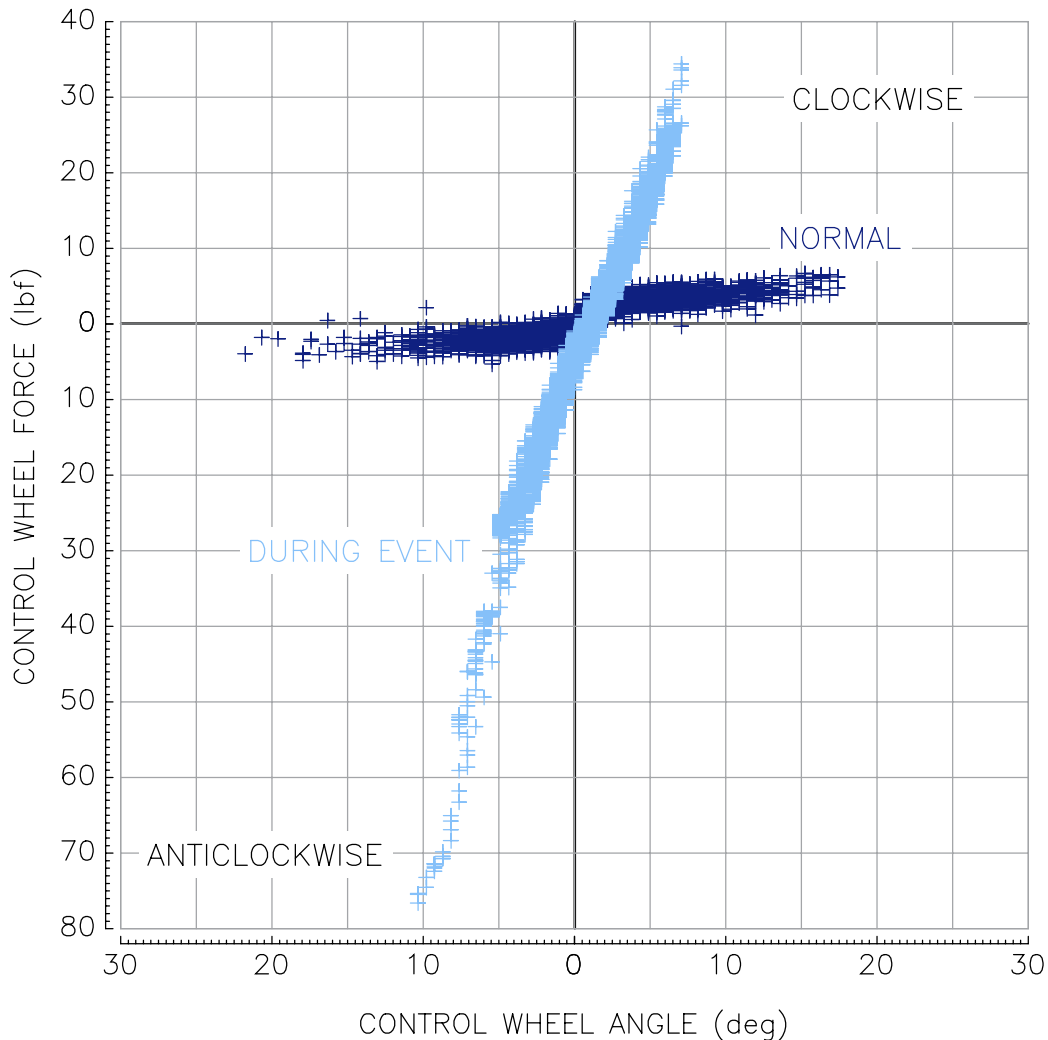
**Figure 2**

flight during the descent from FL350 to FL200. The figure shows that the force required to move the wheel during the event was 15 times more than 'NORMAL'.

The maximum recorded force was 76.6 lbf after which the force required to move the wheel returned to those in the 'NORMAL' region.

Control wheel force versus control wheel angle

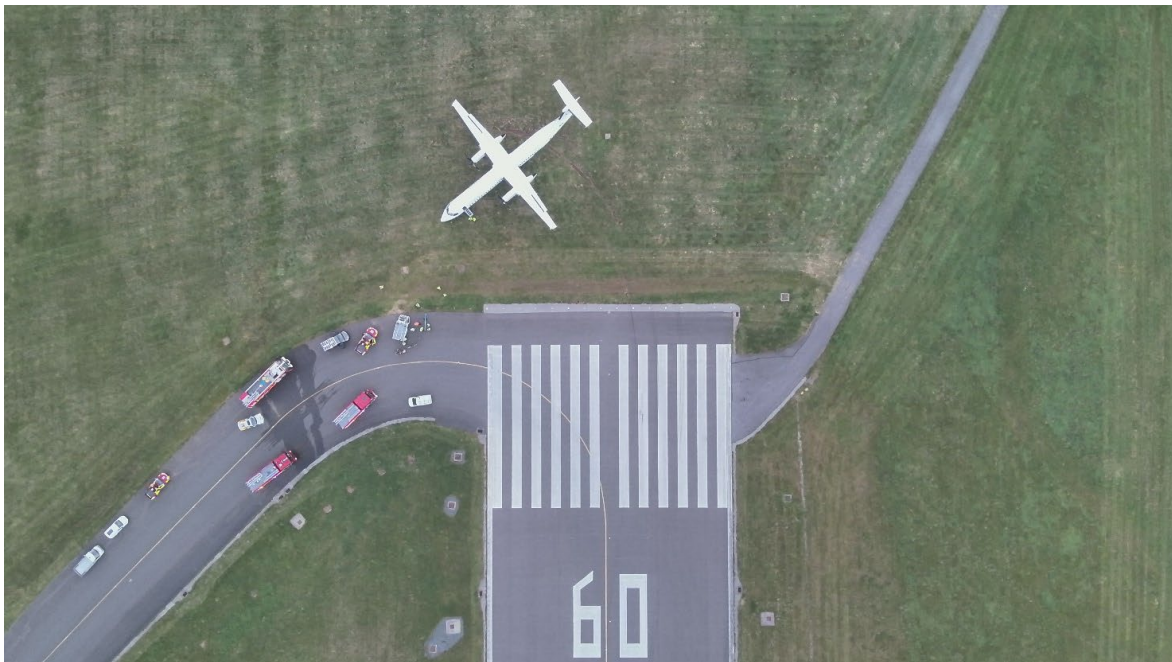
**Figure 2**

The aircraft stopped approximately 30 m from the end of the runway in the grassed area (Figure 2), the main landing gear (MLG) had ploughed a deep furrow in the grass, and the nose gear right wheel had accumulated a thick layer of soil. There were tyre markings on the runway showing the aircraft veering to the right towards the end of the runway. The tyre markings had the characteristic intermittent skid pattern showing where the Anti-Skid system was functioning. Other than disruption of the grassed area there was no other damage to the airfield surfaces or equipment.

Location of aircraft (image used with permission)

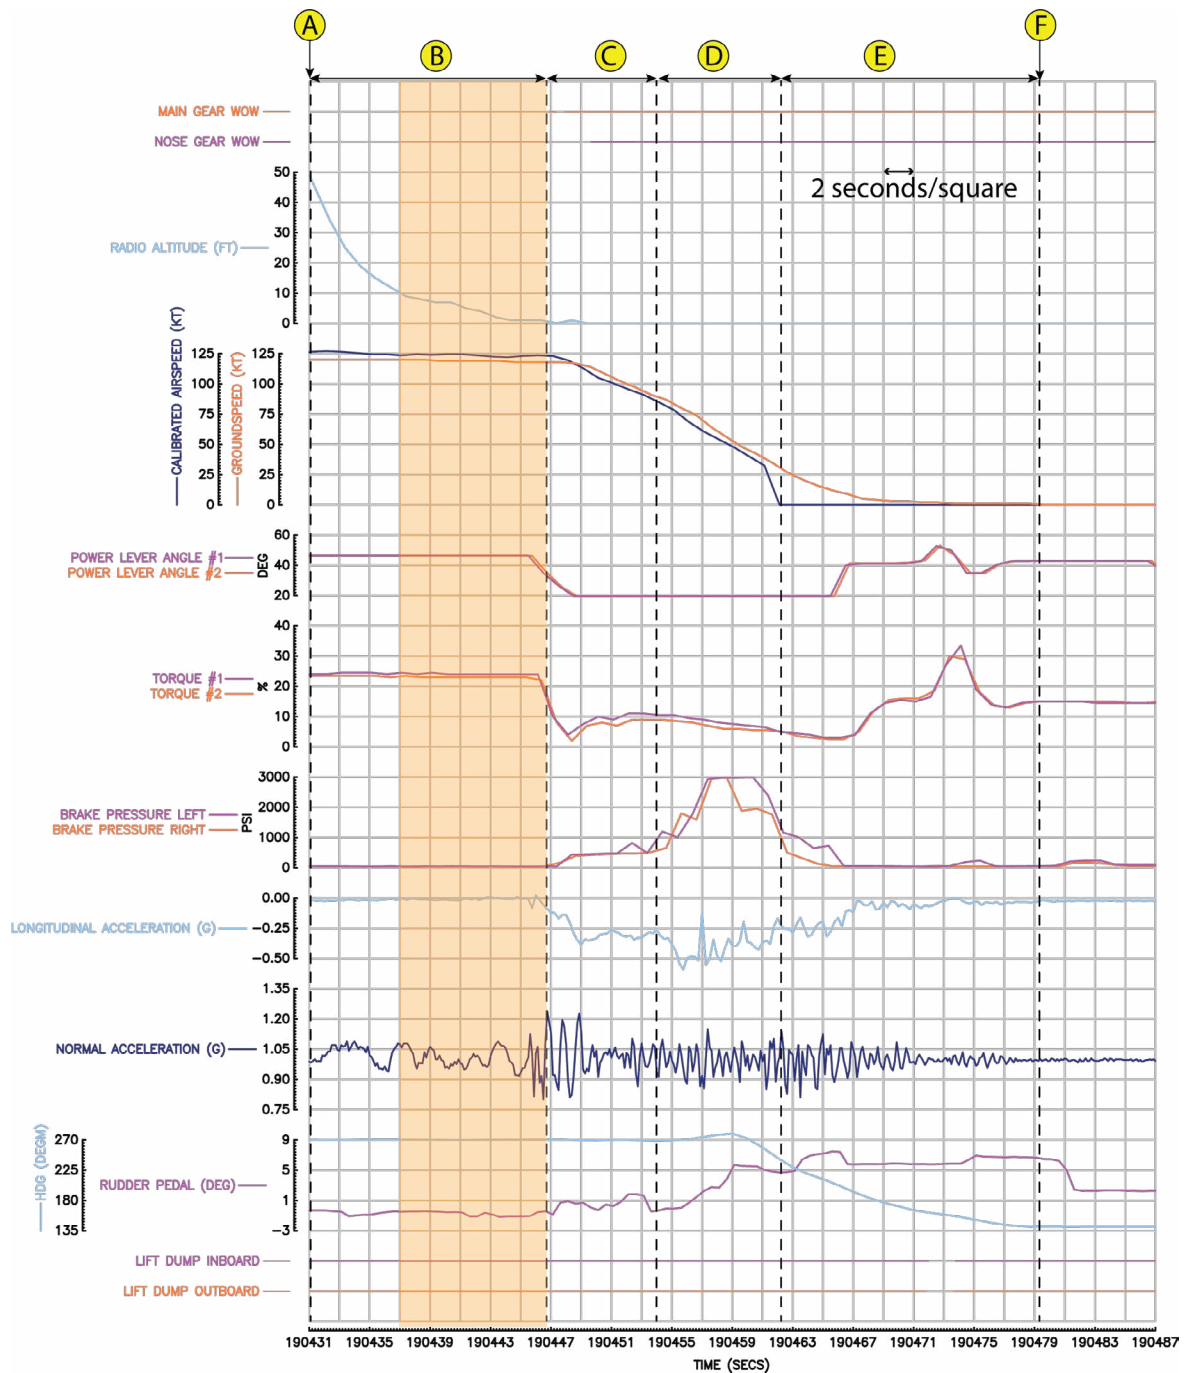
**Figure 3**  
FDR data of the landing

This shows that 9H-LWB passed over the runway threshold at a height of 50 ft and with an airspeed of 124 kt, point A on Figure 3. Region B on Figure 3 shows 9H-LWB’s descent from 50 ft to main landing gear touchdown and, the shaded region, represents the time that 9H-LWB was below 10 ft but hadn’t yet touched down. During this 10 second period, with a ground speed of 120 kt, equivalent to 62 m/s, 9H-LWB would have consumed 620 m of the available landing distance (1,463 m). Region C shows that after a small bounce on the main landing gear manual braking was applied, using 500 psi out of 3,000 psi that was

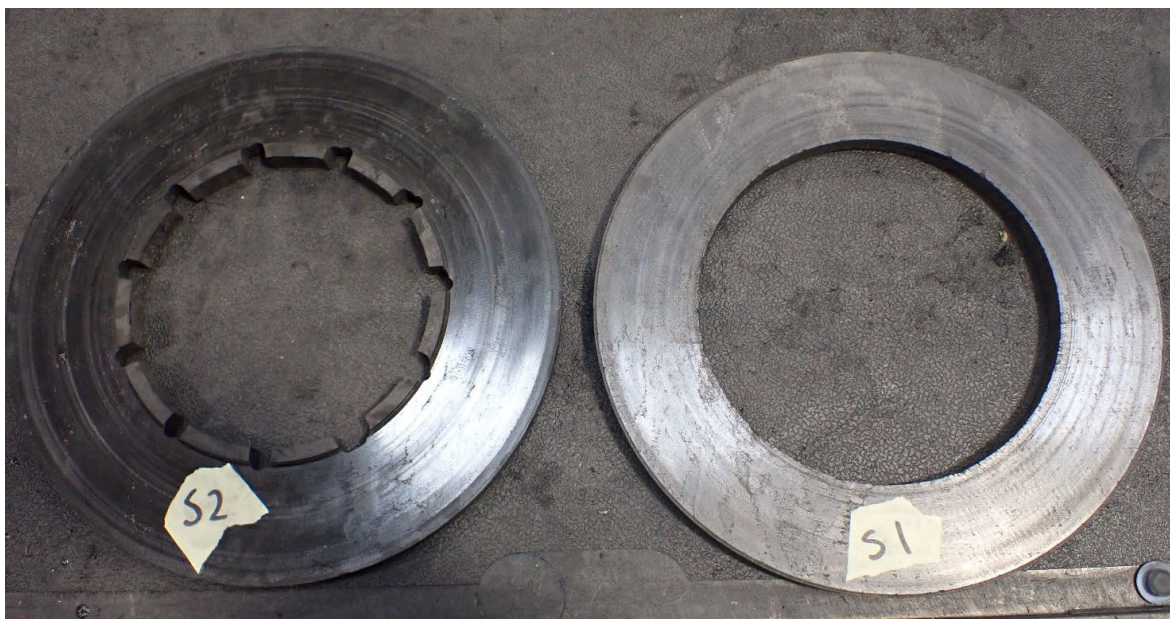
**Figure 6**

The brake unit with the broken stator was taken to the manufacturer for further examination. When disassembled it was found that stator No S1 had lost all its locating lugs (Figure 6) and was free to rotate around the brake torque tube.

Comparison of stators S2 and S1 showing lug wear on S1

The locating lugs which are made of carbon had been filed away by the splines on the torque tube. This occurred because the torque tube had suffered severe corrosion causing the surface to be rough, effectively acting as a file on the carbon locating lugs. The torque tube was sent for a metallurgical examination to understand what had caused the corrosion. The examination confirmed that at some point in its overhaul history the torque tube nickel

alloy surface had been incorrectly treated with a high temperature resistant coating such as paint. This was evidenced by the presence of aluminium on the surface of the torque tube and in the corrosion pits. The manufacturer concluded that this would have an approximate 25% reduction in braking performance on this individual brake unit, but that this effect would be compensated for by the Anti-Skid system. Analysis of braking distance performance showed that the increase in braking distance between the fully working brake system and the worst case of a seized brake calliper for a wet runway is an additional 13 metres of braking distance. The AMM<sup>3</sup> for the aircraft calls for a visual inspection of the brake unit for signs of wear, damage and cleanliness, but does not require a physical check for stator movement of brake units during tyre/wheel changes. The thickness of brakes is monitored during operation and these will be removed for repair and overhaul as required and also checked as part of the aircraft base maintenance cycle. It was not possible to determine if the stator had become completely detached prior to the flight on which the serious incident occurred.

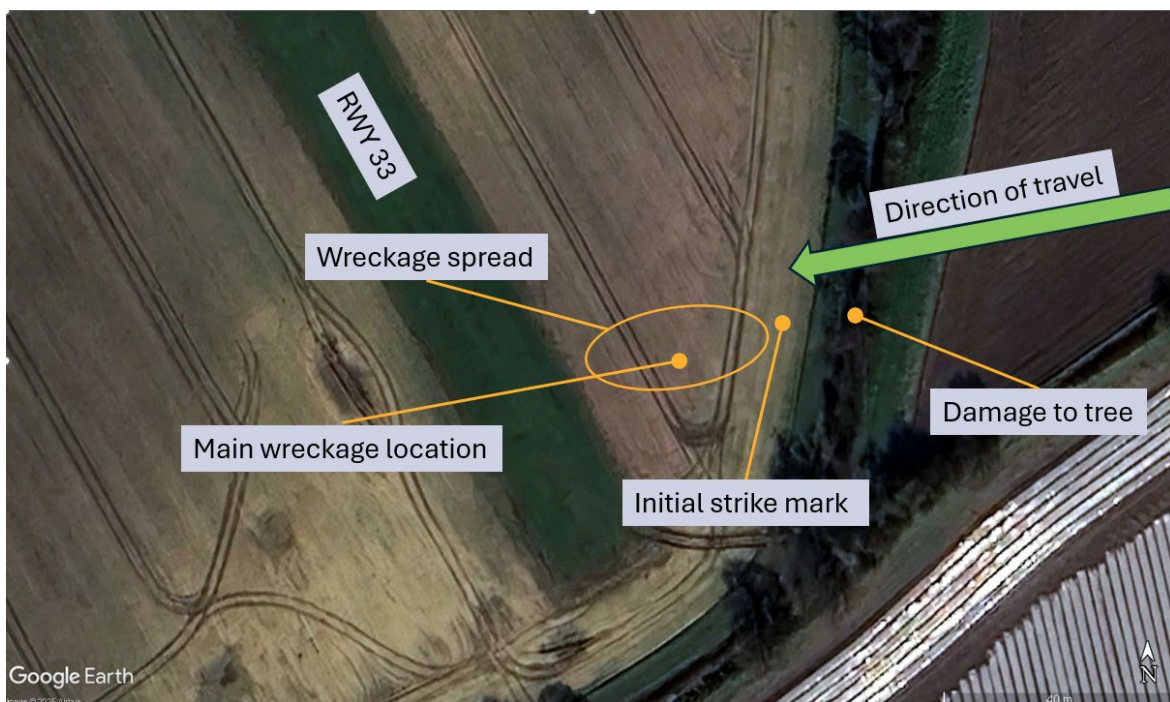
**Figure 1**

The aircraft had come to rest in cultivated farmland to the east of the grass strip of Shenstone Hall Airfield (Figure 1).

G-TOMX accident site location

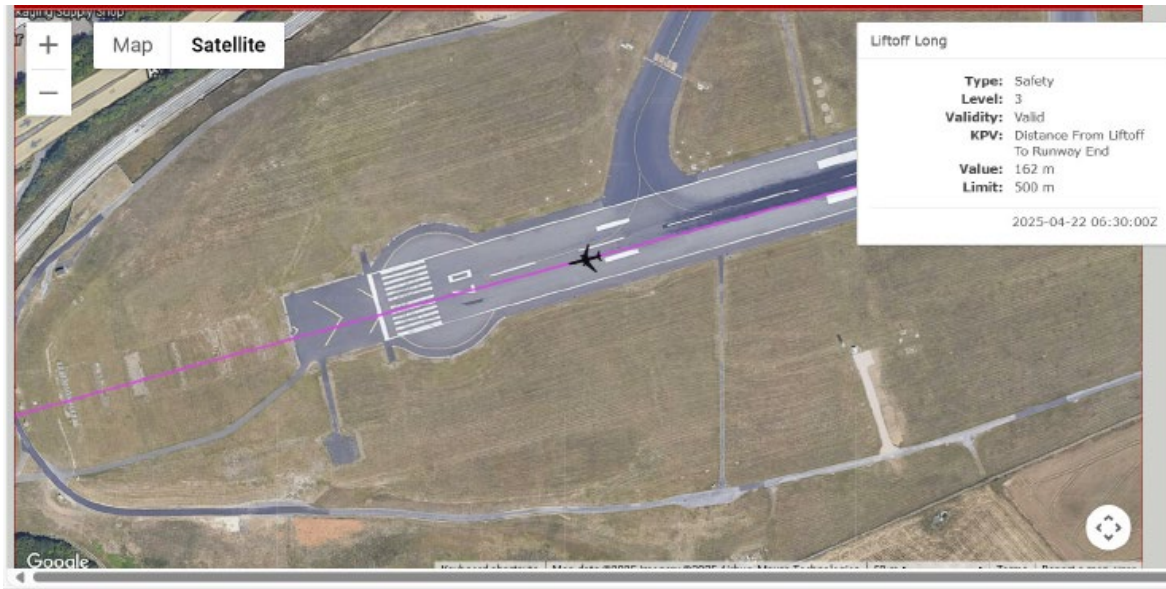
**Figure 1**

instead of the required 85.2% and the  $V_2$  speed was not changed between initial data entry during flight preparation and takeoff, which resulted in the aircraft lifting off 162 m from the end of the paved runway surface (Figure 1).

Flight Data overlay of Google satellite image showing the aircraft lift off point

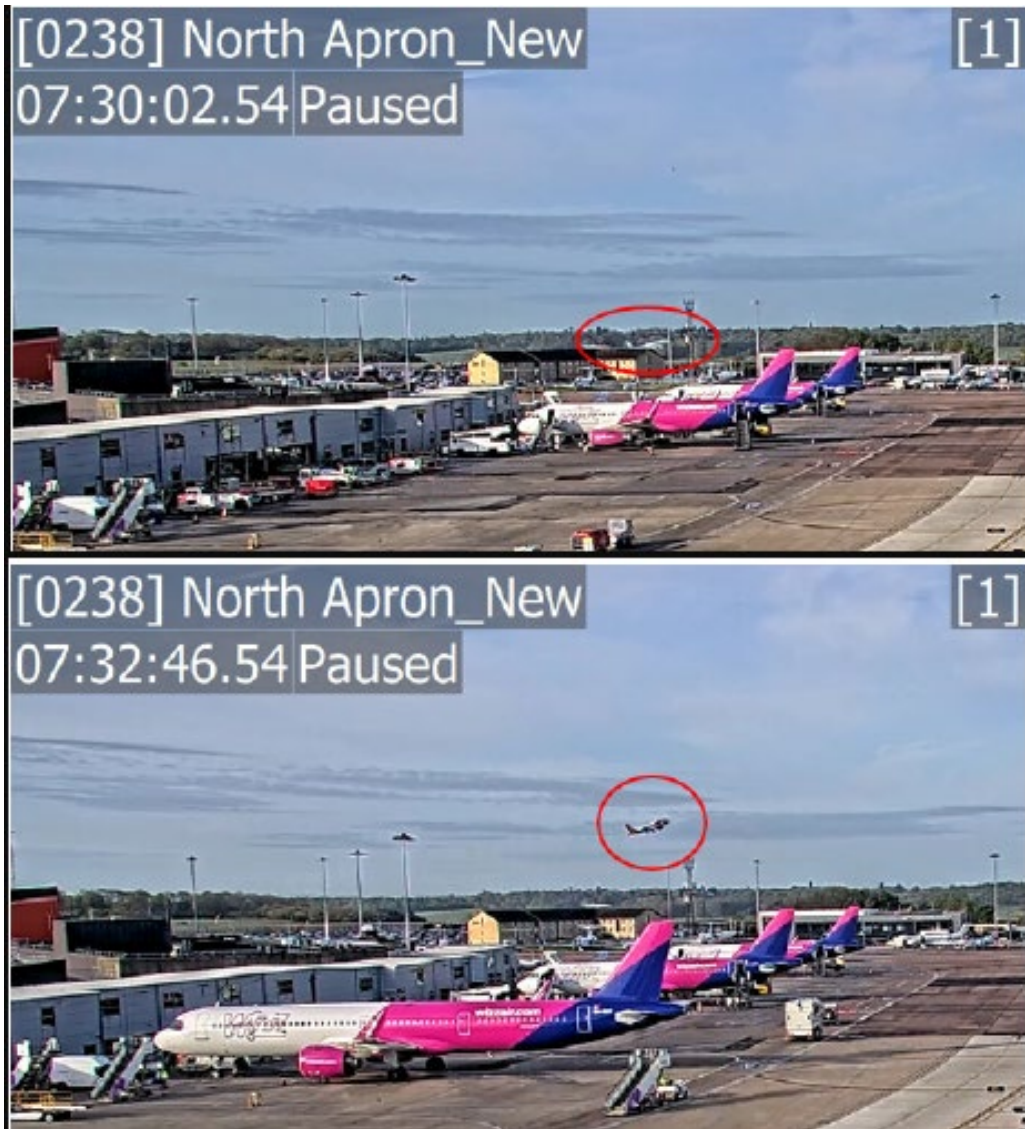
**Figure 2**

Images from LTN ATC CCTV

The upper image is the incident aircraft, the lower image is a representative departure

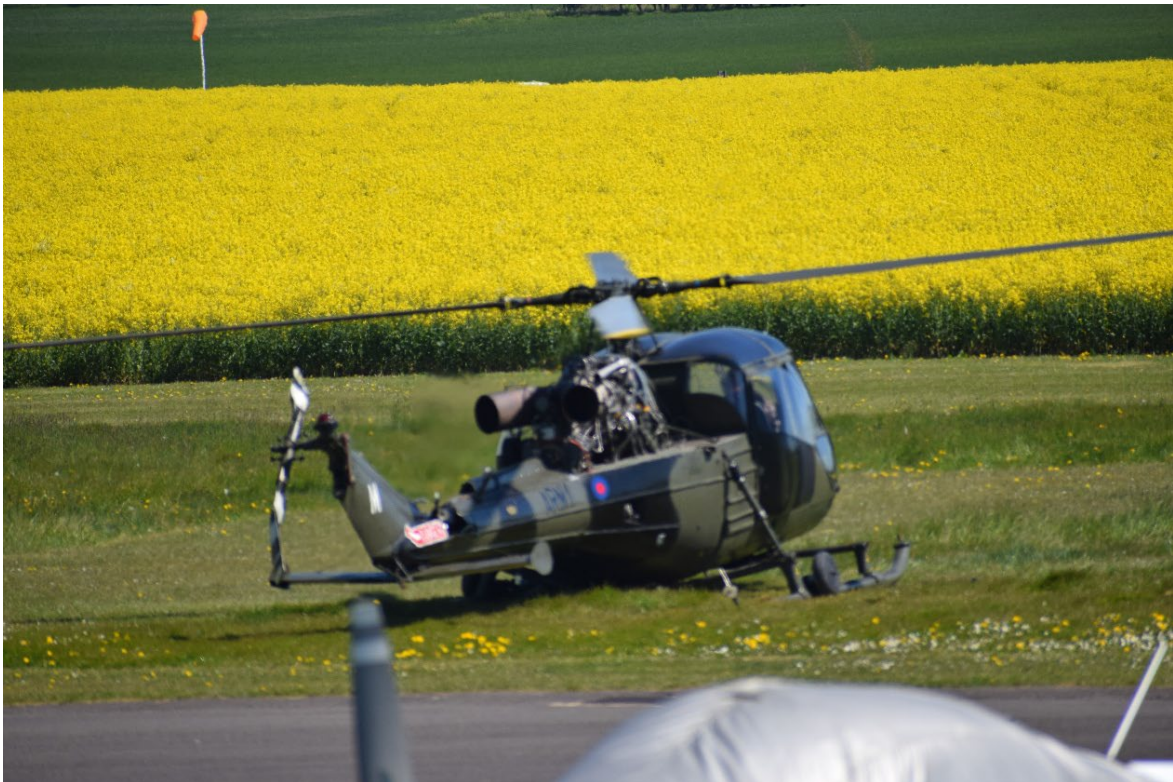
**Figure 1**

The helicopter landed heavily damaging the skids and causing the main rotors to droop whilst rotating and strike the tail boom (Figure 1). This resulted in significant disruption to the tail rotor drive system shafts and support bearings. The pilot and instructor were uninjured.

G-BWHU immediately after landing

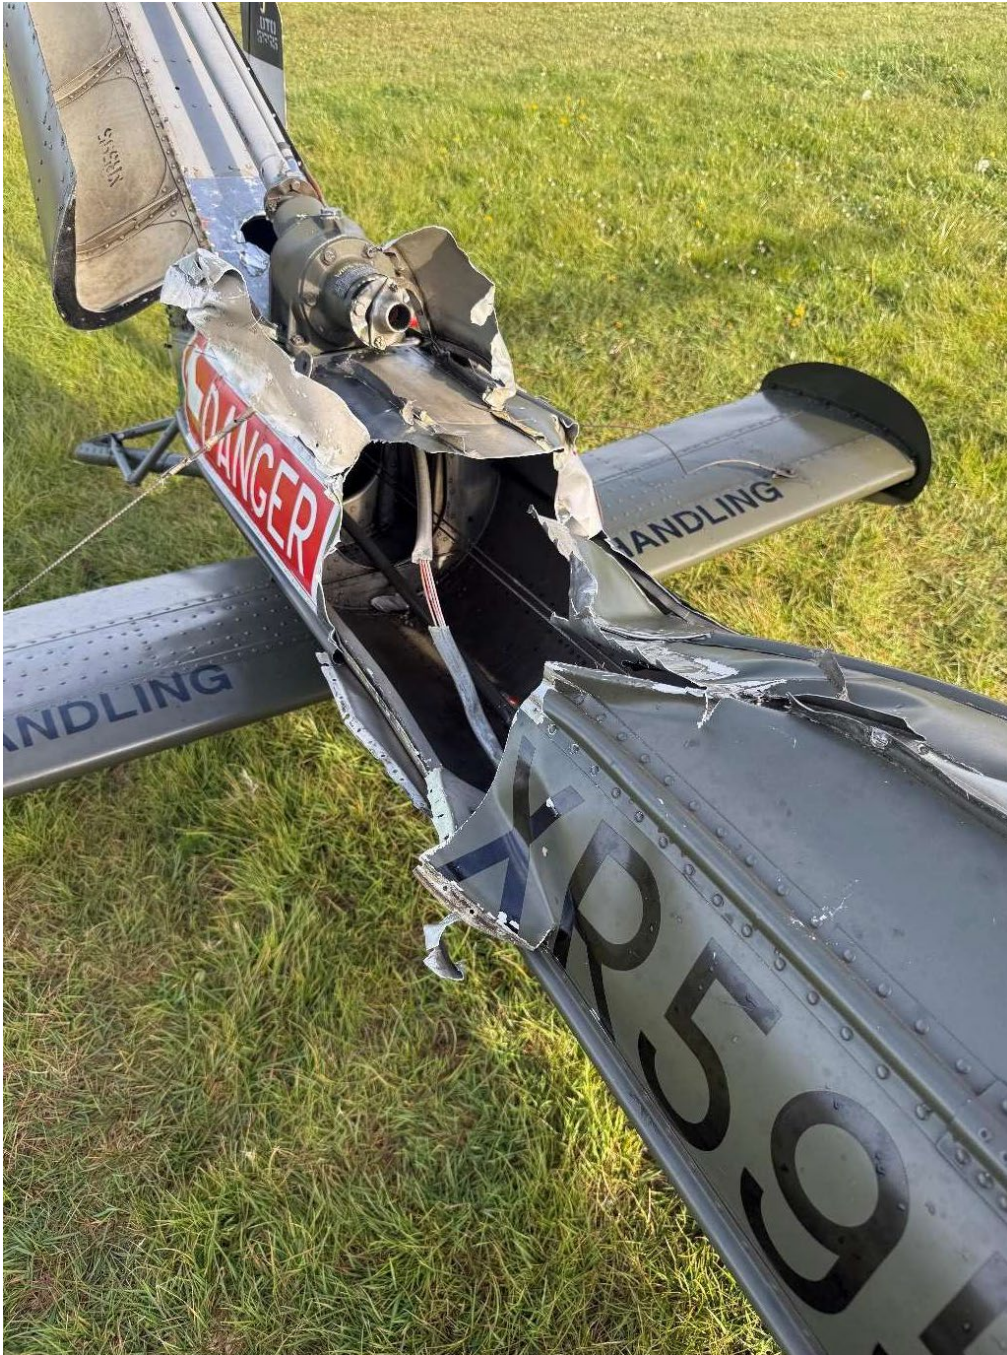
**Figure 2**

The aircraft was examined onsite and the extensive damage to the structure surrounding the tail rotor drive shafts and transmission system was indicative of the main rotor blades striking the tail boom. It was also found that the tail rotor blades had also contacted the ground sustaining damage during the landing, shock loading and further damaging the drive train. There was no evidence of pre-existent faults or malfunctions that could have contributed to this accident. Foreign object or an external control restriction was also considered but no evidence was found.

Tail rotor drive system and fairing blade strike location
