Report on the investigation of  
the collision of the rigid inflatable boat

***Peaky Blinder***

with a navigation beacon in Portsmouth Harbour, England  
resulting in two fatalities  
on 14 August 2025

REPORT NO 15/2026

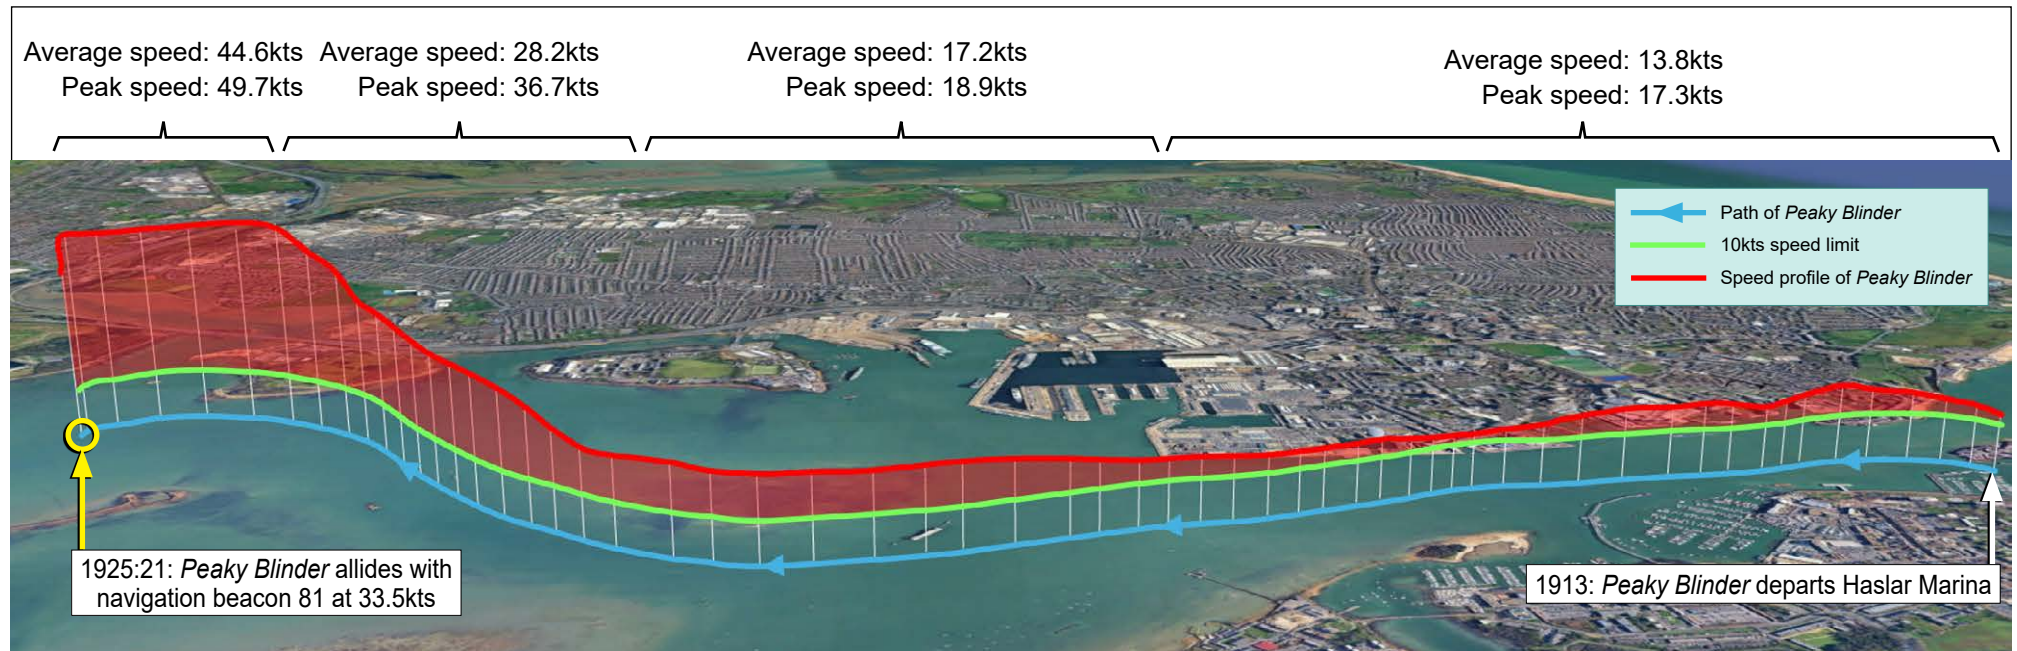
**Figure 2:** Speed profile of *Peaky Blinder* in Portsmouth Harbour on 14 August 2025

*Peaky Blinder* was operating at an unsafe speed immediately before the allision, placing the occupants on board and those on other vessels at risk.

The King's Harbour Master Portsmouth has been recommended to take action to improve adherence to the speed limits in Portsmouth Harbour.

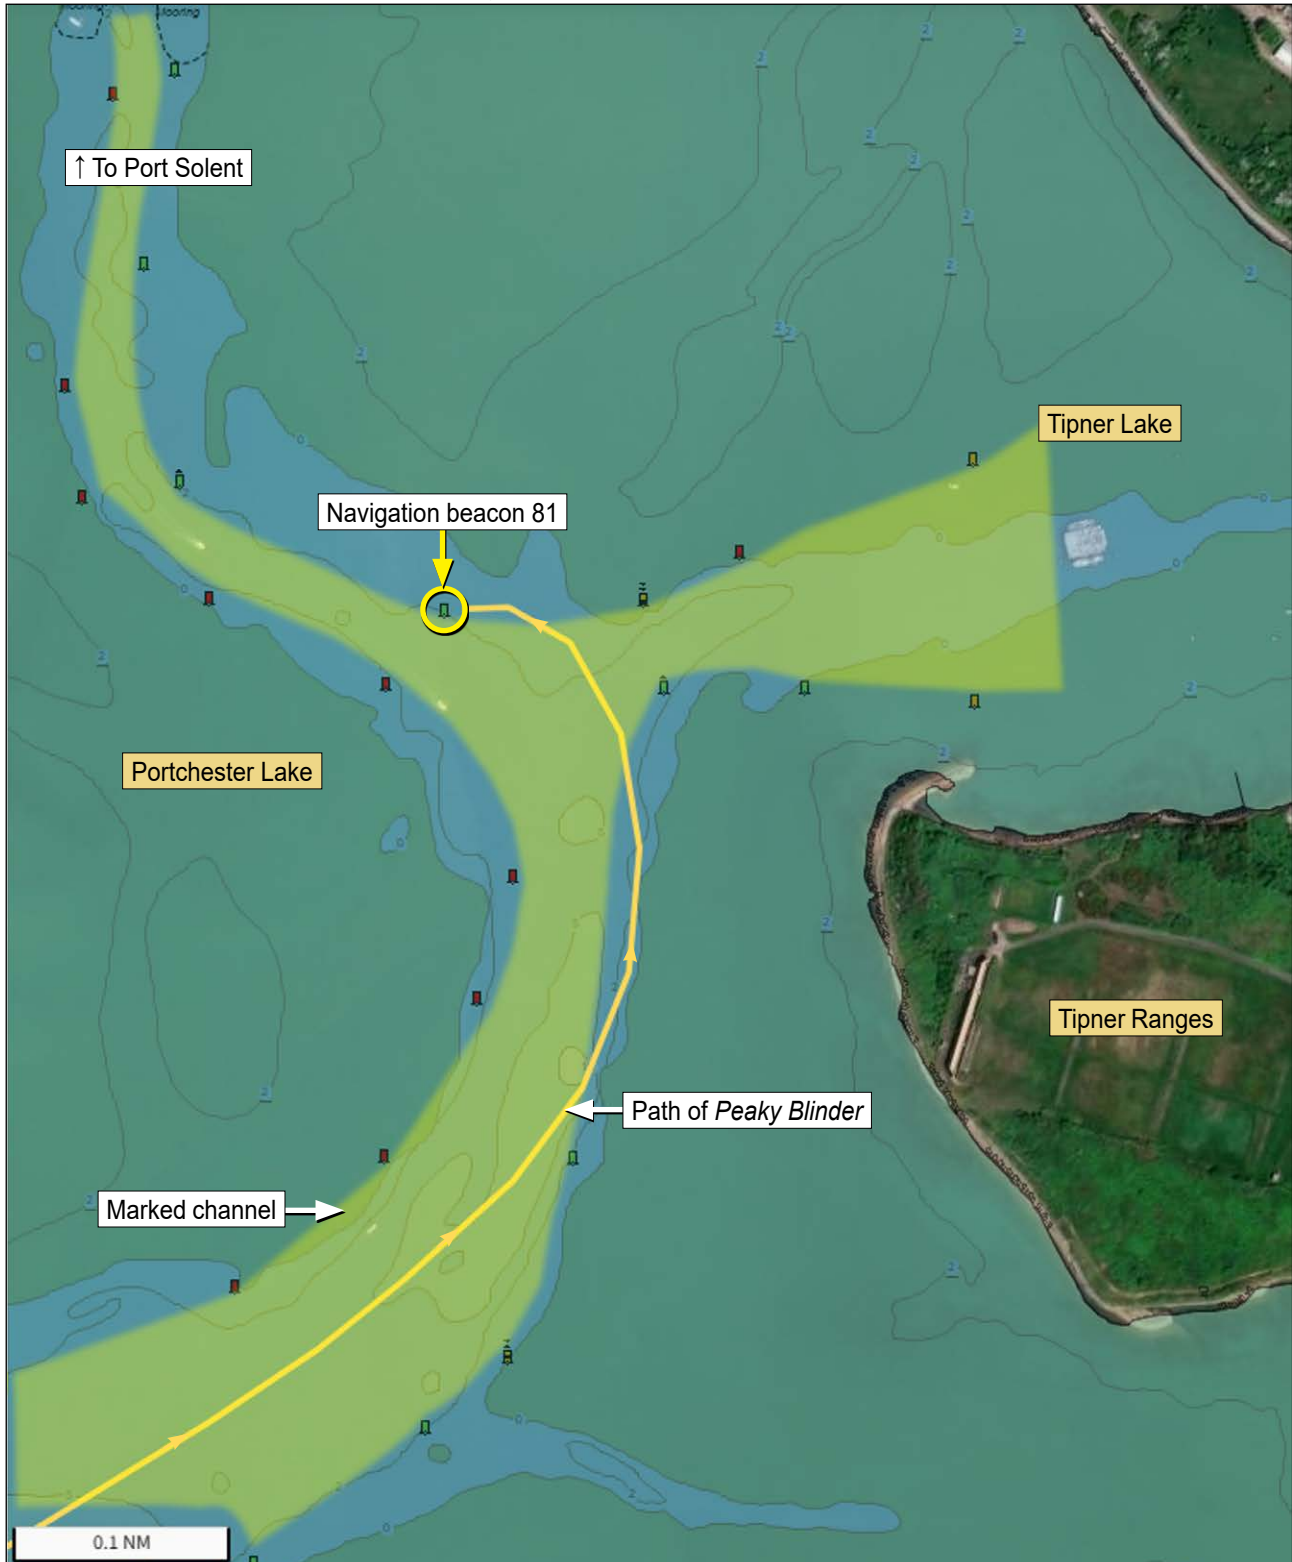
At about 1925, *Peaky Blinder* passed Tipner Ranges to the east. One of the two friends (passenger 2) realised the boat was to the right of the channel (**Figure 3**). Passenger 2 called out to the owner, saying that they were heading along the wrong side of the navigation beacons to the right of the channel. The owner exclaimed and immediately turned the boat hard to port. As the boat turned, it slowed and heeled to port. The owner looked towards the mud flats to starboard. About 4 seconds later, at 1925:21, *Peaky Blinder* hit navigation beacon 81 at 33.5kts, ejecting all three occupants overboard.

**Figure 3:** Departure of *Peaky Blinder* from the marked channel

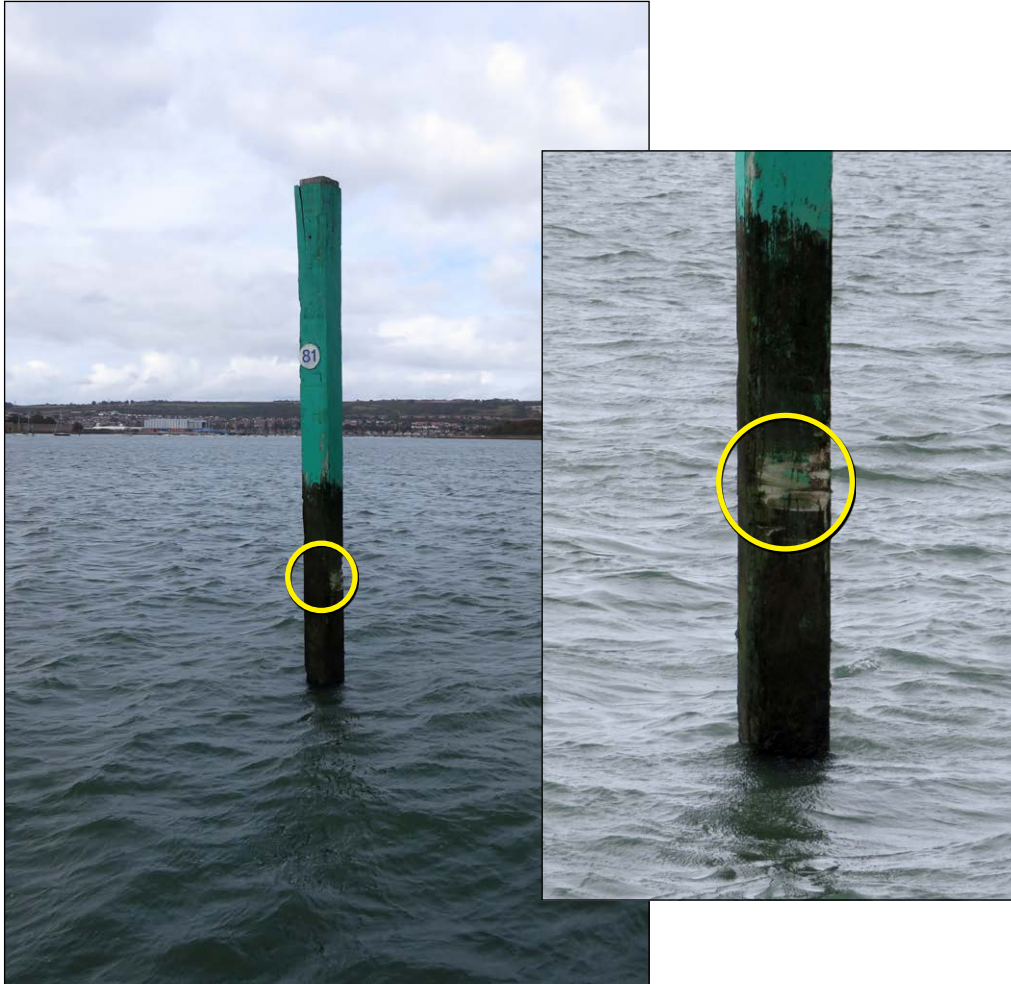
**Figure 4:** Navigation beacon 81 with inset detail of surface damage

When *Peaky Blinder* entered its final turn the RIB rolled to port, lifting its starboard side clear of the water. *Peaky Blinder* contacted navigation beacon 81 at an angle that resulted in the significant damage to the RIB's starboard side.

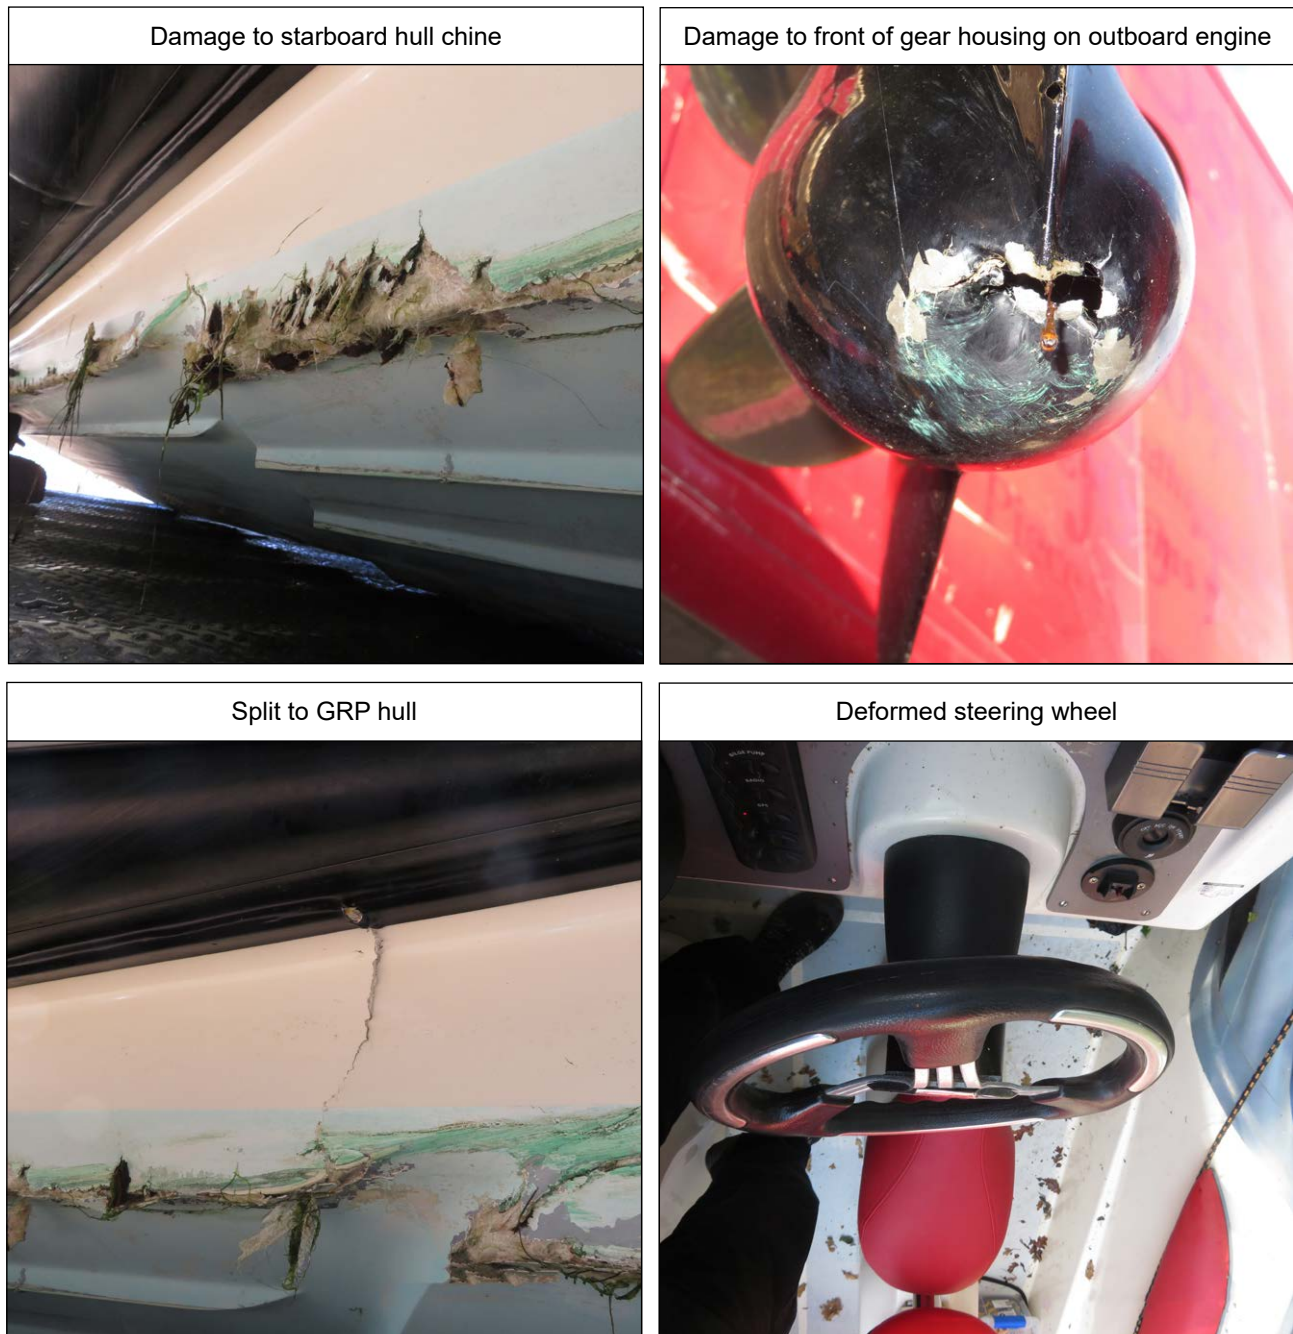
The allision caused extensive damage to *Peaky Blinder*'s starboard side (**Figure 5**) that included:

- a 130mm tear in way of the hull-to-bow sponson joint, approximately 150mm aft of the bow
- notable scrapes forward of the spray rails on the glass-reinforced plastic (GRP) hull form
- significant damage along the starboard chine, breaking through the gel coat into the core of the GRP structure between 450mm and 700mm aft of the bow

- a vertical crack through the starboard hull amidships
- damage to the front of the gear housing on the outboard engine
- the top of the steering wheel was bent forward.

The damaged sections of the GRP structure and engine gear housing showed evidence of green paint transfer. Other parts of the RIB remained undamaged.

**Figure 5:** Post-allision damage to *Peaky Blinder*
