Report on the investigation of  
the fatal man overboard from  
the Isle of Man registered bulk carrier

***World Prize***

3.5 nautical miles east-south-east of  
Rönnskär, Sweden  
on 14 October 2025

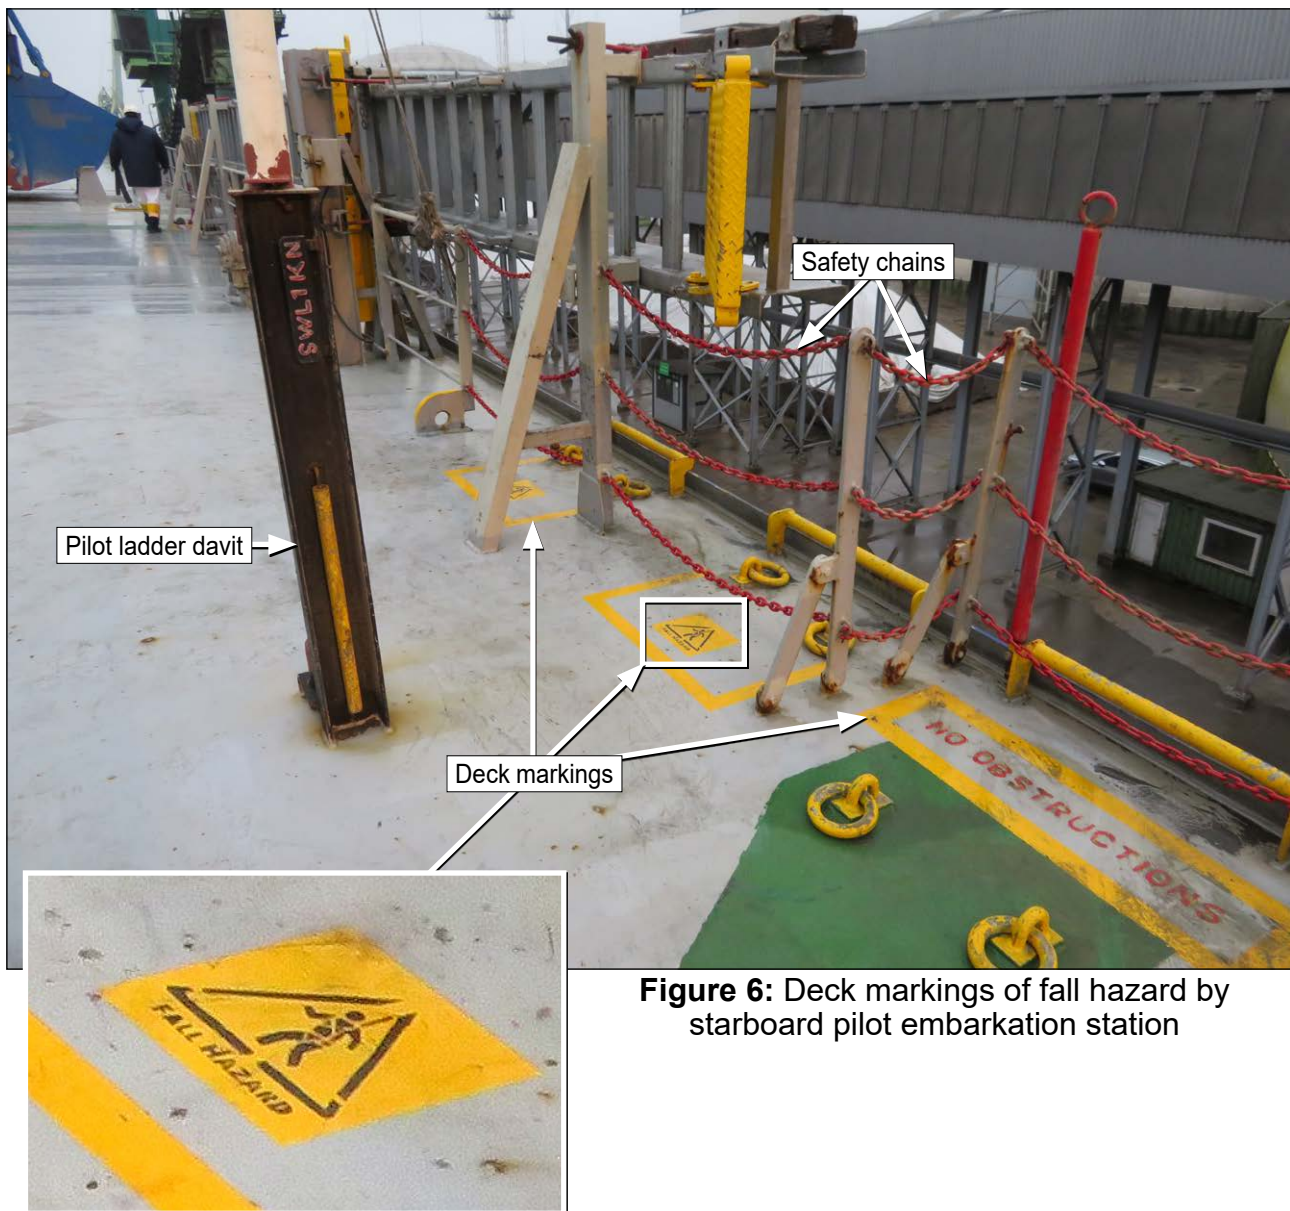
**Figure 6:** Deck markings of fall hazard by starboard pilot embarkation station

The presence of a fall hazard when safety chains at the pilot embarkation stations were removed was partially marked on the deck in way of the pilot ladder access points. The markings did not encompass the extent of the openings in the ship's guardrails, nor the 2m limit of the hazardous area identified in the SMS (**Figure 6**).

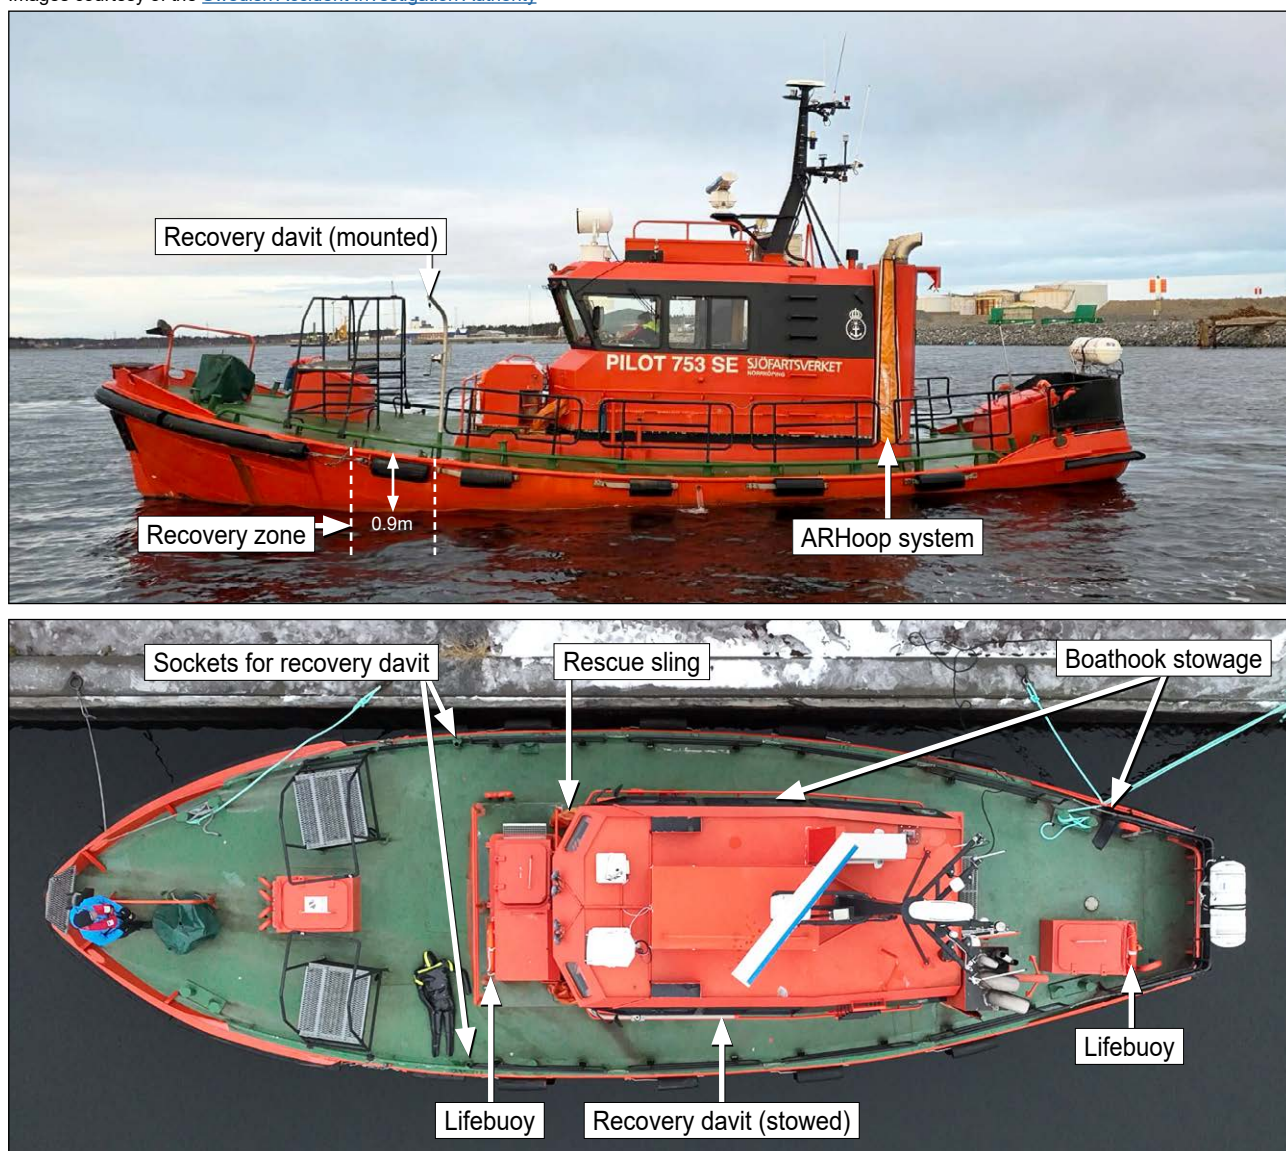
**Figure 8: Pilot 753 SE recovery equipment**

Following the accident SHK attended a trial of the ARHoop system on *Pilot 753 SE*, during which two trained crew members used it to recover a mannequin representing an unconscious person from the water. A post-accident inspection by SHK of the rescue sling on board *Pilot 753 SE* found that its pole sections were difficult to assemble.
