# ***AAIB Bulletin***

# ***7/2026***

Published: 9 July 2026.

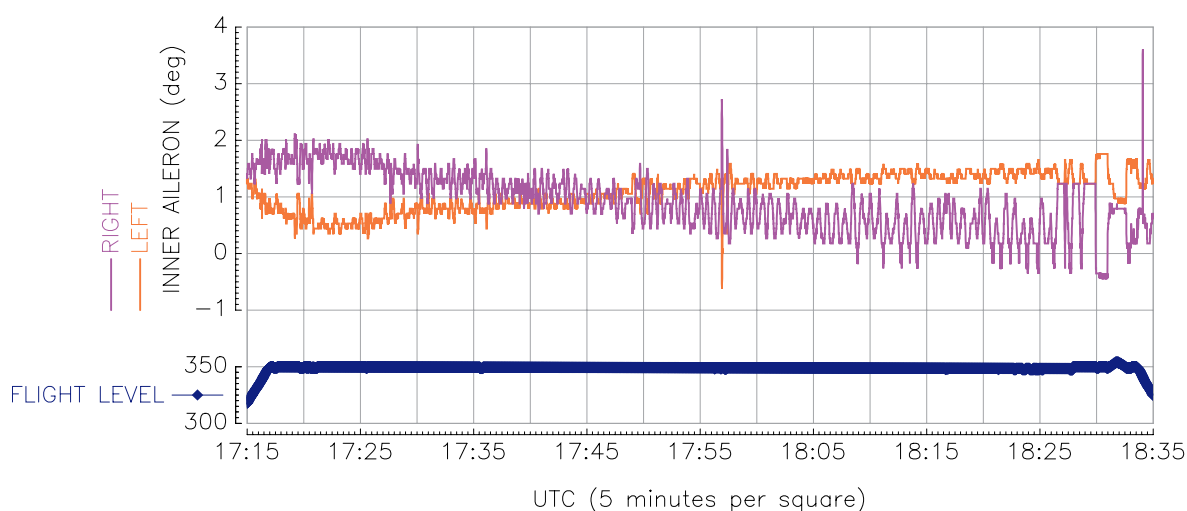
**Figure 1**

Figure 1 plots the inner aileron deflection, with the autopilot on, recorded on the flight data recorder, for the 75 minutes the aircraft was at FL350. Prior to this period and during the 52 hours of recorded data from the previous 22 flights, both ailerons moved in equal but opposite amounts about a nominal position. However, Figure 1 shows that at the beginning of this period, the right aileron was starting to move more than the left aileron, and this differential in movement grew to over four times the amount by the end.

Inner aileron deflection during flight while at FL350

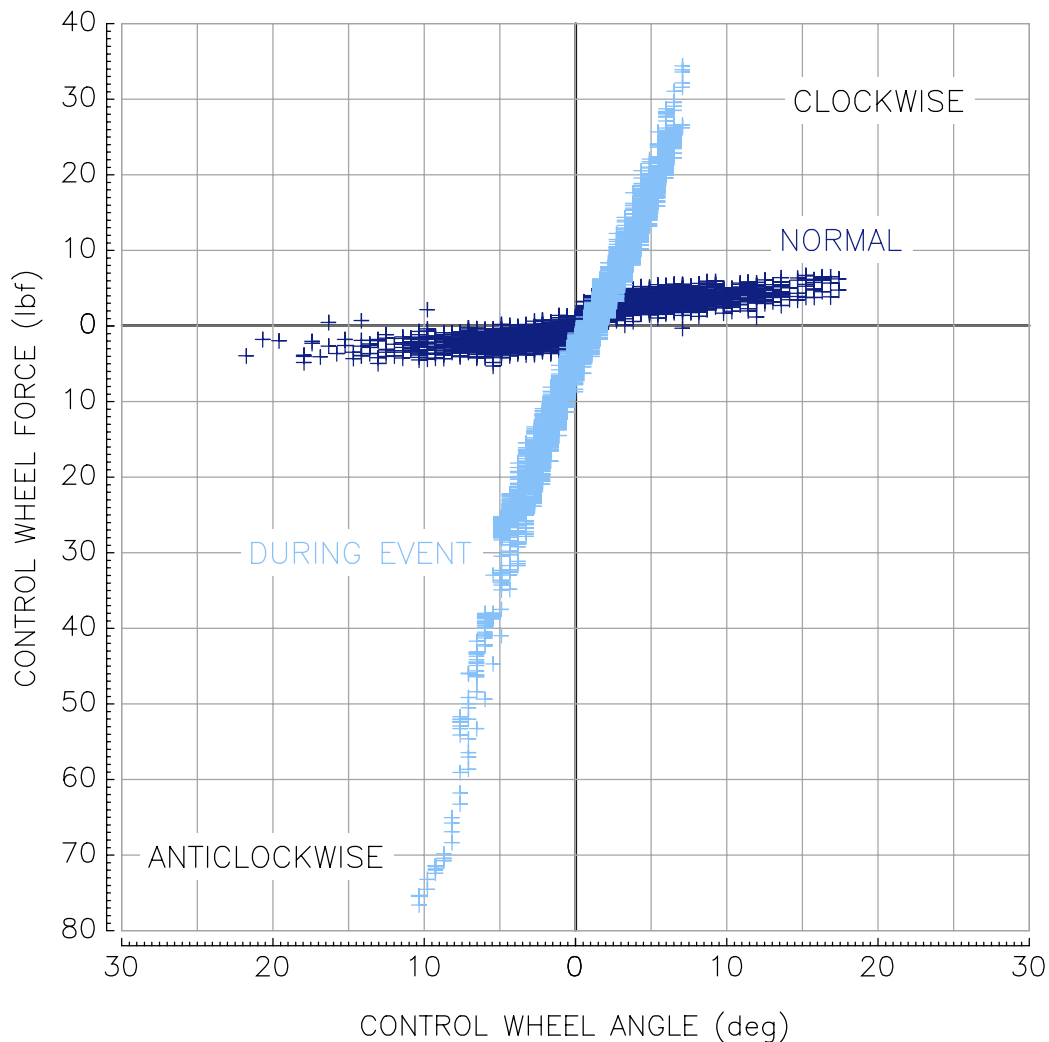
**Figure 2**  
Control wheel force versus control wheel angle

flight during the descent from FL350 to FL200. The figure shows that the force required to move the wheel during the event was 15 times more than 'NORMAL'.

The maximum recorded force was 76.6 lbf after which the force required to move the wheel returned to those in the 'NORMAL' region.

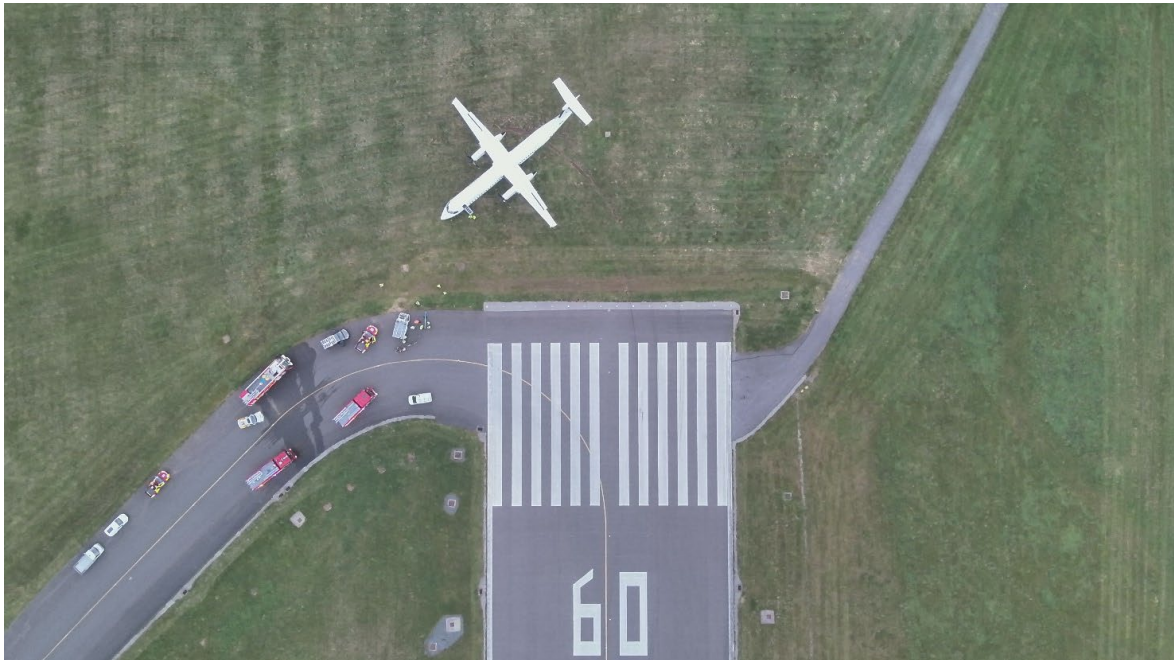
**Figure 2**

The aircraft stopped approximately 30 m from the end of the runway in the grassed area (Figure 2), the main landing gear (MLG) had ploughed a deep furrow in the grass, and the nose gear right wheel had accumulated a thick layer of soil. There were tyre markings on the runway showing the aircraft veering to the right towards the end of the runway. The tyre markings had the characteristic intermittent skid pattern showing where the Anti-Skid system was functioning. Other than disruption of the grassed area there was no other damage to the airfield surfaces or equipment.

Location of aircraft (image used with permission)

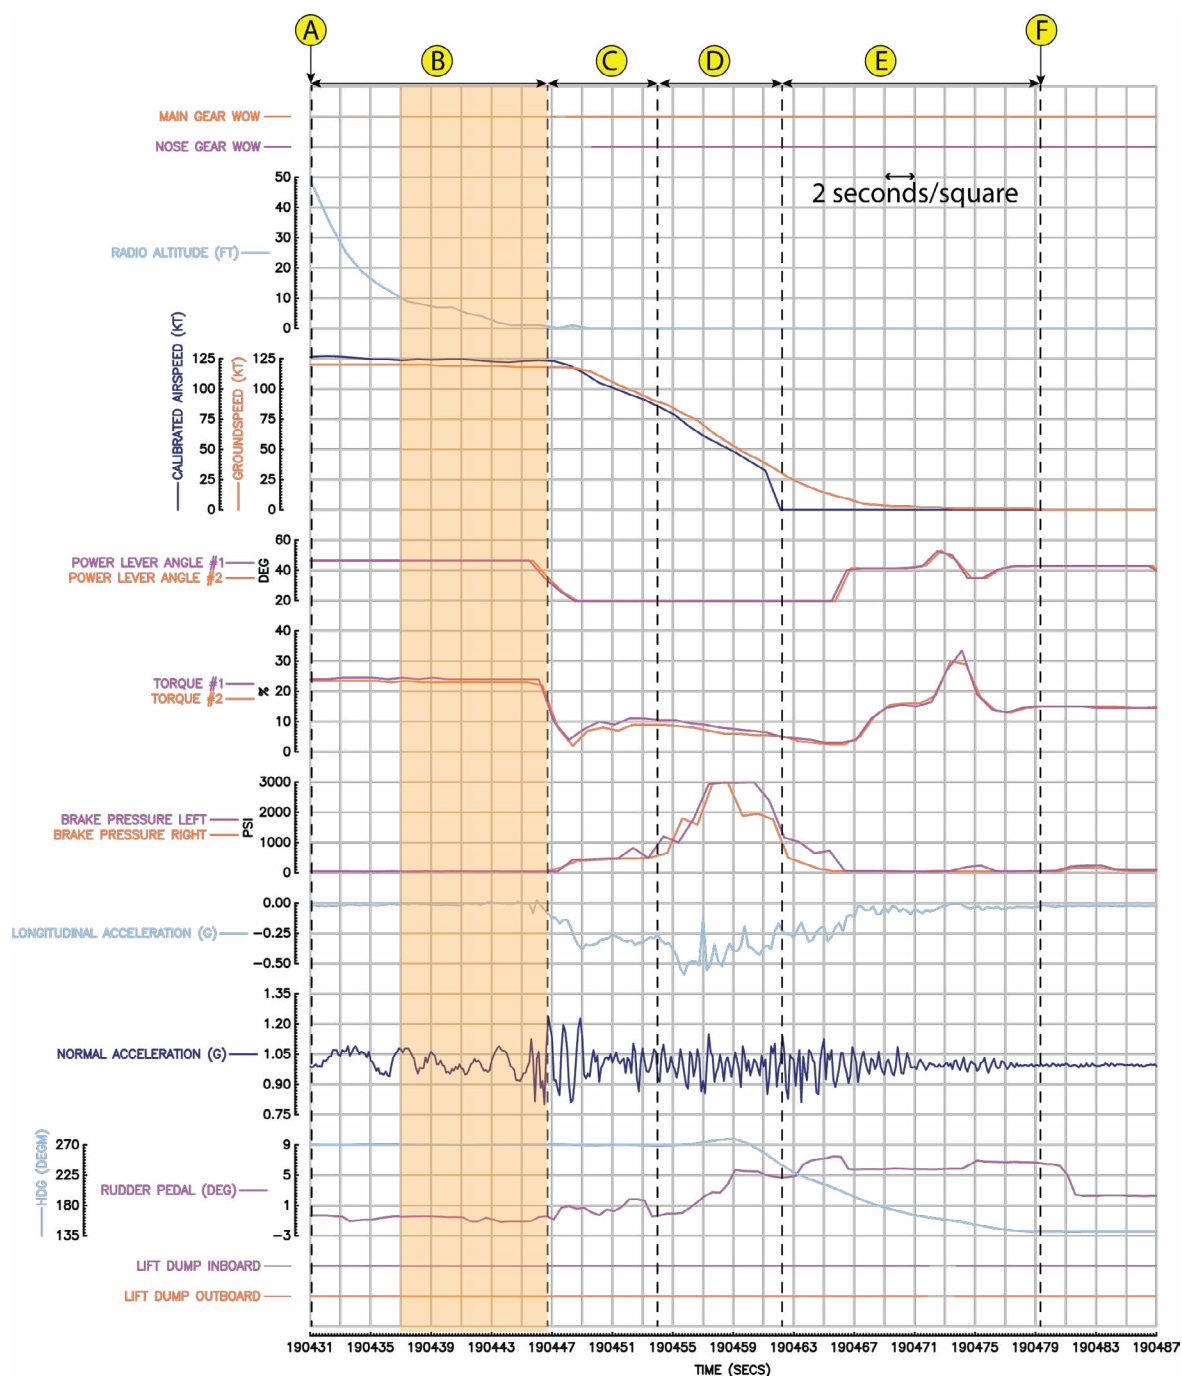
**Figure 3**  
FDR data of the landing

9H-LWB was fitted with a solid-state CVR of 2 hours duration and a solid-state FDR of 25 hours duration. Salient FDR data for the incident landing is plotted below in Figure 3.

This shows that 9H-LWB passed over the runway threshold at a height of 50 ft and with an airspeed of 124 kt, point A on Figure 3. Region B on Figure 3 shows 9H-LWB's descent from 50 ft to main landing gear touchdown and, the shaded region, represents the time that 9H-LWB was below 10 ft but hadn't yet touched down. During this 10 second period, with a ground speed of 120 kt, equivalent to 62 m/s, 9H-LWB would have consumed 620 m of the available landing distance (1,463 m). Region C shows that after a small bounce on the main landing gear manual braking was applied, using 500 psi out of 3,000 psi that was

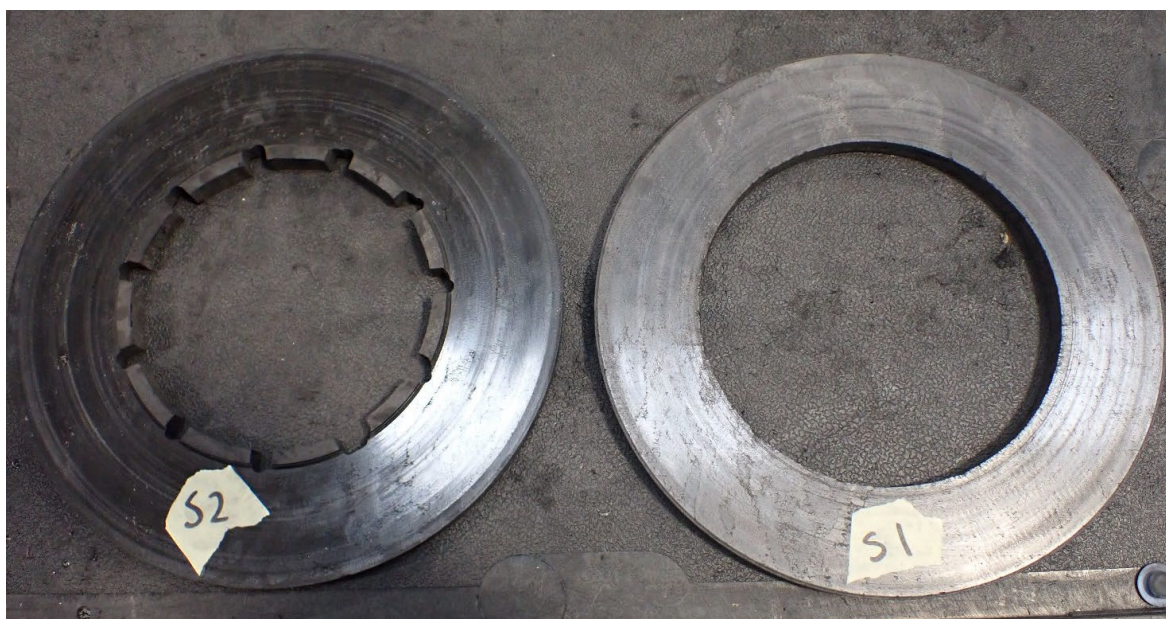
**Figure 6**

The brake unit with the broken stator was taken to the manufacturer for further examination. When disassembled it was found that stator No S1 had lost all its locating lugs (Figure 6) and was free to rotate around the brake torque tube.

Comparison of stators S2 and S1 showing lug wear on S1

The locating lugs which are made of carbon had been filed away by the splines on the torque tube. This occurred because the torque tube had suffered severe corrosion causing the surface to be rough, effectively acting as a file on the carbon locating lugs. The torque tube was sent for a metallurgical examination to understand what had caused the corrosion. The examination confirmed that at some point in its overhaul history the torque tube nickel

alloy surface had been incorrectly treated with a high temperature resistant coating such as paint. This was evidenced by the presence of aluminium on the surface of the torque tube and in the corrosion pits. The manufacturer concluded that this would have an approximate 25% reduction in braking performance on this individual brake unit, but that this effect would be compensated for by the Anti-Skid system. Analysis of braking distance performance showed that the increase in braking distance between the fully working brake system and the worst case of a seized brake calliper for a wet runway is an additional 13 metres of braking distance. The AMM<sup>3</sup> for the aircraft calls for a visual inspection of the brake unit for signs of wear, damage and cleanliness, but does not require a physical check for stator movement of brake units during tyre/wheel changes. The thickness of brakes is monitored during operation and these will be removed for repair and overhaul as required and also checked as part of the aircraft base maintenance cycle. It was not possible to determine if the stator had become completely detached prior to the flight on which the serious incident occurred.

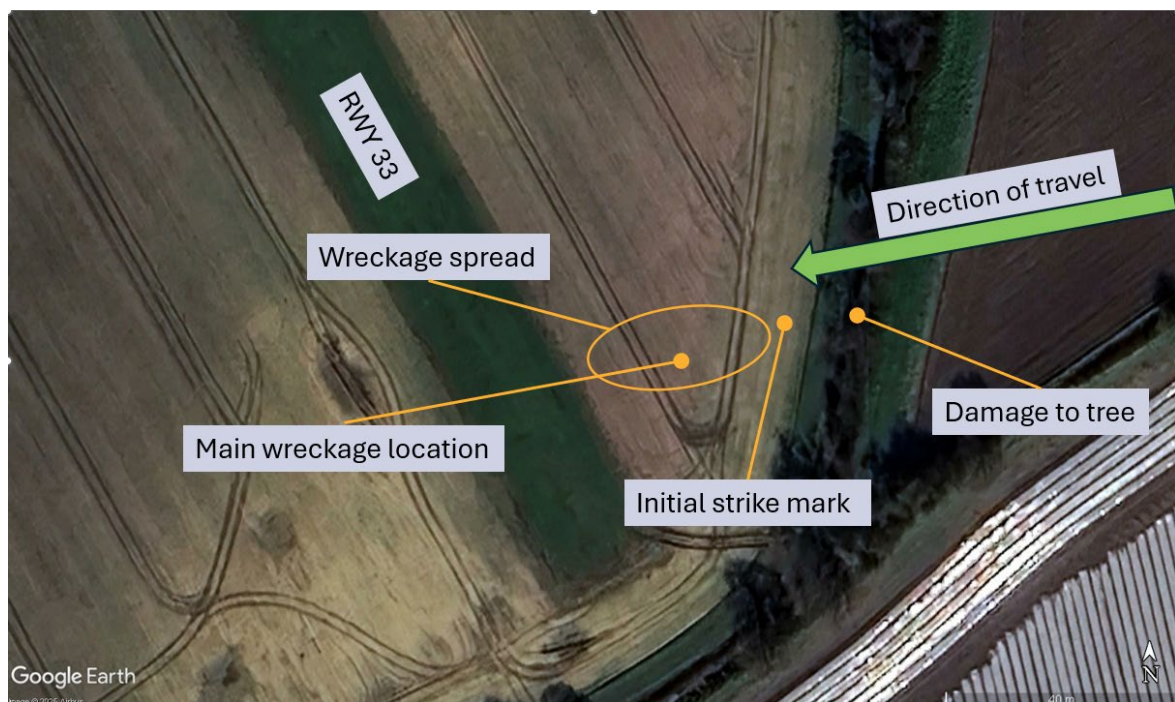
**Figure 1**  
G-TOMX accident site location

The aircraft had come to rest in cultivated farmland to the east of the grass strip of Shenstone Hall Airfield (Figure 1).

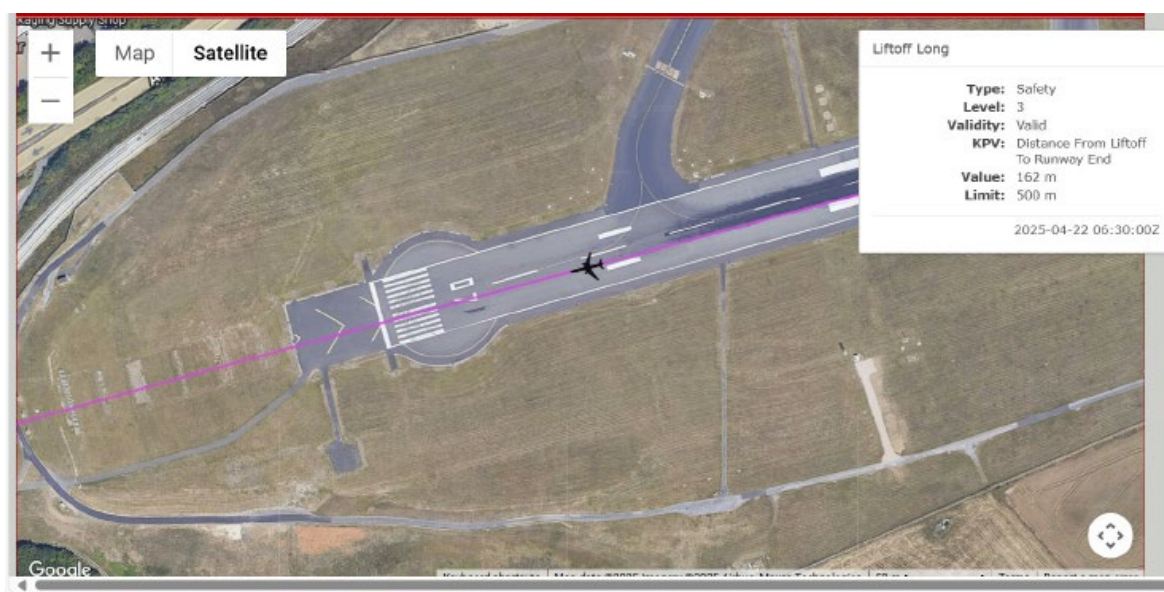
**Figure 1**

instead of the required 85.2% and the  $V_2$  speed was not changed between initial data entry during flight preparation and takeoff, which resulted in the aircraft lifting off 162 m from the end of the paved runway surface (Figure 1).

Flight Data overlay of Google satellite image showing the aircraft lift off point

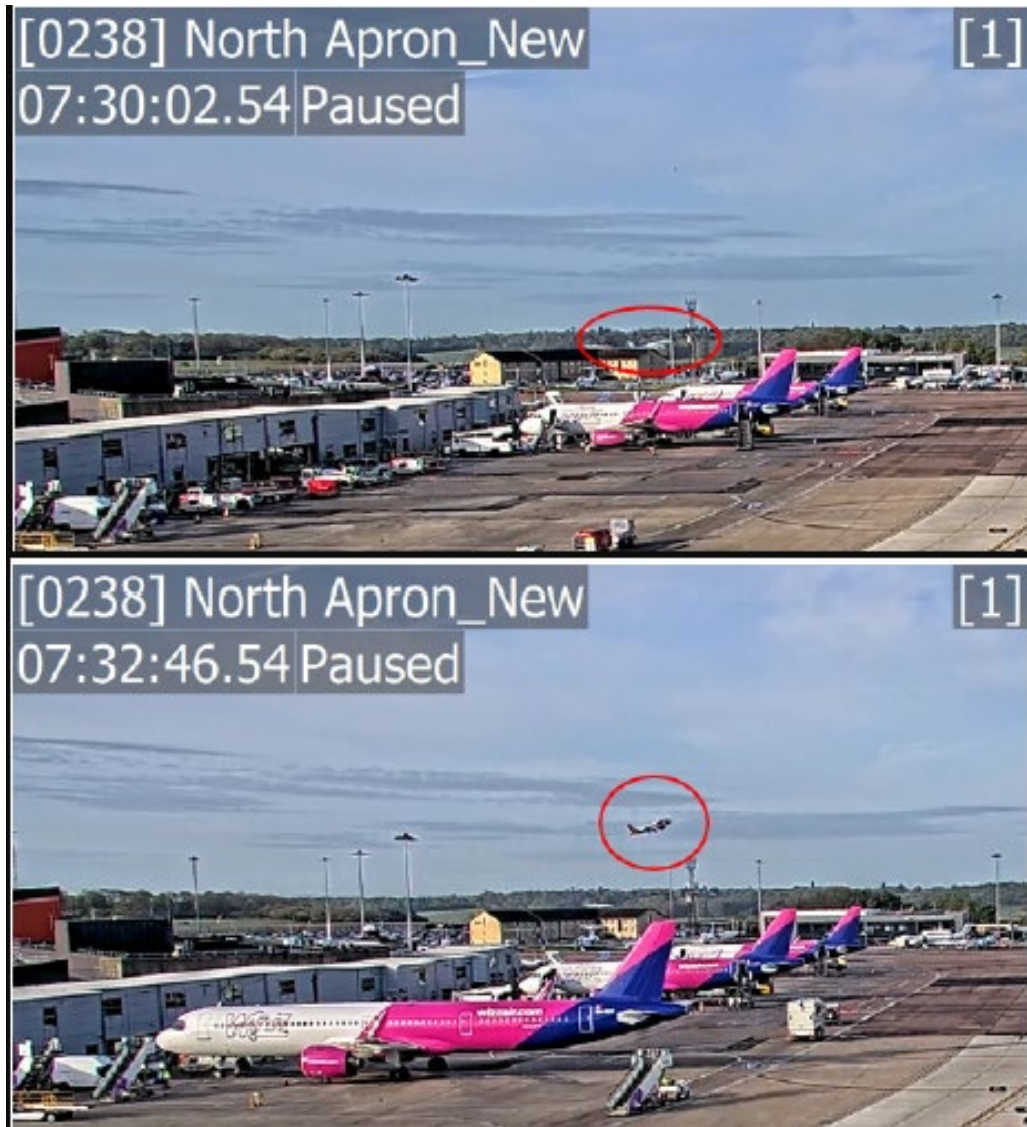
**Figure 2**

The aircraft crossed the end of the runway at an altitude of 13 ft agl. Reports from ATC described the aircraft appearing on radar climbing through 900 ft agl at approximately 0.8 nm from the airfield. Under normal circumstances the aircraft would appear much closer to the airfield at that height. CCTV from LTN ATC showed two images, one of the incident aircraft and a representative departure a few minutes later (Figure 2).

The upper image is the incident aircraft, the lower image is a representative departure

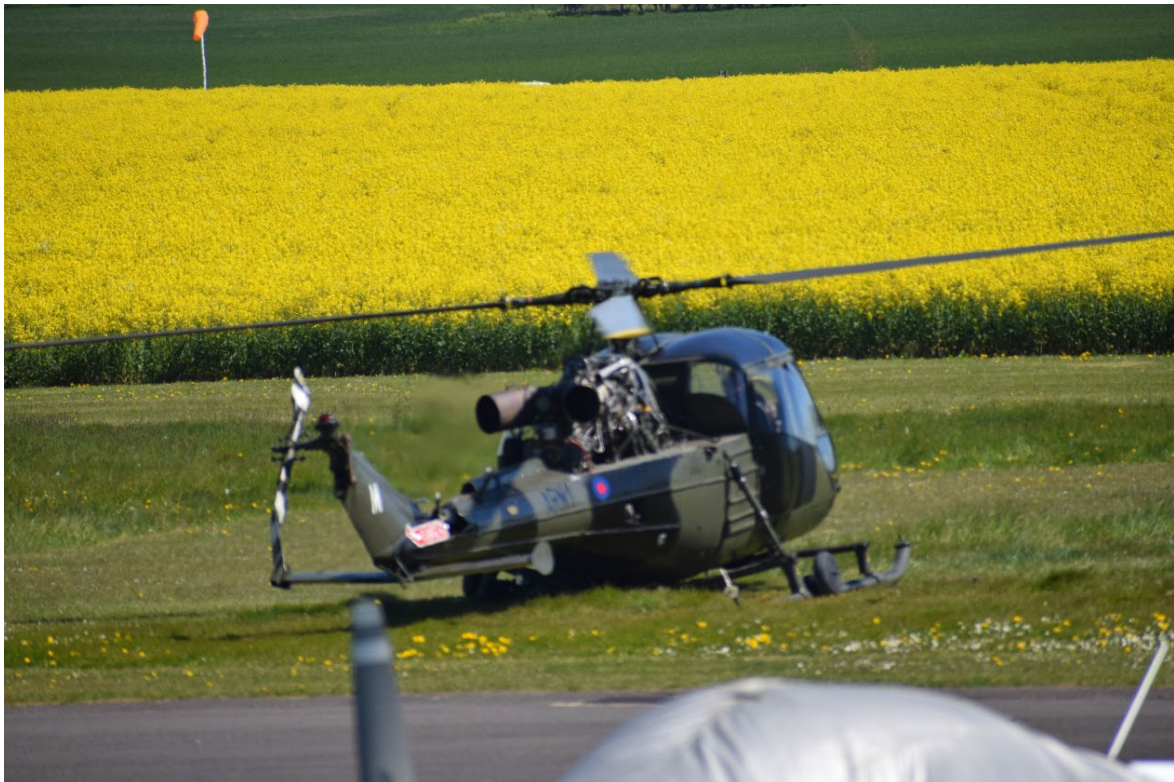
**Figure 1**

The helicopter landed heavily damaging the skids and causing the main rotors to droop whilst rotating and strike the tail boom (Figure 1). This resulted in significant disruption to the tail rotor drive system shafts and support bearings. The pilot and instructor were uninjured.

G-BWHU immediately after landing

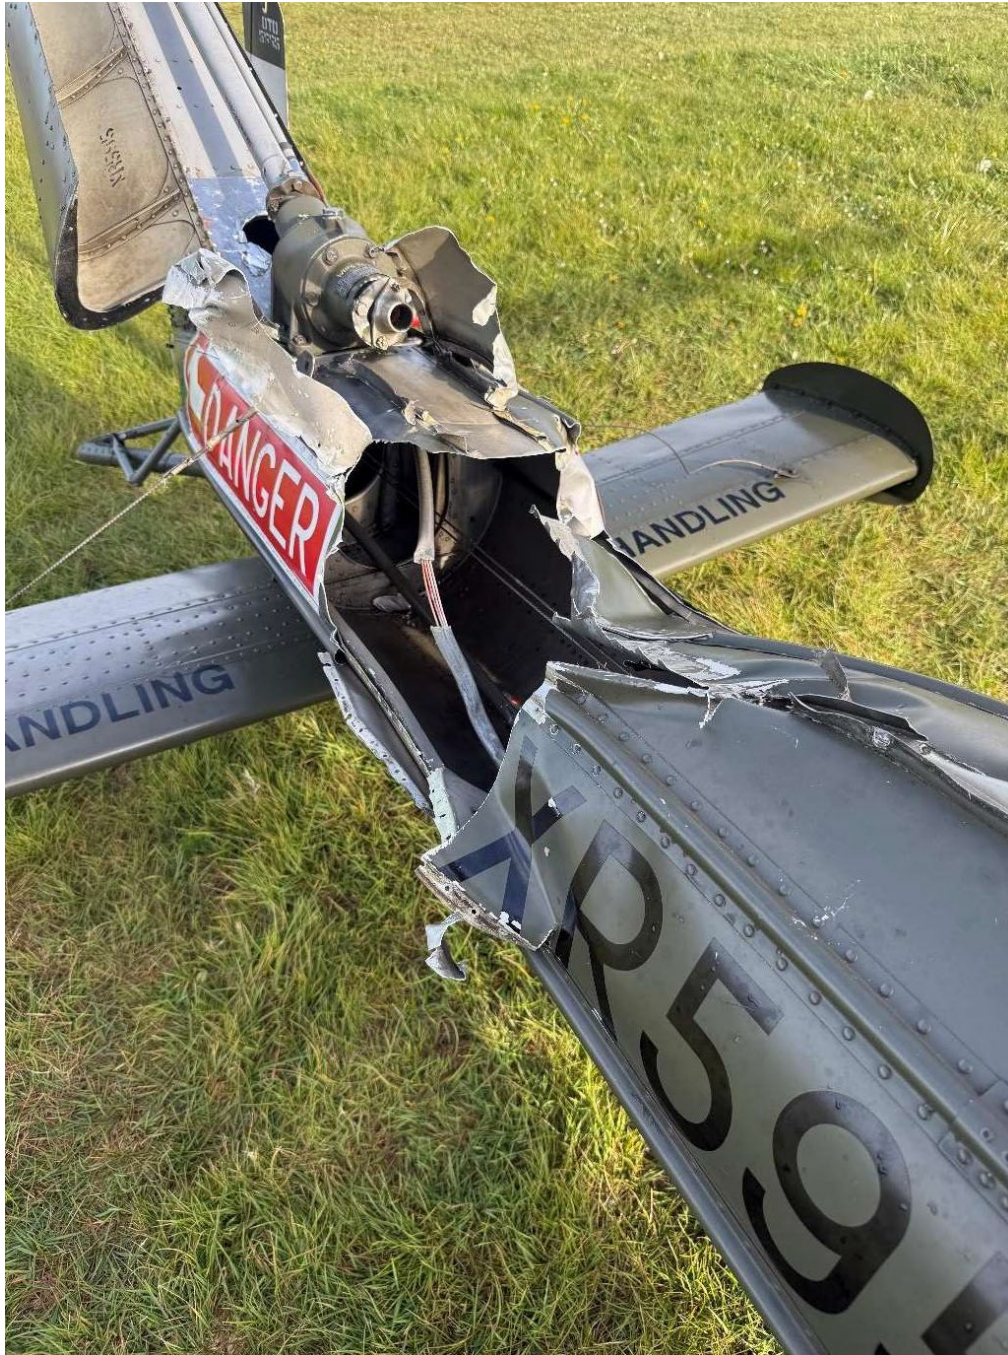
**Figure 2**

The aircraft was examined onsite and the extensive damage to the structure surrounding the tail rotor drive shafts and transmission system was indicative of the main rotor blades striking the tail boom. It was also found that the tail rotor blades had also contacted the ground sustaining damage during the landing, shock loading and further damaging the drive train. There was no evidence of pre-existent faults or malfunctions that could have contributed to this accident. Foreign object or an external control restriction was also considered but no evidence was found.

Tail rotor drive system and fairing blade strike location
