# Rail Accident Investigation: Explanation of discontinuation

**Derailment of a tram at Piccadilly tram stop,  
Manchester  
5 April 2026**

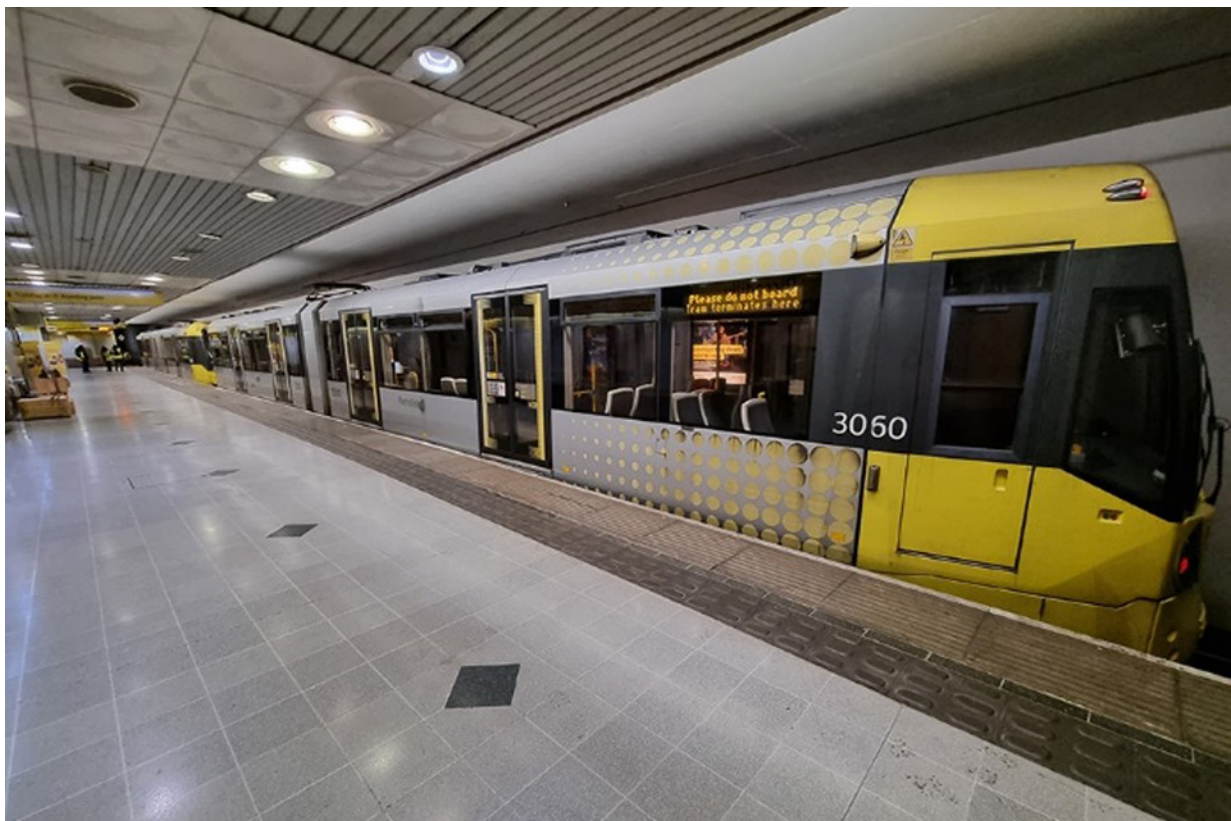
- 1 At around 13:39 on 5 April 2026, a Metrolink tram travelling from Ashton to Bury derailed on the approach to Piccadilly tram stop in Manchester (figure 1).
- 2 The tram, formed of two coupled sets, was travelling at about 8 mph (13 km/h) when one wheelset derailed. This was the leading wheelset of the rear bogie of the leading tram, which derailed after its left-hand wheel climbed up and over the running rail. The driver was initially unaware of the derailment and the tram continued into the tram stop, where passengers were able to disembark.
- 3 There were no injuries reported as a result of the derailment and minor damage was caused to the tram and to the infrastructure.

*Figure 1: The tram involved in the derailment at Piccadilly tram stop.*
