# Rail Accident Report

## **Collision between a tram and two pedestrians at Staniforth Road, Sheffield 22 June 2025**

Report 10/2026  
July 2026

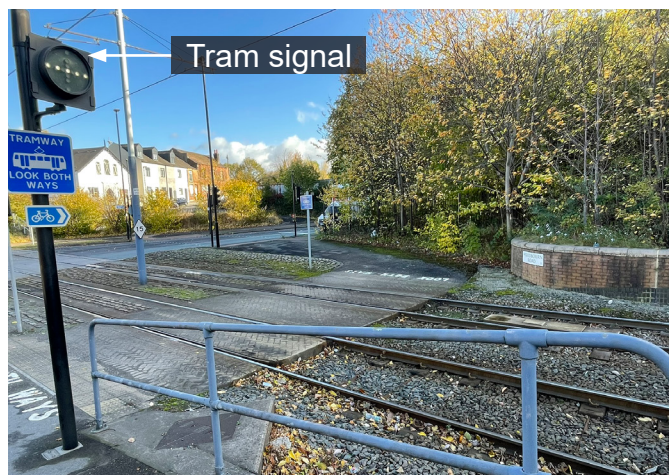
Figure 3: The approach to the footpath crossing looking east.

- 68 The signs to indicate the 15 mph (24 km/h) speed reduction area on both the outbound and inbound tracks are positioned between the footpath crossing and the road crossing (figure 3). The speed reduction was intended to control the risk associated with road traffic; however, this measure also reduces the speed of trams approaching the outbound footpath crossing. The audible warning board was installed in response to recommendations made by RAIB following the investigation into a pedestrian collision at the footpath crossing in 2005 (see paragraph 90).

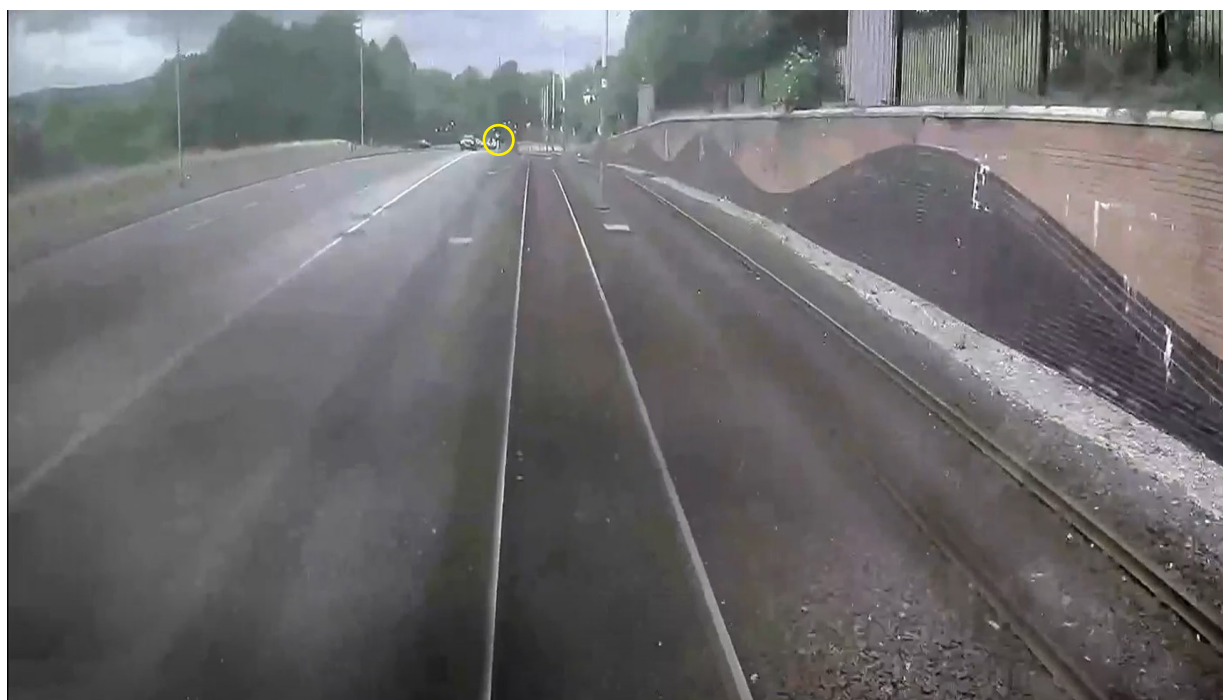
- 23 The driver did not receive any requests for the Woodbourn Road stop, so the tram passed through without stopping. Shortly after driving through Woodbourn Road tram stop, the driver observed the two pedestrians on the pavement, running ahead of the tram and alongside the track (figure 7).

*Figure 7: Forward-facing CCTV footage from tram 101 showing the driver's view of the pedestrians (circled) 10 seconds after driving through Woodbourn Road tram stop (courtesy of SYFTL with RAIB annotations).*

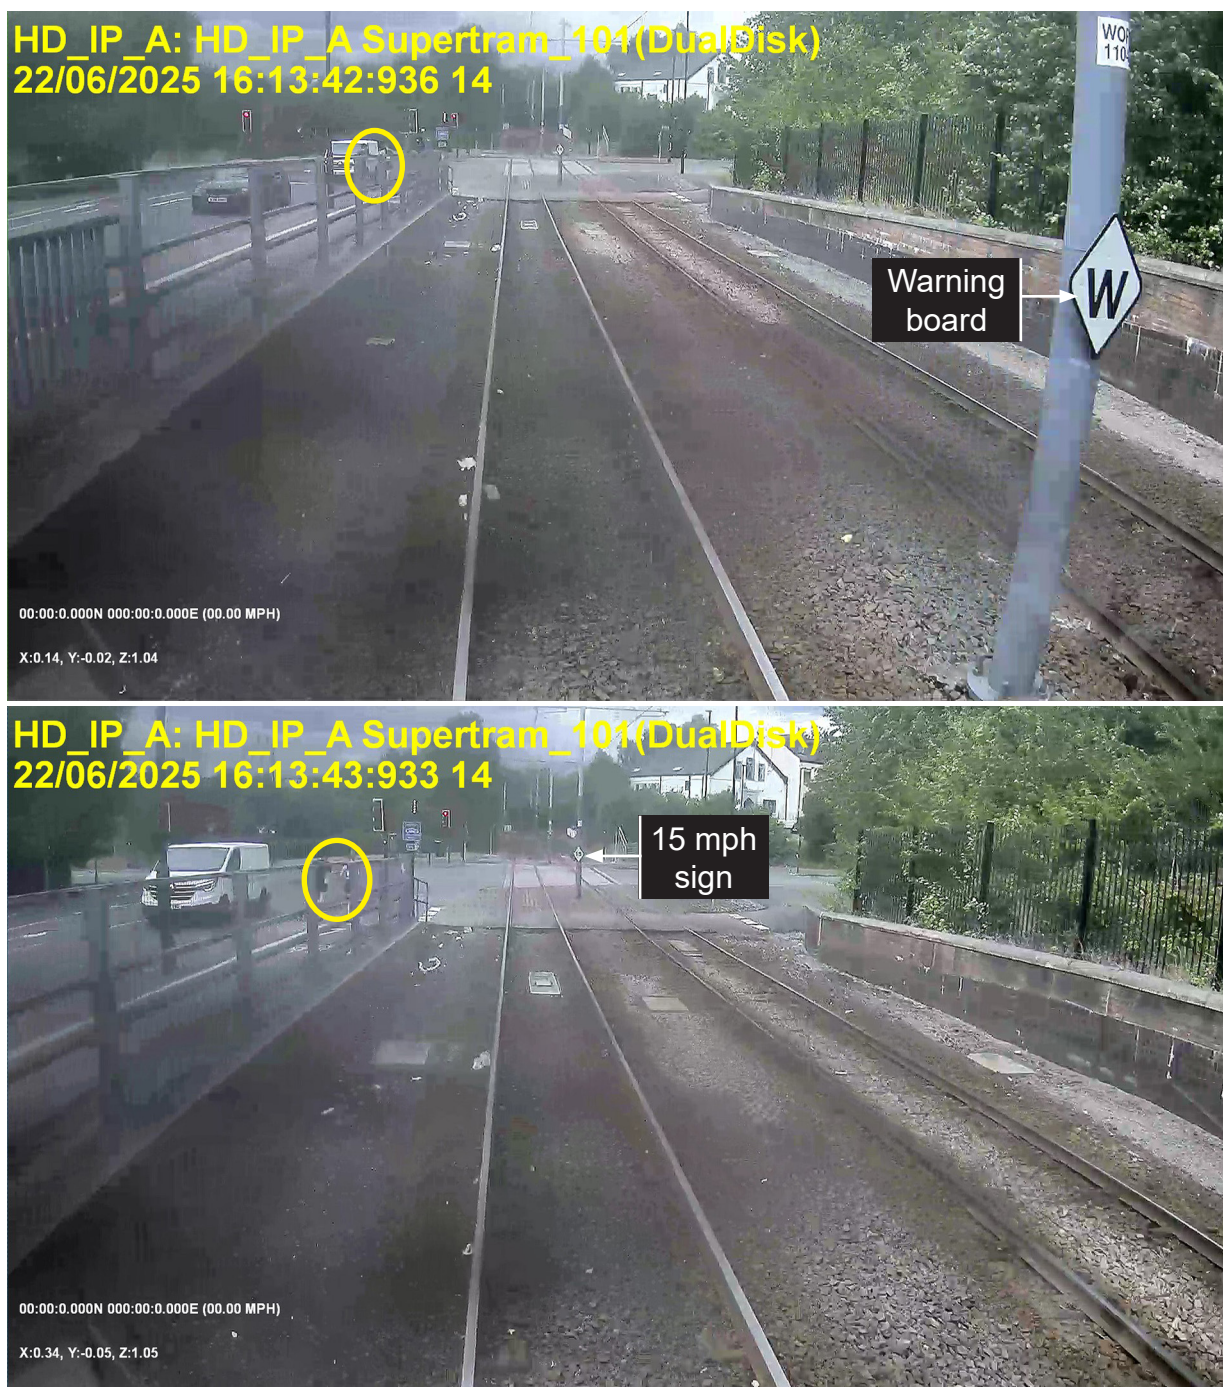
- 36 For the tram to have stopped before the crossing, the second hazard brake application would have needed to have been made 2 to 3 seconds (or 20 to 30 metres) earlier than it was. However, as the pedestrians were still approaching the crossing and had not yet turned towards the track at this point, there was no reason for the driver to make such a brake application at that time (figure 8).

Figure 8: Proximity of the pedestrians (circled) to the crossing from the FFCCTV 3 seconds and 2 seconds before the final hazard brake was applied (courtesy of South Yorkshire Future Trams Ltd with RAIB annotations).

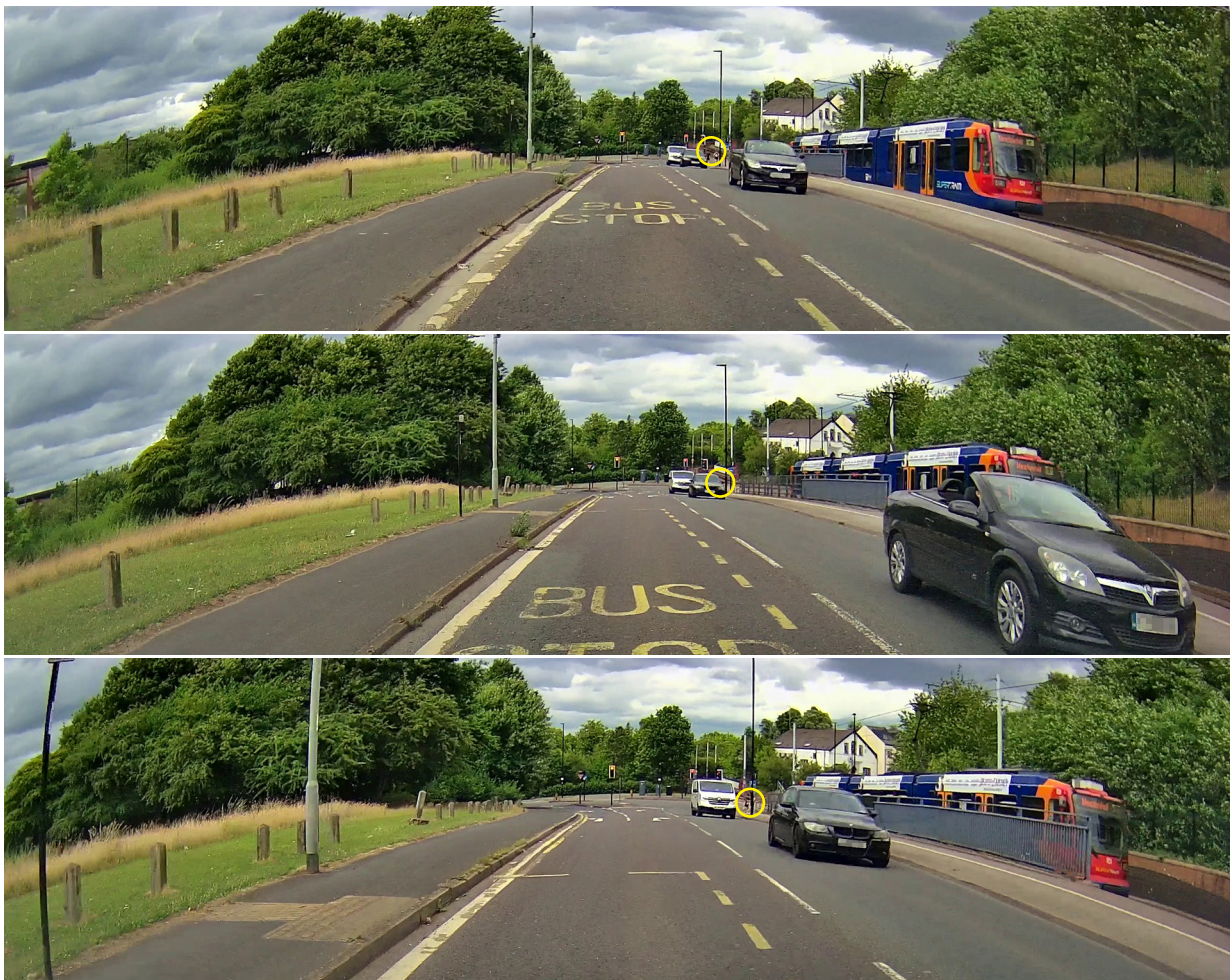
- 42 Witness and CCTV evidence shows that the pedestrians did not hear or see the approaching tram and did not react to its presence.
- 43 CCTV, road vehicle 'dash cam' footage, and witness evidence corroborate that the pedestrians were running at a steady pace ahead of the tram, with the tram approaching from behind them to their right (figure 9). This means that the tram would not have been in the pedestrians' sight lines as they approached the crossing while running along Woodbourn Road.

Figure 9: Movement of the tram behind the pedestrians (circled) on the approach to Staniforth Road footpath crossing (dash cam footage courtesy of a member of the public via South Yorkshire Police with RAIB annotations).

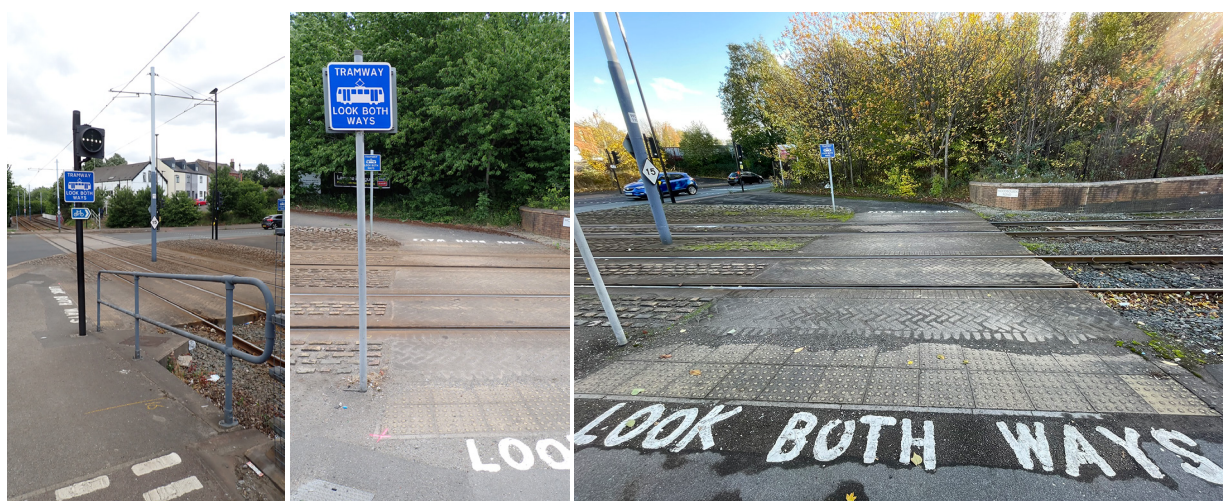
- 60 A 45-metre-long fence divides the pavement and the tramway on the approach to the footpath crossing from the south. The first 40 metres of the fence are constructed primarily to prevent road vehicle incursions onto the tramway, and the different gradient profiles here create a drop in height between the pavement and the tramway. The final 5-metre section of fence immediately before the footpath crossing is intended to segregate pedestrians from the tramway. It follows the downward slope of the footpath towards the crossing. At the end of the pedestrian fence, a signal post displays a blue 'TRAMWAY LOOK BOTH WAYS' sign (figure 11).

Figure 11: Signage at Staniforth Road footpath crossing when approaching from the west.

- 63 The information conveyed by the signage and road markings was not effective in informing the pedestrians, who were running and conversing, and were unfamiliar with the location and the tramway, of the correct way to use the crossing. The layout and design of the crossing also did not challenge the pedestrians' expectation that they would not encounter a tram when using it (paragraph 57). The management of the crossing and its safety are examined further from paragraph 64.

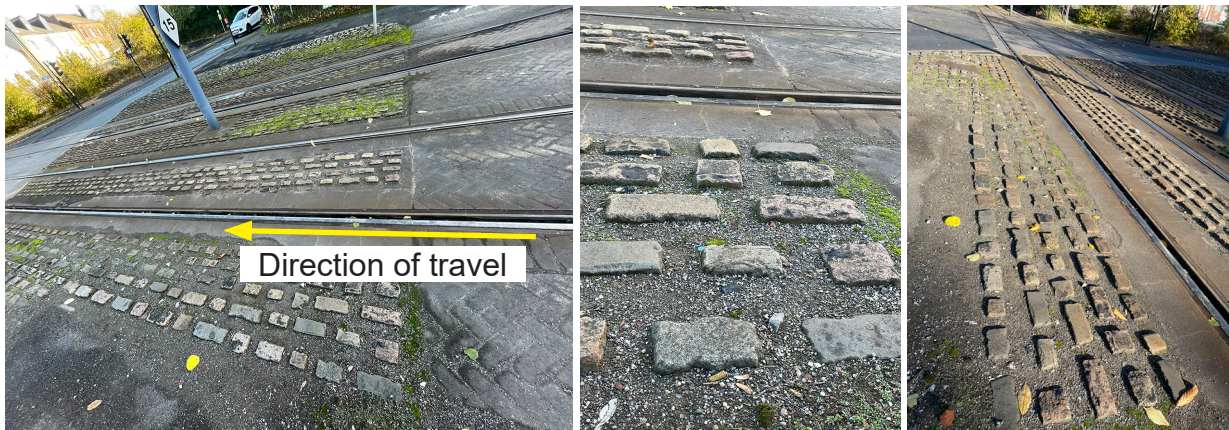
- 87 The surface of the area beyond the footpath crossing on the outbound track at Staniforth Road is level with the top of the rails, but with inserted granite cobbles protruding from the surface by an additional 10 to 30 mm. The cobbles range between 90 mm and 150 mm in length, with an average width of 80 mm (figure 13). The cobbles at Staniforth Road crossing create a high friction surface, on which a person would not easily slide.

Figure 13: Cobbled surface past the footpath crossing on the outbound line at Staniforth Road footpath crossing.

- 88 The cobbled area is on Sheffield City Council land and was designed to create a visual boundary between the footpath crossing, the segregated track area, and Staniforth Road itself. Although the cobbled area has brought the track bed to the level of the rails, there is no warning on the crossing to highlight the area of risk to the crossing user (as suggested in the LRSSB NMU guidance), and it is not conducive to a prone pedestrian sliding along. It is possible that the increased friction caused by the pedestrian being pushed along the cobbles during this accident exacerbated their injuries.

- 3 *The intent of this recommendation is that injuries sustained by pedestrians struck by trams are minimised.*

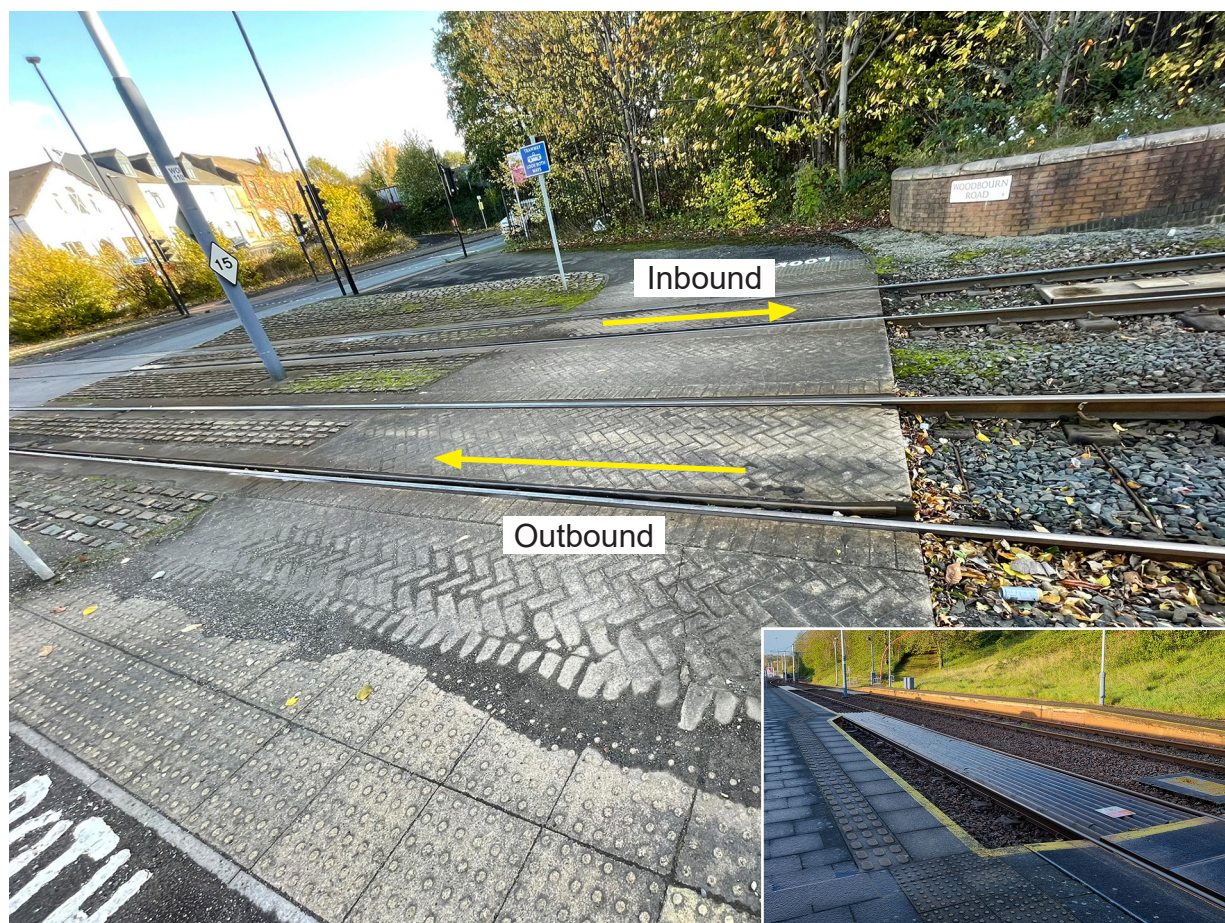
- 89 While the cobbles were identified as underrun protection for the outbound track where the accident took place, RAIB observed that there is no underrun protection for the inbound track on the same crossing. Immediately after the footpath crossing, the inbound track returns to segregated track with ballast (figure 14). It is likely that this lack of underrun protection is a consequence of the ineffective management of risk as discussed in paragraph 65.

Figure 14: Absence of underrun protection infill on the inbound track and (inset) an example of underrun protection installed at a crossing elsewhere in Sheffield.
