**REPORT**  
**OF THE**  
**OPERATIONAL SAFETY REVIEW TEAM**  
**(OSART)**  
**MISSION**  
**TO THE**  
**HEYSHAM 2**  
**NUCLEAR POWER PLANT**  
**UNITED KINGDOM**  
**2 TO 19 OCTOBER 2023**  
**AND**  
**FOLLOW-UP MISSION**  
**26 TO 30 JANUARY 2026**

**DIVISION OF NUCLEAR INSTALLATION SAFETY**  
**OPERATIONAL SAFETY REVIEW MISSION**  
**IAEA-NSNI/OSART/220F/2026**

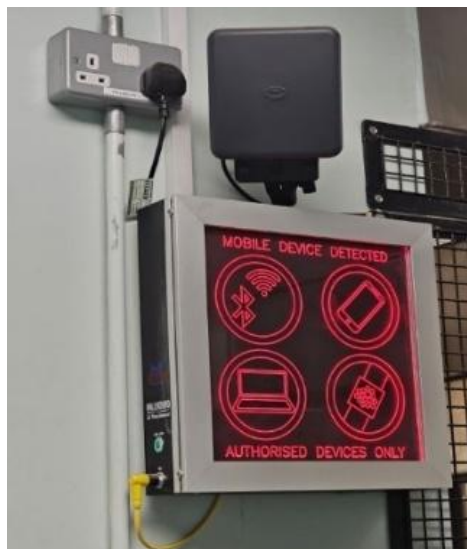
Figure 1.1: Picture of a Wall hound device

The benefit of the Wall Hound System is the prompt detection of EMI/RFI which could impact sensitive plant equipment and possibly impair equipment function resulting in a transient or plant trip.

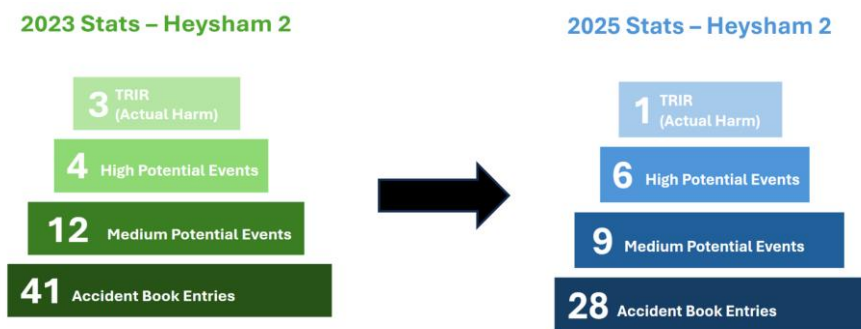
The Safety Pyramid was used to compare safety performance from the time of the initial OSART mission in 2023 to December 2025. The comparison noted a reduction in the number of consequential injuries resulting from Lost Time Accidents and improved performance overall. However, events related to high potential industrial safety risk have increased.

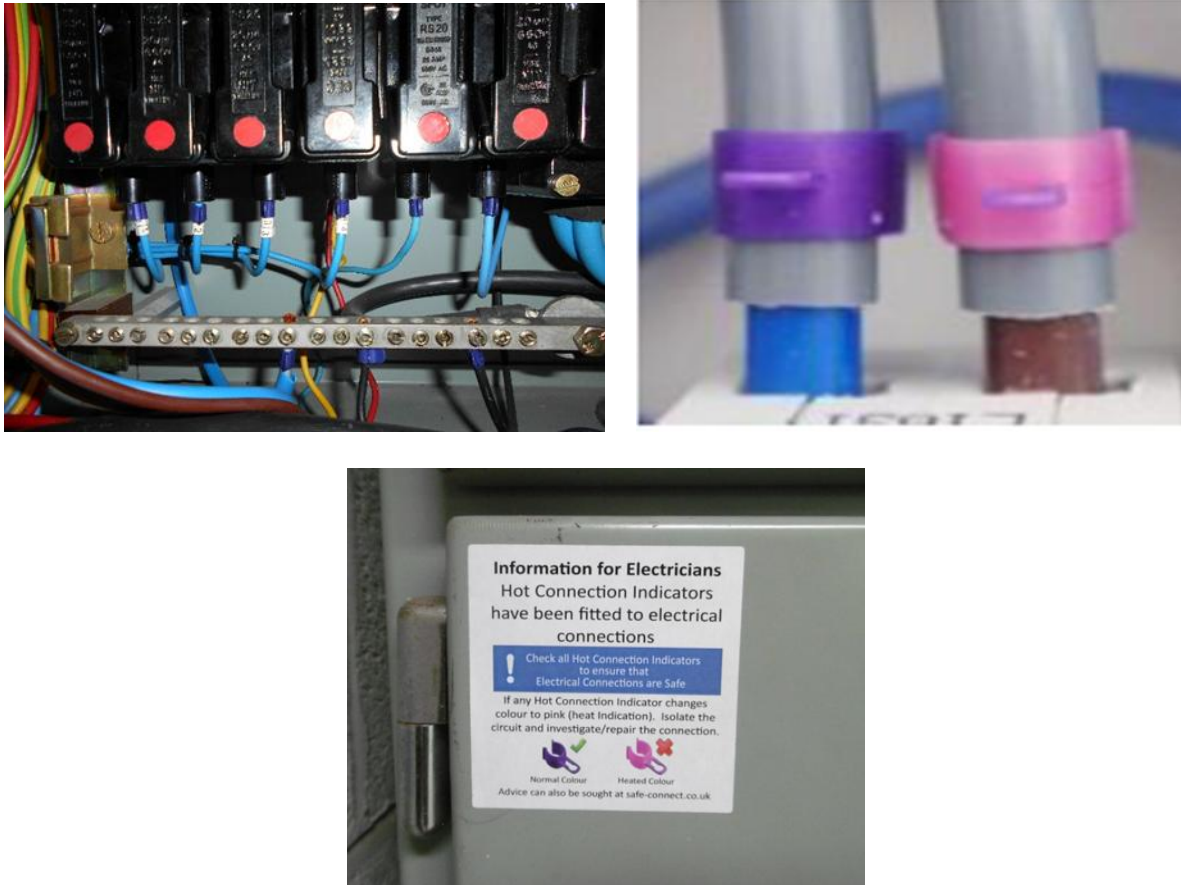
Figure 3.1: Cable hot connection indicators

Hot connection indicators are installed in the plant over cables to give a warning of high temperature connections by changing colour, i.e., Purple is normal temperature (OK), Pink indicates high temperature (Warning).

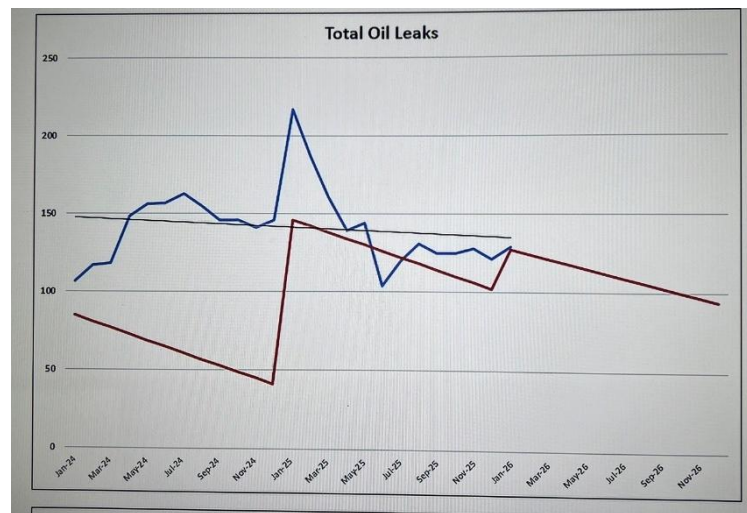
(target in red, number of oil leaks in blue). (2024, 2025, 2026)

An internal monitoring of the oil leaks is performed by the maintenance department. Until January 2025, oils leaks increased significantly above the target. Since the 2025 statutory outage, a decreasing target has been set, and oil leaks have been reduced according to the plan.

In the leaks backlog, amongst the 134 oils leaks, 67 are planned to be repaired in a normal work week and 24 during either Fuel Route, interim or statutory outages.
