## Housing Health and Safety Rating System (HHSRS)

## Case Studies

Hazard A4  
Fire and Explosions

Example A4.7  
Post-1979  
Common parts of a  
Residential High-rise

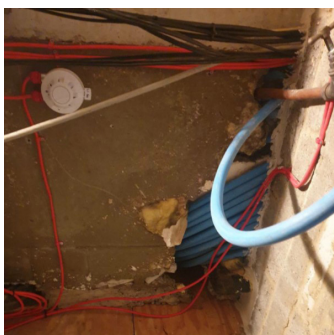
Several service cupboards are located on each floor of the building. Attempts have been made to fill penetrations with a pink or yellow expanding foam. Some service pipes had fire collars visible, but not all.

Numerous doors to service cupboards do not fit their doorways, with gaps between door frames and walls being sealed with yellow or pink expanding foam in many cases.

Yellow expanding foam is unsuitable as a fire barrier. Pink (fire-resisting) expanding foam is not suitable for sealing excessively large gaps.

4  
Penetrations to service  
cupboards and damaged  
ceiling
