**Accident**

| <b>Aircraft Type and Registration:</b> | Eurofox 2K, G-CMAX | |
| <b>Location:</b> | Talgarth Airfield, Powys | |

**Synopsis**

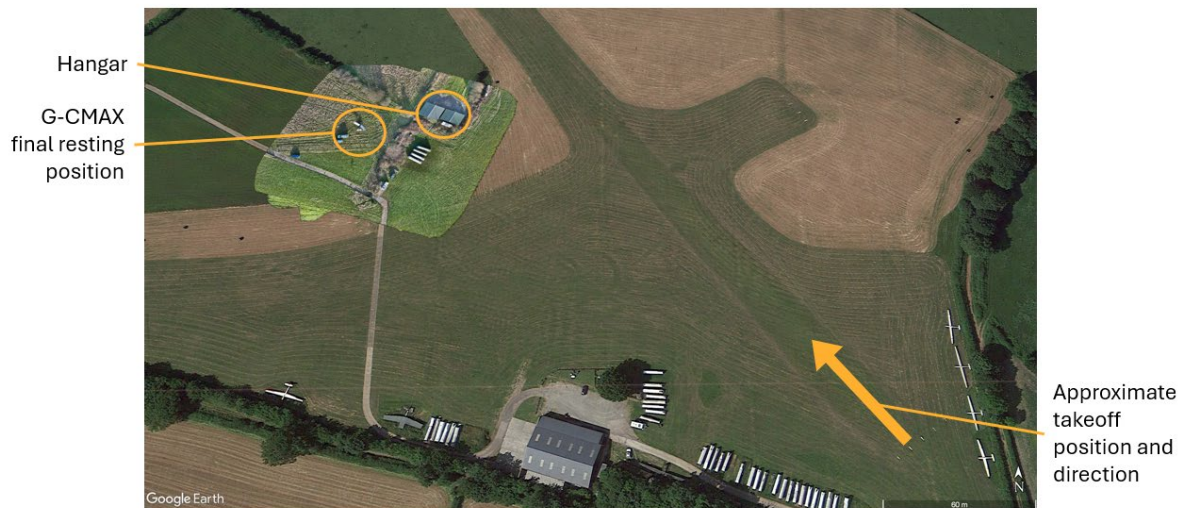
**Figure 1**

The aircraft came to rest in a field to the west of and adjacent to the gliding site (Figure 1). Damage to the aircraft’s wings, a wire fence on the edge of the field and ground scars in the field indicated that the aircraft initially clipped the top of the fence with its left wingtip before striking the ground in a nose down attitude. It then turned horizontally through 270° before coming to rest on its wheels, facing in a northerly direction. The glider towing line remained attached to the aircraft and trailed over the boundary fence and foliage, indicating the direction from which the aircraft had come (Figure 2).

Google Earth image of Talgarth Airfield with aerial image of G-CMAX accident site overlaid

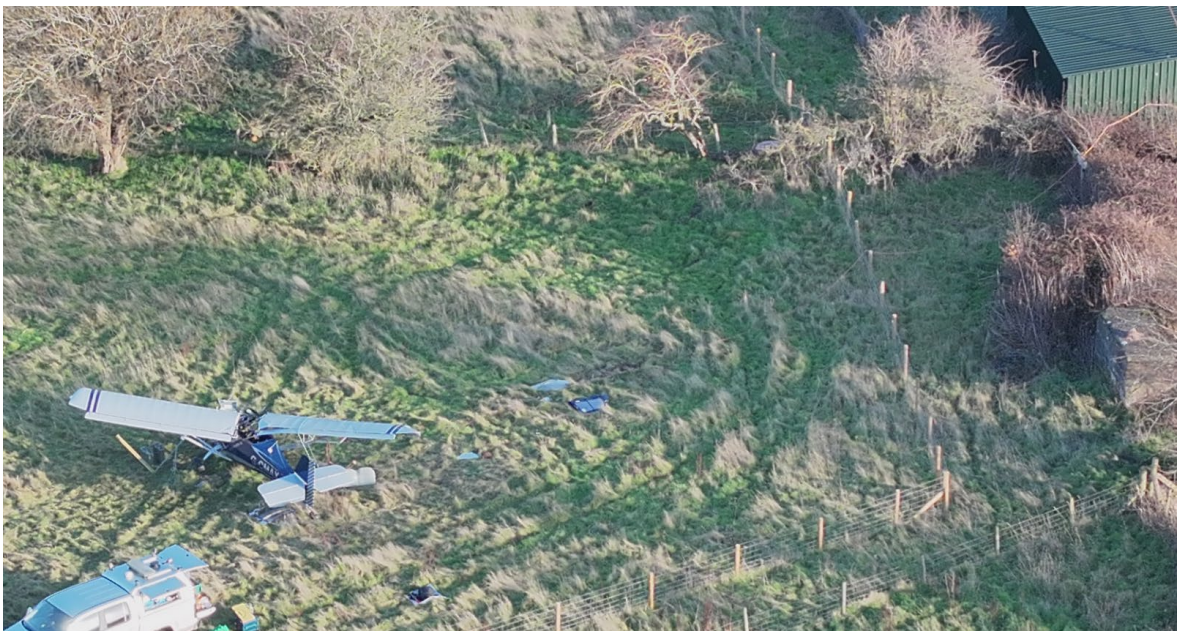
**Figure 2**

G-CMAX final resting position – note tow rope trailing over foliage in the right of the image

Although the wings remained attached to the aircraft, the left wing had been displaced forwards and the right rearwards by approximately 45°. The cockpit had been severely disrupted.

The Rotax 915 iS engine was largely intact and one of the four propeller blades was missing from approximately 25% height. One of the remaining blades had also fractured at the hub but remained attached.

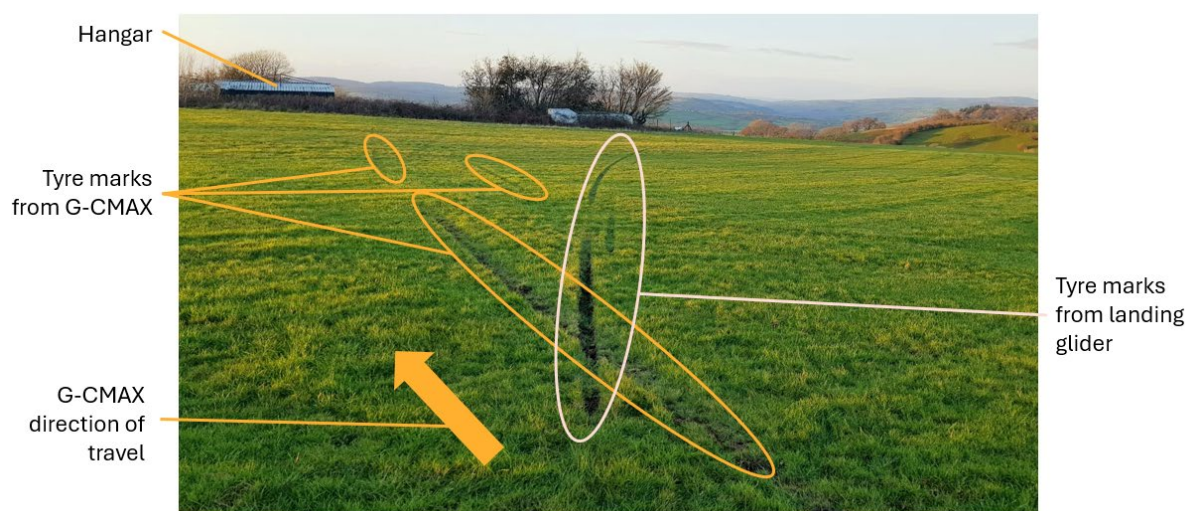
**Figure 3**

Wheel marks in the soft ground between the runway and the accident location indicated that the aircraft touched down briefly and became airborne again before crossing the airfield boundary (Figure 3).

Tyre marks in airfield from G-CMAX and towed glider

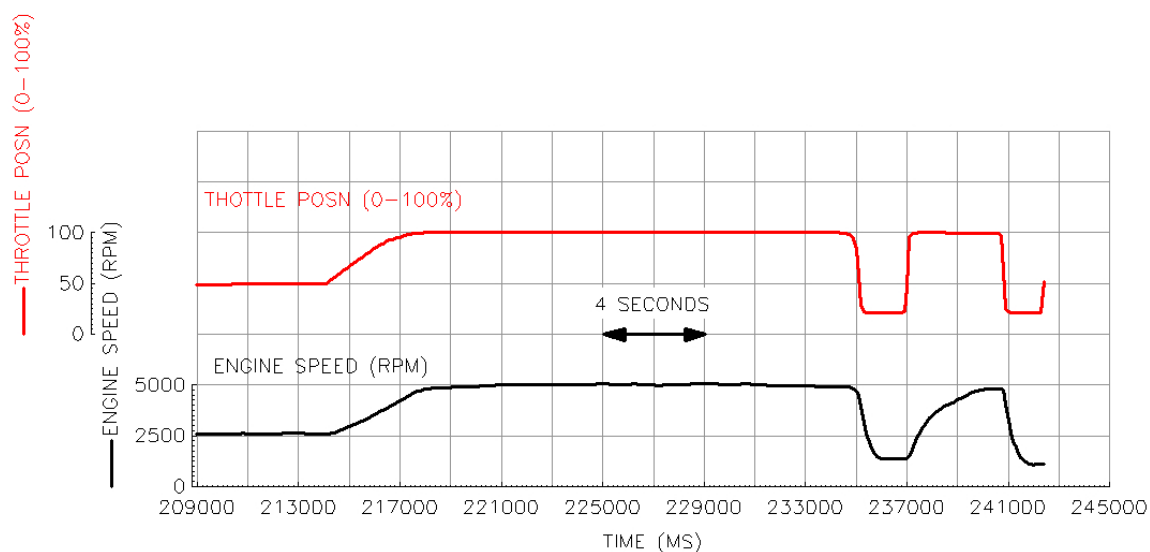
**Figure 4**  
G-CMAX ECU data

The aircraft was fitted with an Engine Control Unit (ECU) which logged engine parameters for the last hour of operation. The ECU was downloaded and the accident flight was recorded at up to 10 samples per second. The data confirmed that the engine was responding and operating as expected. Figure 4 shows the throttle command and engine speed, showing a full power demand on takeoff with engine rpm maintaining approximately 5,000 rpm. Towards the end of the recording, the throttle command was reduced to 21% for approximately 2 seconds before being restored to 100%.

Assessment of the aircraft found no issues that could have caused an uncommanded roll during the takeoff. Review of the recorded data from the engine controller identified that the engine was operating normally during the takeoff and throughout the flight.

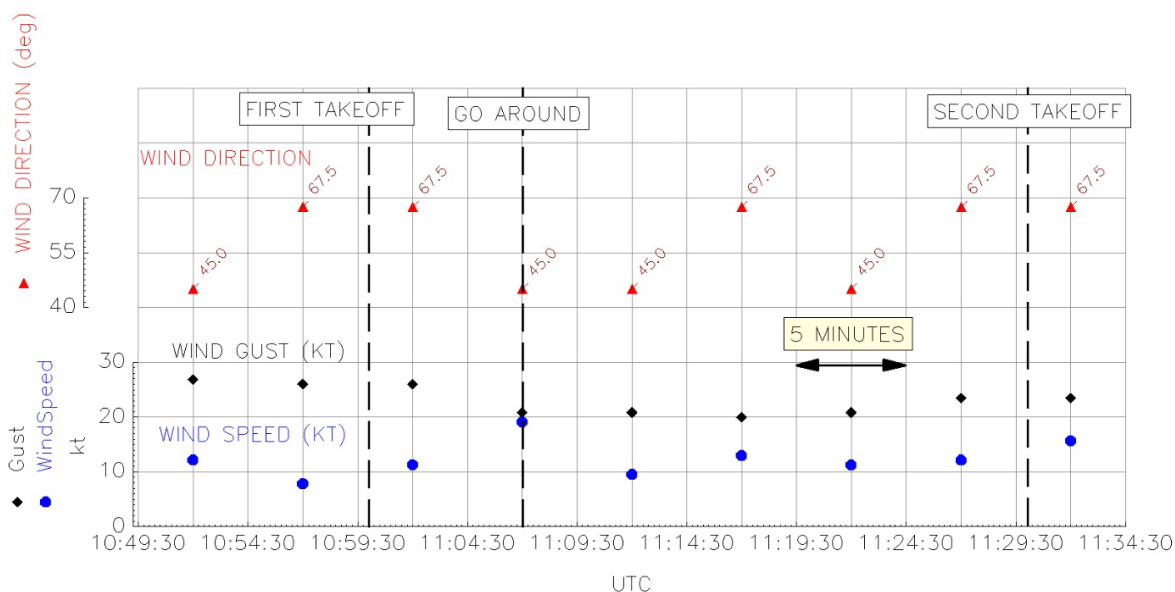
**Figure 5**

Weather data from airfield weather station (Credit: Weather Underground)

At the time of the accident the weather station at the clubhouse was reporting the instant windspeed as between 12 kt and 16 kt, gusting 23 kt from east-north-east. This wind was across the runway in use at the time. The temperature was 4°C with no precipitation and good visibility.

The wind recorded around the time of the accident indicated a crosswind of 12-16 kt gusting to 23 kt. The published crosswind limit for the aircraft is 15 kt. Webcam images recorded from the club house confirmed the large variation in windspeed, but the wind direction remained constant. The pilot believed that at ground level along the runway the crosswind was likely to be less than the values recorded at the weather station, and so the decision was made to take off. There had been successful operations from the airfield many times previously in similar conditions and this might have supported a view that it would be no different on the day of the accident.

The club also introduced a live wind indicator on its website, accessible to all club members, which shows a mean two-minute wind and the maximum ten-minute gust. It also displays headwind, tailwind and crosswinds for all three runways.

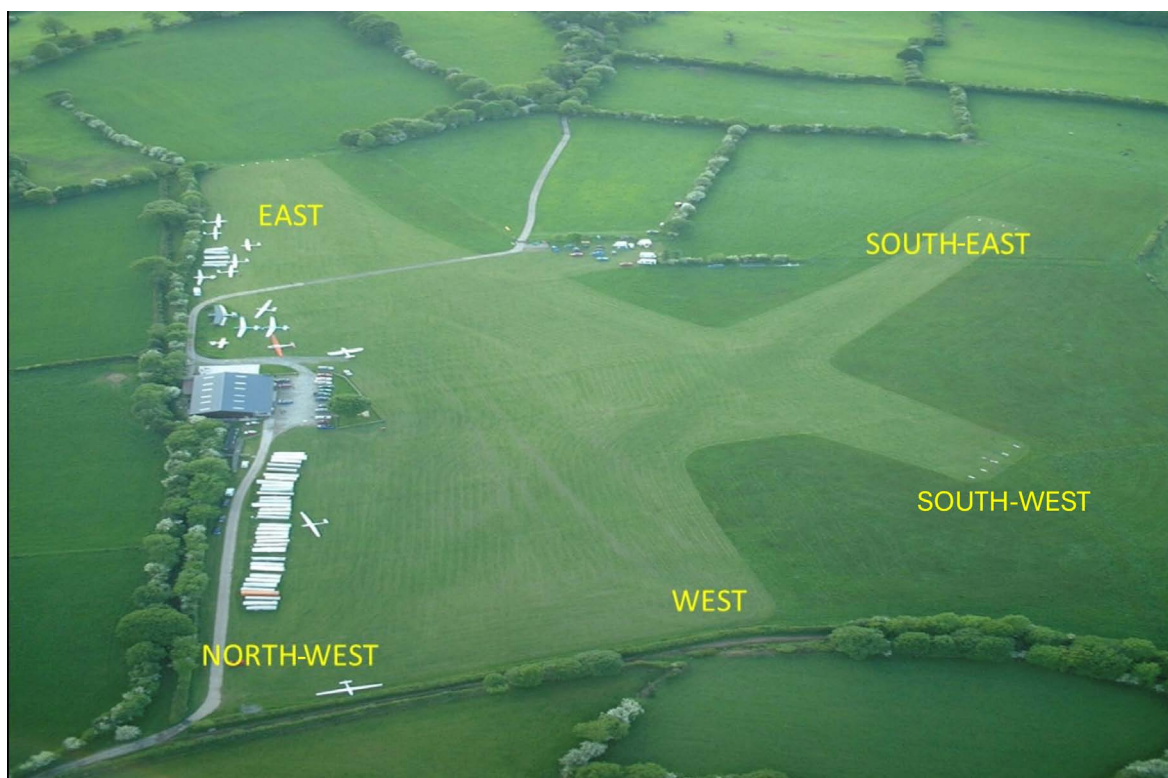
**Figure 6**

Talgarth Airfield is located on the western slopes of the Black Mountains and is 970 ft amsl. The land slopes down from the centre of the strip, described on the gliding club website as being like an upturned saucer. When departing from the north-west runway, G-CMAX would have been starting its ground run with a slight upward incline after which it would have experienced a downward slope (Figure 6). The airfield is smaller than most typical gliding sites and can experience rotor turbulence from the nearby mountains. The north-westerly runway in use at the time of the accident has a length of 360 m. Challenges of operating from the airfield have been recognised by the gliding club, so a site briefing pack and video is available on the club's website to highlight these. It is compulsory for any pilot wanting to operate from the site to have reviewed this material. A briefing is conducted by the duty instructor every morning prior to the day's flying, and this briefing includes the prevailing weather conditions and threats for the day.

Talgarth Airfield runways published on Black Mountains Gliding Club website
