# ***AAIB Bulletin***

# ***8/2026***

Published: 13 August 2026.

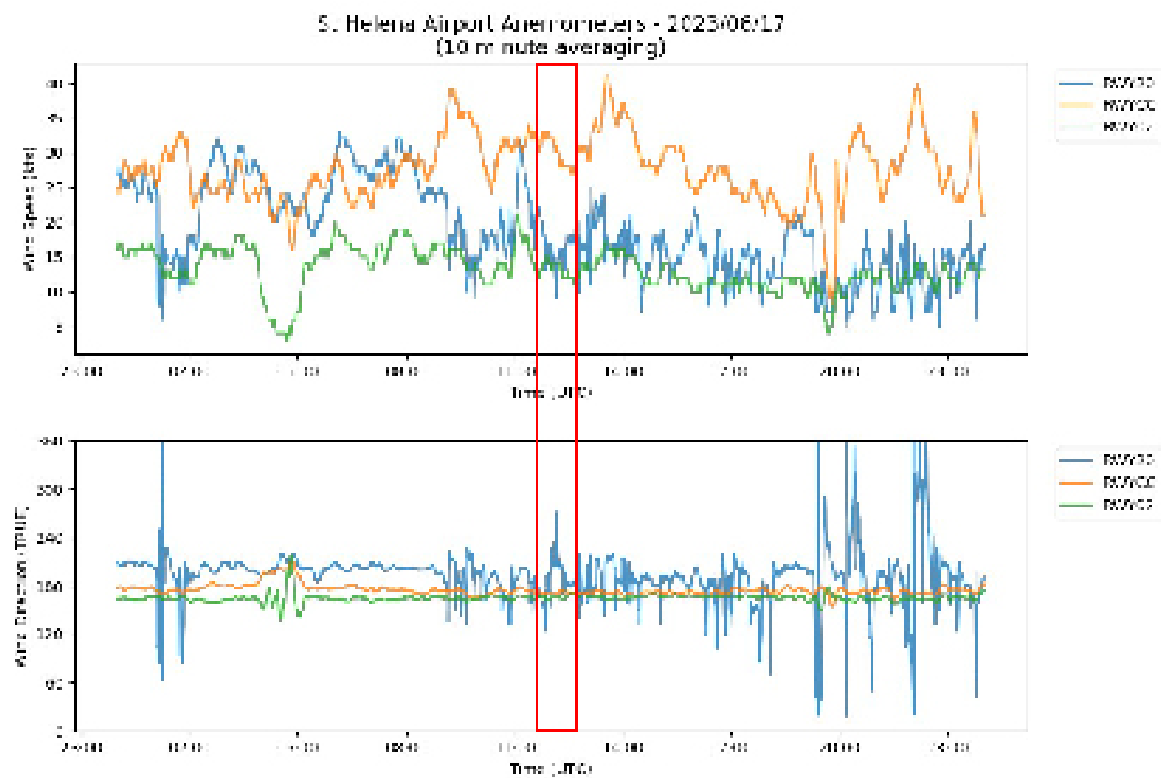
**Figure 1**

The Met Office provided recordings of the actual wind conditions at St Helena Airport for both 17 June and 10 September 2023. On 17 June, at the aircraft's planned arrival time of 1325 hrs, the 10-minute average wind speed at the mid-point reached 40 kt. The general wind direction was around 180° true at the Runway 19 mid-point and 180°/160V220 for the Runway 19 threshold.

St Helena Airport Wind Recordings - 17 June 2023

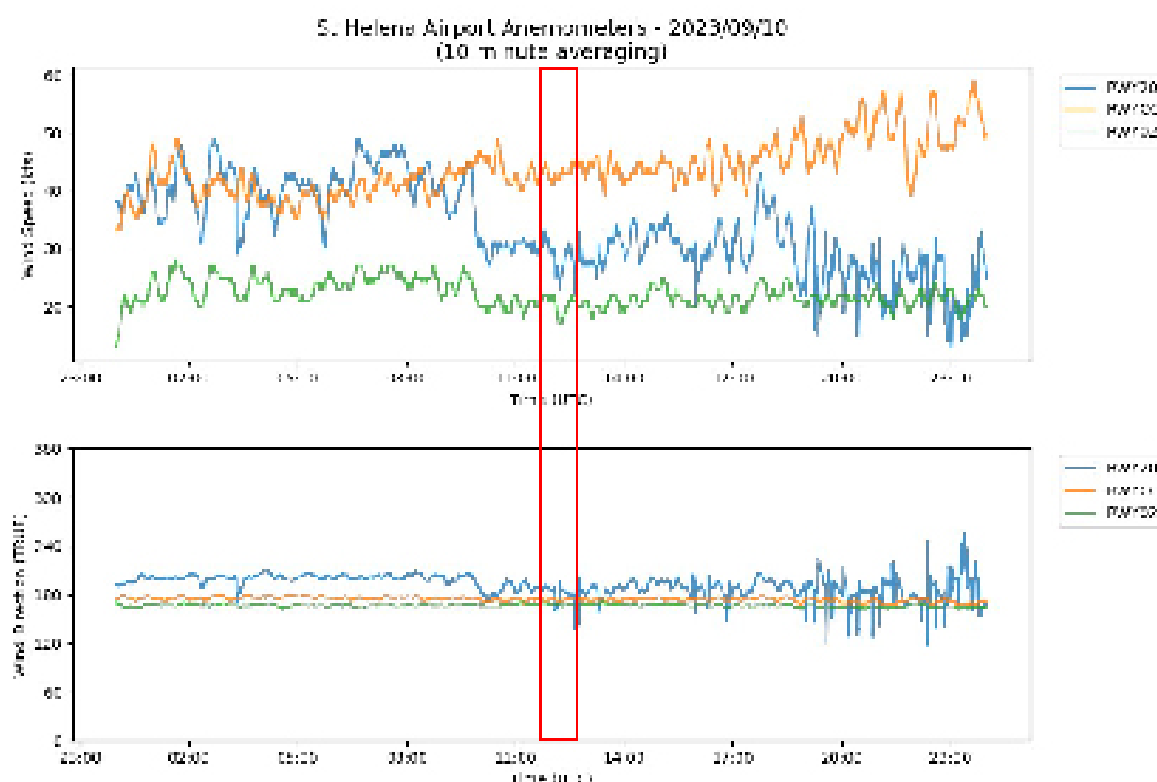
**Figure 2**

On 10 September, the 10-minute average wind speed at the Runway 19 mid-point was consistently 40 kt and above, and at the threshold around 30 kt. The wind direction gave a general head wind along Runway 19.

St Helena Airport Wind Recordings - 10 September 2023

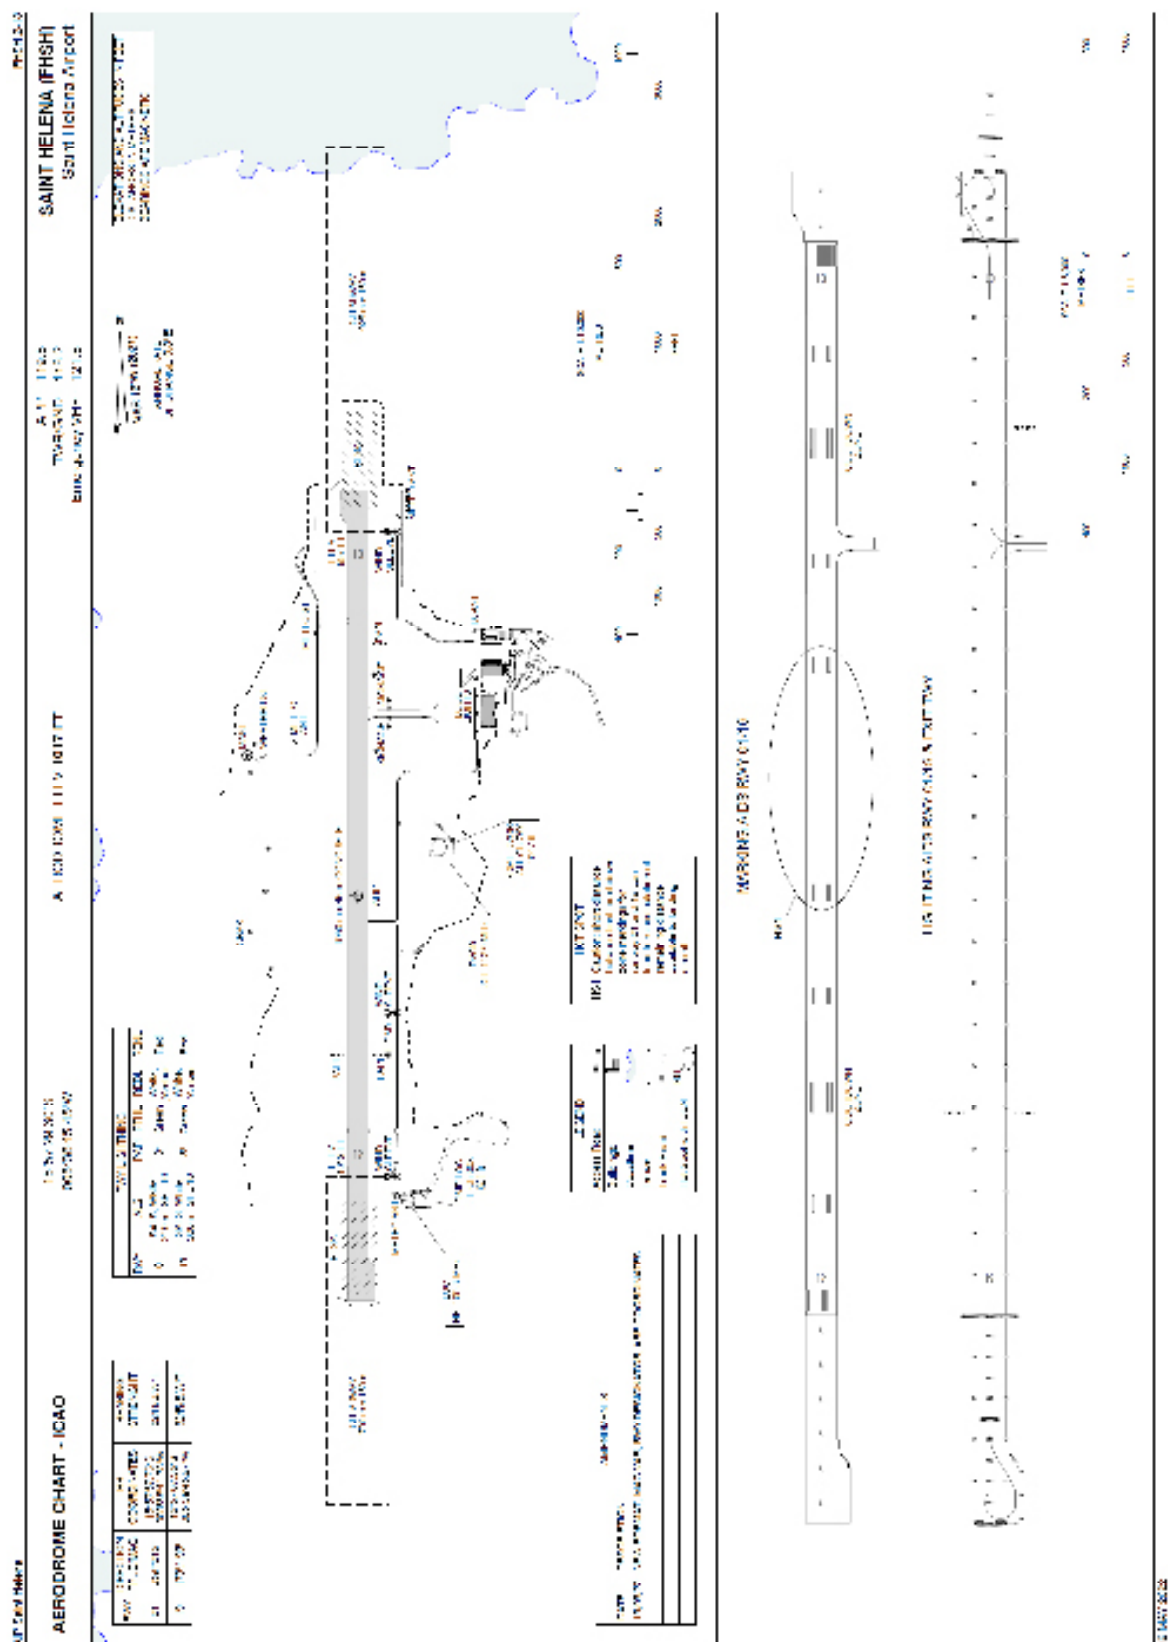
### Appendix 3: St Helena Aerodrome AIP Chart

The aerodrome chart contained in the Aeronautical Information Publication (AIP) for St Helena Airport noted this potential problem and marked a hot spot on the runway, referred to as HS1. This covered the area between the final touchdown markings for both runway directions with the following caution:

It is recommended that St Helena Airport Limited updates FHS AD Section 2.9 of the airport's Aeronautical Information Publication, to include a warning of the potential for pilots to mis-interpret their position on the runway due to the short distance between reciprocal Touchdown Zone markings.

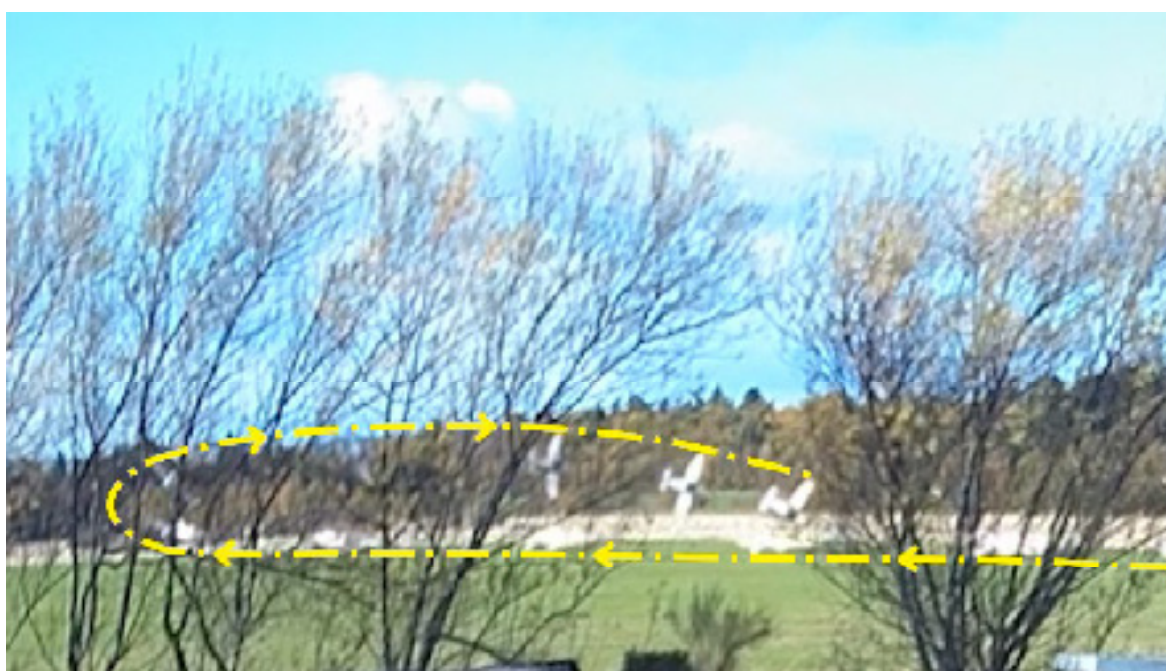
**Figure 1**

During the takeoff ground roll from Portmoak Airfield, the aircraft yawed sharply to the right. After becoming airborne, while still yawed, it then rolled to the right and entered a descending turn. Approximately six seconds after takeoff the aircraft struck the ground in a field to the north of the runway. The aircraft was destroyed and the pilot was fatally injured. No mechanical or technical defects were identified which would have prevented normal control of the aircraft. It is possible that the pilot suffered either a partial or complete incapacitation during the takeoff roll.

checks before lining up on the runway. It then commenced its takeoff roll. The tailwheel lifts off from the ground and a few seconds later appears to make contact with the ground again. During the final section of the ground roll, the aircraft deviated sharply to the right. Despite the deviation, the aircraft continued to accelerate and became airborne. Immediately after lifting off, the aircraft continued to yaw to the right and did not realign with the original takeoff heading. Within seconds the aircraft began to roll to the right while climbing only slightly. The rate of roll then increased rapidly, and the aircraft descended in a tightening right turn. Approximately six seconds after leaving the ground the right wingtip struck the ground followed by the nose of the aircraft. Figure 1 shows a composite photo taken from the CCTV footage.

Composite CCTV image G-BODT, arrow shows flight direction
