## Man overboard from the lone-operated creel fishing vessel *Sea Eagle* (AH18) resulting in one presumed fatality in fishing grounds south-east of Montrose, Scotland on the 20 December 2025

## SUMMARY

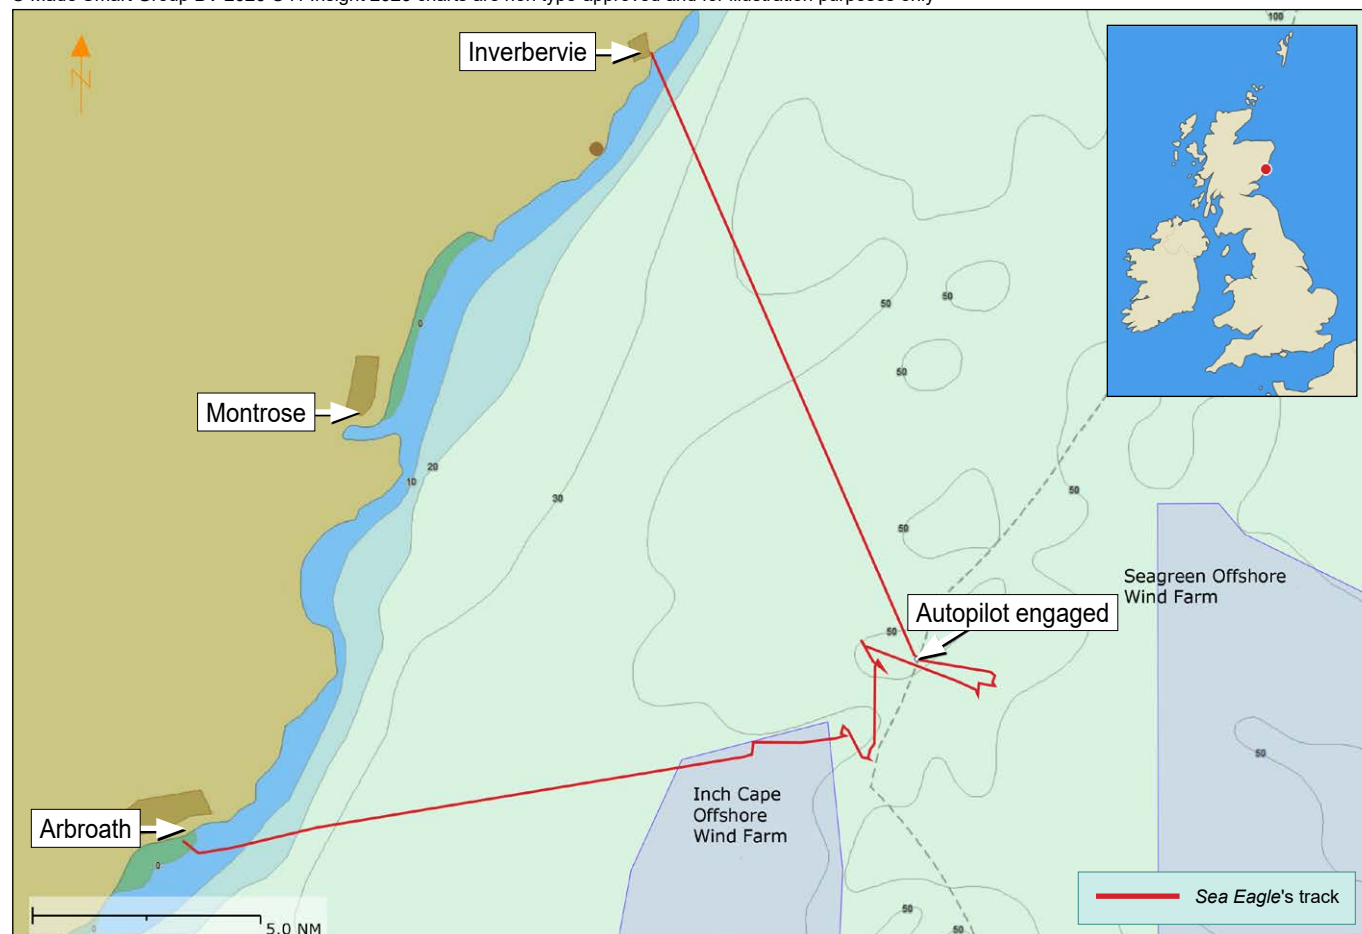
**Figure 1: Sea Eagle's final track with inset of accident location south-east of Montrose**

At about 0905, *Sea Eagle*'s skipper engaged the autopilot, setting the vessel on a north-westerly course at 7 knots (kts). At some point afterwards, with the vessel on autopilot and making way, the skipper left the wheelhouse and subsequently entered the water.

At about 1055, two people walking on Inverbervie beach noticed a fishing vessel approaching the shore continue its course until it ran ashore at 1101. The two people then approached the vessel, identified it as *Sea Eagle*, and noticed it was unmanned. They boarded the vessel, stopped its engines and, at 1112, alerted Police Scotland.

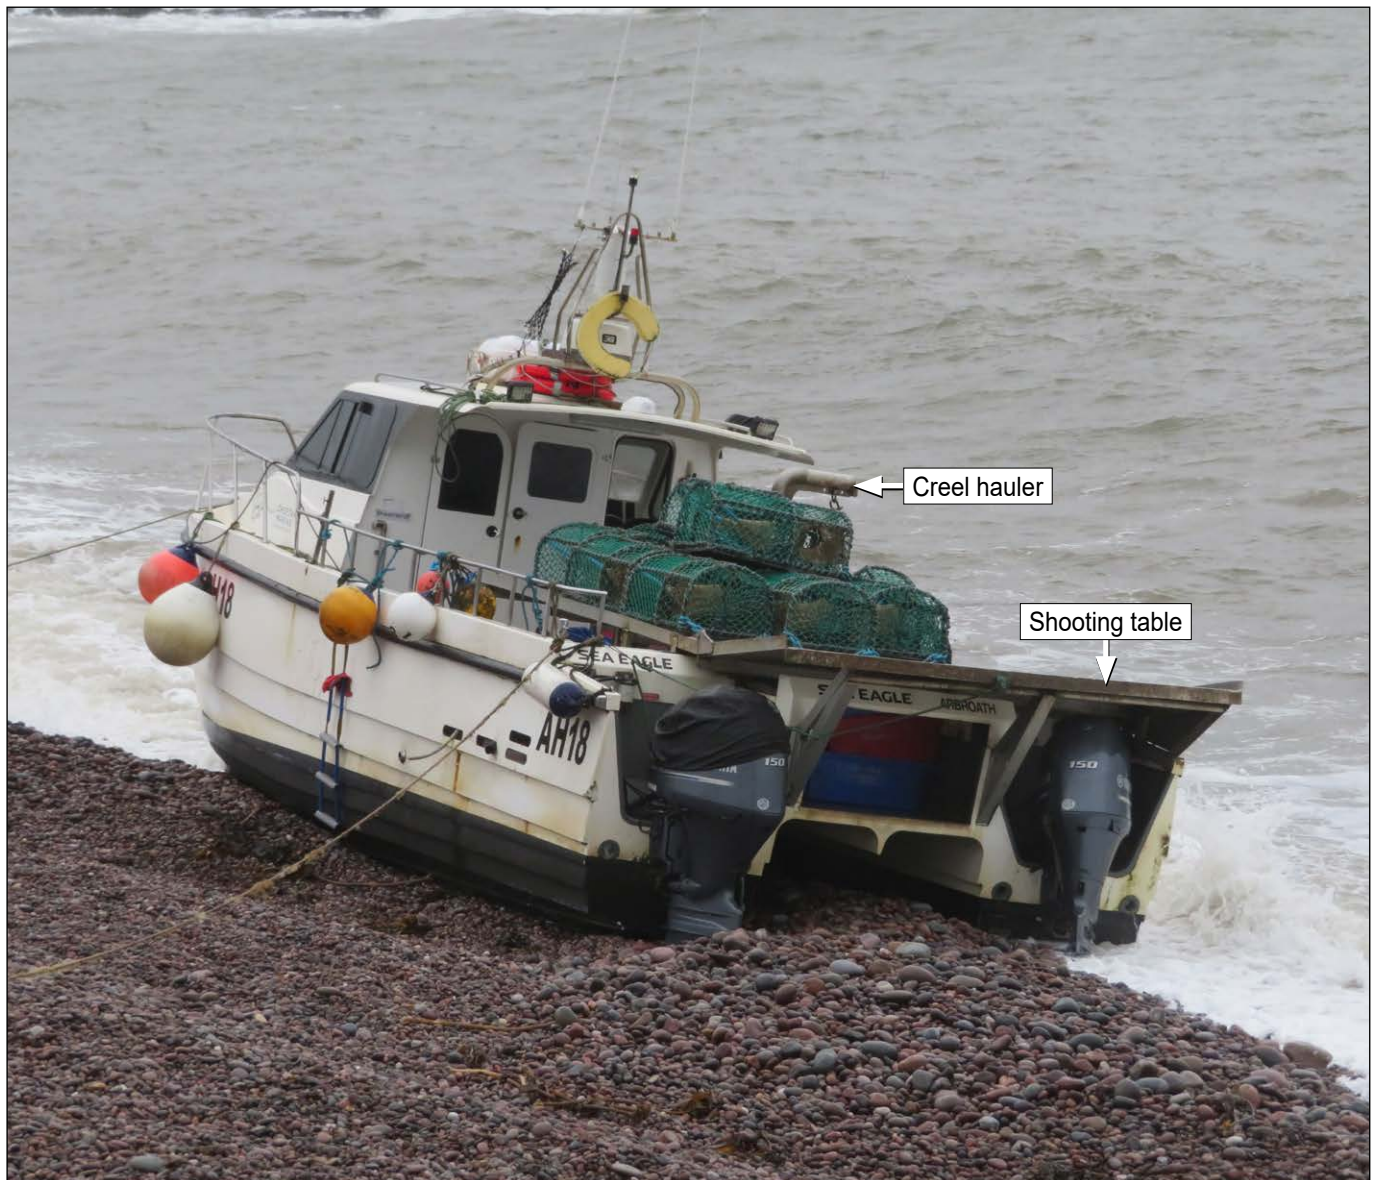
**Figure 2: Sea Eagle**

The majority of *Sea Eagle's* aft deck area was covered with an aluminium shooting table on which the creels were processed and stacked before shooting. The table's height was slightly above the vessel's side rail and there was a ramp section at the aft end to assist with the deployment of the creels over the stern. Access to the aft end of the vessel was achievable from either side of the shooting table. The creel hauler was on the starboard aft side of the wheelhouse (**Figure 2**).

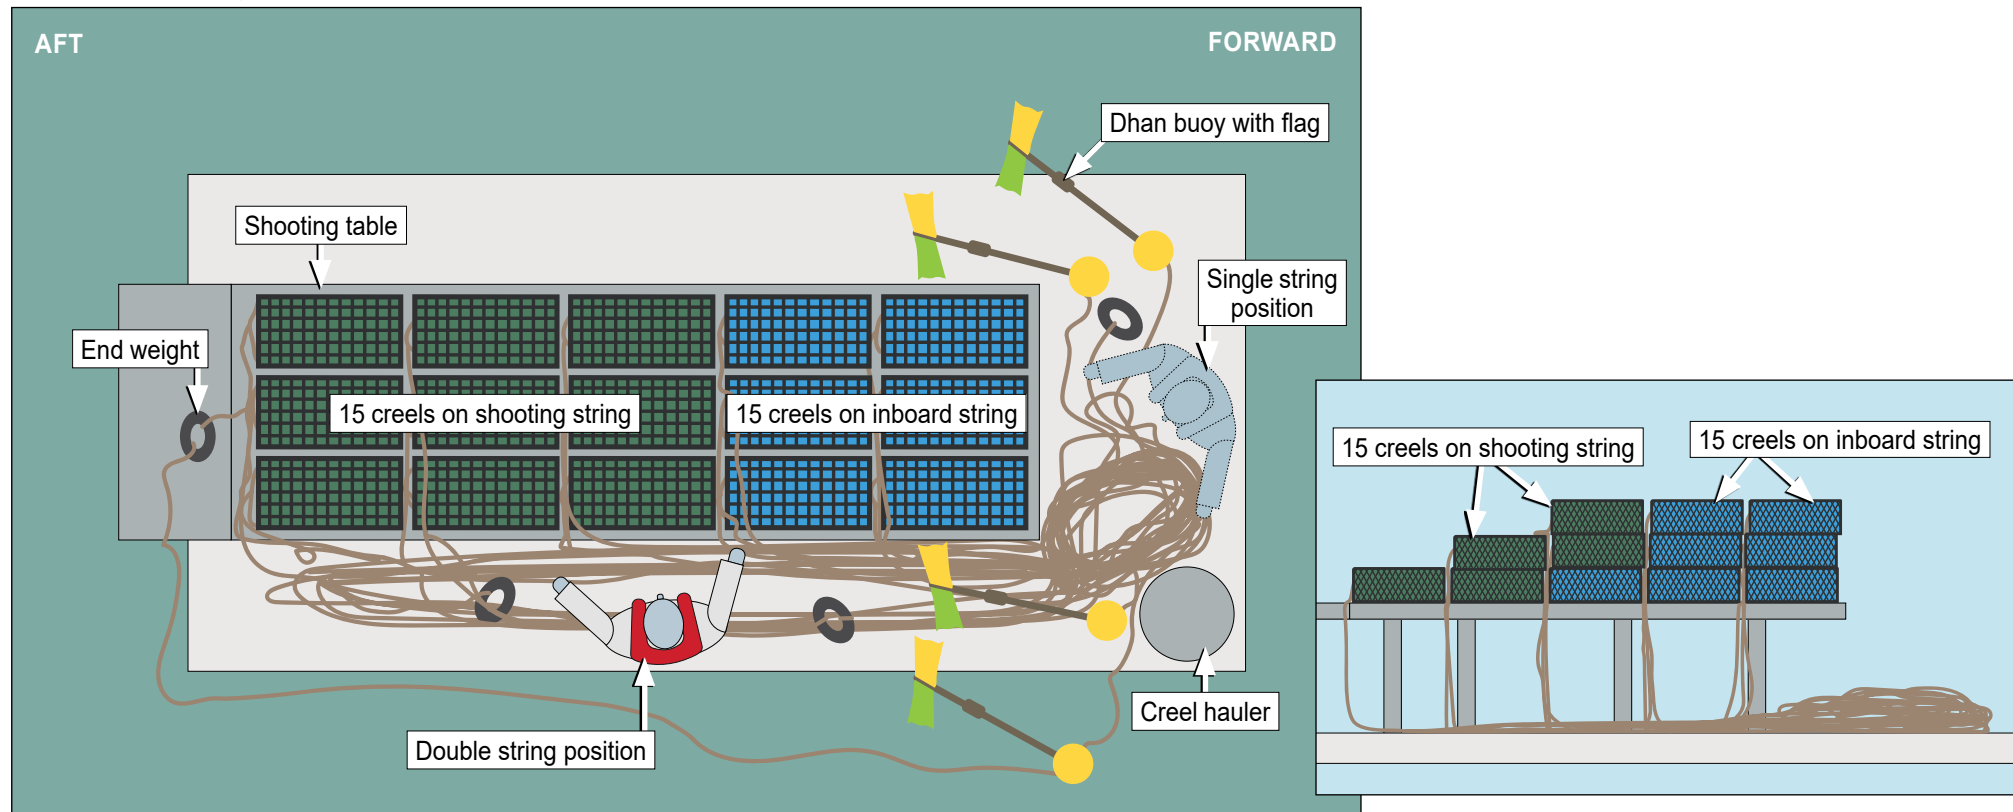
**Figure 3:** Illustrated aerial view of deck, showing stacking arrangement and (inset) profile view of the possible configuration at the time of the accident

The skipper usually worked one string at a time except when transiting between fishing locations when two strings of creels and associated gear were carried, including approximately 1,120m of rope. This was typically achieved by stacking the creels on top of one another up to three creels high (**Figure 3**). When deploying multiple strings it was necessary for creels to be physically downstacked.

It is unknown at what time and how *Sea Eagle's* skipper came to enter the water. However, the broken dhan flag found on board and the corresponding missing dhan flag at the end of the fourth string of creels indicated that the accident occurred between shooting the fourth and fifth string of creels. The fifth string had been hauled before the fourth string was re-shot, indicating that the two strings were both on board simultaneously, possibly for repositioning purposes.

Working two strings of creels simultaneously created a greater likelihood that crew would need to interact with the gear. This increased the risk of entanglement.
