**Serious Incident**

| <b>Aircraft Type and Registration:</b> | Boeing 747-433, G-ONEE | |
| <b>Date &amp; Time (UTC):</b> | 8 February 2024 at 0813 hrs | |
| <b>Location:</b> | After departure from London Heathrow Airport | |

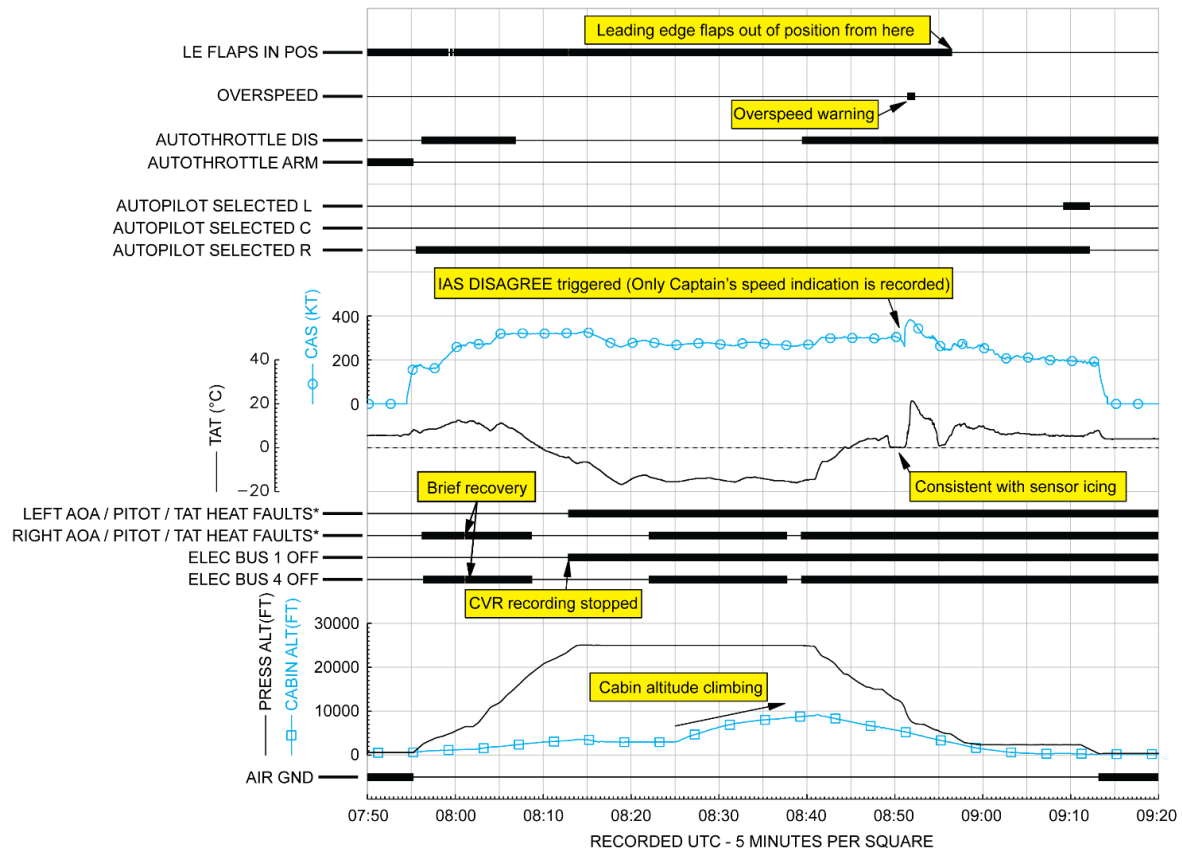
**Figure 4**

The data in Figure 4 shows the timings for when AC Bus 1 and 4 were powered and unpowered, and it shows that the cabin altitude started climbing while the aircraft was level at FL250. At the time the cabin altitude started climbing the air conditioning packs showed a change from high flow to normal flow (not plotted).

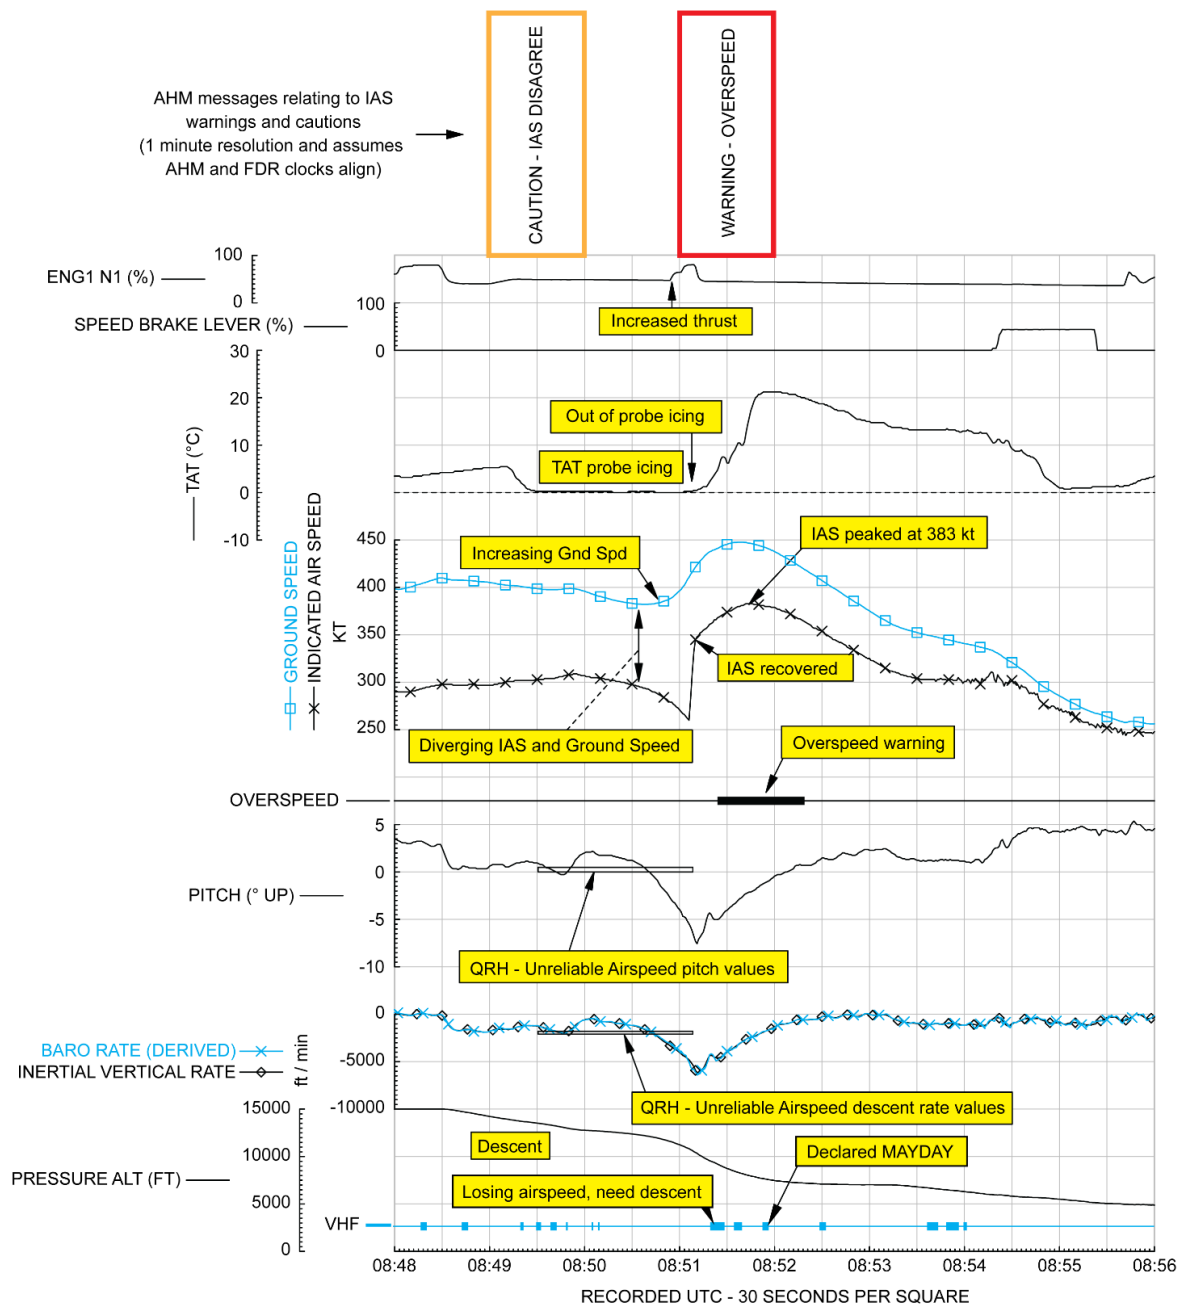
**Figure 5**  
Unreliable airspeed event

The data for the unreliable airspeed event (Figure 5) shows that throughout this period the right autopilot was engaged, the autothrottle was disengaged, the pitot, Total Air Temperature (TAT) and Angle of Attack (AOA) heat faults were active, and the AOA recorded values did not indicate icing of the AOA sensors.

The engaged autopilot mode was not explicitly recorded on this installation type. Recorded aircraft behaviour and system availability given the recorded AC bus failures made it likely that FLCH mode was engaged during the descent in icing conditions. In this mode the autopilot controls pitch to achieve the IAS or Mach values selected by the crew on the mode control panel.

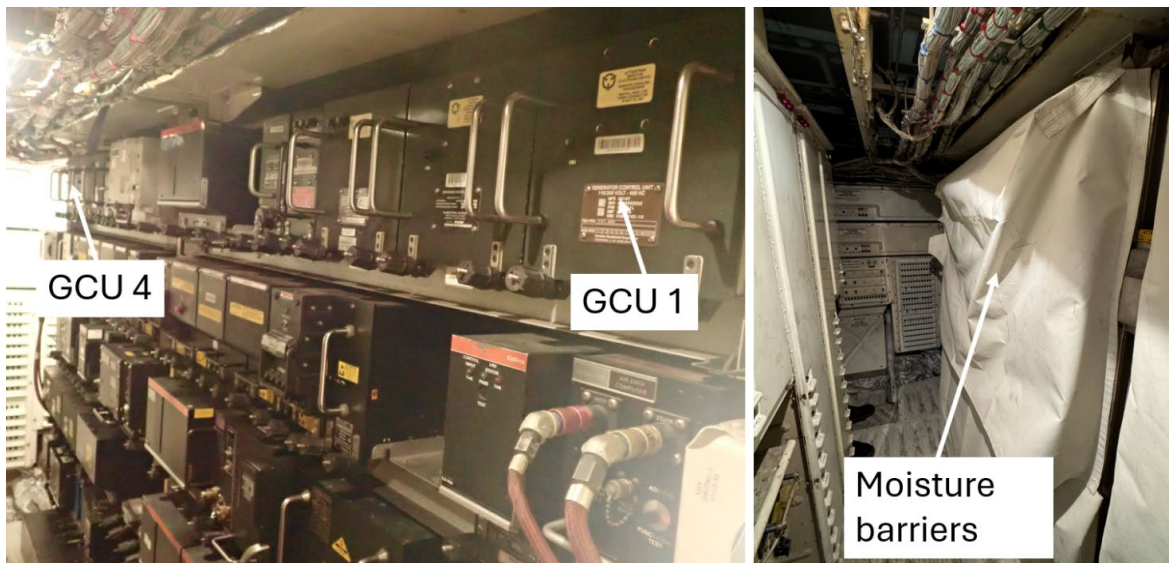
**Figure 11**

As the aircraft was registered in the UK the DSB handed the investigation to the AAIB and an AAIB inspector arrived to examine the aircraft the following day. Water was poured down the drain in the mat near the L1 door and the drain on the opposite side of the aircraft, but no leaks were found. Some water was found in the bilge at the bottom of the fuselage but that was not unusual. There were no obvious defects in the visible part of the drip shield that overhung the E1/E2 racks. No moisture or dampness was found in the intake of the air duct fan that provided cooling air to the E1/E2 racks. The moisture barrier curtains in front of the E1/E2 racks were not fitted (Figure 11).

Left image taken on day after the incident. Right image shows moisture barriers, which were fitted in March 2024, to the front of the E1 and E2 racks, covering the GCUs and other equipment

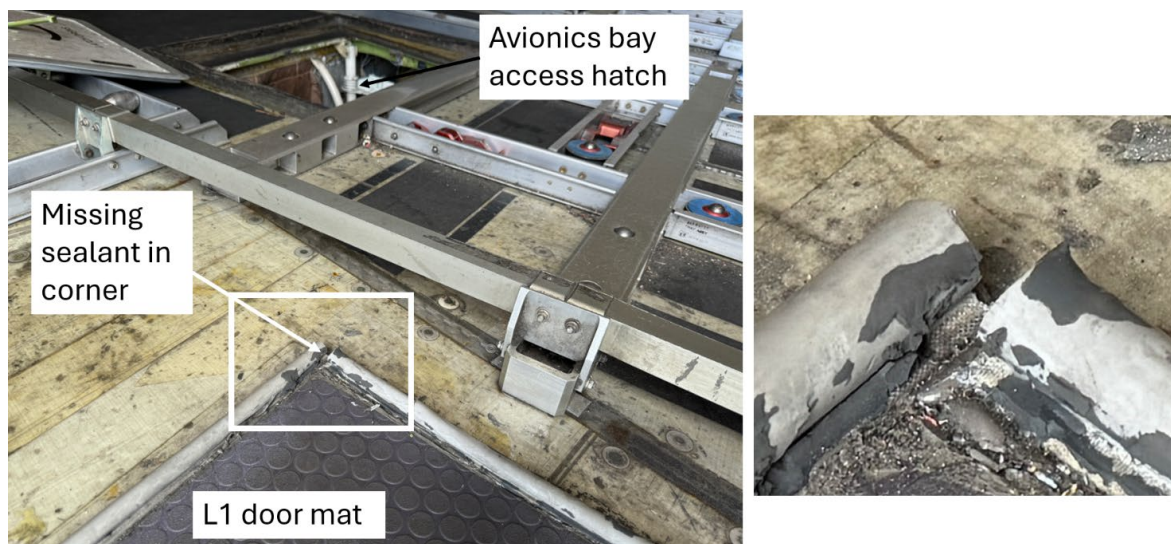
**Figure 14**

A close examination of the door mat revealed that the forward right corner was missing sealant between the rubber barriers, creating a path for water to travel along the floor above the E1/E2 racks (Figure 14).

L1 door mat showing missing sealant in forward right corner

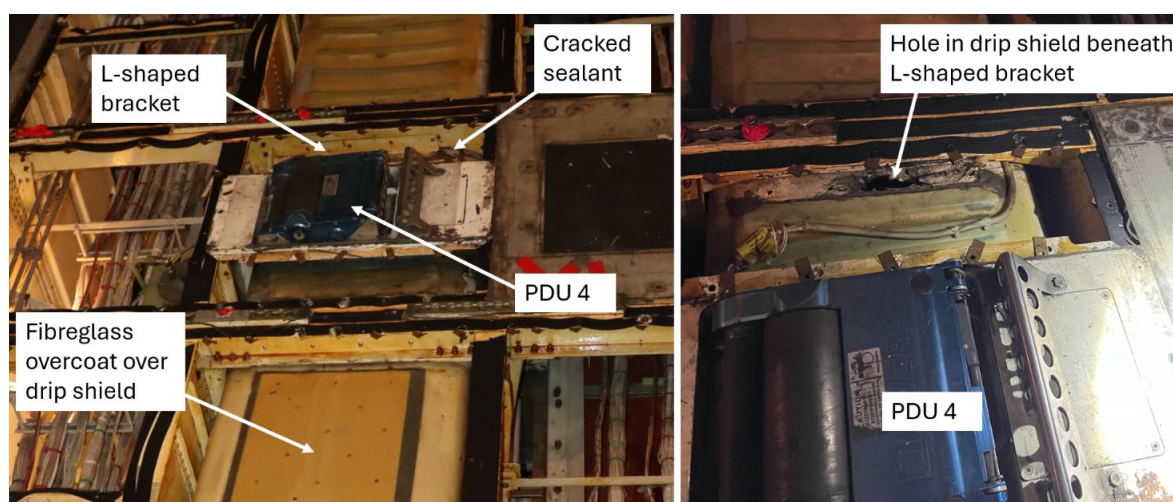
**Figure 17**

The fibreglass reinforced overcoat<sup>16</sup> on the drip shield appeared to be undamaged, but there were cracks in some sealant at the edge of an L-shaped bracket on the right side of PDU 4 (Figure 17), and on the left side of PDU 4. When the bracket was removed to repair the sealant, the drip shield was found to be damaged and had holes which could have been a potential path for water. Similar damage and holes were found in the drip shield when the bracket on the left side of PDU 4 was removed.

Hole in top of drip shield near PDU 4

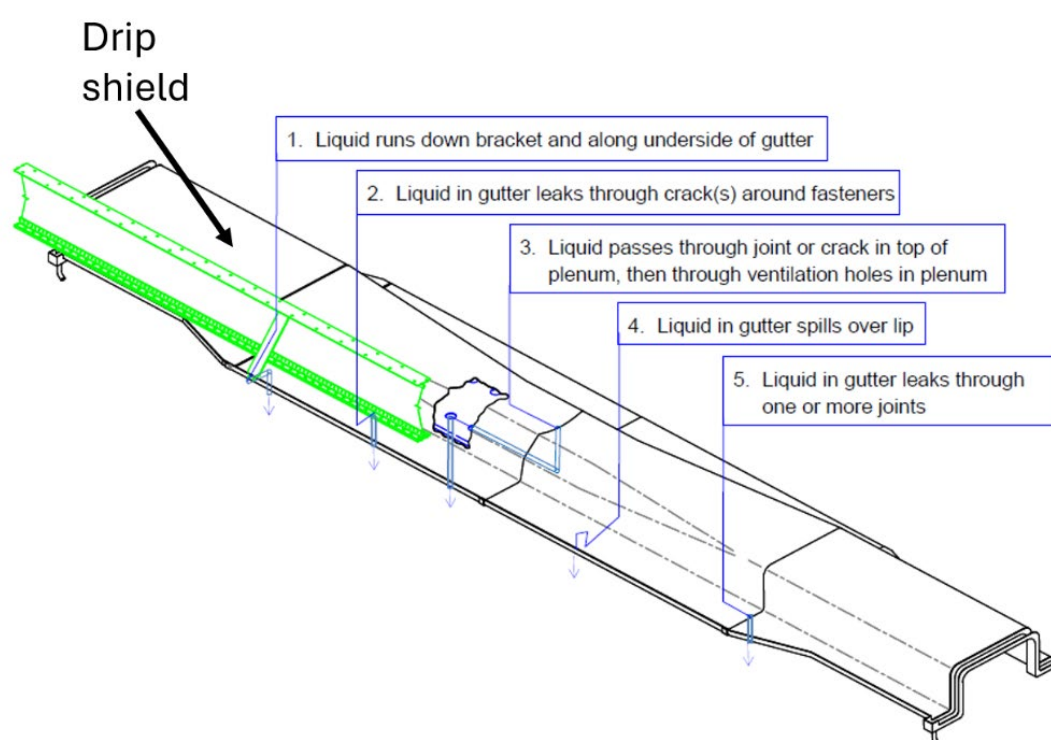
**Figure 20**

The Australian Transportation Safety Board (ATSB) published a report on an electrical failure event involving a passenger variant of the Boeing 747-400 that occurred on 7 January 2008<sup>20</sup> (registration VH-OJM). During the descent and approach into Bangkok International Airport, power was lost from AC buses 1, 2 and 3 and the power was not recovered. The aircraft suffered multiple system failures, but the flight crew were able to land safely under VMC conditions. Prior to the failures the cabin crew had reported a substantial water leak in the forward galley, which is located above the MEC. The investigation revealed that the cause of the failures was water ingress into GCUs 1, 2 and 3. The path the water took from the galley floor into the top of the GCUs was not identified but a number of possible paths were identified as shown in Figure 20 (extracted from the ATSB report).

Potential water paths identified by ATSB in report on VH-OJM electrical failure event  
(image courtesy of ATSB)
