**Accident**

| <b>Aircraft Type and Registration:</b> | ATR 72-212 A, G-OASB | |
| <b>Date &amp; Time (UTC):</b> | 14 November 2025 at 2055 hrs | |
| <b>Location:</b> | East Midlands Airport | |

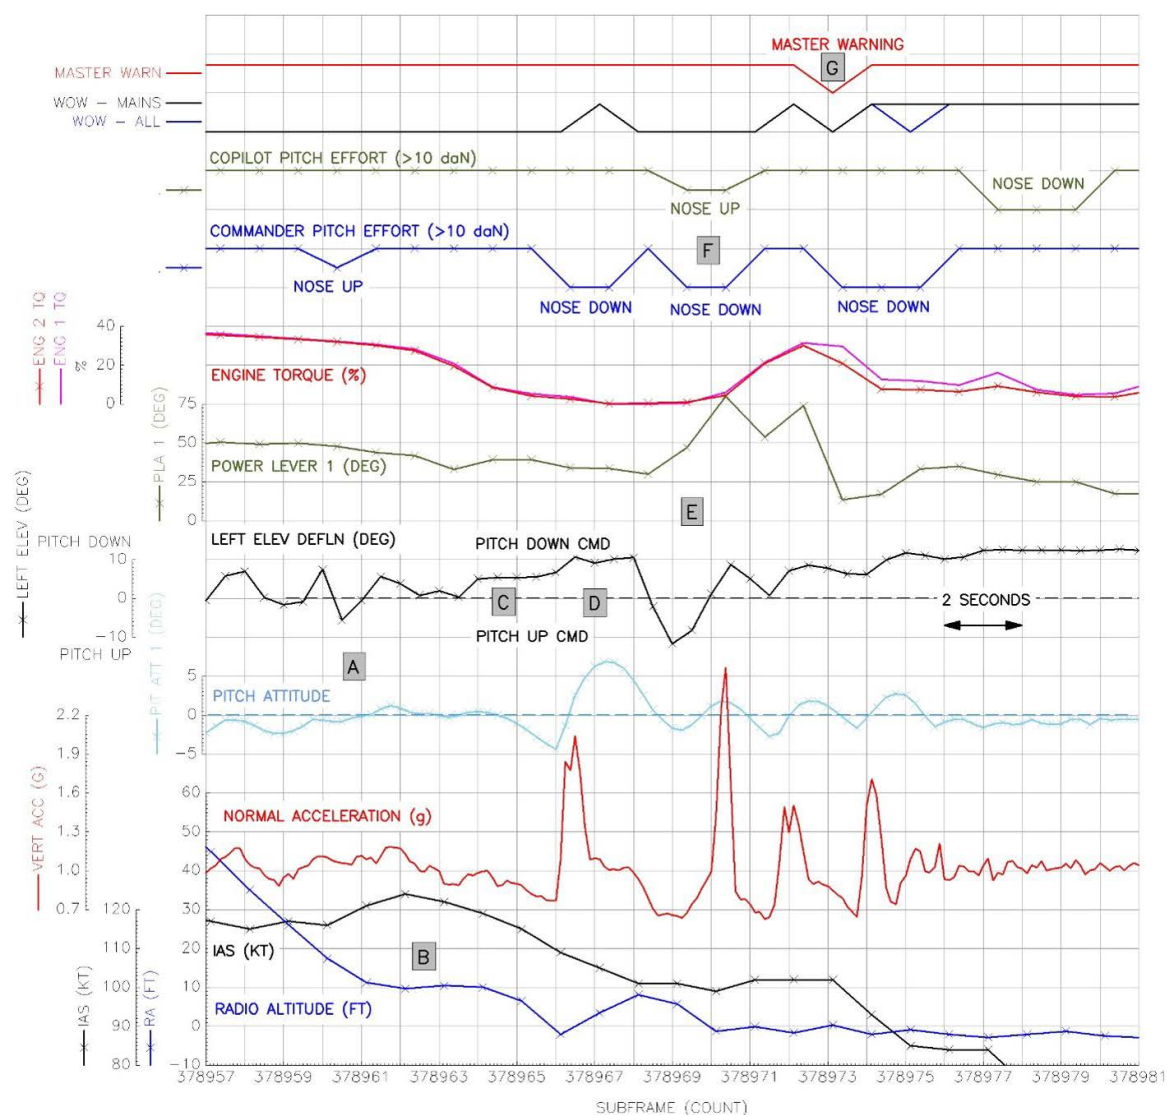
**Figure 2**  
G-OASB flight data parameters

As the aircraft descended through a radio altitude of 50 ft, the recorded power lever position was 50°<sup>1</sup>, engine torque was 37% on both engines and indicated airspeed was 120 kt. Over the next five seconds, the recorded power lever position began to reduce to 44°, engine torque gradually reduced to 30% and the aircraft began to pitch up (Figure 2, Point A).

The power levers were reduced further and engine torque reduced but the aircraft floated at approximately 10 ft radio altitude for the next three seconds (Point B). After this, nose-down elevator was recorded (Point C) and the aircraft pitched down from +0.4°<sup>2</sup> to -4.4°, consistent with that elevator deflection, over the next two seconds.

The first touchdown was at a pitch attitude of  $-4.4^{\circ}$  and a vertical acceleration of 2.04 g. The aircraft bounced and pitched up during which the main landing gear was momentarily recorded as being on ground (Point D). During this time, continued pitch-down elevator was applied, before reversing to pitch-up. At the same time, the power levers were advanced and the engine torque increased (Point E). The recorded 'pitch force discrete' indicated that just prior to the second bounce, the commander was applying a pitch-down effort and the co-pilot pitch-up (Point F).

The aircraft bounced a second time at 2.6 g, a third at 1.5 g before settling on the runway with a 1.7 g touchdown. Just after the third bounce, the master warning was heard on the CVR (and also recorded on the FDR (Point G)). The manufacturer commented that this was likely to have been a takeoff configuration warning, with the weight-on-wheels system briefly sensing that the aircraft was on the ground while the flaps were not in the takeoff position.

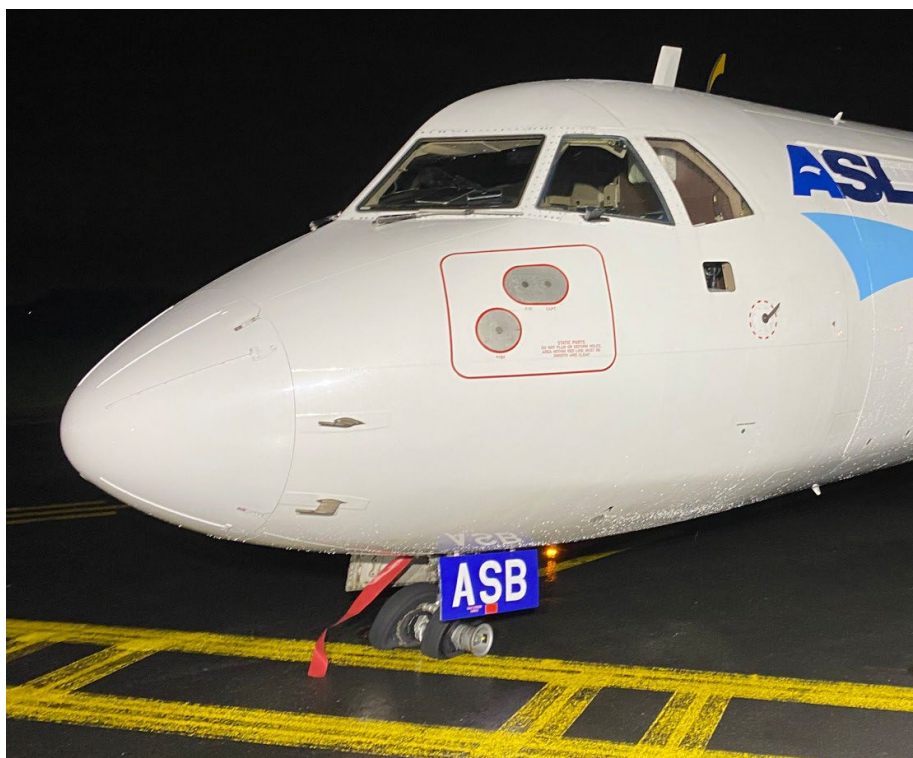
**Figure 3**  
Damage to nose landing gear after landing

Both nose landing gear wheels were fractured during the landing, causing the tyres to deflate and difficulty for the flight crew in steering the aircraft from the runway. Figure 3 shows the damage to the nose landing gear after the aircraft stopped on Taxiway S.

The aircraft manufacturer assessed the loading sustained during the heavy landing and determined that the nose landing gear leg, drag brace, right main landing gear leg and shock absorber required replacement due to exceeding their design load capacities. The manufacturer also required the left main landing gear shock absorber to be removed and inspected to determine whether it remained in a serviceable condition.

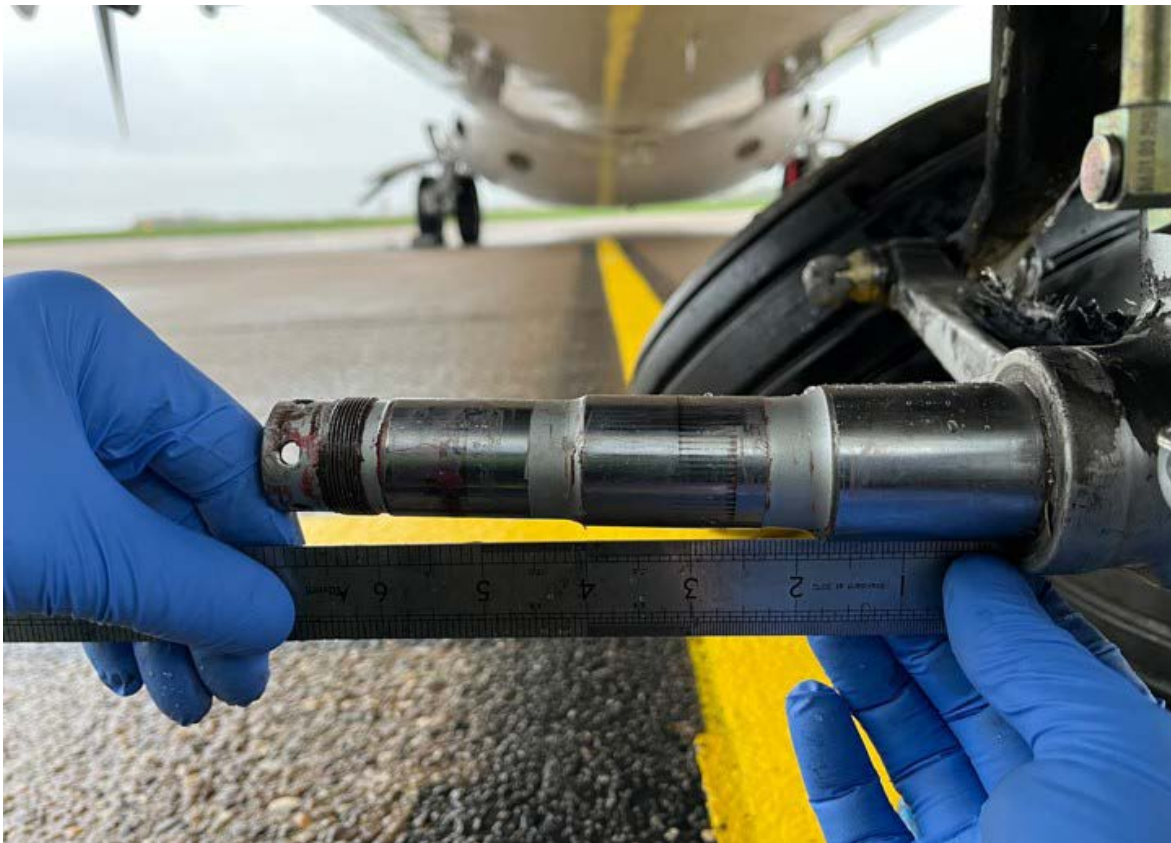
**Figure 5**

The damaged nosewheels were removed and serviceable wheels installed to permit the aircraft to be towed to a parking apron. Subsequent examination of the nose landing gear axle revealed that it had been bent upwards during the landing (Figure 5).

Upward bend evident in right nosewheel axle (left axle similarly damaged)
