# Collision between a passenger train and rail handling trolleys at Queens Park, 9 May 2026

## Summary of the accident

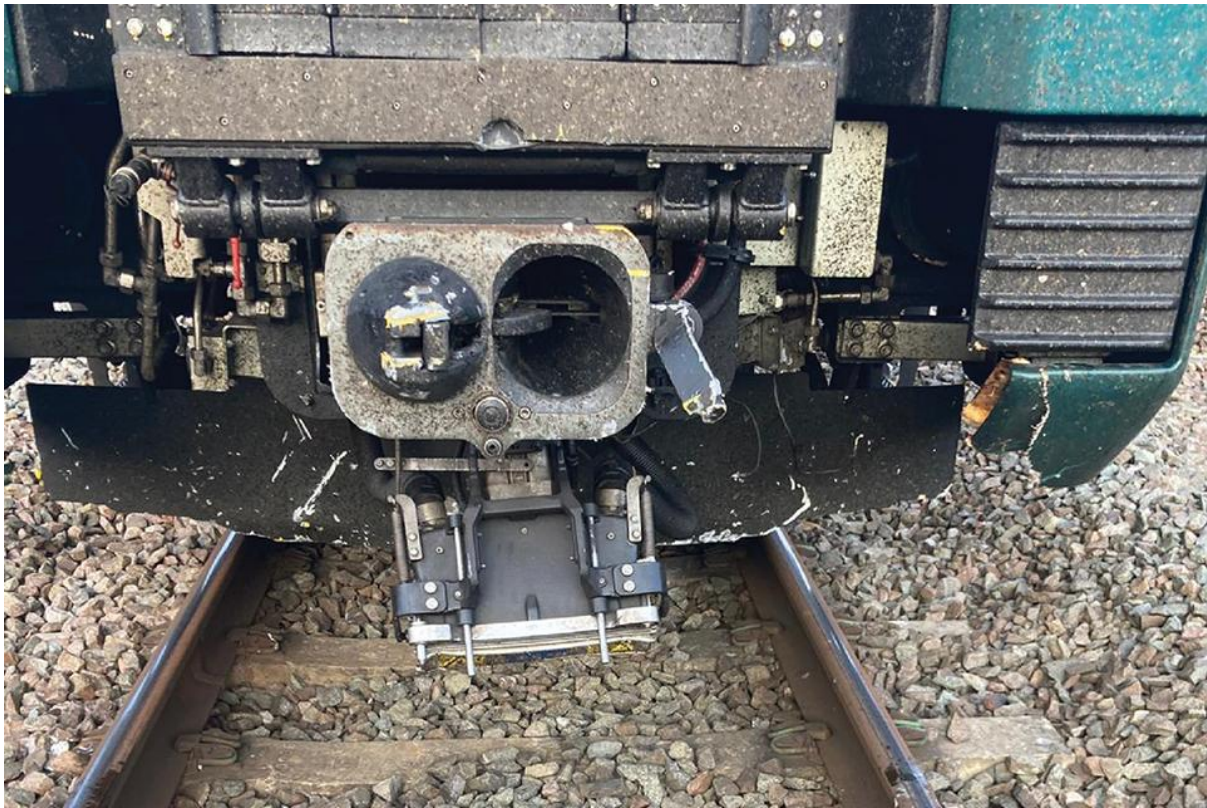
No injuries were caused to anyone in the collision. The MPRHs involved were damaged beyond economic repair. The train did not derail but sustained minor damage to the coupler and underside and was unable to continue in service.

The damage to the front of the train (courtesy of Network Rail).

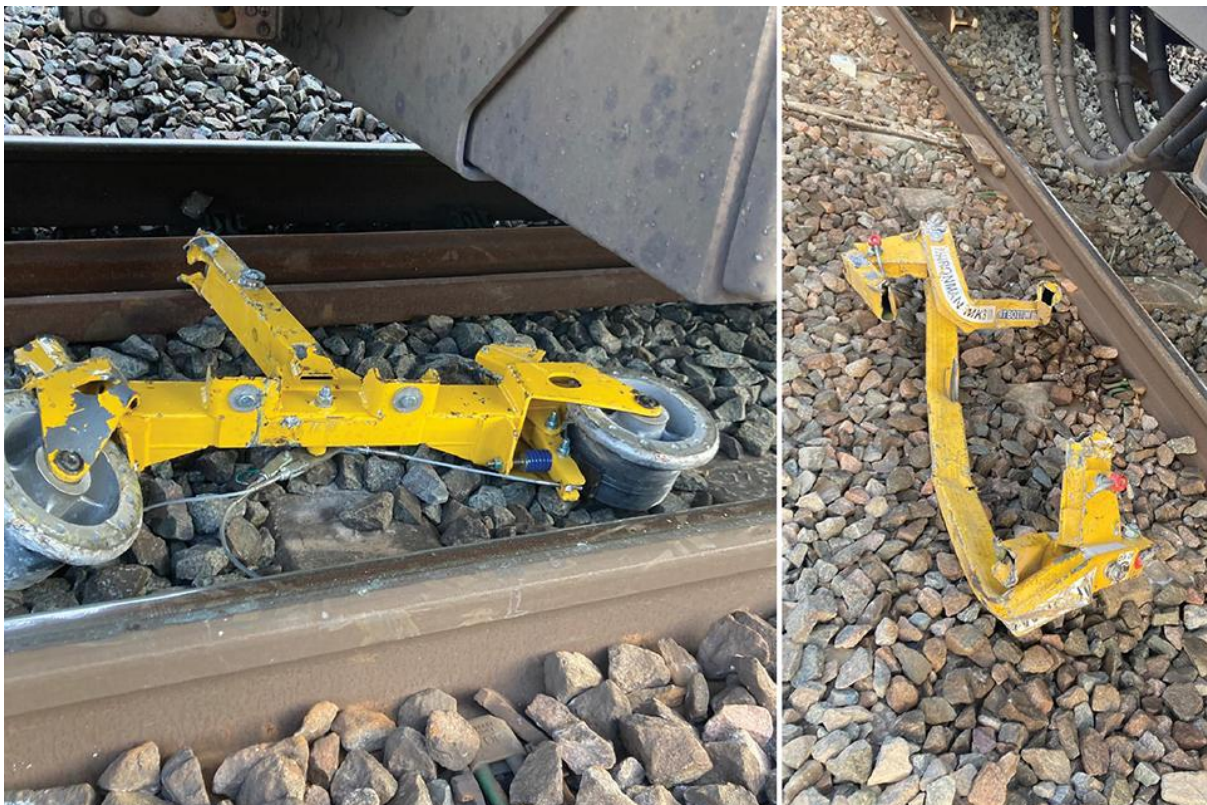
The remains of one of the MPRHs after the collision (courtesy of Network Rail).

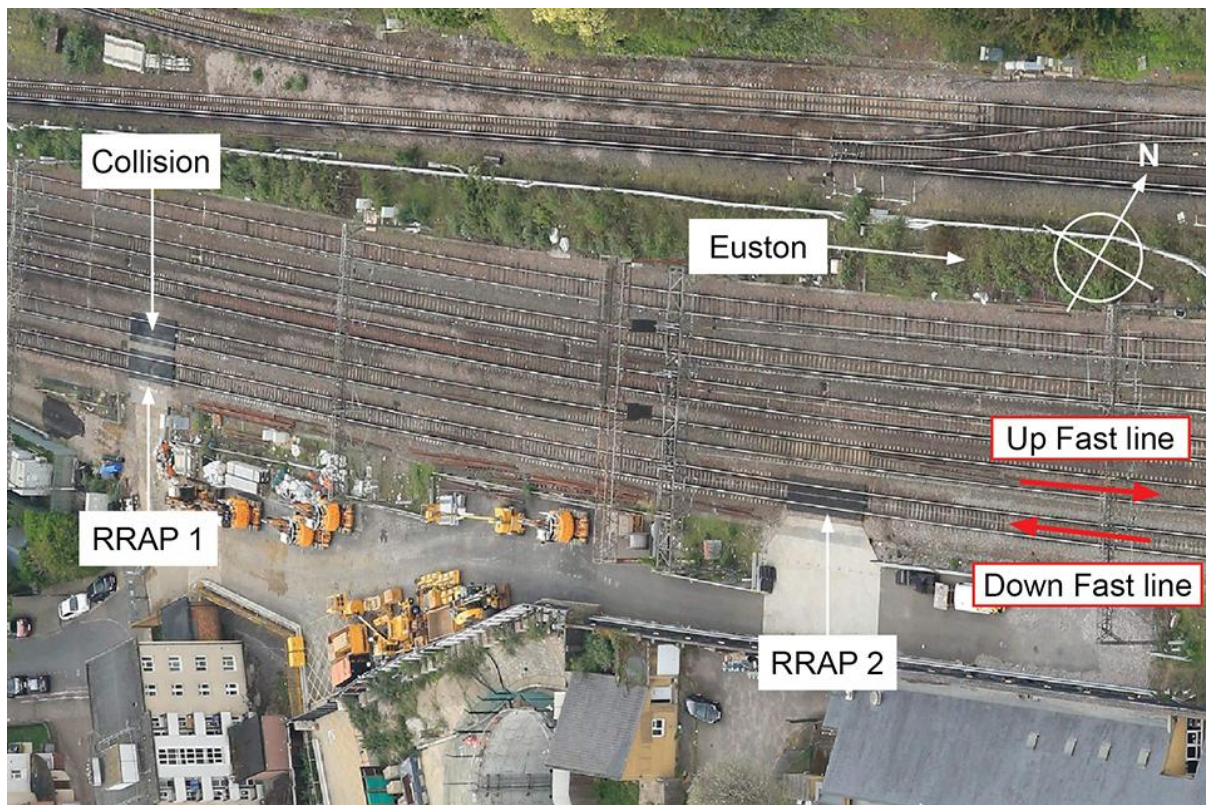
The collision occurred at a road-rail access point (RRAP1) situated beside Canterbury Terrace, where staff can gain access to the railway to place equipment, including trolleys, on the track during maintenance work. There is a second RRAP about 110 metres closer to the southern terminus of the line at Euston station (RRAP2), which can also be accessed from Canterbury Terrace.

Location of the two RRAPs (courtesy of Network Rail).

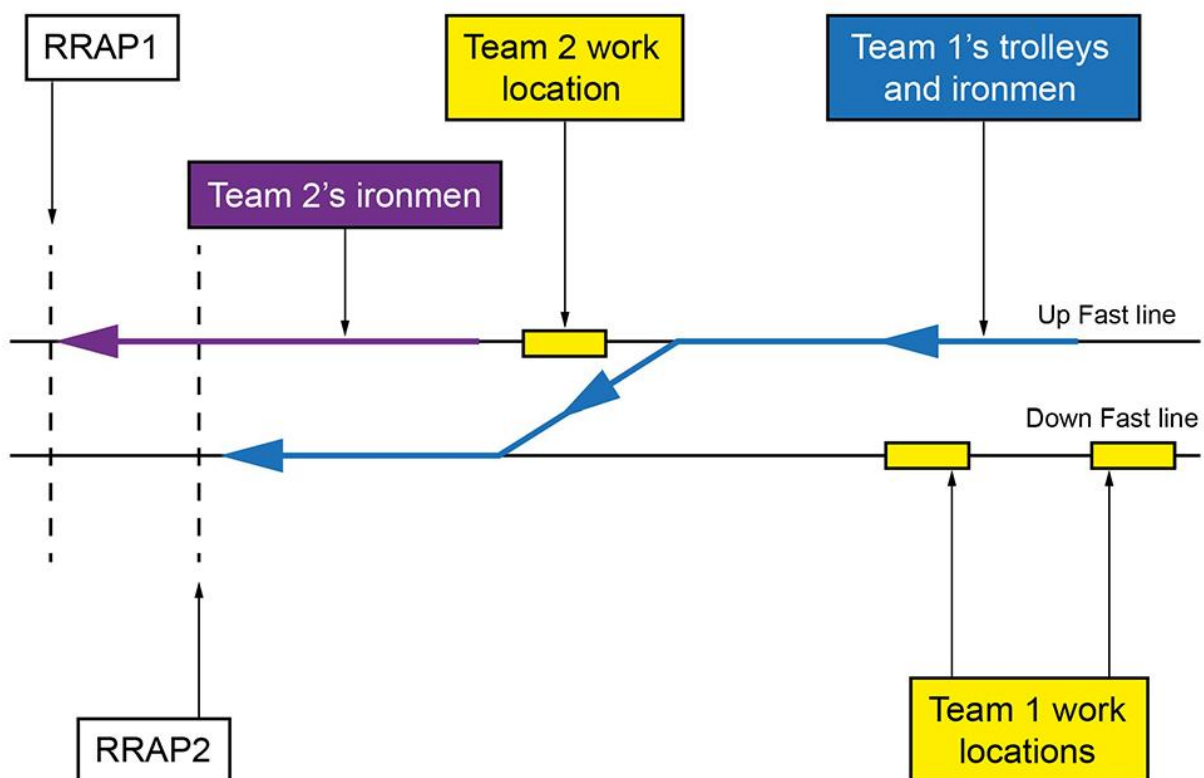
Team 1 completed their work at about 03:15 and started to push their MPRHs and flat trolleys back along the Up Fast line towards RRAP2. En route, they encountered team 2, who were still undertaking their repair work. Team 1 spoke with team 2, who helped them to move their MPRHs and flat trolleys from the Up Fast line to the Down Fast line so that they could continue to be pushed towards RRAP2.

**Movements of the trolleys and MPRHs by team 1.**

At this point, team 2 asked team 1 to help them by pushing their MPRHs back to the access point, which team 1 agreed to do. Team 2's COSS was aware that this had been agreed. Team 1 then pushed their flat trolleys and MPRHs along the Down Fast line and team 2's MPRHs along the Up Fast line to RRAP2. While they were offloading their own equipment onto their road vehicle, a member of team 1 pushed team 2's MPRHs further to RRAP1, as they knew that this was where the trolleys had been on-tracked and where team 2's vehicle was parked. The MPRHs were left on RRAP1 ready for team 2 to take them off the track when they returned.
