# ***AAIB Bulletin***

**9/2026**

| Boeing 747-433 | G-ONEE | 8-Feb-24 | 3 |

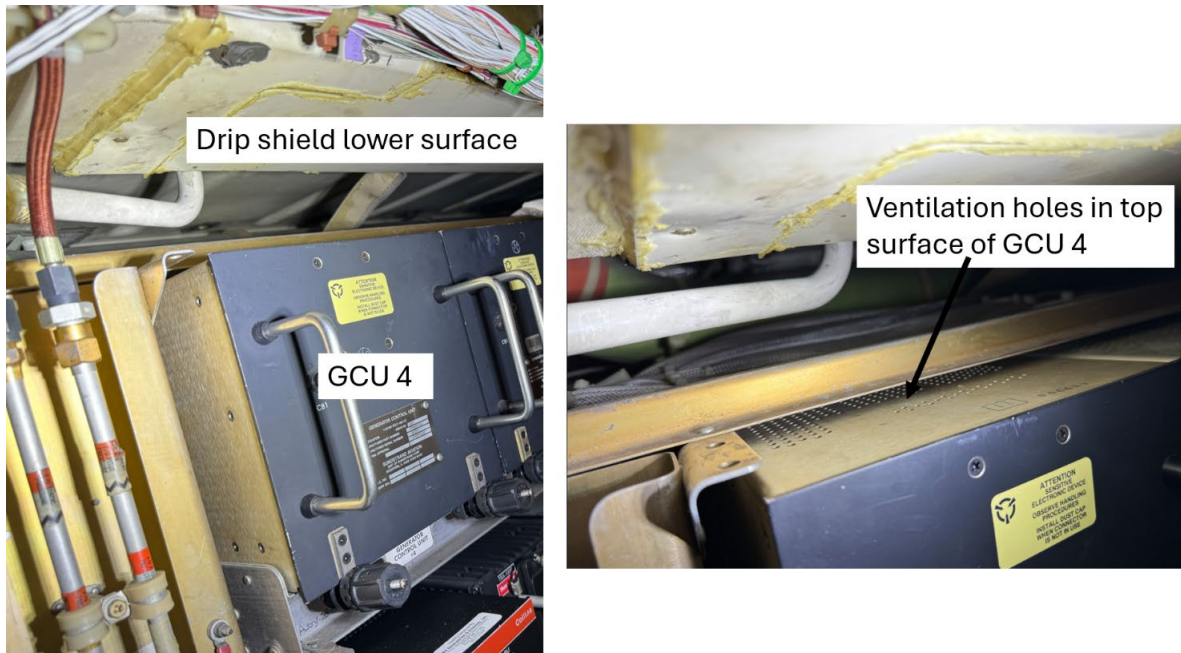
**Figure 10**

After the aircraft arrived at Amsterdam Schiphol Airport the engineer onboard carried out initial troubleshooting. He noticed that the circuit breaker on GCU 4 had tripped and when he removed the GCU, a few drops of water came out the bottom of it, and there was slight wetness in the base of the area the GCU was removed from. When he shook the GCU a few more drops came out. When GCU 1 was removed it was dry. The GCUs have multiple small holes on their upper and lower surfaces to allow cooling air to pass through from below (Figure 10).

GCU 4 location below drip shield and ventilation holes in top surface

Two investigators from the DSB arrived to oversee subsequent work. GCU 4 was replaced, and tests revealed that all faults had disappeared with both AC buses 1 and 4 being powered. As a precautionary measure GCU 1 was also replaced.

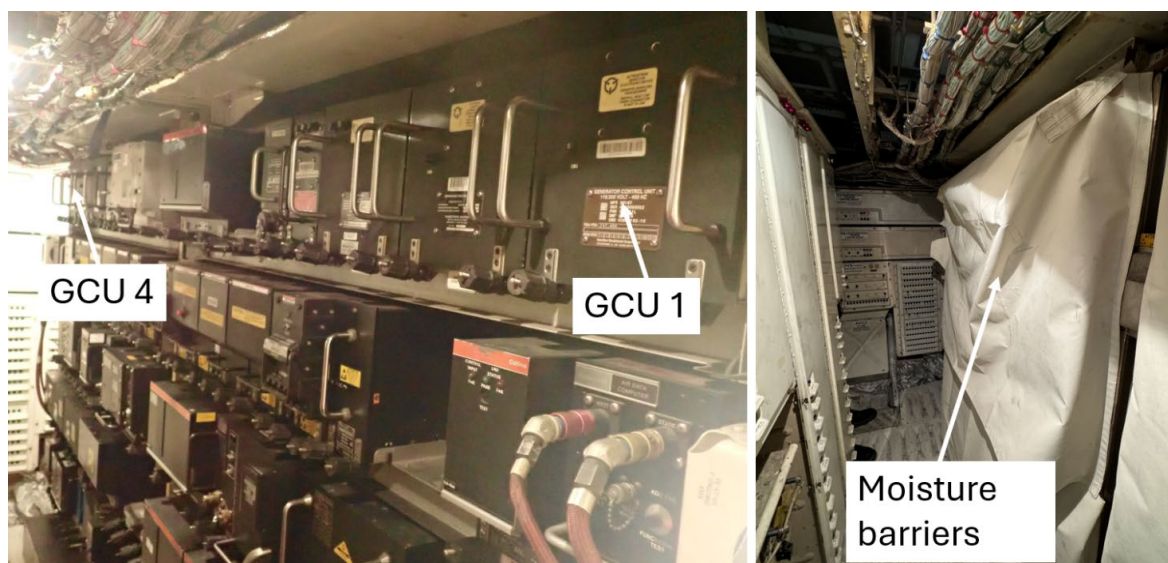
**Figure 11**

As the aircraft was registered in the UK the DSB handed the investigation to the AAIB and an AAIB inspector arrived to examine the aircraft the following day. Water was poured down the drain in the mat near the L1 door and the drain on the opposite side of the aircraft, but no leaks were found. Some water was found in the bilge at the bottom of the fuselage but that was not unusual. There were no obvious defects in the visible part of the drip shield that overhung the E1/E2 racks. No moisture or dampness was found in the intake of the air duct fan that provided cooling air to the E1/E2 racks. The moisture barrier curtains in front of the E1/E2 racks were not fitted (Figure 11).

Left image taken on day after the incident. Right image shows moisture barriers, which were fitted in March 2024, to the front of the E1 and E2 racks, covering the GCUs and other equipment

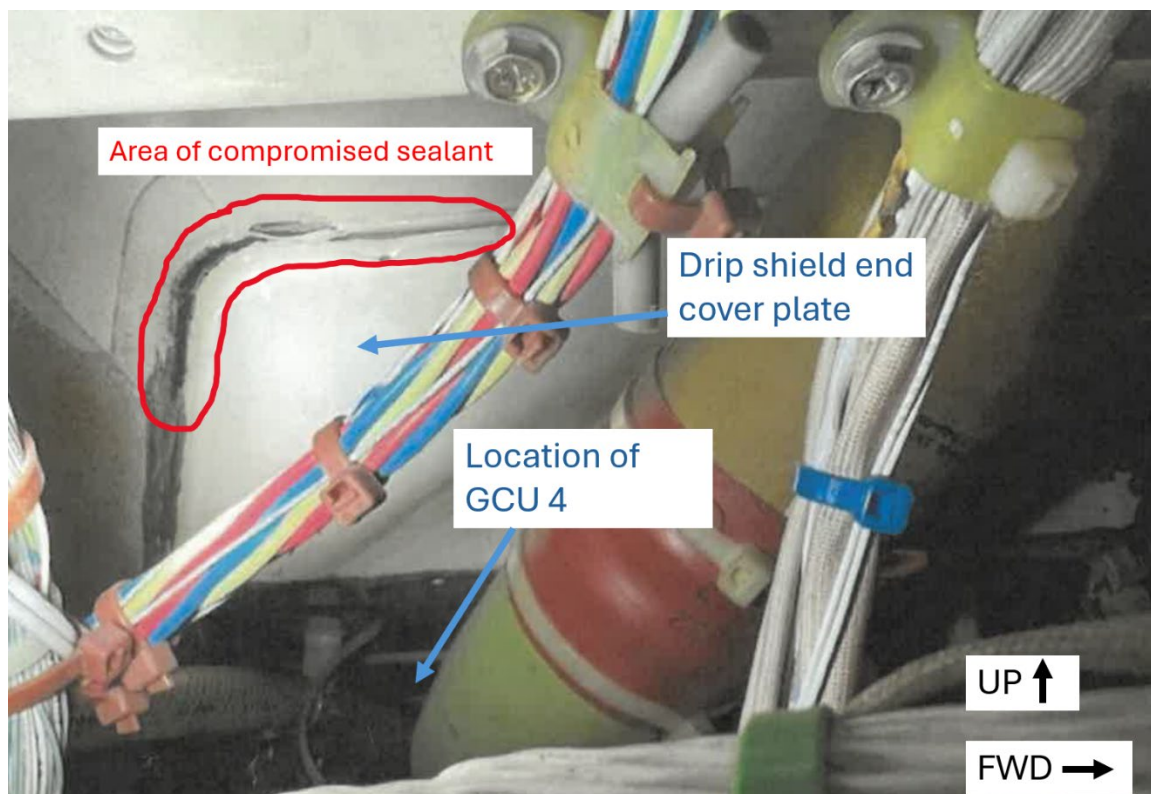
### Figure 12

Further examination by the operator revealed that there were areas on the main deck, above the E1/E2 racks, where the moisture barrier tape and polyurethane tape were in poor condition. This was rectified at the subsequent A-check in March 2024 and the missing moisture barrier curtains were fitted (Figure 11). Examination of the drip shield above the E1/E2 racks revealed that the drip shield end cover plate, above the location of GCU 4, had compromised sealant (Figure 12) which could have provided a path for water to travel to the GCU from above the drip shield. The sealant on the end cover plate on the opposite side, above the location of GCU 1, was similarly compromised. These areas were both re-sealed.

Compromised sealant in drip shield end cover plate above GCU 4 location

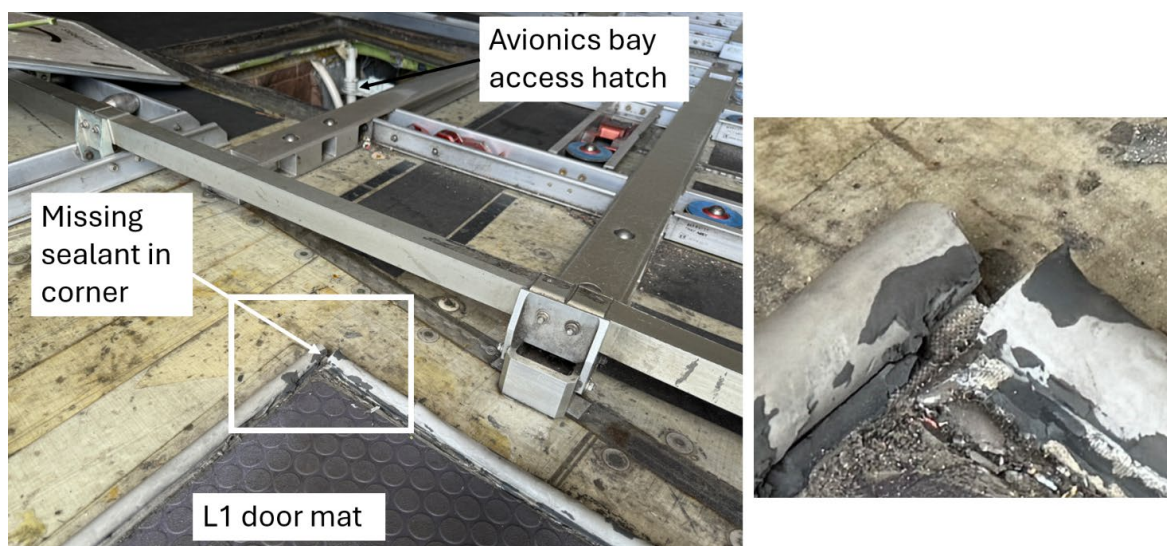
**Figure 14**

A close examination of the door mat revealed that the forward right corner was missing sealant between the rubber barriers, creating a path for water to travel along the floor above the E1/E2 racks (Figure 14).

L1 door mat showing missing sealant in forward right corner

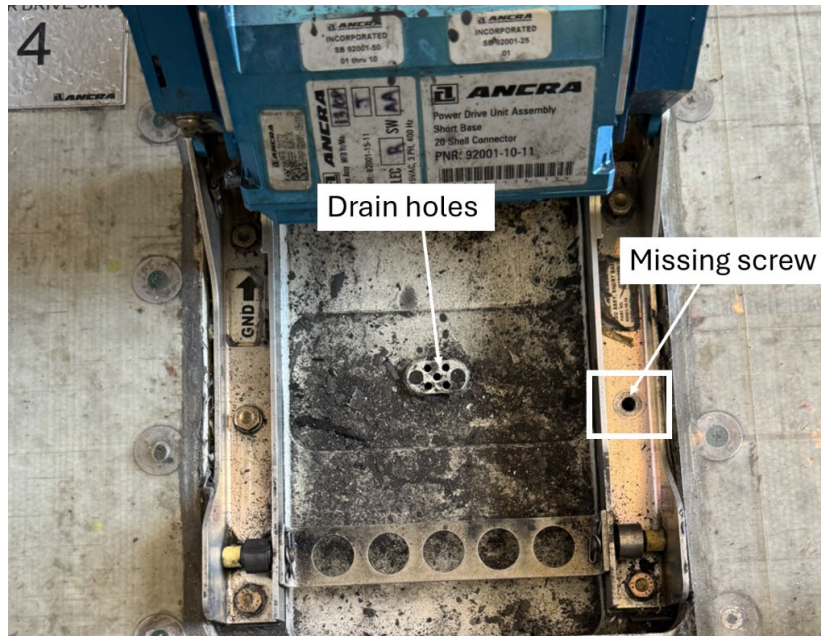
**Figure 15**

right side (Figure 15). Subsequent tests showed that the drain hole was clear and did not leak. The missing screw created a hole that could have allowed water to pass down directly on top of the drip shield above the E1/E2 racks.

Missing screw beneath PDU 4

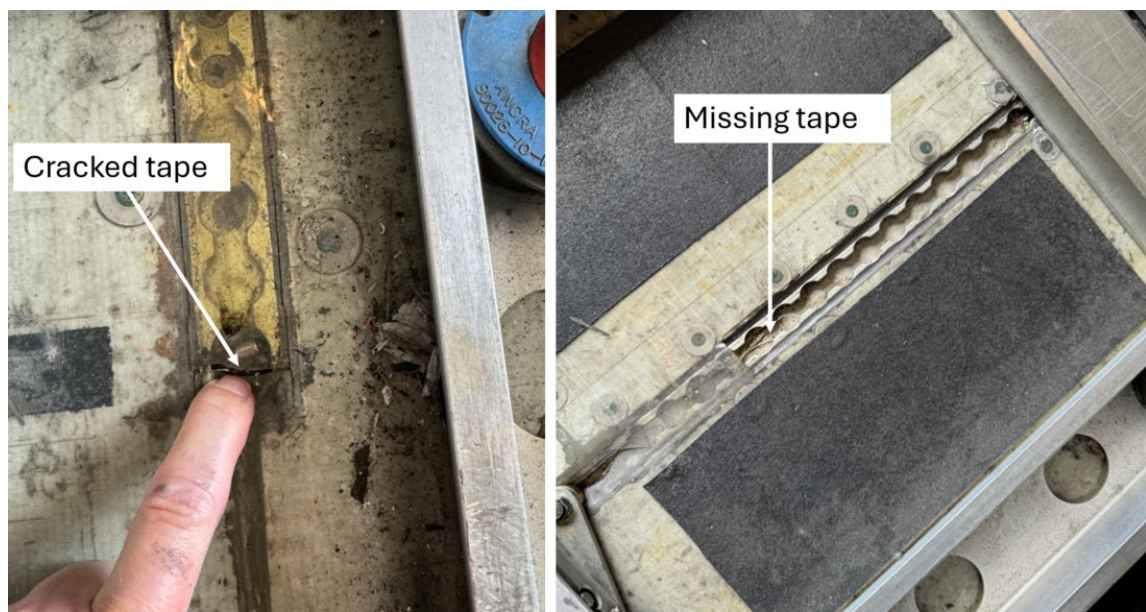
**Figure 16**

Despite the rectification work that had been carried out during the A-check, sections of the cargo deck floor near the L1 door were found to have cracked and missing polyurethane tape (Figure 16). These findings were all rectified by the aircraft operator.

Cracked and missing polyurethane tape in cargo deck floor area near L1 door

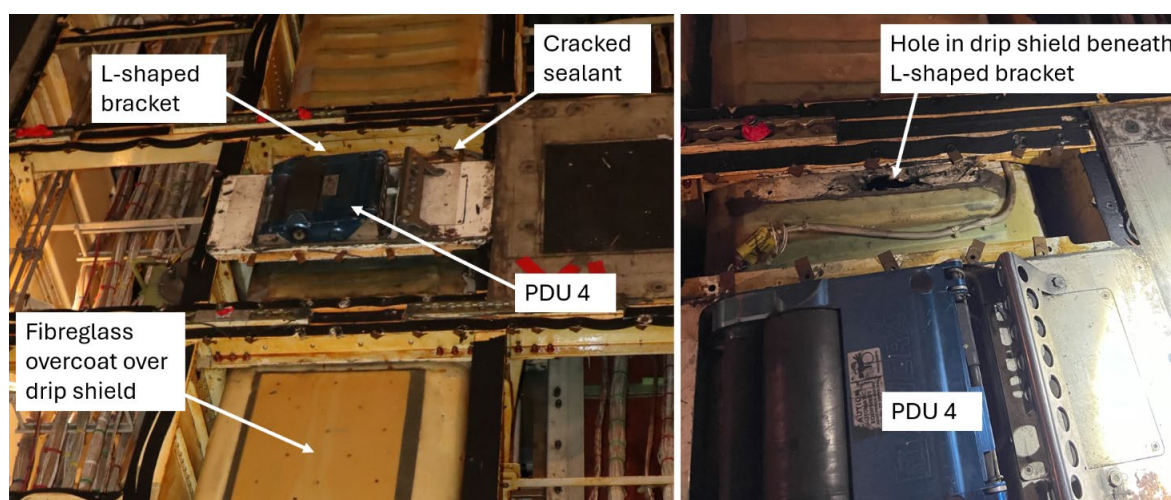
**Figure 17**

The fibreglass reinforced overcoat<sup>16</sup> on the drip shield appeared to be undamaged, but there were cracks in some sealant at the edge of an L-shaped bracket on the right side of PDU 4 (Figure 17), and on the left side of PDU 4. When the bracket was removed to repair the sealant, the drip shield was found to be damaged and had holes which could have been a potential path for water. Similar damage and holes were found in the drip shield when the bracket on the left side of PDU 4 was removed.

Hole in top of drip shield near PDU 4

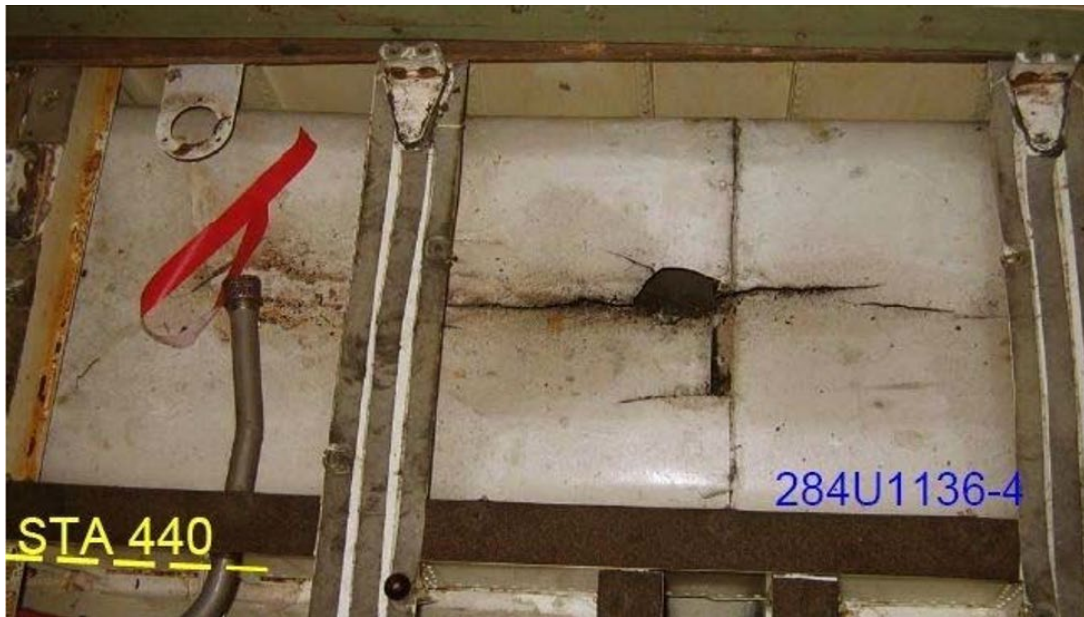
**Figure 21**

Cracks in the top of a drip shield from an unidentified Boeing 747-400 aircraft – prior to fibreglass re-enforcement overcoat  
(image courtesy of ATSB)

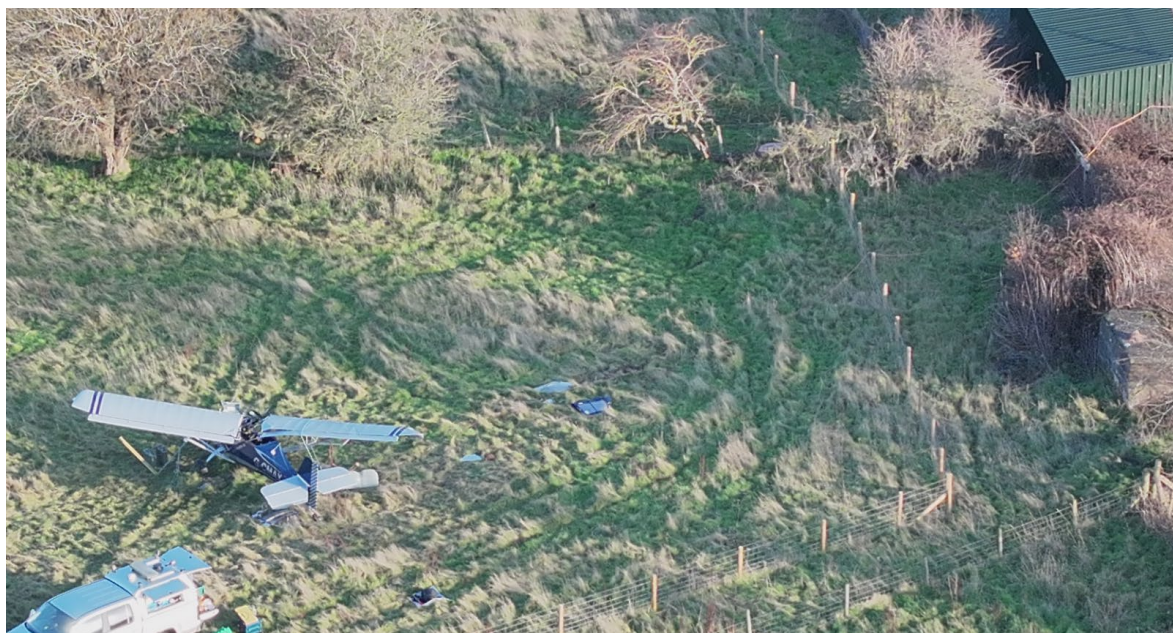
**Figure 2**

G-CMAX final resting position – note tow rope trailing over foliage in the right of the image

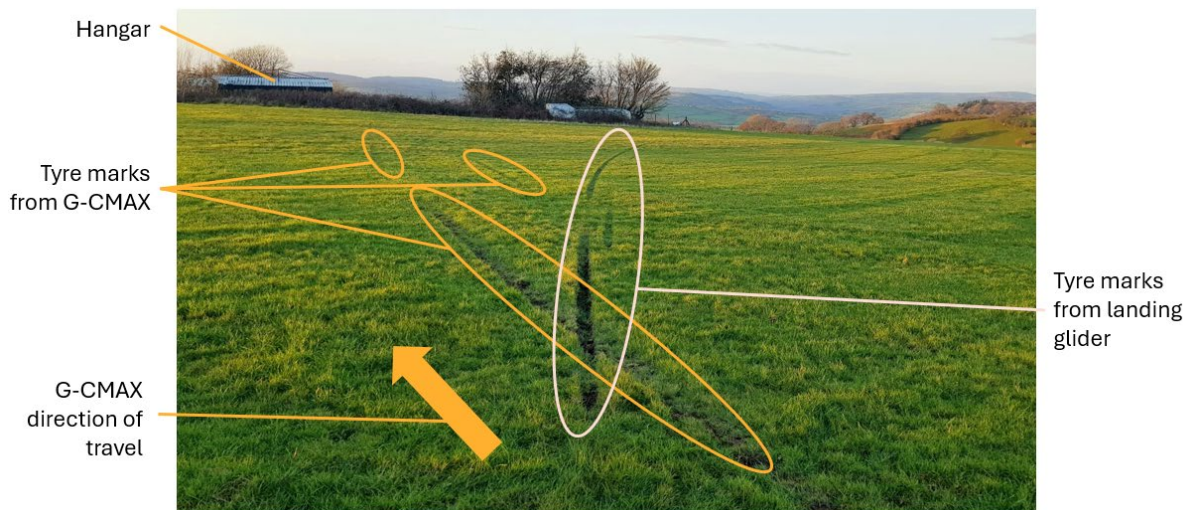
**Figure 3**

Wheel marks in the soft ground between the runway and the accident location indicated that the aircraft touched down briefly and became airborne again before crossing the airfield boundary (Figure 3).

Tyre marks in airfield from G-CMAX and towed glider

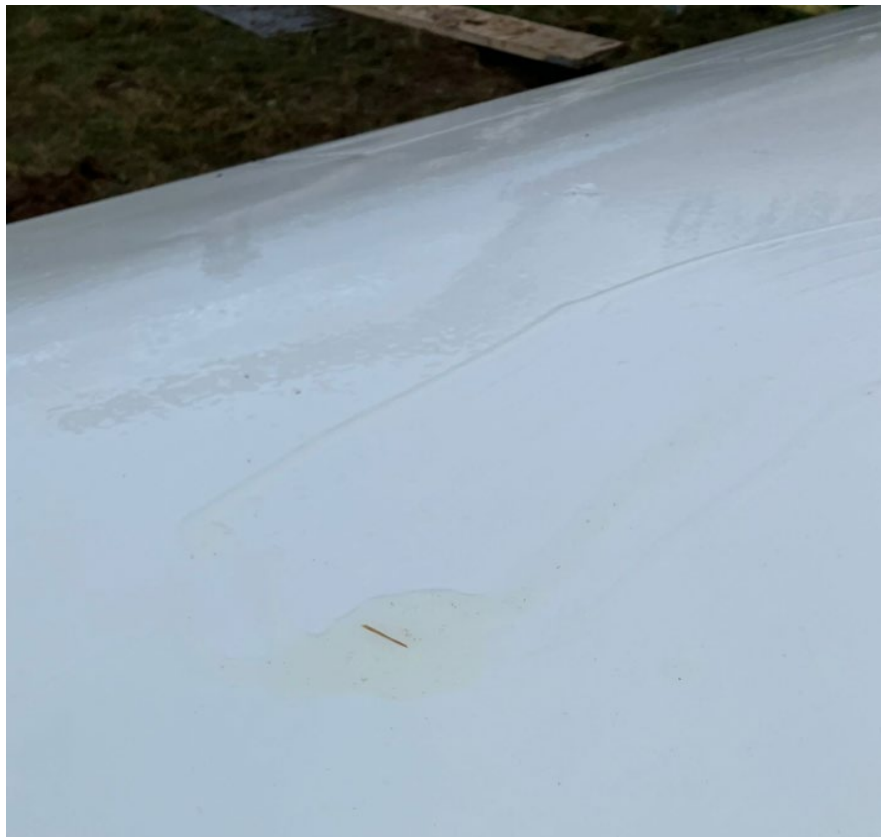
**Figure 1**

The aircraft was reported by the pilots to have more de-icing fluid remaining on its wings than they would have expected, given the high speed at which the rejected takeoff was initiated (Figure 1).

De-icing fluid remaining on wing after rejected takeoff
