# Rail Accident Report

**Near miss with track workers at Bookham  
Tunnel, Surrey  
29 April 2025**

Report 07/2026  
June 2026

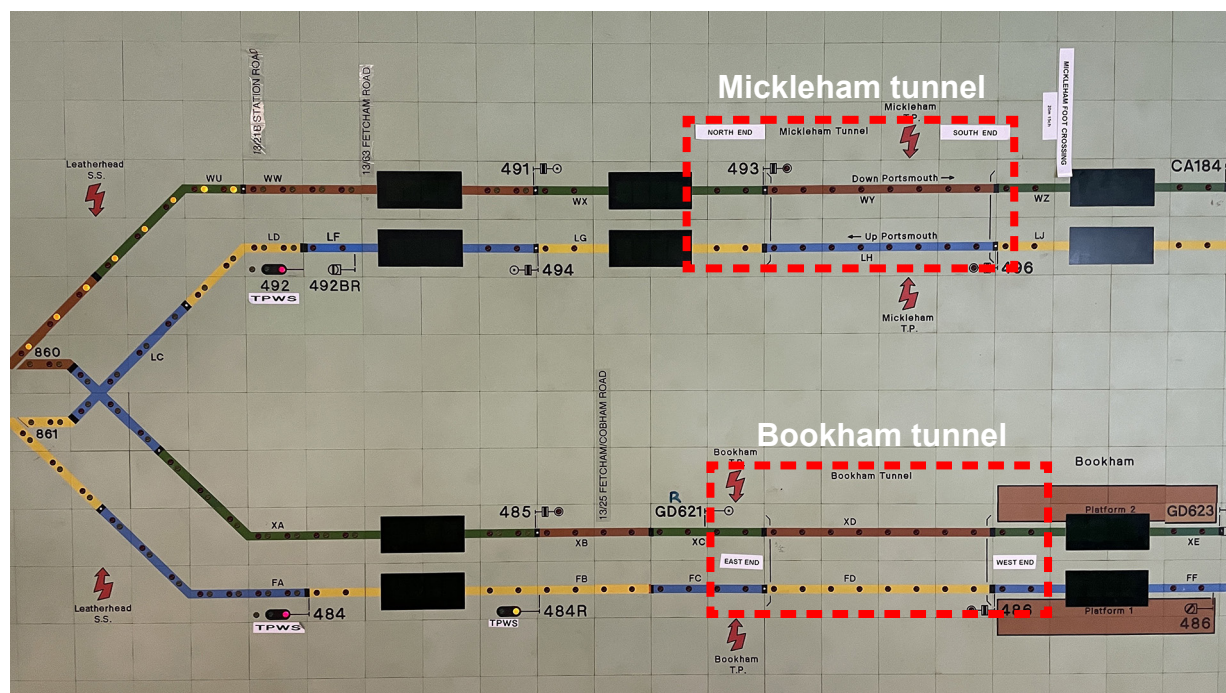
- 56 The signaller found the line blockage information using the reference number provided by the PIC (figure 7). This information had been provided to the signaller at the start of their shift on a printed list of pre-arranged line blockages. This showed that the line blockage being requested was for Mickleham Tunnel. The signaller asked for the PIC’s contact details and how long they required for the work. The phone call ended with the signaller telling the PIC that a train was approaching and hence the line blockage could not be taken at this time. The signaller said that they would call the PIC back about the line blockage. The signaller did not realise that the PIC was at Bookham Tunnel and not at Mickleham Tunnel during this initial call (figure 8).

Figure 8: Signaller's panel showing the location of the tunnels (highlighted in red dotted boxes).

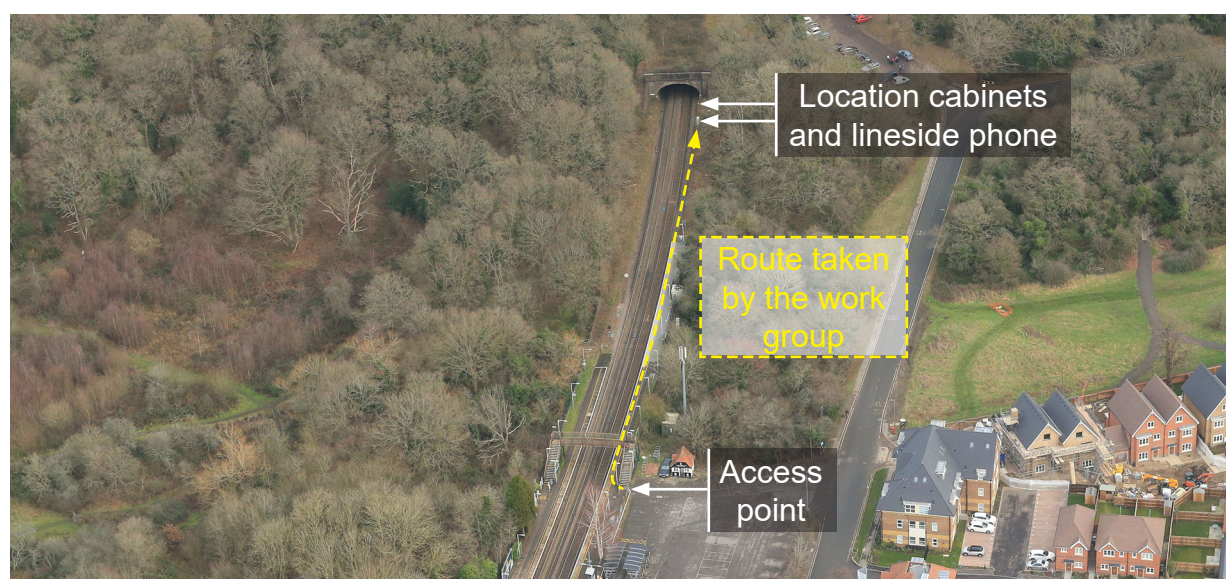
58 At 11:12, the signaller called the PIC back to grant the line blockage. During the conversation, the signaller confirmed the blocking points (defined railway features, such as signals, used to geographically bound a line block) given in their copy of the line blockage documentation, which matched the documentation held by the PIC (figure 7). There was no repeat of the blocking point information by the PIC back to the signaller and no mention of the physical location of the line blockage. The line blockage was granted, and a handback time was agreed. The Down Portsmouth line through Mickleham Tunnel was now blocked but the Down Bookham line through Bookham Tunnel, where the team was, remained open. The PIC and the track workers walked from west to east, on the Down Bookham line through the tunnel (figure 10).

Figure 9: Track workers location before taking first line blockage (courtesy of Network Rail with RAIB annotations).

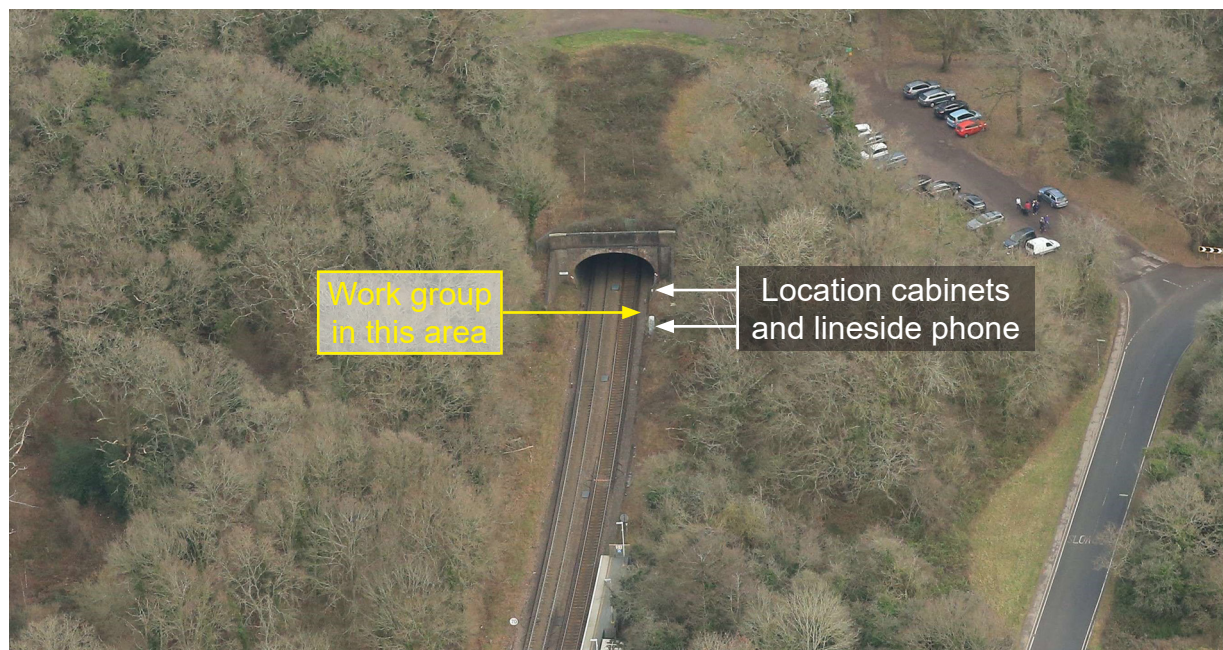
Figure 10: Track workers location after taking first line blockage (courtesy of Network Rail with RAIB annotations).

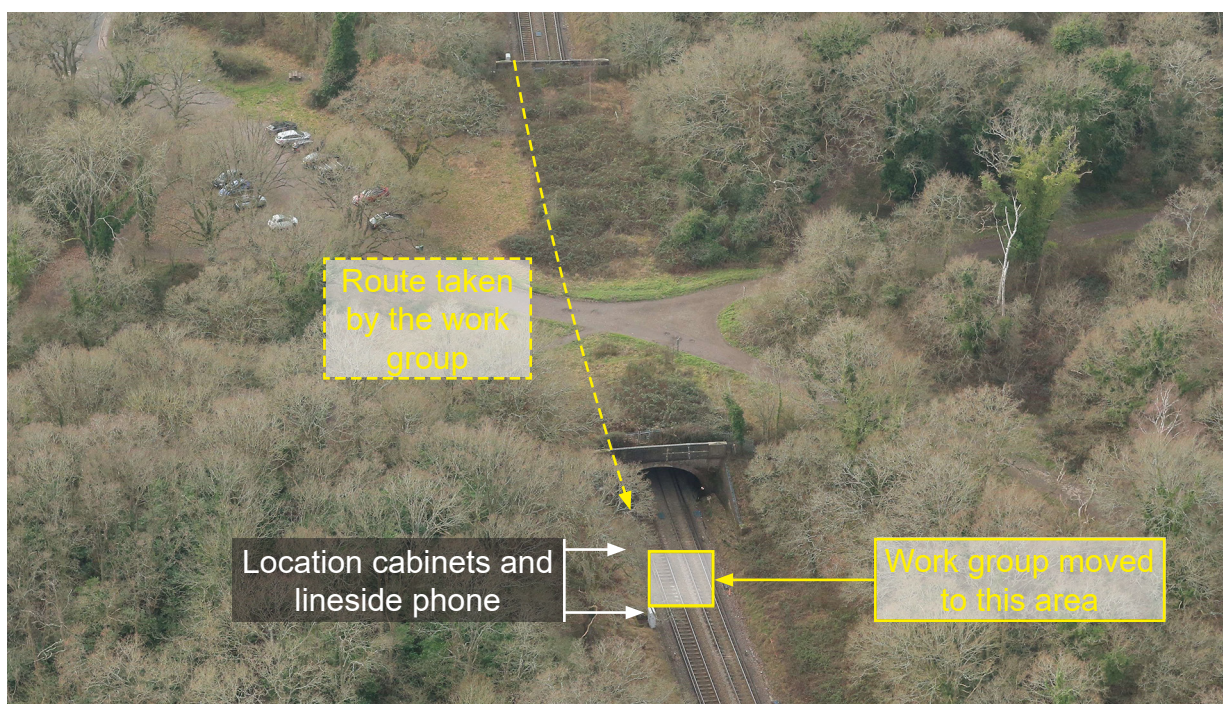
Figure 12: Track workers location before taking second line blockage (courtesy of Network Rail with RAIB annotations).

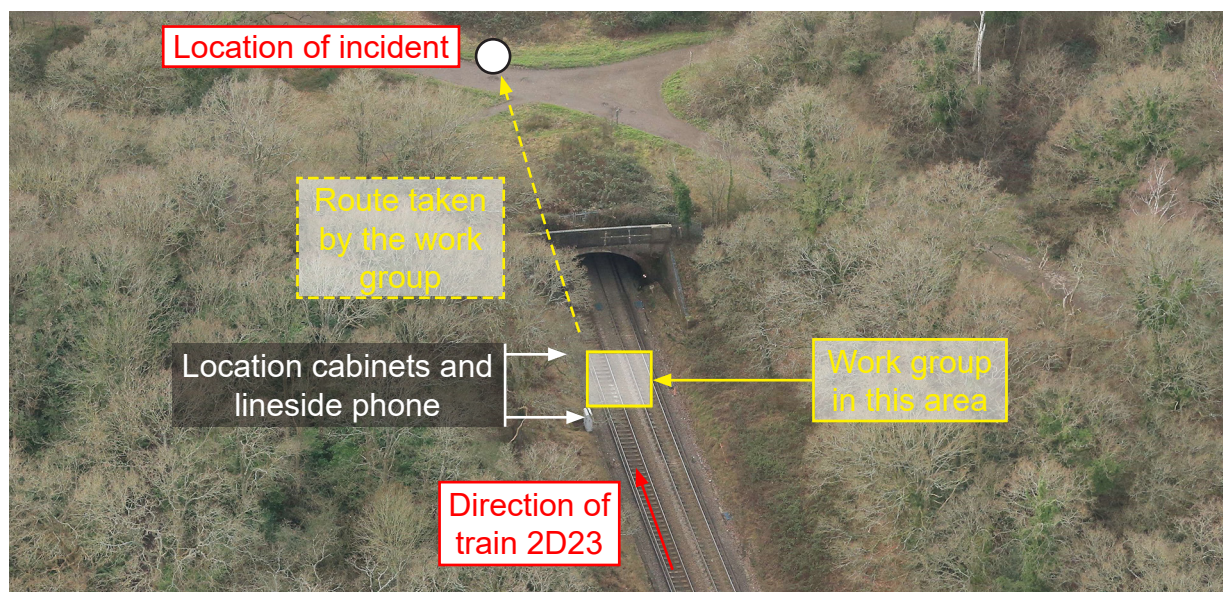
- 63 At approximately 11:41, while walking inside the tunnel, trackworker 1 heard a train approaching behind them and shouted a warning to the rest of the group. At around the same time, the train driver saw the group and sounded the horn. The group then moved quickly to the side of the tunnel. Once the train had passed, the group then headed toward Bookham station (figure 13).

Figure 13: Track workers location after taking second line blockage and during incident (courtesy of Network Rail with RAIB annotations).

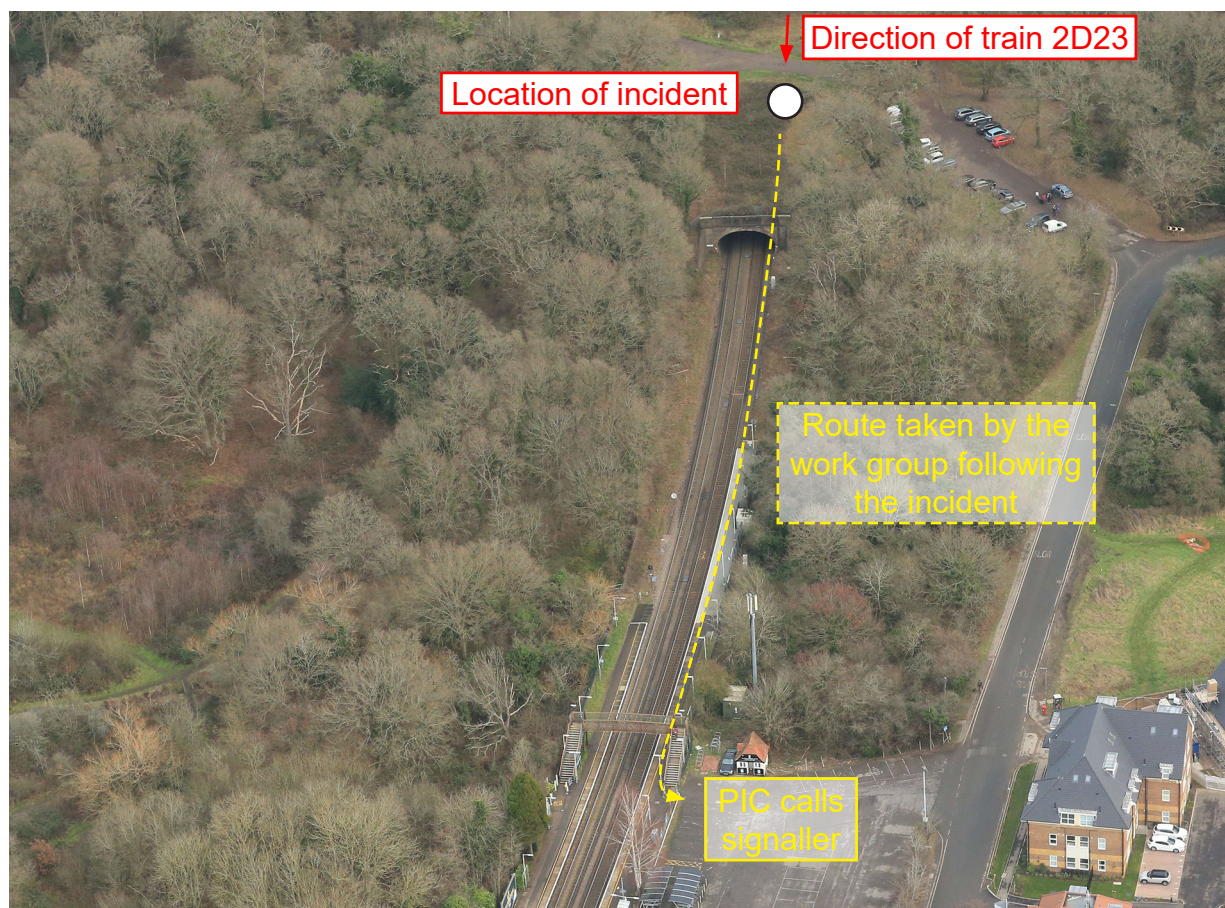
- 64 At 11:45, a relief signaller took over from the signaller at Wimbledon who had granted the line blockage. At 11:46, the PIC called to hand the line blockage back. Having done this, the PIC then mentioned that a train had passed through the blockage. The relief signaller handed the phone to the original signaller, who questioned this with the PIC. The PIC confirmed their line blockage limits and stated they were at Bookham Tunnel. The signaller replied that these were the blocking limits for Mickleham Tunnel, not Bookham Tunnel. The PIC said that they would look at their paperwork and then ended the call (figure 14).

Figure 14: Track workers location post-incident (courtesy of Network Rail with RAIB annotations).

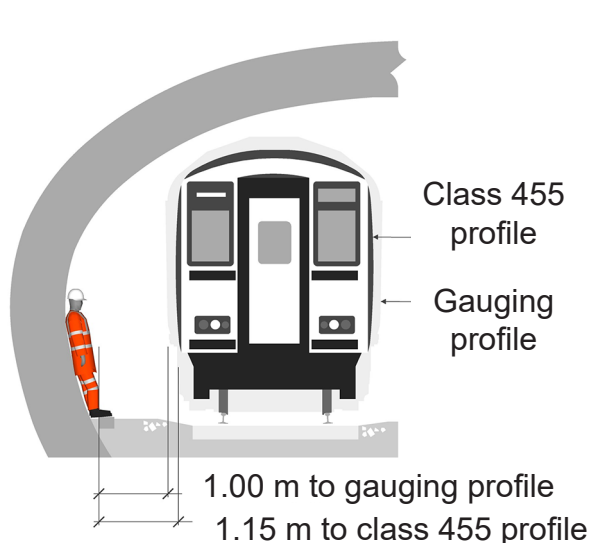
68 The distance between the tunnel wall and the nearest running rail of the down line where the track workers were walking is about 1.6 metres. The available space between the tunnel wall and the passing train was between 1 and 1.15 metres (figure 15).

Figure 15: Position of track worker inside the tunnel as the train passed, based on gauging information from Network Rail (left-hand image) and from FFCCTV (right-hand image, courtesy of South Western Railway).

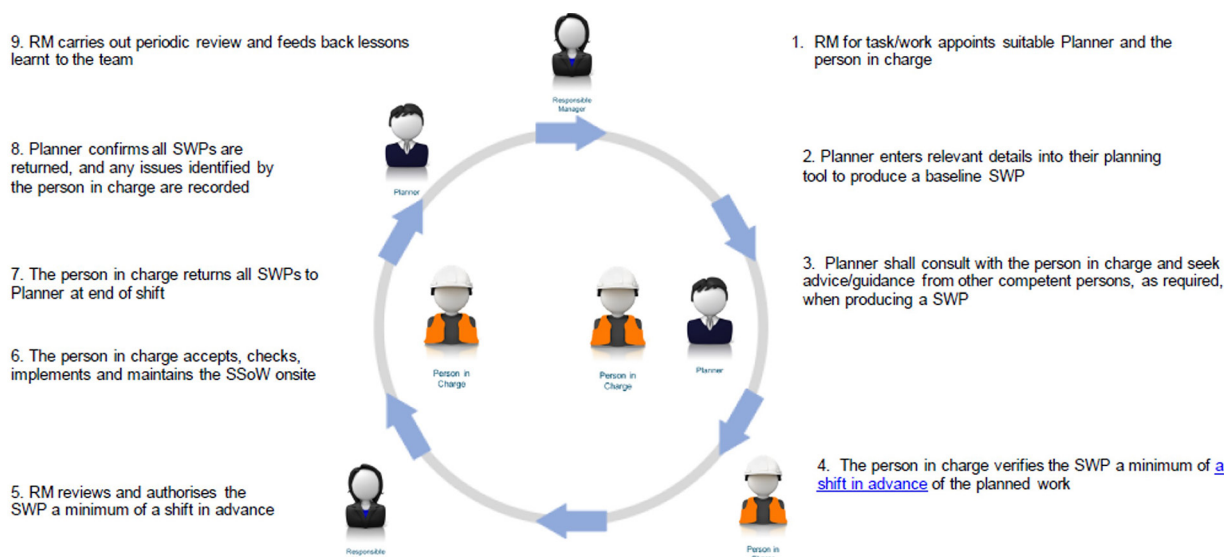
- 86 Network Rail standard NR/L2/OHS/019 (paragraph 31) states that the planner and PIC shall collaborate and create the SWP together (figure 17). Previous versions of the standard had allowed for a PIC not undertaking the work to be involved in the planning phase, but this had been removed from the version of NR/L2/OHS/019 which was current at the time of the incident.

Figure 17: Workflow diagram for NR/L2/OHS/019 (courtesy of Network Rail).
