# Rail Accident Report

**Near miss with track workers at Bookham  
Tunnel, Surrey  
29 April 2025**

Report 07/2026  
June 2026

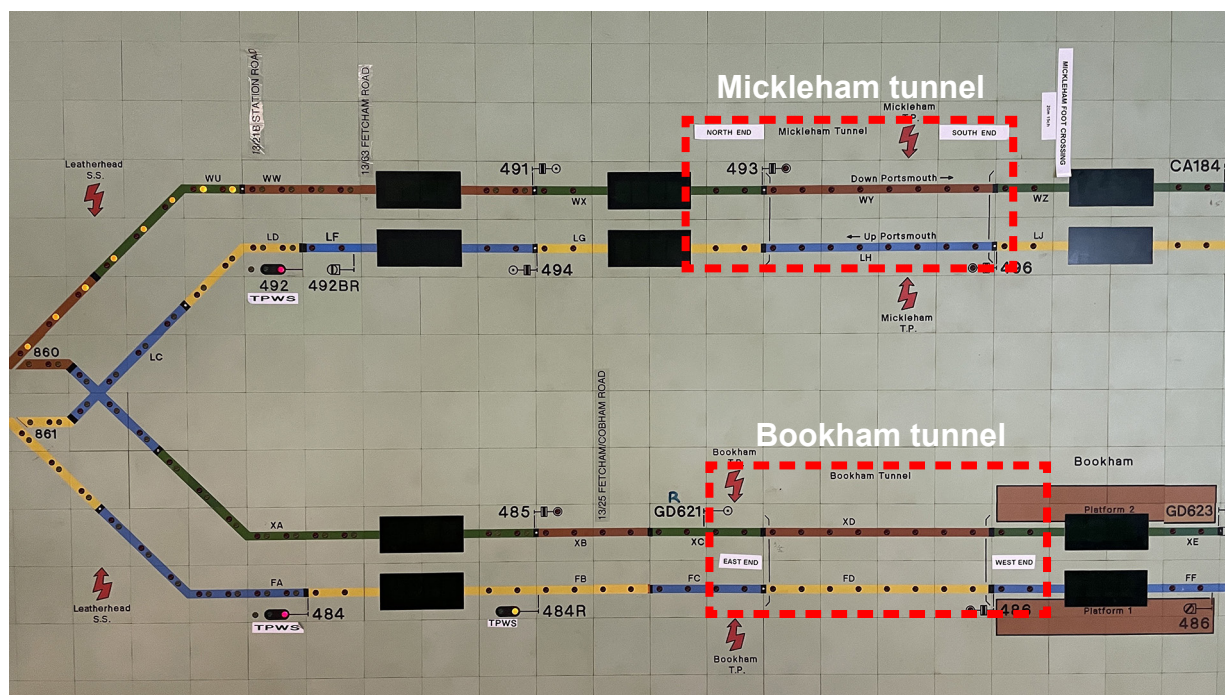
Figure 8: Signaller's panel showing the location of the tunnels (highlighted in red dotted boxes).

- 56 The signaller found the line blockage information using the reference number provided by the PIC (figure 7). This information had been provided to the signaller at the start of their shift on a printed list of pre-arranged line blockages. This showed that the line blockage being requested was for Mickleham Tunnel. The signaller asked for the PIC’s contact details and how long they required for the work. The phone call ended with the signaller telling the PIC that a train was approaching and hence the line blockage could not be taken at this time. The signaller said that they would call the PIC back about the line blockage. The signaller did not realise that the PIC was at Bookham Tunnel and not at Mickleham Tunnel during this initial call (figure 8).

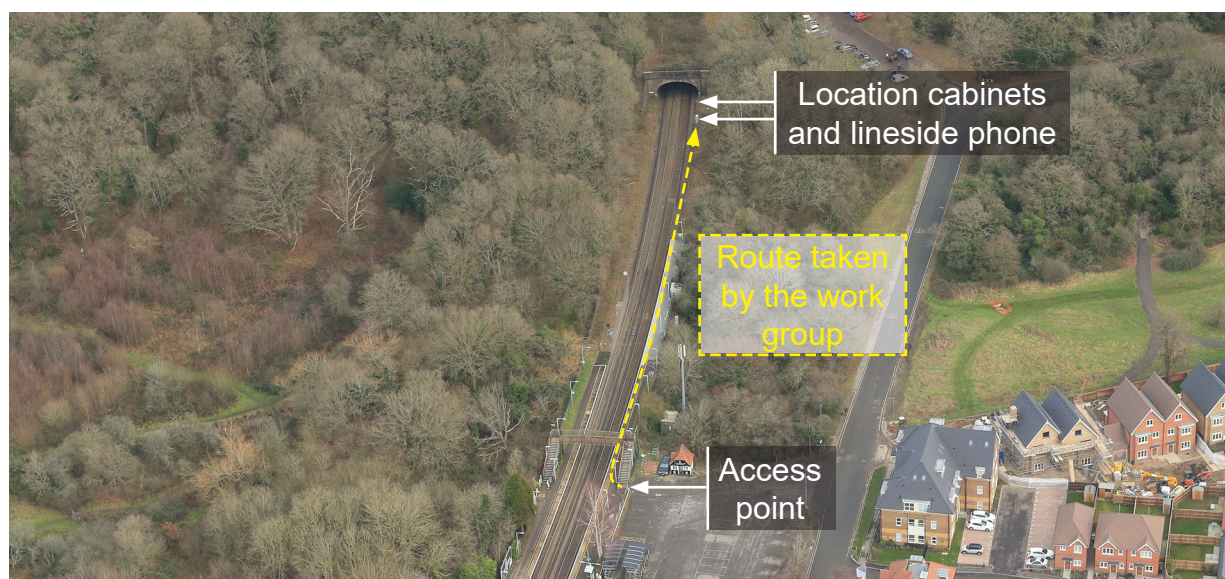
Figure 9: Track workers location before taking first line blockage (courtesy of Network Rail with RAIB annotations).

58 At 11:12, the signaller called the PIC back to grant the line blockage. During the conversation, the signaller confirmed the blocking points (defined railway features, such as signals, used to geographically bound a line block) given in their copy of the line blockage documentation, which matched the documentation held by the PIC (figure 7). There was no repeat of the blocking point information by the PIC back to the signaller and no mention of the physical location of the line blockage. The line blockage was granted, and a handback time was agreed. The Down Portsmouth line through Mickleham Tunnel was now blocked but the Down Bookham line through Bookham Tunnel, where the team was, remained open. The PIC and the track workers walked from west to east, on the Down Bookham line through the tunnel (figure 10).

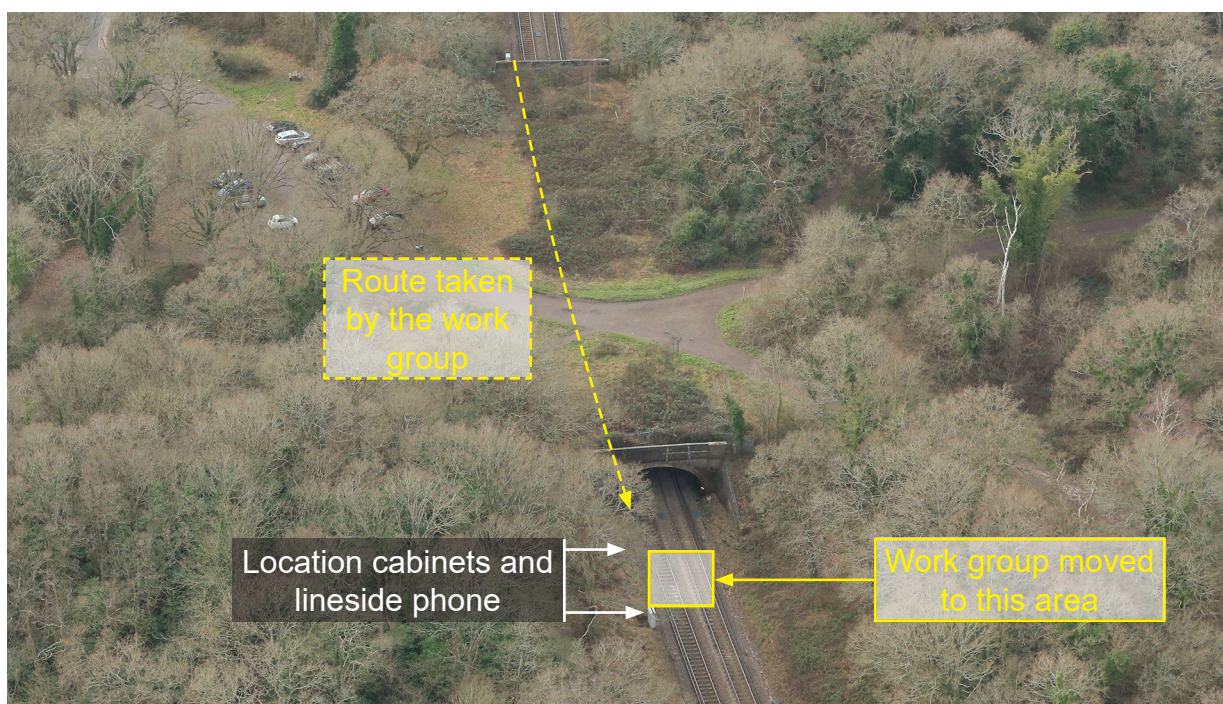
Figure 12: Track workers location before taking second line blockage (courtesy of Network Rail with RAIB annotations).

- 62 At 11:39, the signaller phoned the PIC back to confirm the line was clear for the requested line blockage. The signaller confirmed the blocking points and agreed a handback time with the PIC. This again blocked the Down Portsmouth line through Mickleham Tunnel, while the down line through Bookham Tunnel remained open. The team set off back to Bookham station with the PIC leading, followed by trackworker 2 and trackworker 1. At the same time, train 2D23 left Leatherhead station.

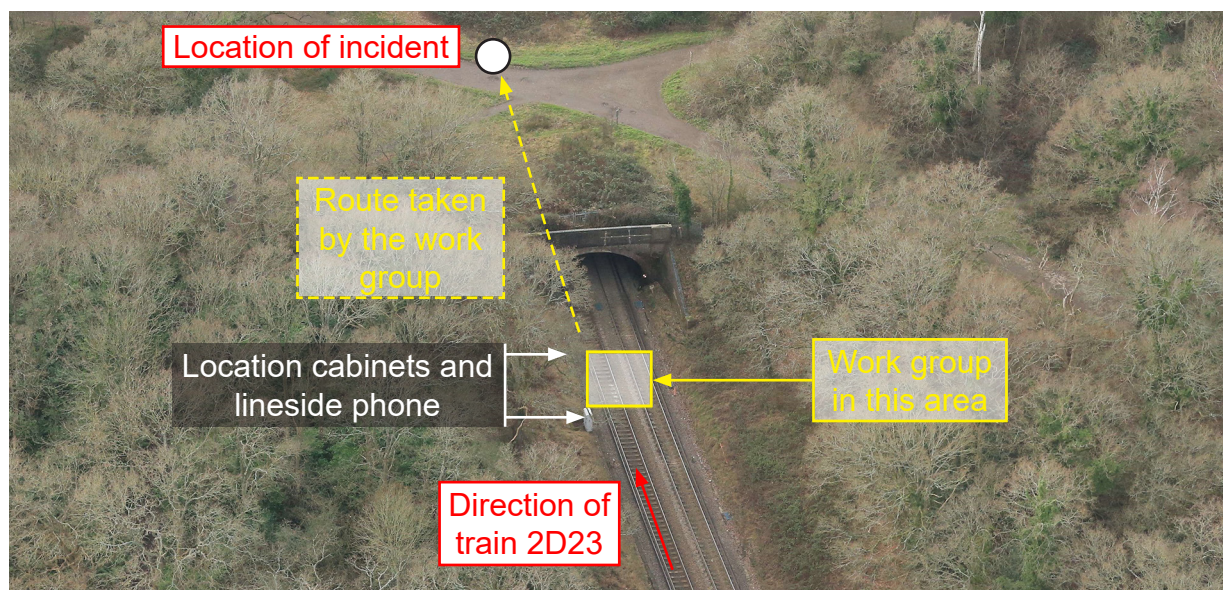
Figure 13: Track workers location after taking second line blockage and during incident (courtesy of Network Rail with RAIB annotations).

- 63 At approximately 11:41, while walking inside the tunnel, trackworker 1 heard a train approaching behind them and shouted a warning to the rest of the group. At around the same time, the train driver saw the group and sounded the horn. The group then moved quickly to the side of the tunnel. Once the train had passed, the group then headed toward Bookham station (figure 13).

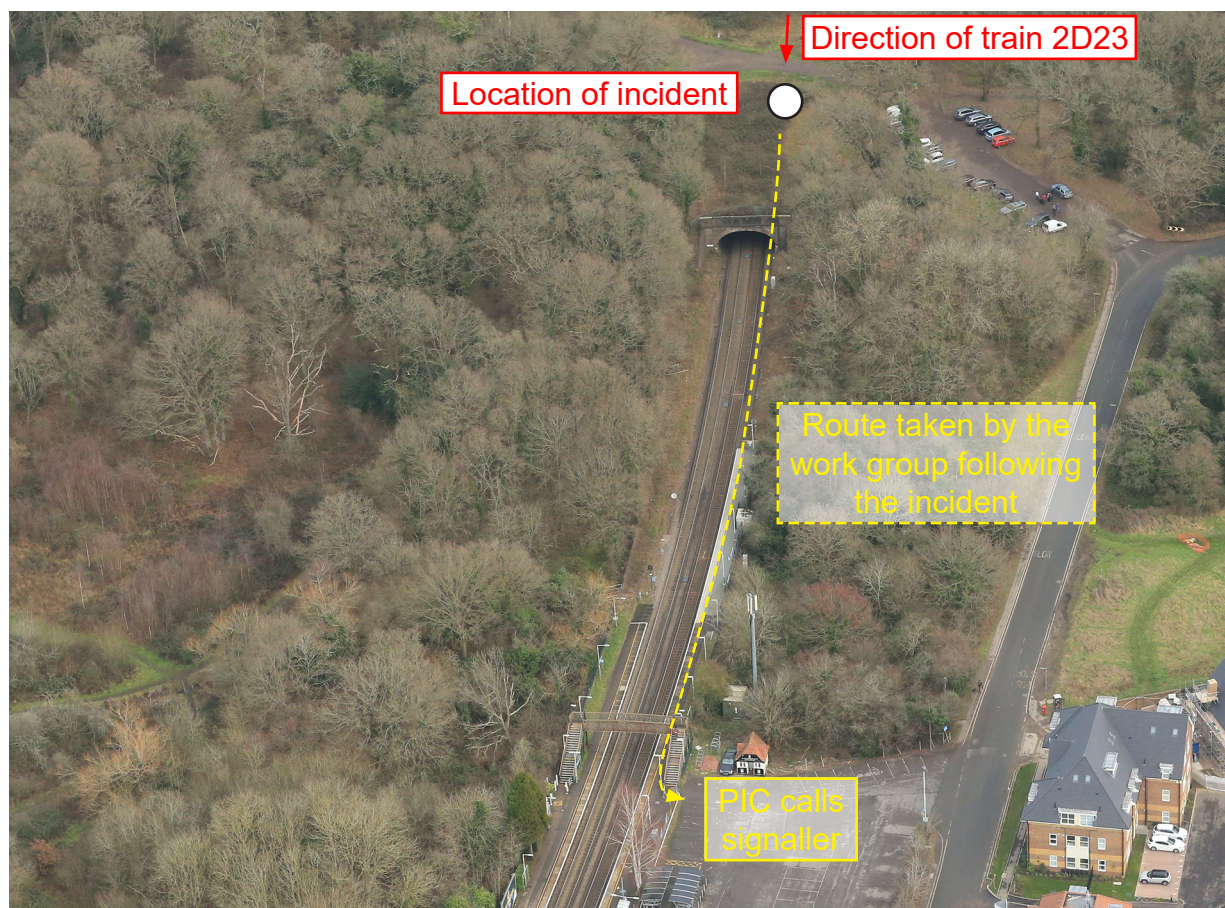
Figure 14: Track workers location post-incident (courtesy of Network Rail with RAIB annotations).

- 64 At 11:45, a relief signaller took over from the signaller at Wimbledon who had granted the line blockage. At 11:46, the PIC called to hand the line blockage back. Having done this, the PIC then mentioned that a train had passed through the blockage. The relief signaller handed the phone to the original signaller, who questioned this with the PIC. The PIC confirmed their line blockage limits and stated they were at Bookham Tunnel. The signaller replied that these were the blocking limits for Mickleham Tunnel, not Bookham Tunnel. The PIC said that they would look at their paperwork and then ended the call (figure 14).

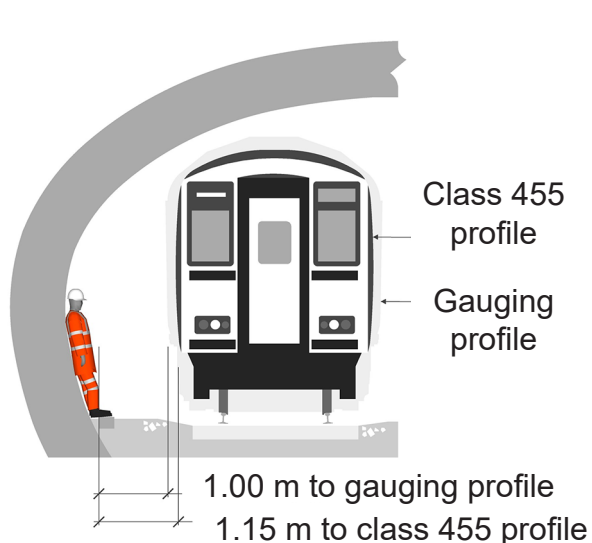
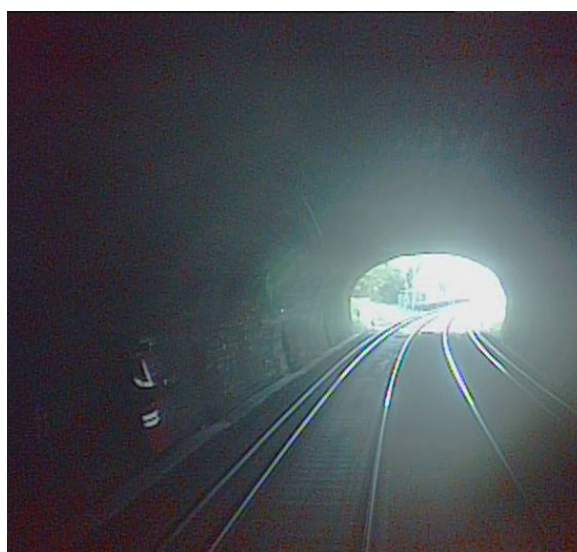
Figure 15: Position of track worker inside the tunnel as the train passed, based on gauging information from Network Rail (left-hand image) and from FFCCTV (right-hand image, courtesy of South Western Railway).

67 The Rule Book (paragraphs 28 and 30) requires anyone working on or near the line to be in a position of safety at least 10 seconds before a train passes them. For line speeds below 100 mph (161 km/h), a position of safety should be a minimum of 1.25 metres from the nearest running rail.

68 The distance between the tunnel wall and the nearest running rail of the down line where the track workers were walking is about 1.6 metres. The available space between the tunnel wall and the passing train was between 1 and 1.15 metres (figure 15).

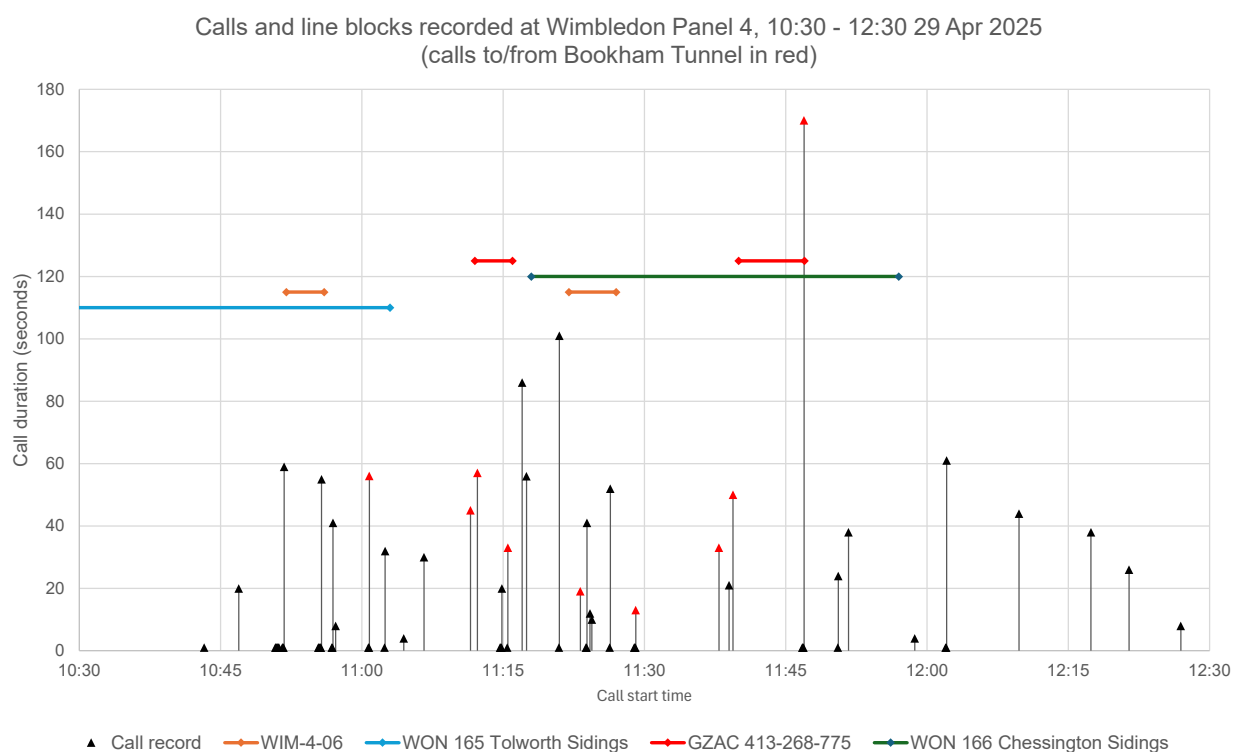
Figure 18: Telephone calls being dealt with by the signaller at the time of the incident.

- 115 Witness evidence indicates that the period leading up to the incident had been busy for the signaller, with many phone calls from different locations (paragraph 53). The signaller was dealing with phone calls regarding four other line blockages and possessions before and during the line blockage associated with the near miss. Witness evidence showed that, at times of increased workload, the main check carried out by the signaller was that the information supplied matched the details given in the paperwork when a line block was being taken.
