## Accident

| <b>Aircraft Type and Registration:</b> | Beagle B121 Series 2, G-AZDG | |
| <b>Location:</b> | Hanningfield Reservoir, Essex | |
| <b>Information Source:</b> | AAIB Field Investigation | |

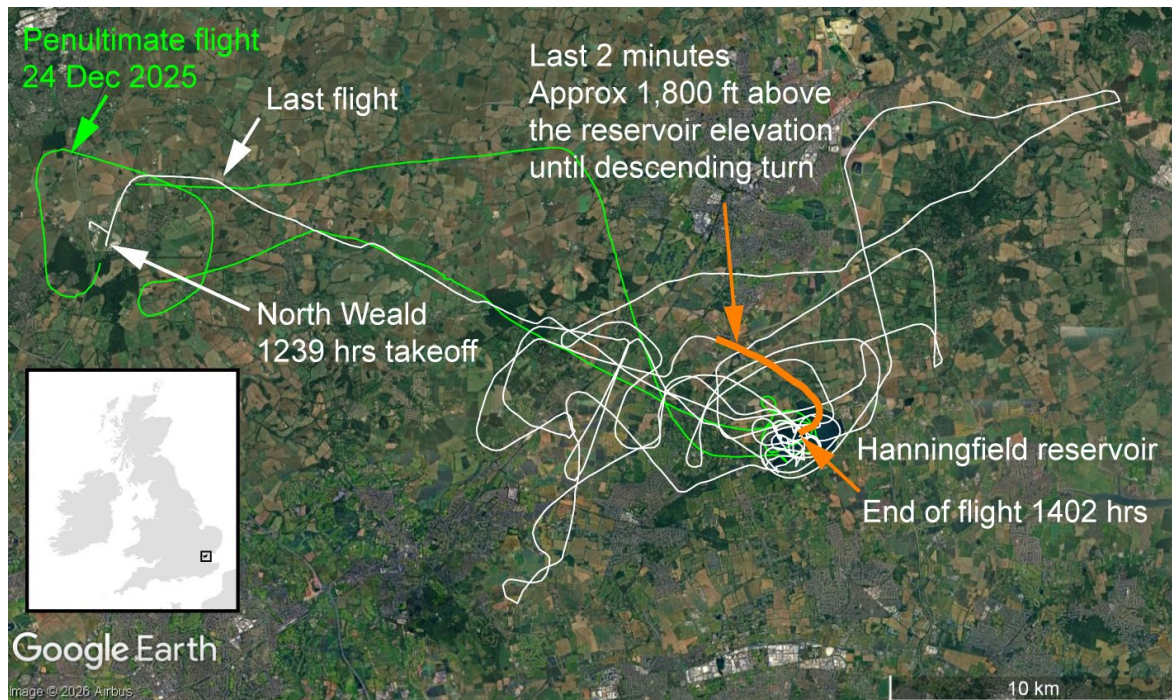
**Figure 1**

The aircraft flew towards Hanningfield Reservoir<sup>3</sup>, 13.5 nm east-south-east of North Weald where it remained in the vicinity for about 70 minutes (Figure 1). During this time the aircraft's flight path involved many turns centred on the reservoir, with some excursions to the south-west and north-east, before returning to the reservoir<sup>4</sup>. It also included, at about 1253 hrs, one descent in excess of 6,000 ft/min, down to about 600 ft above the reservoir, before entering a climb. At 1401 hrs the aircraft turned south-east flying towards the north-east corner of the reservoir, at an altitude of approximately 1,800 ft above the reservoir, with a ground speed averaging about 90 kt. The ground speed started increasing in conjunction with a slight climb. A right turn was initiated just prior to reaching the reservoir, the turn tightened and the aircraft descended rapidly with an increasing groundspeed<sup>5</sup>. The last recorded point, at 1402 hrs, was approximately 500 ft above the reservoir with a descent rate greater than 5,000 ft/min. At this time the aircraft was seen by some eyewitnesses that were about 450 m south-east of the impact point. They stated that they saw the aircraft, in a level attitude, "nose diving" from height at an angle of approximately 60° nose-down, before it struck the water making "a big splash and a loud bang". The aircraft then disappeared under the water. They added that during the descent the engine sounded normal and there was no "spluttering engine" noise. After it had disappeared, they observed oil and small pieces of wreckage on the surface of the water. They immediately called the emergency services, who arrived about 15 minutes later. This subsequently included an air ambulance helicopter and a police helicopter. At the time there was an easterly wind.

Aircraft's flight path on 24 and 28 December 2025

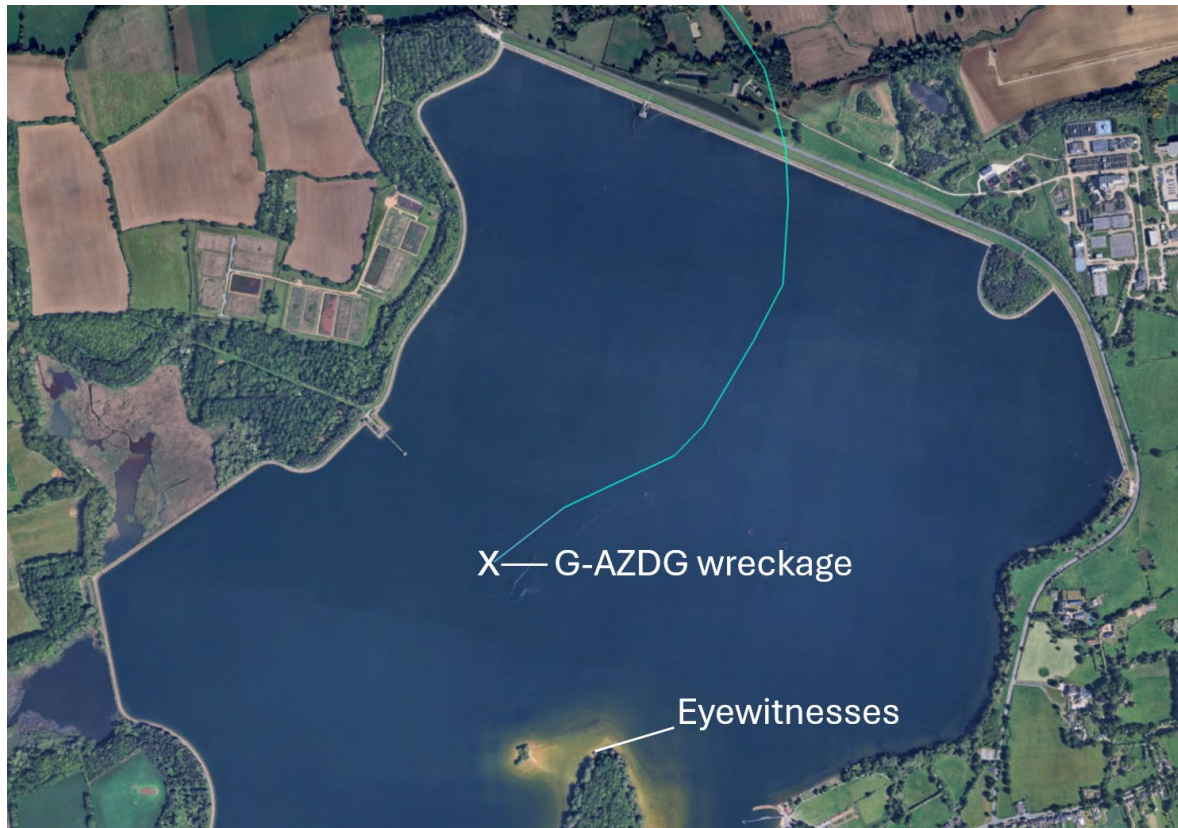
**Figure 2**

The aircraft wreckage was found on 30 December 2025 using side-scan sonar and police divers. It was submerged at a depth of about 6 m near the centre of Hanningfield Reservoir (Figure 2).

Wreckage and eyewitnesses' location with final flight path from recorded tracking services  
© Google Earth, Image © Airbus

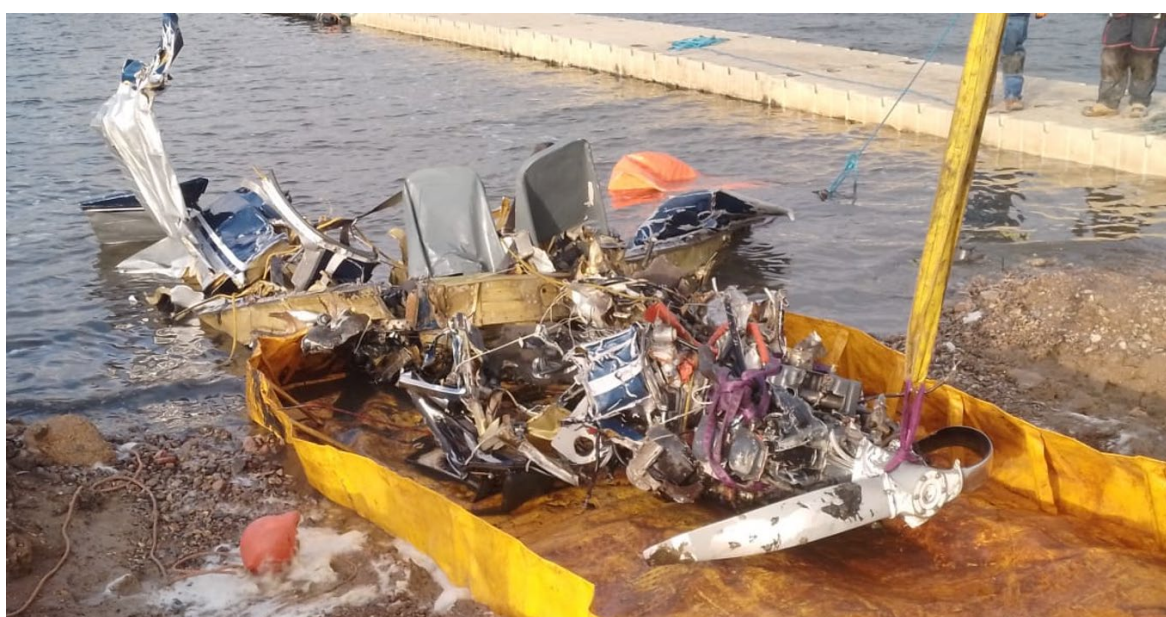
**Figure 3**  
G-AZDG aircraft wreckage

The aircraft wreckage was severely broken up (Figure 3) indicating a high-speed impact. The wreckage was found in a relatively small compact area which was consistent with a steep impact. One of the propeller blades was curled backwards which often occurs in steep impacts and makes it difficult to determine if the propeller was being driven by engine power at the time. The left horizontal tail and left elevator were attached, while the right horizontal tail and right elevator had partially detached in a manner consistent with impact forces. The elevator control cables were attached to the elevator bellcrank, but the cables had failed due to overload consistent with the airframe break-up. The elevator was in a neutral position and could be actuated via the cables. Due to the circumstances leading up to the accident no further wreckage examinations were carried out.

The aircraft damage was consistent with a steep high-speed impact. There was no evidence of a pre-impact failure of the horizontal tail or elevators which could have caused a steep uncontrolled nosedive. According to eyewitnesses the aircraft hit the reservoir in a wings level attitude indicating that the aircraft was likely under control.
