Report on the investigation of  
the foundering of the longline fishing vessel

***Argos Georgia***

approximately 190 nautical miles east of Port Stanley,  
Falkland Islands

REPORT NO 19/2026

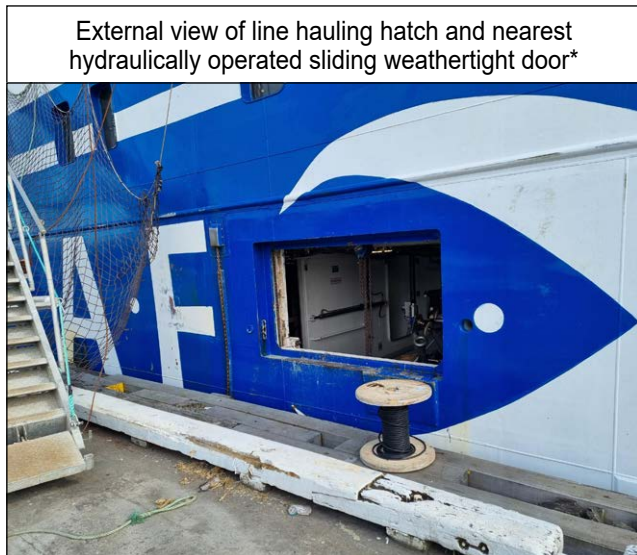
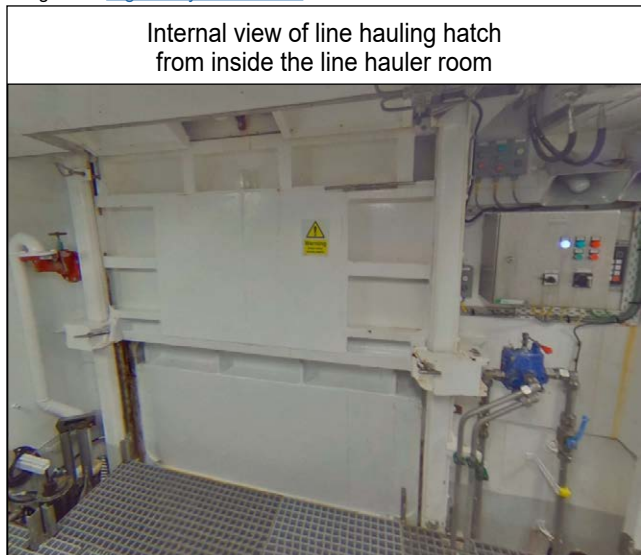
**Figure 2: The line hauling hatch**

The investigation found that the previously closed line hauling hatch opened uncommanded and unexpectedly at the time of the accident. The hatch's manual securing bolts had likely not been applied before proceeding to sea. The crew were unable to close the hatch once it had opened, probably due to a failure of the hatch's operating mechanism. A hinged weathertight door leading from the line hauling compartment was open and hooked back. Sliding electro-hydraulic weathertight doors could not be closed, probably because of deluged control system short-circuits. The floodwater prevented crew accessing the manual emergency control.

The Maritime and Coastguard Agency has been recommended to enhance requirements for shell door securing arrangements in the relevant fishing vessel code. Recommendations have been made to the vessel's management company, Argos Froyanes Limited, to implement a safety management system for its fleet. A recommendation has also been made to the Falkland Islands Government, Directorate of Emergency Services and Islands Security to enhance its search and rescue communications capability.

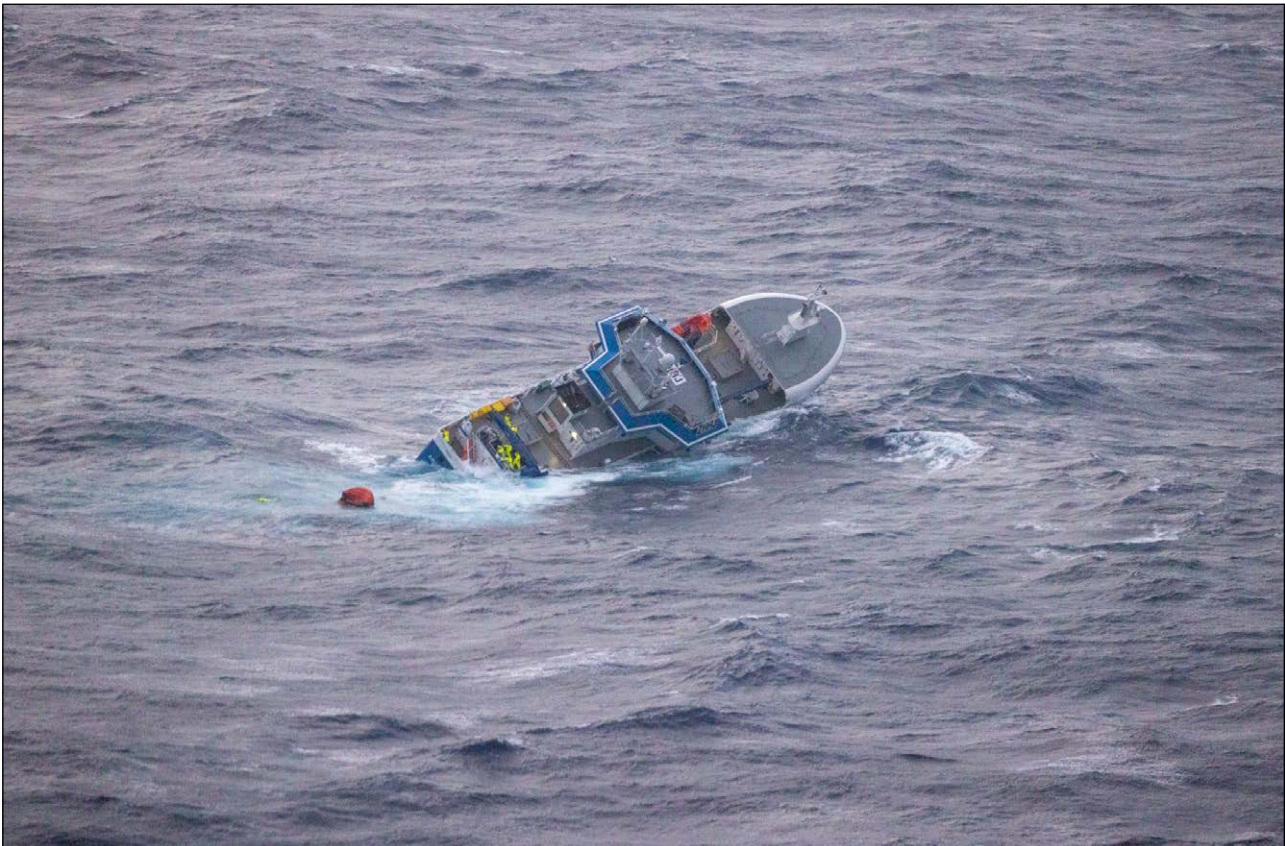
**Figure 4:** *Argos Georgia* as viewed from the fixed-wing aircraft on arrival at the scene

The fixed-wing aircraft was unable to establish communication with the liferafts and could not associate any detected distress beacons with them. The only visible indicators were strobe lights. Shortly afterwards, two liferafts were identified, one of which appeared partially deflated, and *Argos Georgia*'s stern was observed to be partially submerged.

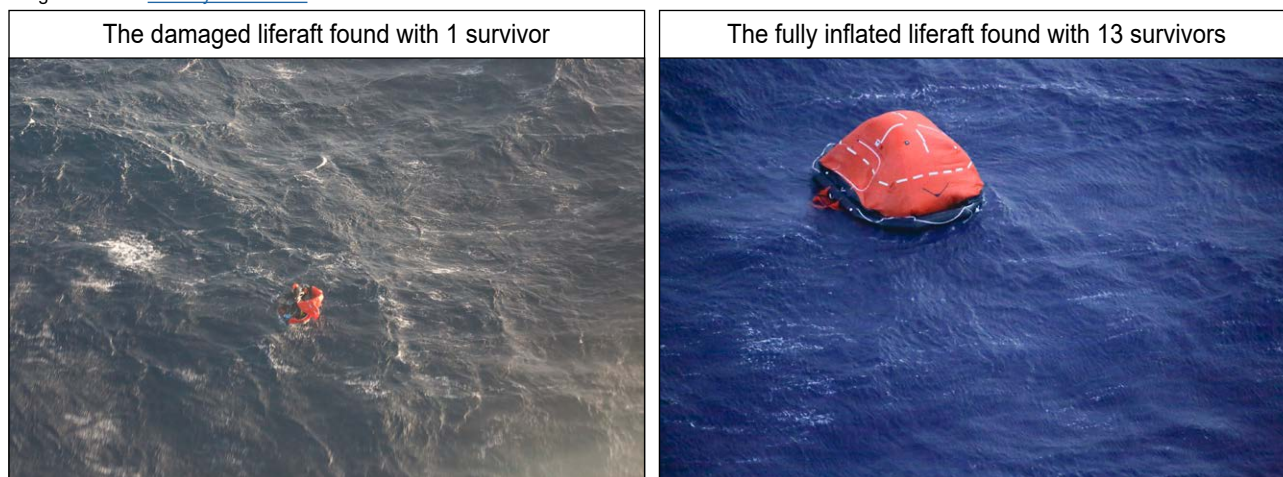
**Figure 7:** *Argos Georgia* liferafts as located by search vessels, viewed from the fixed-wing aircraft

By about 1730, FV *Puerto Toro*, having arrived on scene at 1000, had recovered eight deceased crew members, all wearing immersion suits, and the damaged liferaft from the water. At this time there were 14 survivors, nine deceased and four missing<sup>9</sup>. FV *Puerto Toro* then started heading north to seek shelter from the worsening weather conditions.

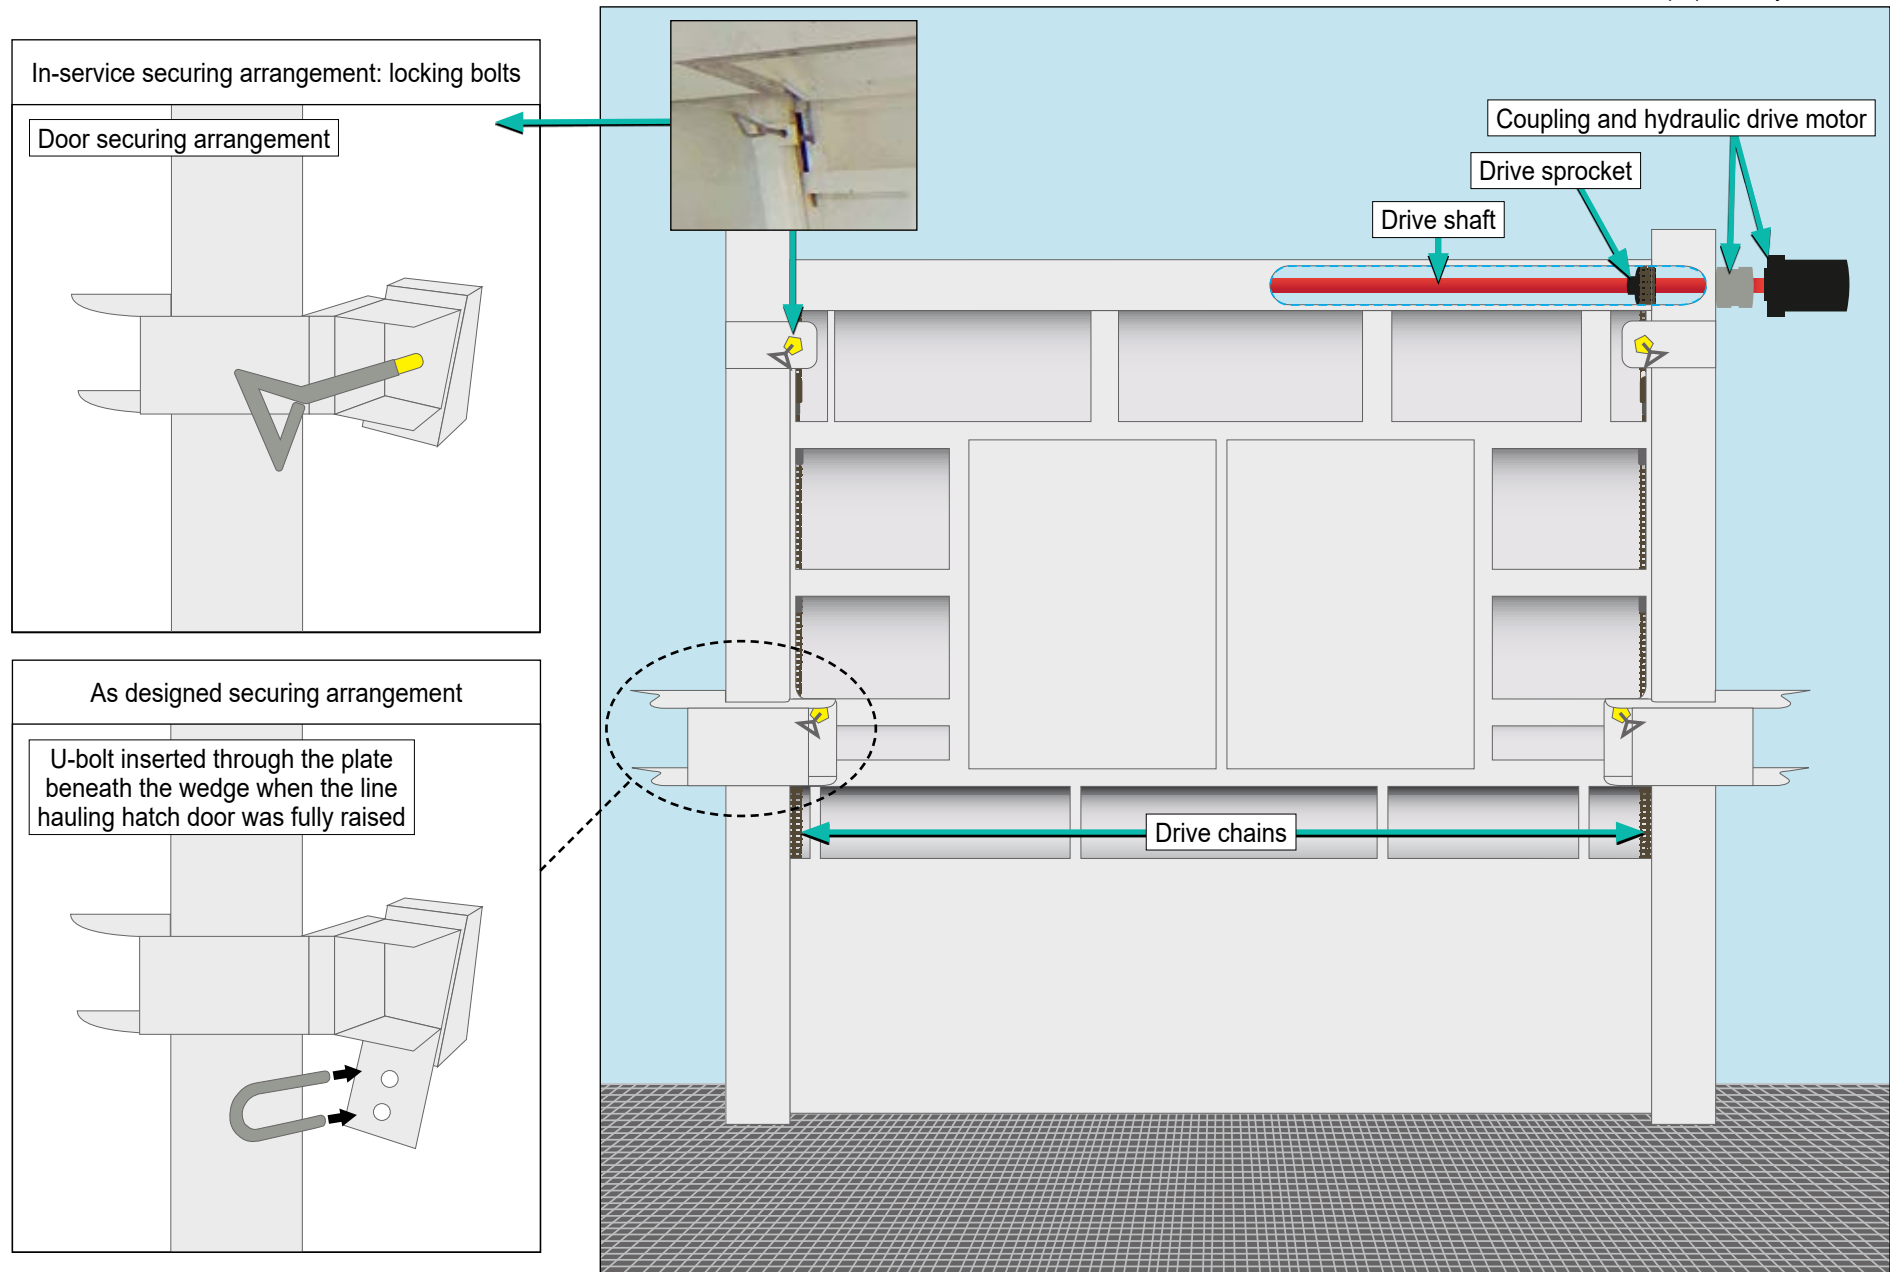
**Figure 9: Argos Georgia side hauling hatch operating mechanism and locking arrangement**

In 2019, the line hauling hatch sealing rubber was renewed and the two-part drive shaft was removed for modification. Longer keyways were cut into the shafts and fitted with new stainless steel keys, and a new coupling with a broached keyway was installed. Crew later reported that grub screws intended to maintain pressure between the key and keyway were sometimes found loose during maintenance.

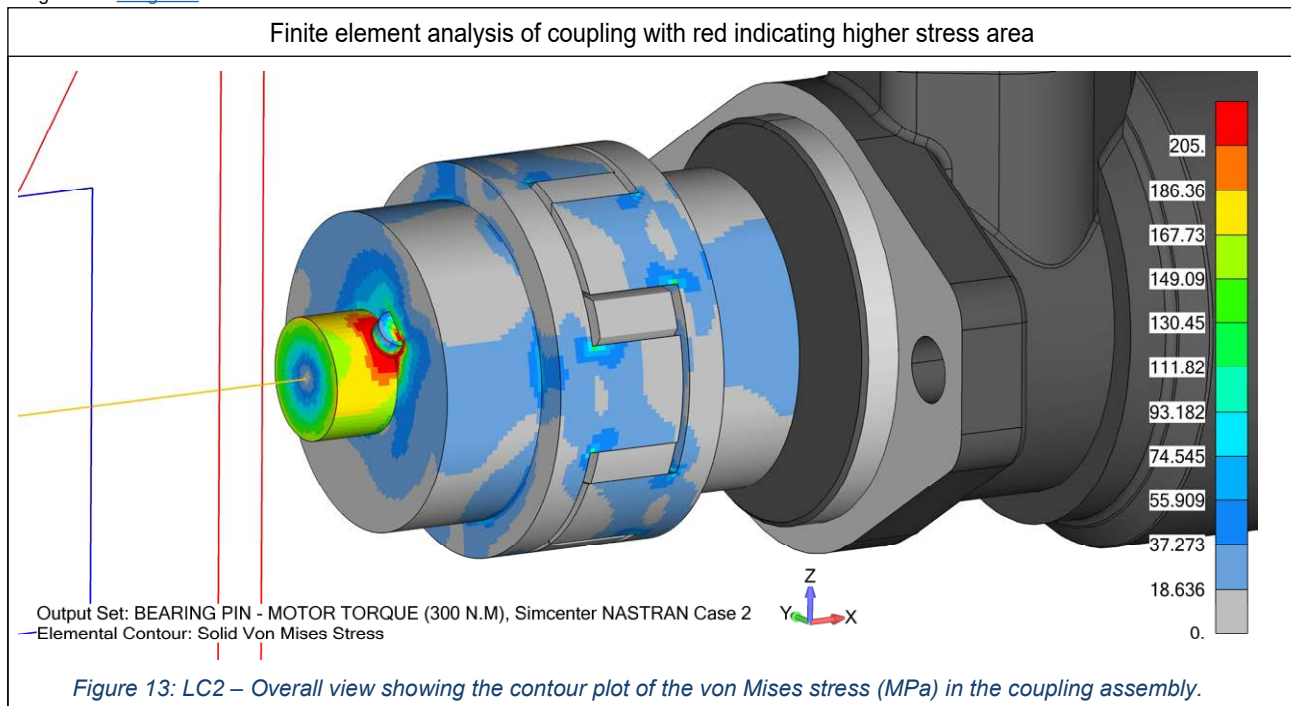
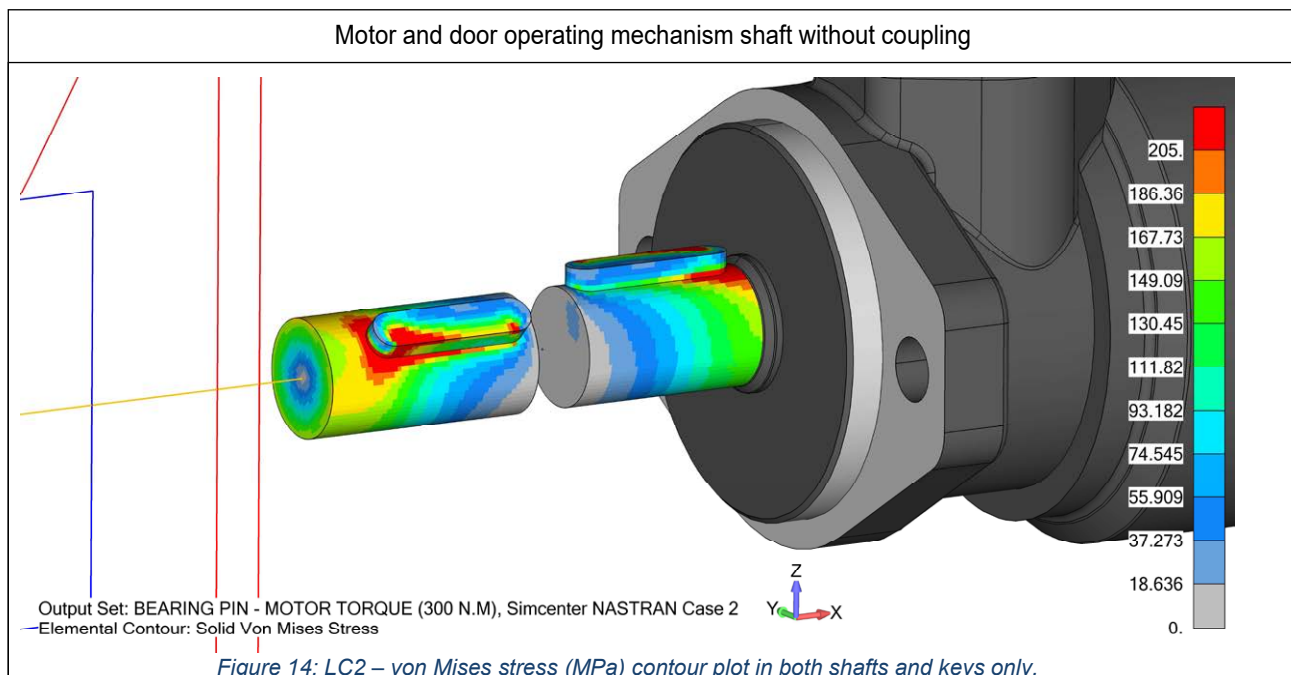
**Figure 11:** Extract from finite element analysis report

The FEA also identified additional design factors that increased the likelihood of hatch failure, including the absence of a fail-safe locking mechanism in the closed position, either manual or interlocked with the motor controls, and exposure to cyclic inertial loading from vessel motion/wave strike without an independent locking arrangement, increasing the risk of fatigue damage.

The post-accident FEA of the hatch drive shaft arrangement revealed that the modified (shortened) dog coupling and associated keys/keyways were susceptible to plastic deformation, cracking and loosening of grub screws. Two out of three of the modelled conditions resulted in potential yielding of these components. In the worst-case scenario, the peak torque of the hydraulic motor exceeded the yield stress of the stainless steel components by a factor of four, and the motor's continuous torque was more than double the yield threshold. The reduced contact area caused by the shortened coupling length further increased stress concentrations, with the possibility of sudden failure. The recovered similar parts from *Nordic Prince* when tested during the investigation did not show evidence of stress-related failure but it was unknown how long they had been in service or why they had been replaced. The modifications that had been carried out to the *Argos Georgia* coupling suggest that there had been previous partial failures in this area.

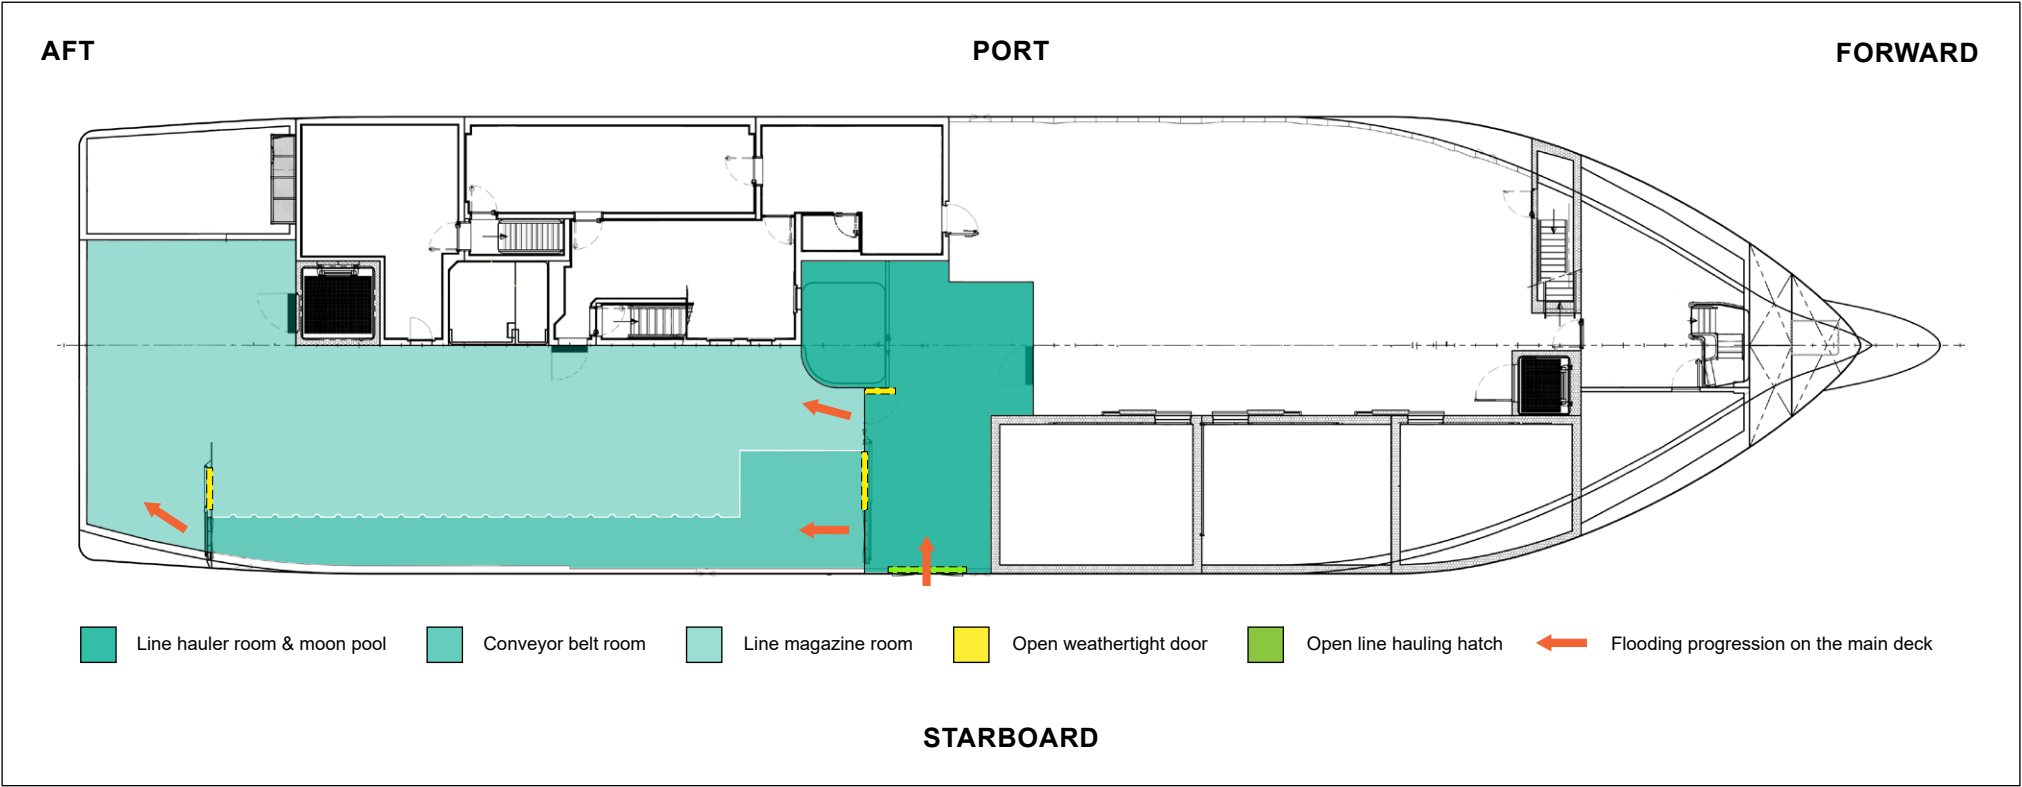
**Figure 13:** Likely progressive flooding of *Argos Georgia* main deck

It cannot be definitively known what caused *Argos Georgia*'s line hauling hatch to open but, since it descended smoothly and evenly without tilting or jamming, it is unlikely that the drive chains failed. Since the motor's brake required hydraulic pressure for it to release, it is also unlikely that the braking mechanism failed. The fact that the hatch could not be closed nearly immediately after it descended suggested that the drive mechanism was no longer operational. The hydraulic motor potentially applied excessive torque to the drive mechanism during normal operation, causing stress to the coupling and keys and shaft keyway. It is possible that the effect of this stress was exacerbated due to fretting transmitted to the drive mechanism from the wave action against the line hauling hatch. Consequently, it is possible that a component in the drive mechanisms such as the coupling, the drive keys or drive shaft failed and the hatch's weight caused it to descend.

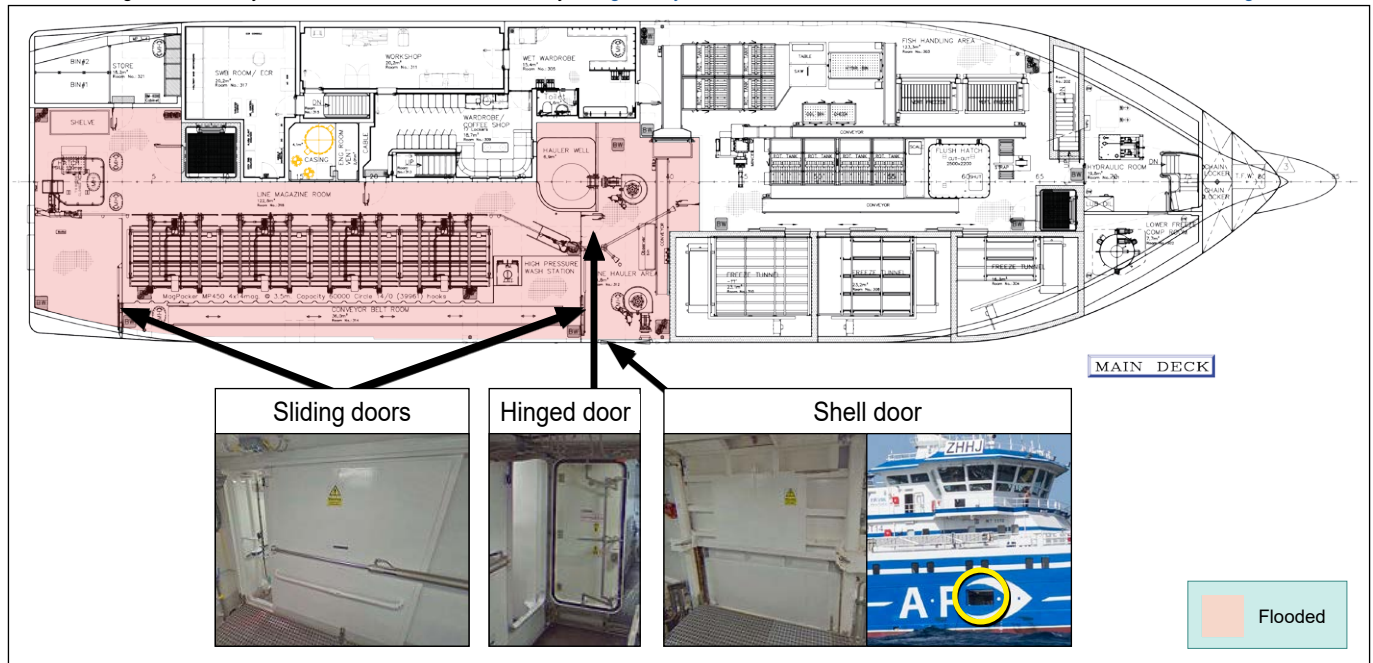
**Figure:** Plan of *Argos Georgia* main deck, showing the extent of the initial flooding

At about 1230<sup>1</sup>, in a position approximately 190 nautical miles east of Port Stanley, *Argos Georgia* suffered an uncontrolled ingress of water through the shell door into the hauling compartment on its starboard side. Water then entered other areas aft of the hauling compartment (see **Figure**) and the vessel took on a starboard list. *Argos Georgia* was turned into the weather and the master raised the alarm via a colleague on a fishing vessel operating in the same region. This alarm was relayed to the authorities in the Falkland Islands and a SAR operation initiated using air and sea assets, supported by other fishing vessels.

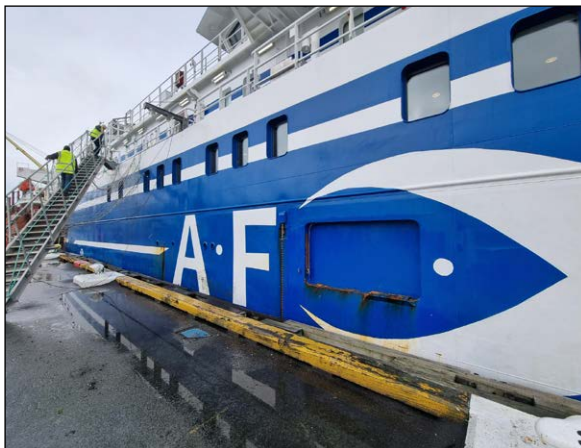
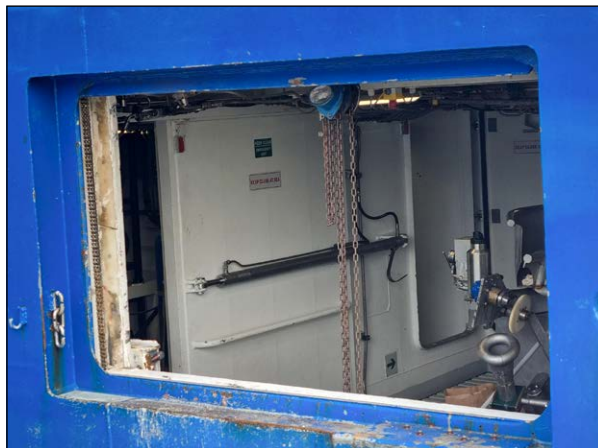
**Figure:** Line hauling hatch similar to that of *Argos Georgia*\*

*Argos Georgia* was on passage to fishing grounds in rough seas near the island of South Georgia. At about 1300 on 22 July, the line hauling hatch (see **figure**) set in the main deck starboard side of the hull opened uncommanded. Water poured into the line hauling room and flooding progressed through the main deck compartments via weathertight doors that had been left open. The floodwater probably damaged door remote closing systems and impeded the crew's attempts to manually shut weathertight doors. *Argos Georgia* soon took up an extreme list to starboard.
