Report on the investigation of  
the foundering of the longline fishing vessel

***Argos Georgia***

VERY SERIOUS MARINE CASUALTY

REPORT NO 19/2026

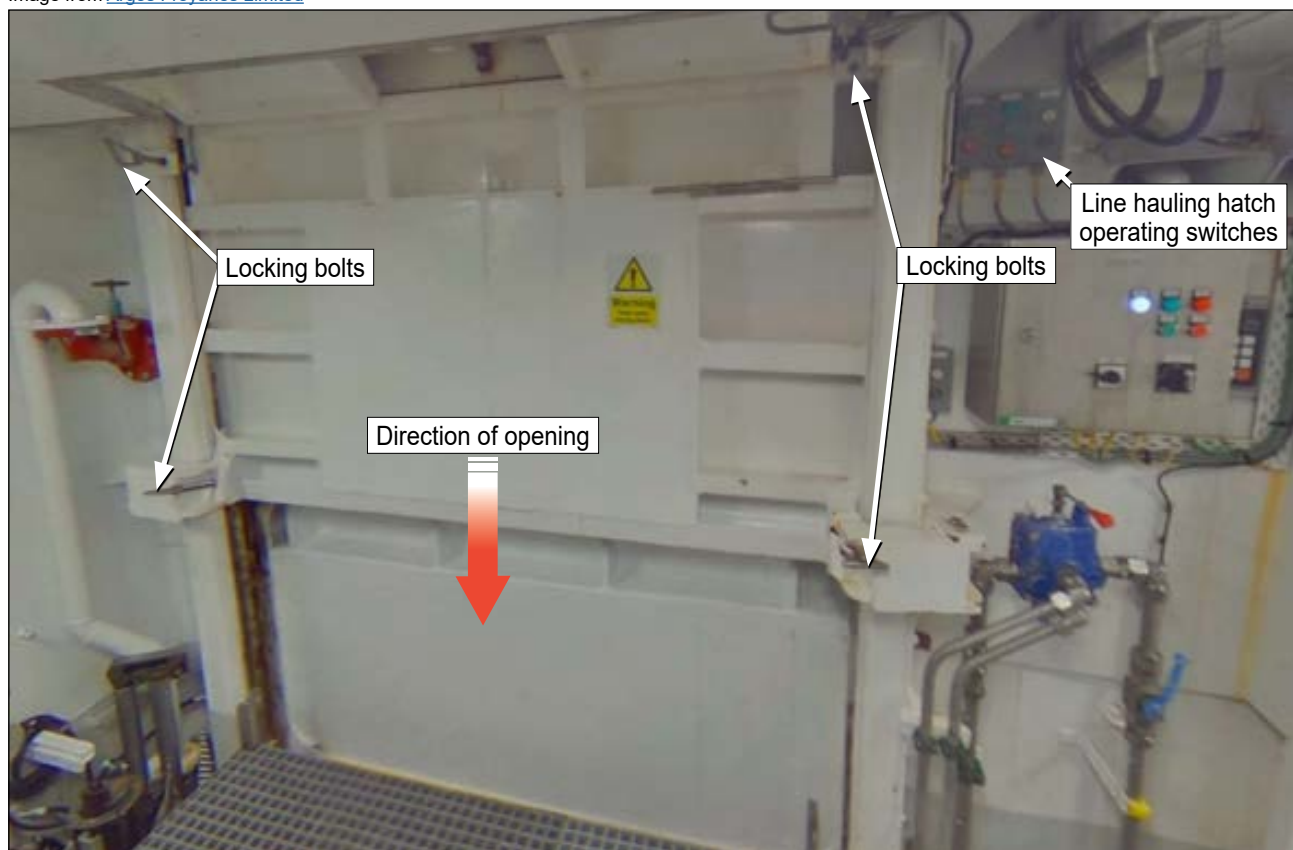
**Figure 8:** *Argos Georgia* side hauling hatch assembly and controls

The line hauling hatch was constructed from 10mm marine-grade aluminium alloy with strengthening plates and weighed 69kg. It was raised and lowered by mechanical/hydraulic mechanism driving duplex stainless steel chains running over sprockets mounted on a two-part, stainless steel drive shaft located above the hatch. The shaft rotated within two bearings and was joined at mid length by a coupling secured with parallel keys and grub screws. Additional sprockets at main deck level connected the drive chains to a lower shaft (**Figure 9**).

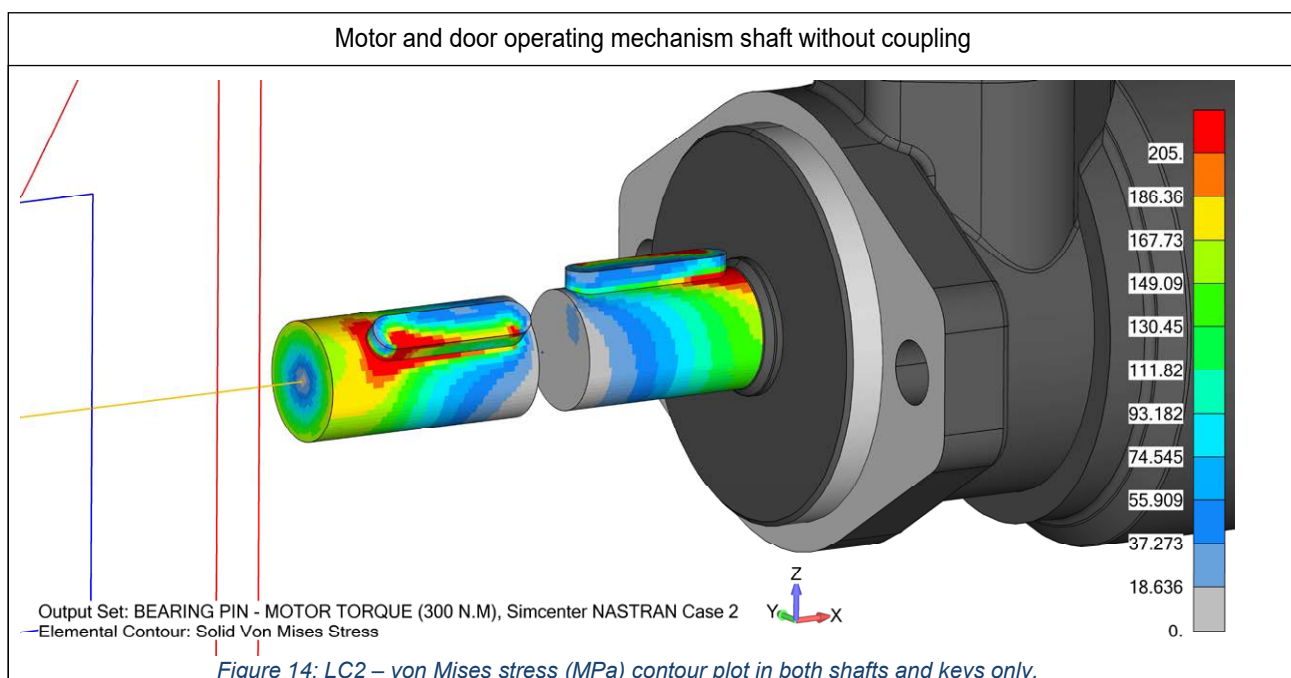
**Figure 11:** Extract from finite element analysis report

The FEA also identified additional design factors that increased the likelihood of hatch failure, including the absence of a fail-safe locking mechanism in the closed position, either manual or interlocked with the motor controls, and exposure to cyclic inertial loading from vessel motion/wave strike without an independent locking arrangement, increasing the risk of fatigue damage.

The post-accident FEA of the hatch drive shaft arrangement revealed that the modified (shortened) dog coupling and associated keys/keyways were susceptible to plastic deformation, cracking and loosening of grub screws. Two out of three of the modelled conditions resulted in potential yielding of these components. In the worst-case scenario, the peak torque of the hydraulic motor exceeded the yield stress of the stainless steel components by a factor of four, and the motor's continuous torque was more than double the yield threshold. The reduced contact area caused by the shortened coupling length further increased stress concentrations, with the possibility of sudden failure. The recovered similar parts from *Nordic Prince* when tested during the investigation did not show evidence of stress-related failure but it was unknown how long they had been in service or why they had been replaced. The modifications that had been carried out to the *Argos Georgia* coupling suggest that there had been previous partial failures in this area.
