**Serious Incident**

| <b>Aircraft Type and Registration:</b> | Airbus A319-131, G-EUPS | |

**Synopsis**

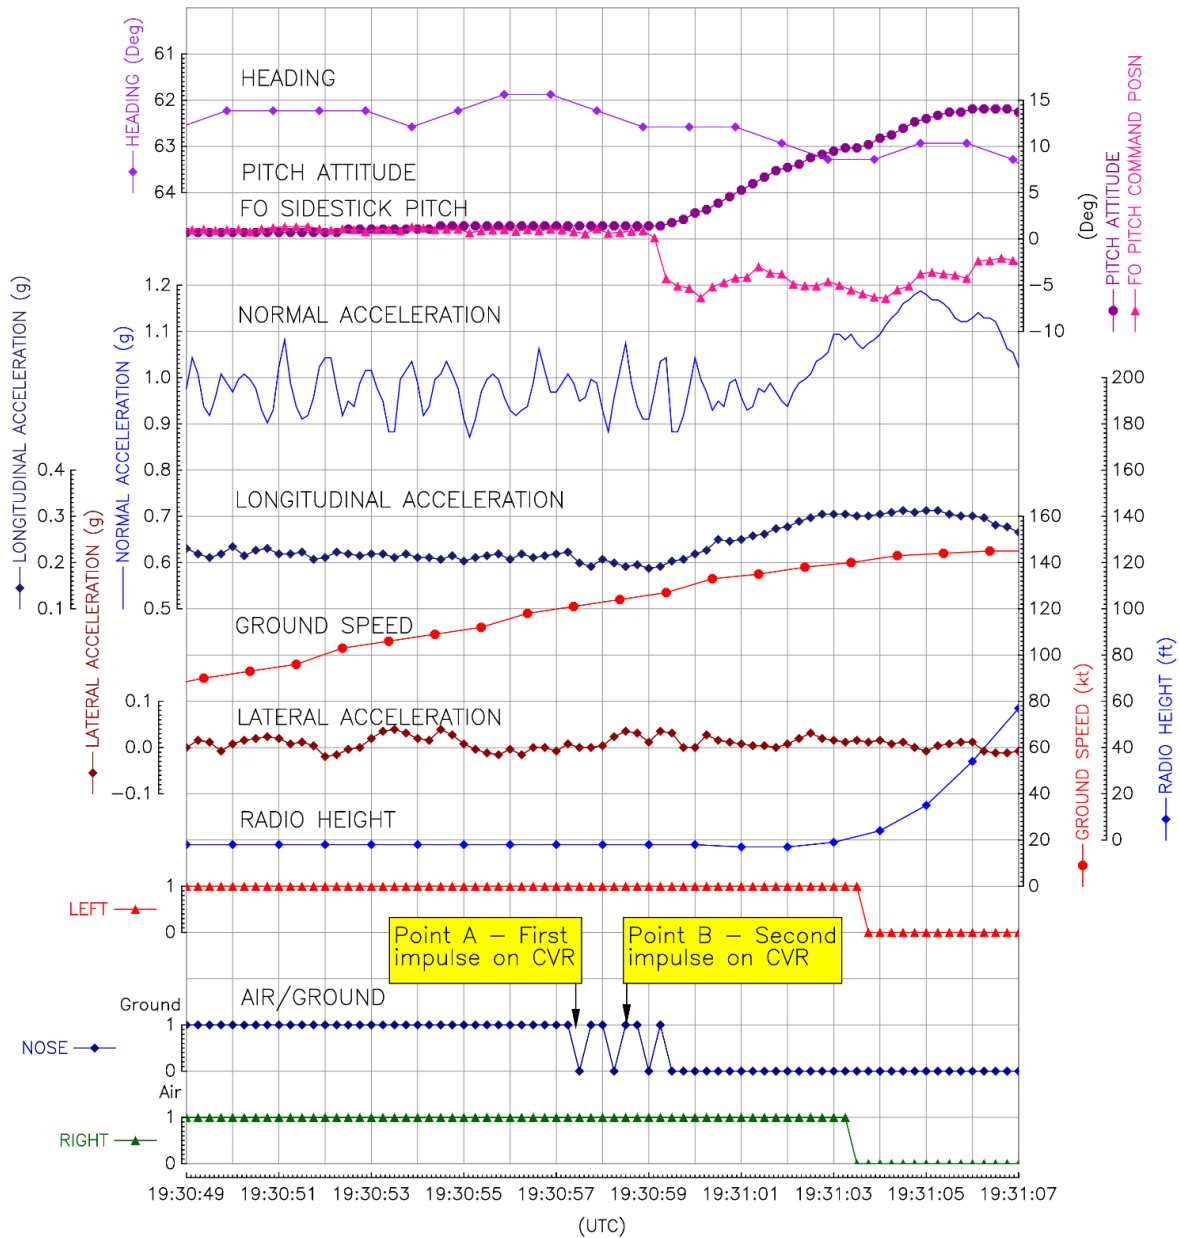
**Figure 1**  
Relative timing of CVR sounds during takeoff roll

The taxi out to the runway and initial takeoff roll appeared normal. As the aircraft accelerated along the runway, rhythmic sound pulses were recorded on the CVR cockpit area microphone (CAM), which were consistent with one of the NLG tyres contacting the runway centreline lights. As the aircraft reached a ground speed of about 118 kt (an airspeed of 128 KCAS), the amplitude of one of the sound impulses increased (Figure 1 and Figure 2 - Point A). This coincided with the aircraft's NLG squat switch (recorded at an update rate of four samples per second) starting to oscillate quickly back and forth between its GROUND and AIR indication. One second later (Figure 1 and Figure 2 - Point B), there was a further short duration sound impulse, which was of sufficient intensity to be captured by the CAM and the pilot's headset hot-microphones<sup>6</sup>. Less than one second after this, the aircraft's airspeed reached  $V_R$  and the PF applied aft stick, rotating the aircraft into the climb.

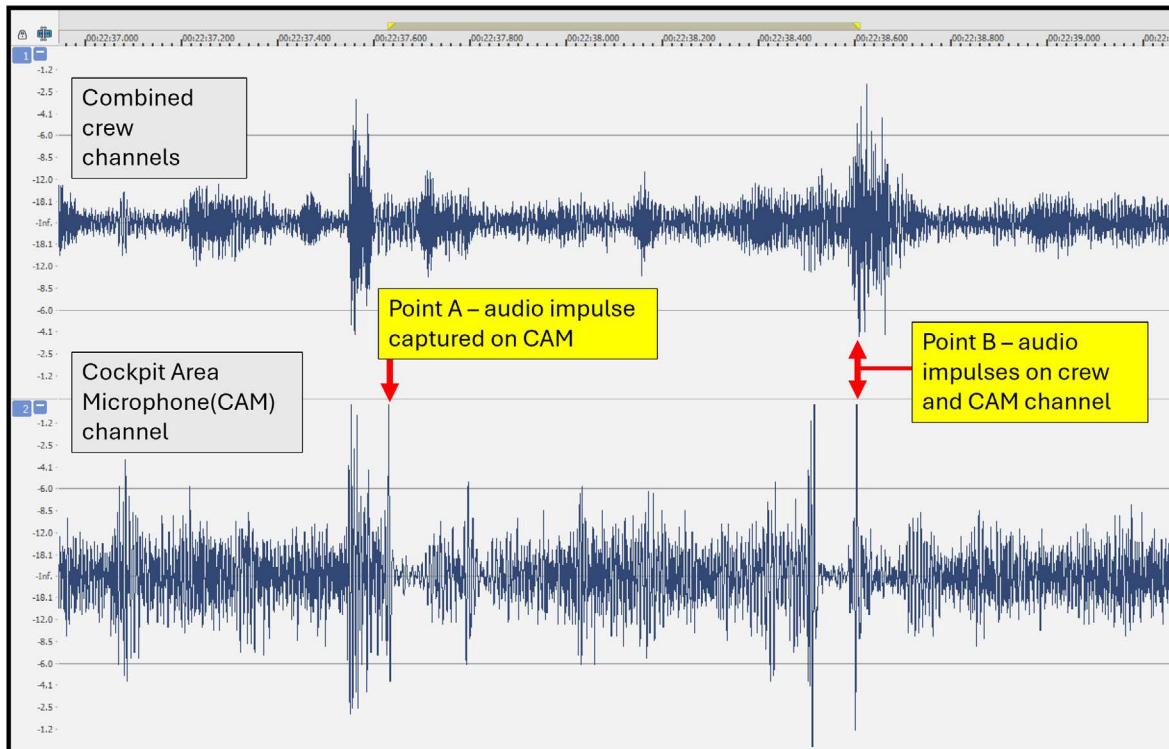
**Figure 2**

High amplitude sounds recorded on the CVR during takeoff

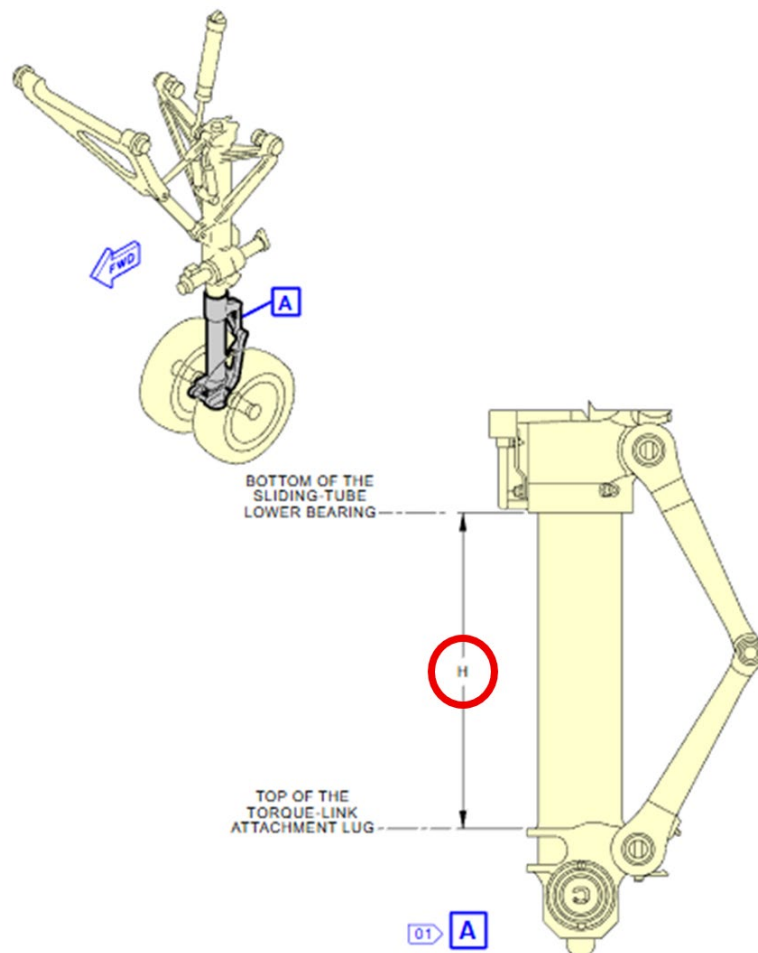
**Figure 3**  
NLG shock absorber

When uncompressed, the NLG shock absorber can extend to 44.9 cm (Figure 3 - dimension H). If the shock absorber extension is less than 44.1 cm, a proximity sensor indicates that the NLG is on the ground, and when the shock absorber extension is beyond 44.46 cm, the NLG is in the air position. Between 44.1 and 44.46 cm, the shock absorber is referred to as being within a transition zone, whereby it is possible that the indication could be either air or ground.

The aircraft's NLG ran over several runway centreline lights plus another larger irregularity on the runway surface, immediately prior to rotation. The NLG squat switch fluctuated between the AIR/GROUND positions several times during this period, indicating that vertical loads transferred into the NLG were sufficiently high for the NLG leg to decompress past the 44.1 cm extension required for GROUND indication, and up to, or in excess of, the 44.9 cm extension required for air indication.

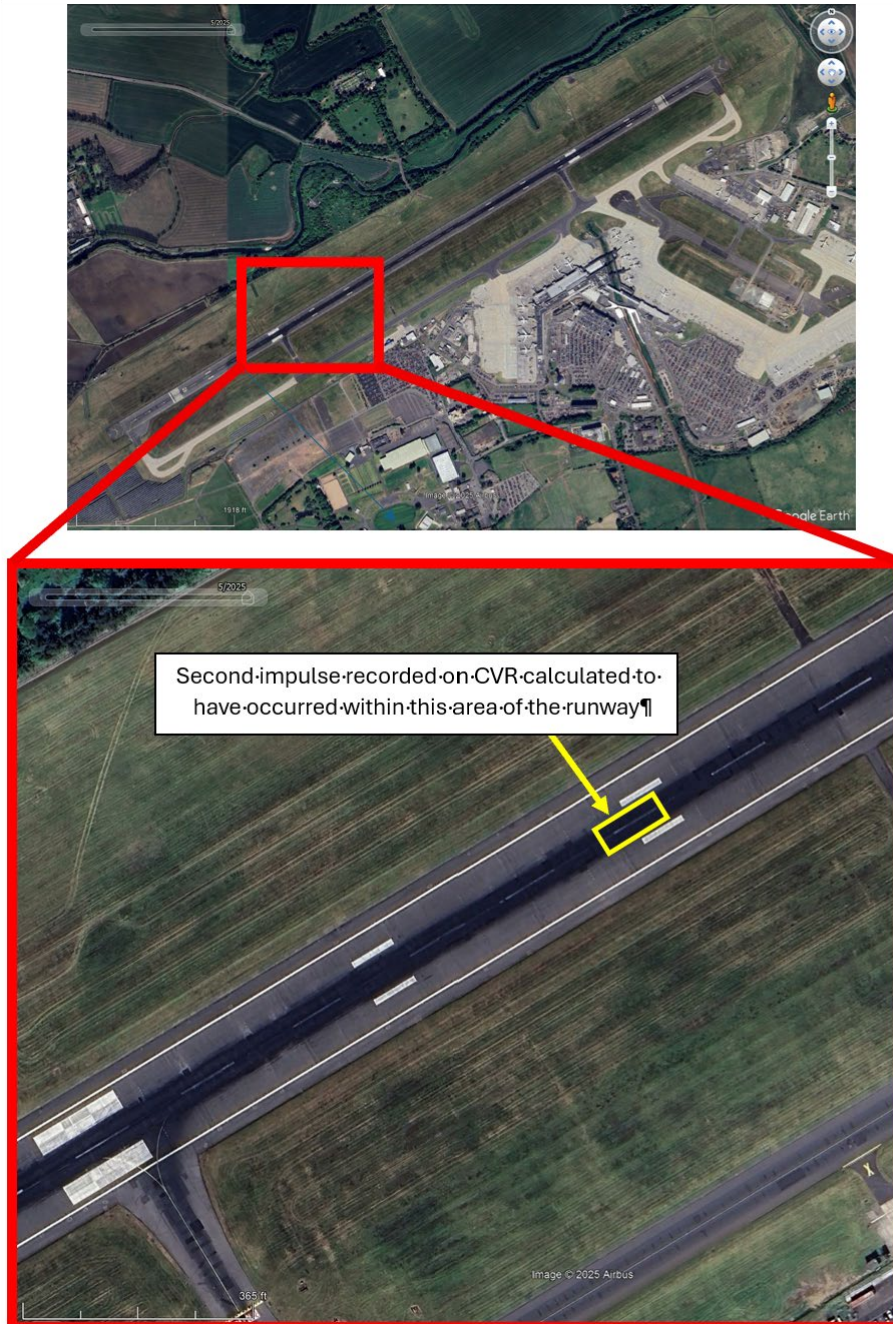
**Figure 4**

Figure 4 shows the approximate area of the runway where the second sound impulse was recorded by the CVR.

Approximate area of runway when second CVR sound impulse occurred

The runway was inspected the same day by the Edinburgh airport operations team in the area where it was calculated the aircraft experienced the shock load. Details of the surface condition and previous repairs were provided to the investigation. The runway surface had multiple repair patches along its length, with several on or near the centreline, in the area just before where the aircraft was calculated to have rotated. One repair patch was identified by the operations team to have developed an abnormal surface condition in comparison with its previous inspection and was subsequently replaced. However, its location was offset from the centreline and it is unlikely the nosewheels travelled over the degraded area. Planned resurfacing of the entire runway commenced in November 2025 and was completed during April 2026.

The runway surface was inspected, with no singular irregularity appearing capable of causing the shock load. Full runway resurfacing at Edinburgh will minimise the probability of surface irregularities affecting other aircraft.
