# Rail Accident Investigation: Interim Report

**Collision between passenger trains near Elstow,  
Bedfordshire  
19 June 2026**

# Collision between passenger trains near Elstow, Bedfordshire, 19 June 2026

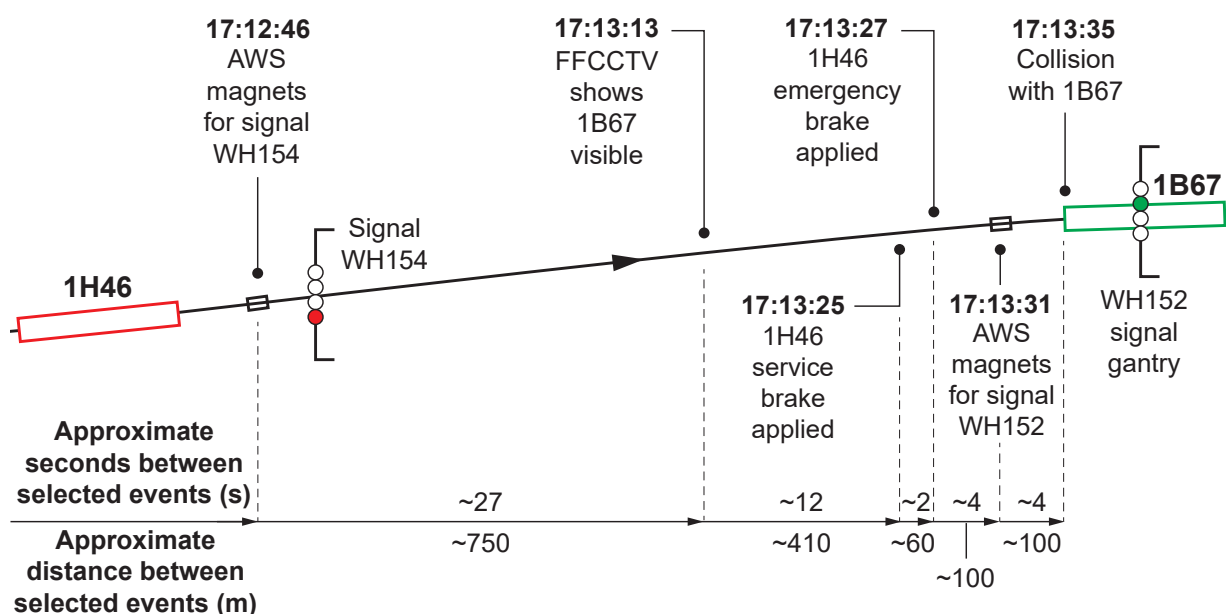
Figure 5: Train 1H46 approaching the rear of train 1B67 (not to scale and not all features shown for clarity).

- 53 At 17:12:46, train 1H46 received an AWS warning indication associated with signal WH154 (figure 5). FFCCTV images show that this signal was displaying a red aspect as the train approached. The OTDR from train 1H46 recorded that the driver acknowledged the AWS warning indication, but the train continued to accelerate towards and beyond the signal, which it passed at 17:12:53.

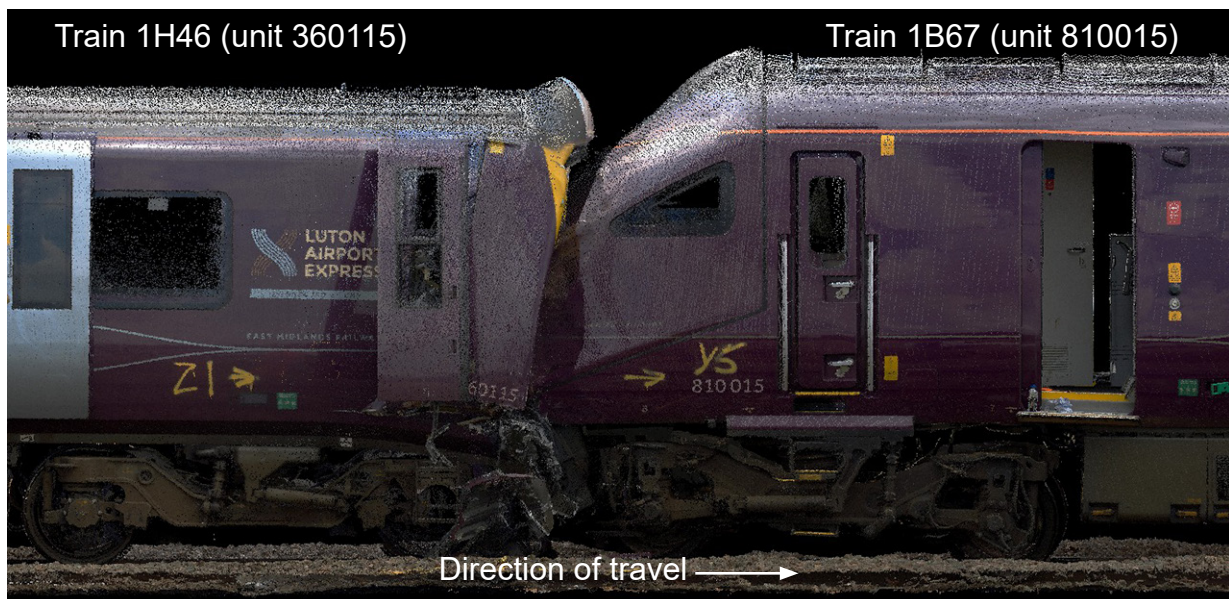
Figure 7: Side view of the collision (image created from laser scans).

- 65 Both trains involved in the accident derailed. All the vehicles remained broadly in line and upright.
- 66 During the collision, the leading driving cab of train 1H46 and the rear cab of train 1B67 became embedded together (figure 7), and the trains travelled together for approximately a vehicle length before coming to a stop. As a result of the collision, the combined total length of the trains reduced by around 9 to 10 metres.

- 67 Modern trains are designed to absorb energy at the initial point of impact (in this case the cab ends) and at the intervehicle interfaces, which are designed to deform during a collision. An initial examination of the rail vehicles involved by RAIB showed substantial damage to the structure of both trains at the point of impact as well as at all the intervehicle connections (figure 8).
