# Rail Accident Investigation: Interim Report

**Collision between passenger trains near Elstow,  
Bedfordshire  
19 June 2026**

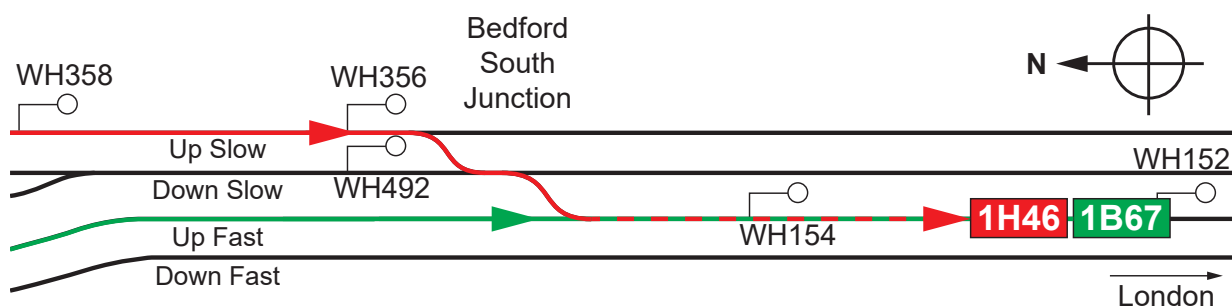
Figure 2: Layout of the track on the approach to signal WH152 (not to scale and not all features are shown for clarity).

- 3 Train 1B67 was stationary beneath the gantry supporting signal WH152 when the accident occurred (figure 2) and had come to an unexpected stop following an automatic emergency brake application. As train 1B67 was occupying the track in the vicinity of signal WH152, the preceding signal, WH154, was displaying a red (danger) aspect to protect the train from other movements on that line.

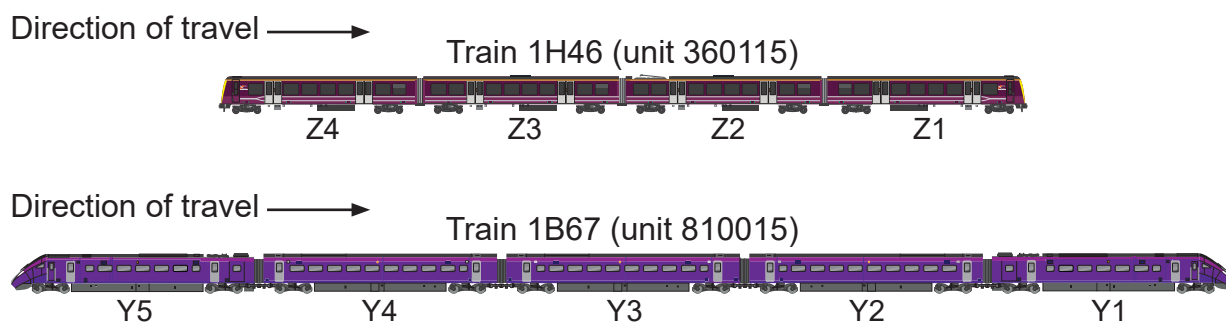
Figure 3: Formation of trains 1H46 and 1B67. The Y and Z numbering system was assigned by RAIB after the accident to assist with identifying vehicles.

- 12 Train 1B67 was formed of a five-car class 810 bi-mode multiple unit, number 810015 (figure 3). From saloon and platform CCTV footage, RAIB has so far identified 100 people as being on board this train, including eight EMR staff. This included the train's driver, who was already qualified as a driver and was undertaking additional training to drive class 810 trains, and a driver-instructor, who was with the driver in the cab at the time of the accident.

- 14 Train 1H46 was formed of a four-car class 360/1 electric multiple unit, number 360115 (figure 3). Using saloon and platform CCTV footage, RAIB has so far identified 157 people as being on board this train, including two EMR staff. These were the train's driver and the guard.

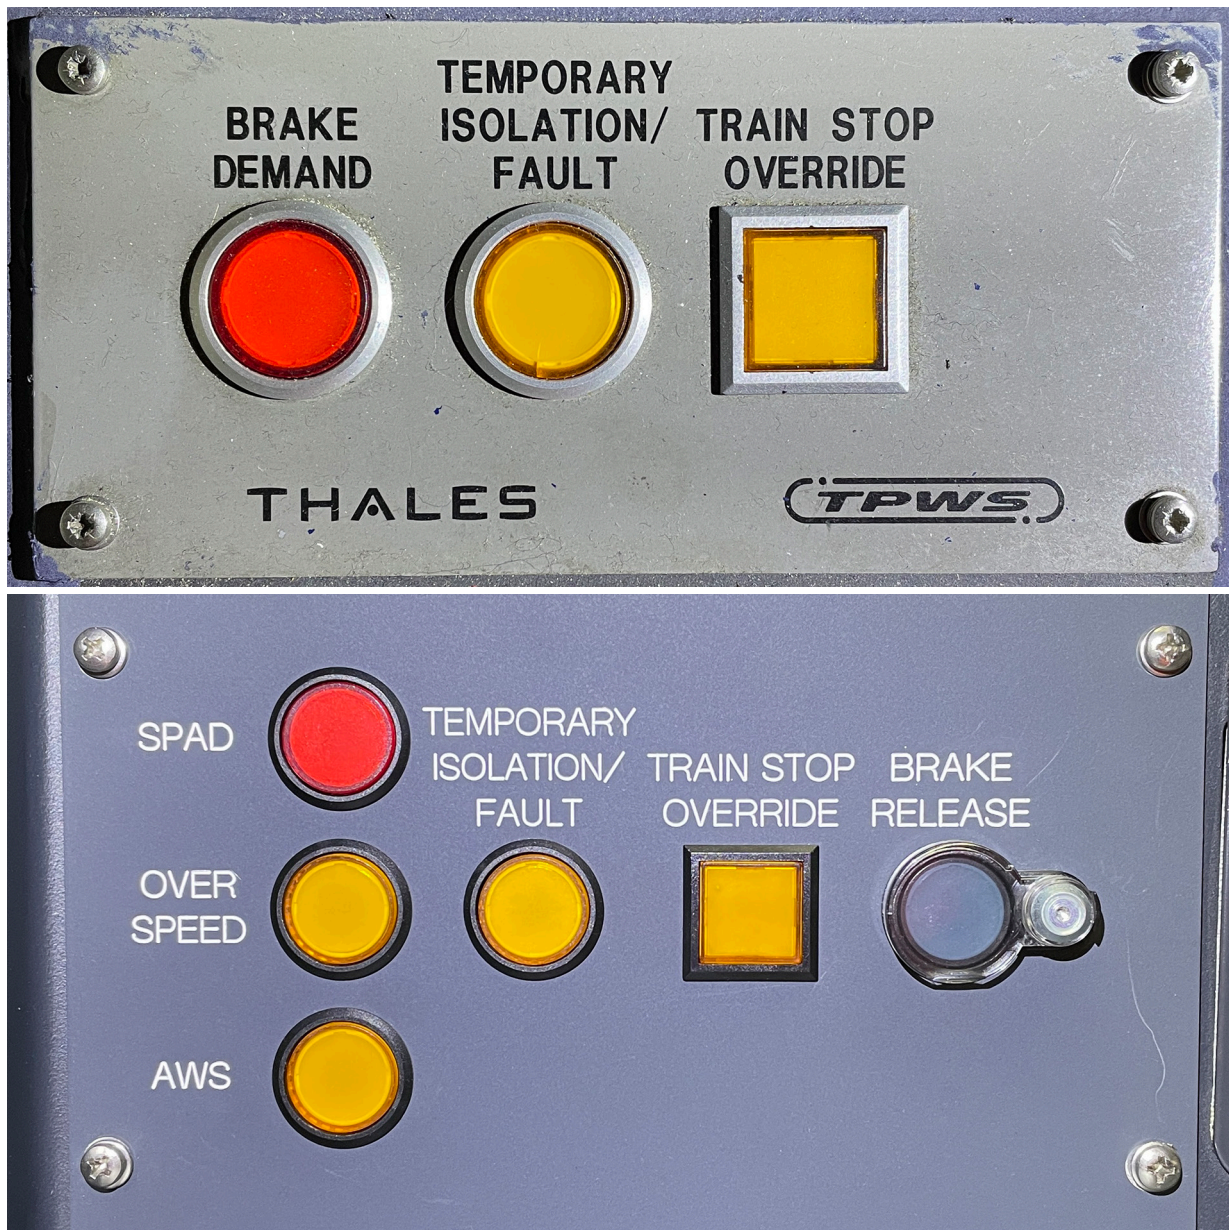
Figure 4: Standard TPWS control panel (top) and enhanced TPWS control panel (bottom).

- 24 Train 1B67 was fitted with an enhanced Train Protection and Warning System (TPWS) panel in the driver's cab which met the requirements of current industry standards (see paragraph 28 and figure 4). If an emergency brake application results from an AWS warning not being responded to within the set timeframe, a yellow AWS button on this panel will flash to alert the driver as to the cause of the brake demand. This will change to being constantly lit once it is acknowledged (by being pressed). In order to release the brakes on an enhanced TPWS panel, the driver must press the brake release button at the same time as the brake demand indicator light button. This allows the brake to be released 1 minute after the brake demand was initiated.

- 25 This differs from standard TPWS panels on other trains, such as those on the train the driver of train 1B67 was more familiar with. On these standard panels, there is one red button marked 'Brake Demand' which will flash until acknowledged. A flashing circular yellow button on a standard TPWS panel means that there is a fault detected in the train's TPWS equipment. Once a brake demand is acknowledged on a standard TPWS panel, the brakes will release 1 minute after the brake demand was initiated.

- 76 OTDR data and witness evidence showed that the yellow AWS button started flashing on the enhanced TPWS control panel once the brake application was triggered. Witness evidence was that the train control and management system (TCMS) generated a major fault alarm because of the emergency brake application. Data downloaded from the TCMS shows that the TCMS acknowledgement button was pressed by the driver after the brake application generated the alarm.

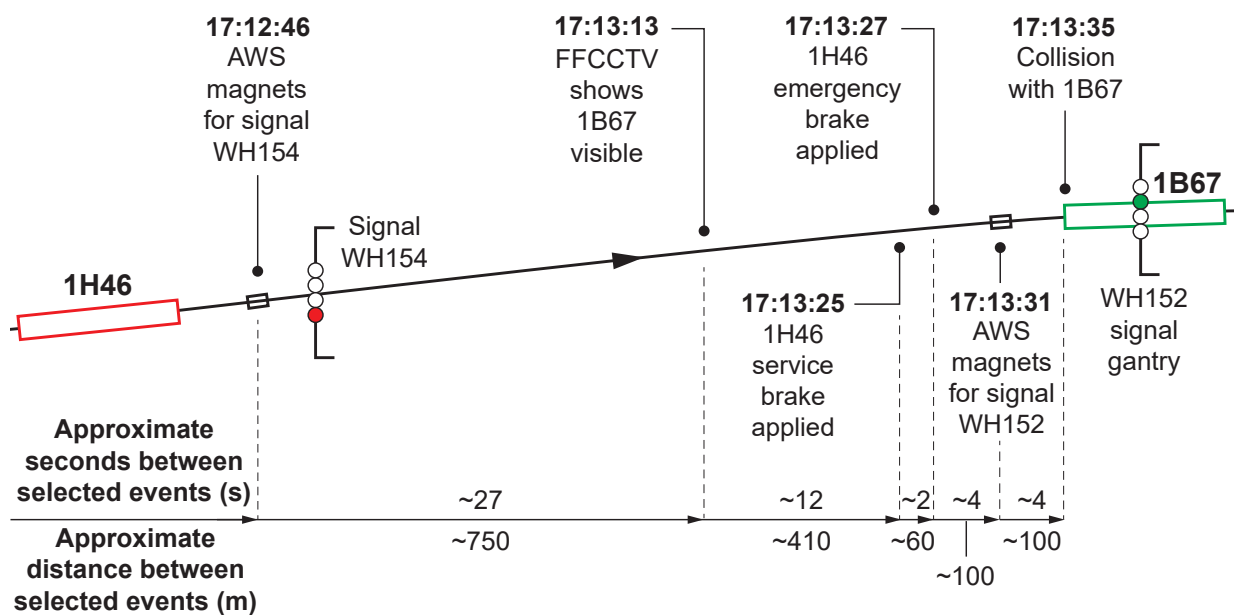
Figure 5: Train 1H46 approaching the rear of train 1B67 (not to scale and not all features shown for clarity).

- 53 At 17:12:46, train 1H46 received an AWS warning indication associated with signal WH154 (figure 5). FFCCTV images show that this signal was displaying a red aspect as the train approached. The OTDR from train 1H46 recorded that the driver acknowledged the AWS warning indication, but the train continued to accelerate towards and beyond the signal, which it passed at 17:12:53.

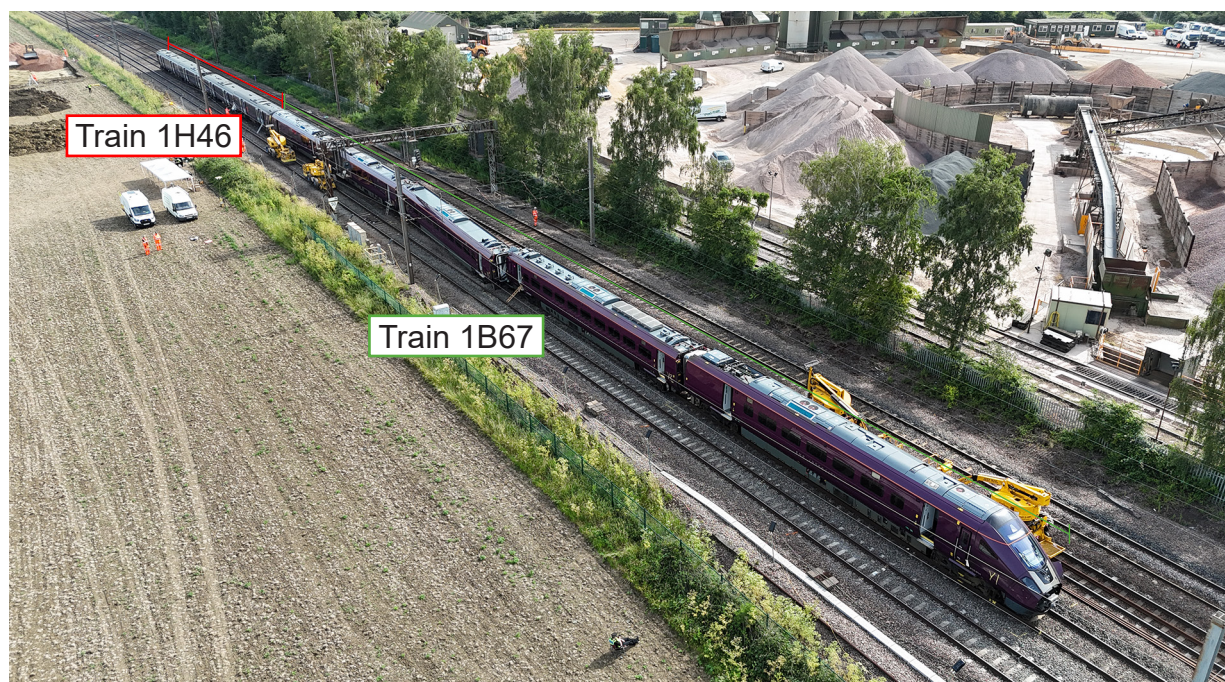
Figure 6: Aerial view of the accident site. Train 1H46 is to the left and train 1B67 to the right of the image.

- 57 About a second later, train 1H46 passed over the AWS magnets associated with signal WH152 and, shortly afterwards, collided with the rear of train 1B67 at around 17:13:35. The OTDR for the leading vehicle of train 1H46 recorded the train's speed as being around 50 mph (80 km/h) at the point of collision (figure 6).

- 65 Both trains involved in the accident derailed. All the vehicles remained broadly in line and upright.
- 66 During the collision, the leading driving cab of train 1H46 and the rear cab of train 1B67 became embedded together (figure 7), and the trains travelled together for approximately a vehicle length before coming to a stop. As a result of the collision, the combined total length of the trains reduced by around 9 to 10 metres.

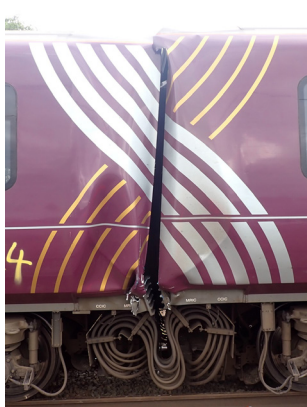
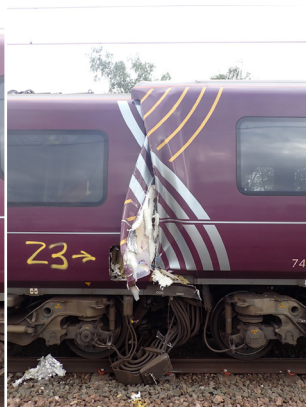
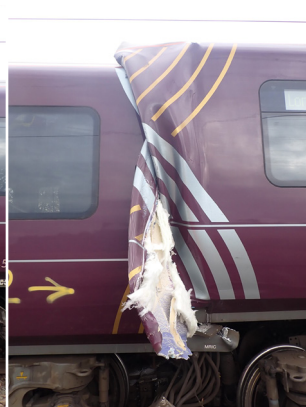
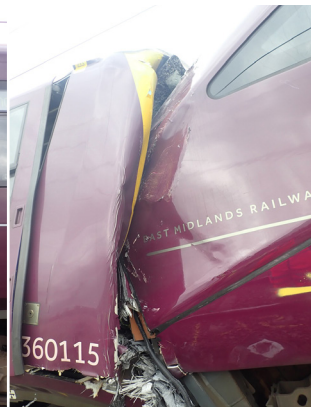
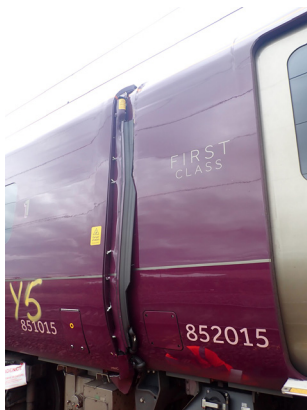
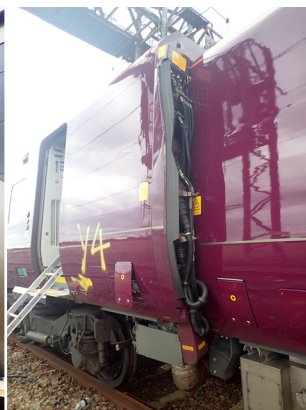
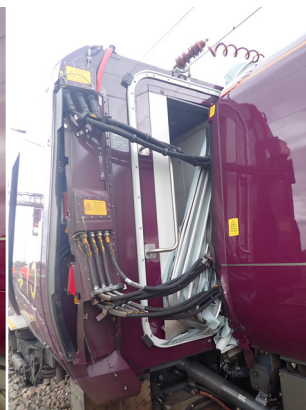
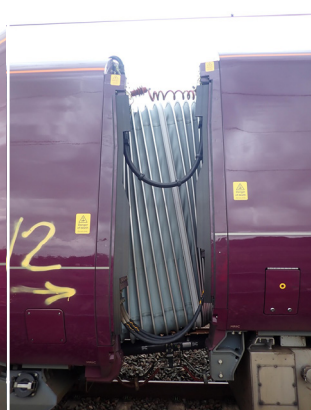
Figure 8: Damage at vehicle ends.

- 67 Modern trains are designed to absorb energy at the initial point of impact (in this case the cab ends) and at the intervehicle interfaces, which are designed to deform during a collision. An initial examination of the rail vehicles involved by RAIB showed substantial damage to the structure of both trains at the point of impact as well as at all the intervehicle connections (figure 8).
