Report on the investigation of  
the fatal accident to a crew member on board the  
Bermuda registered passenger vessel

## ***Arvia***

while on passage from  
Southampton, England, to Santa Cruz de Tenerife, Canary  
Islands, Spain  
on 26 October 2025

REPORT NO 20/2026

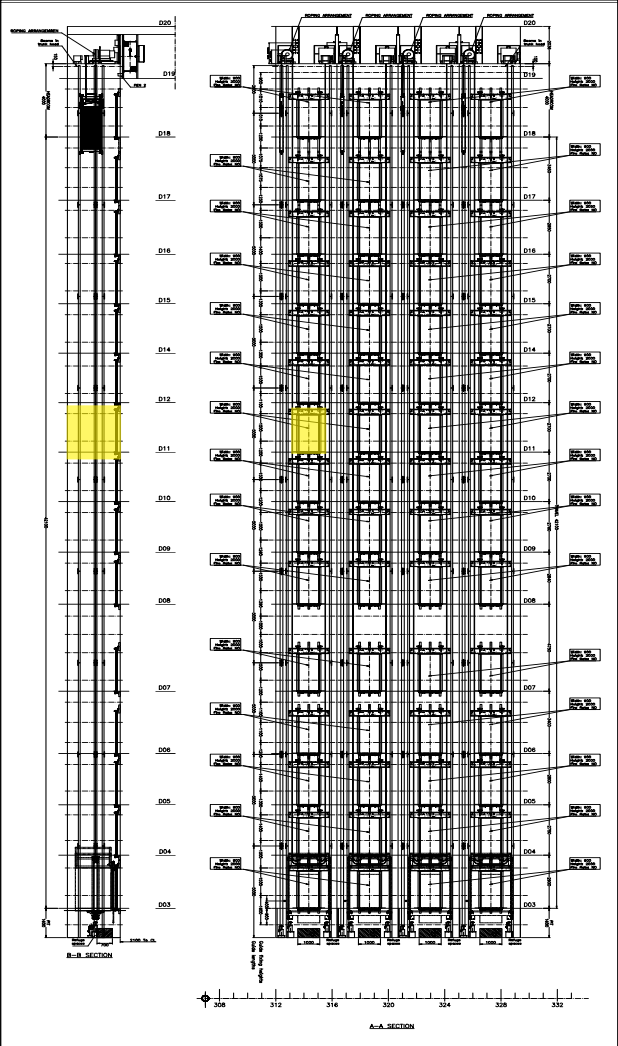
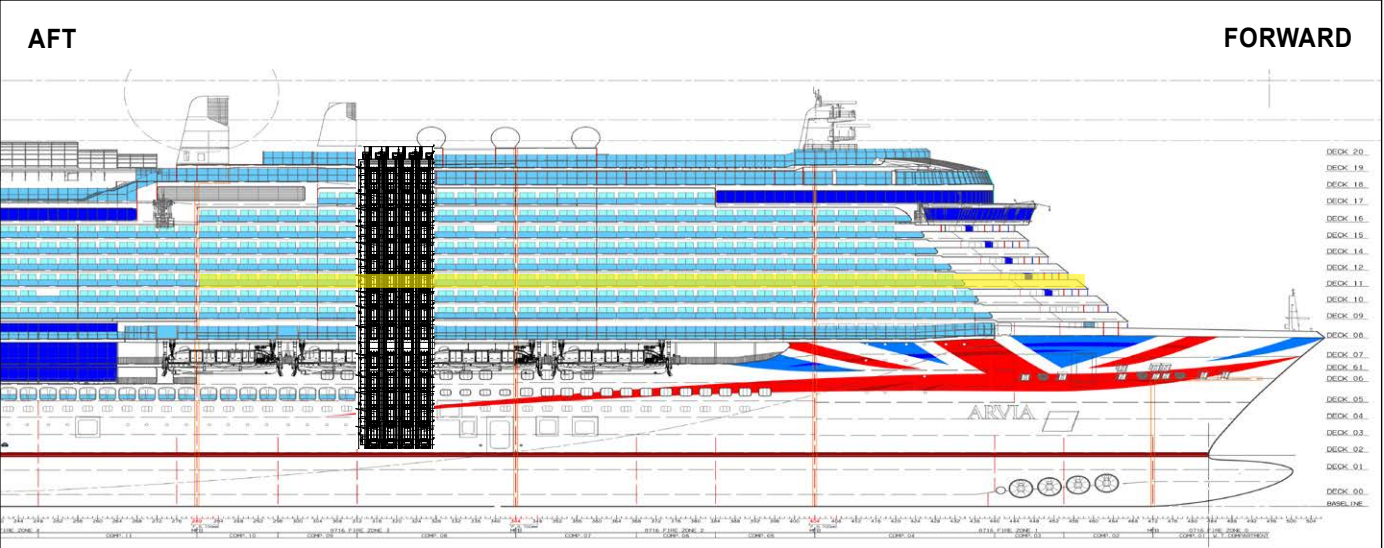
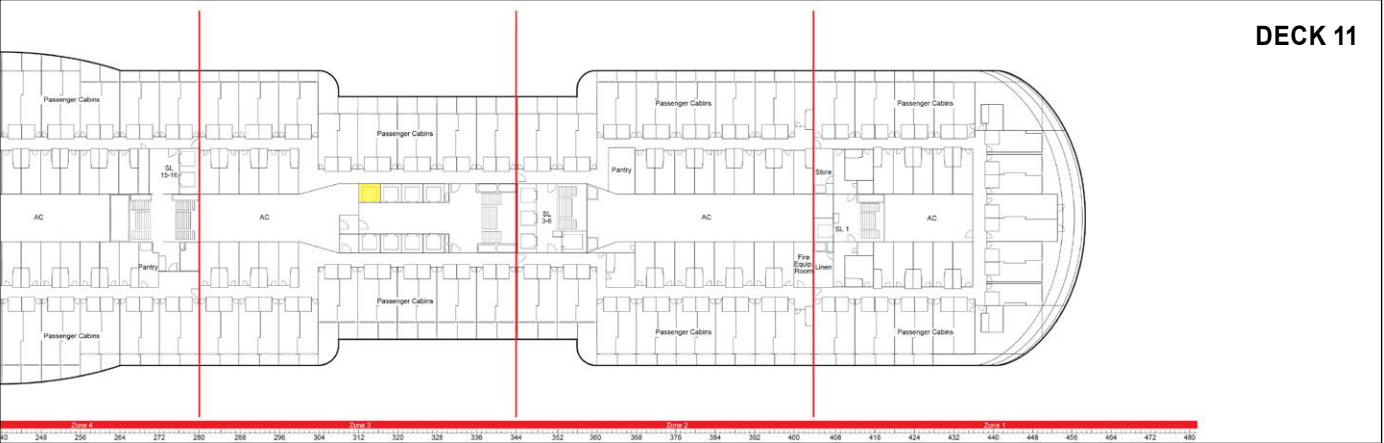
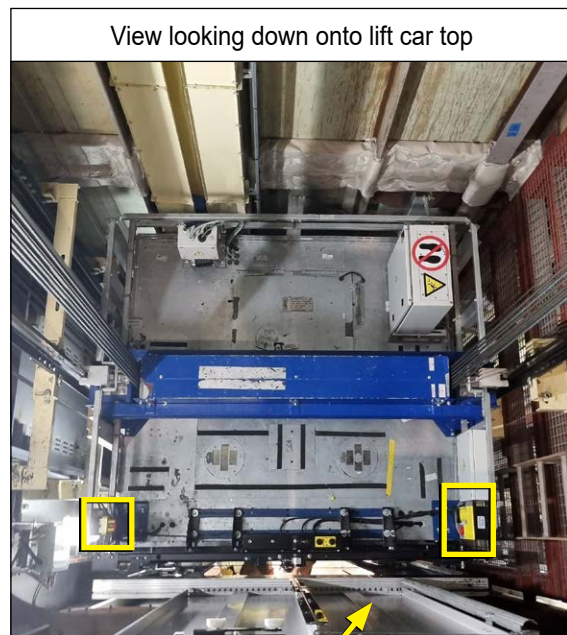
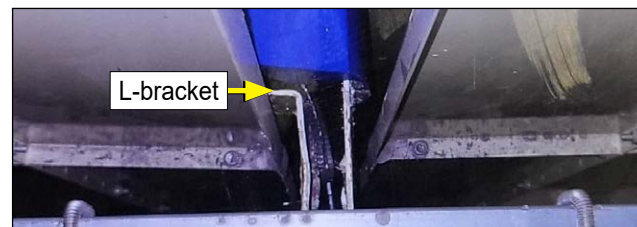
Figure 1: Passenger lift 14 location

The 3ETO was notified about the issue with PL14 (**Figure 1**) and at 2305 raised a permit to work (PTW) for troubleshooting the lift. The PTW was authorised by the first electro-technical officer (1ETO) at 2310. At about 0055 on 25 October, the transport team attended PL14 and confirmed that the lift was inoperable at deck 11.

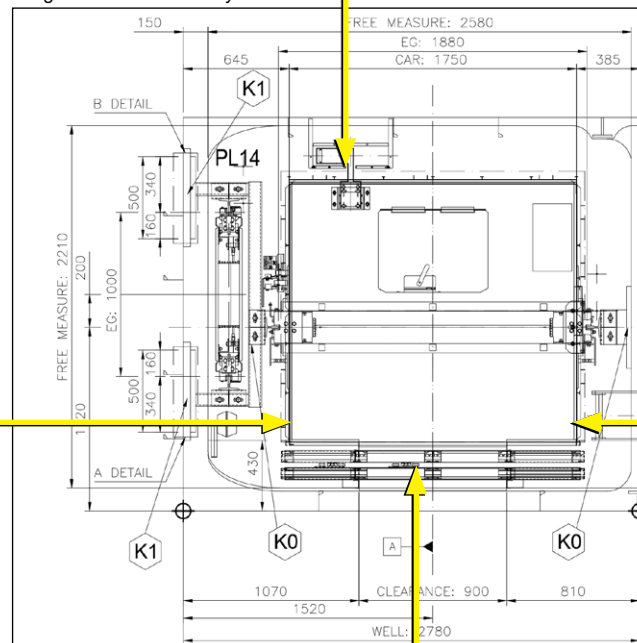
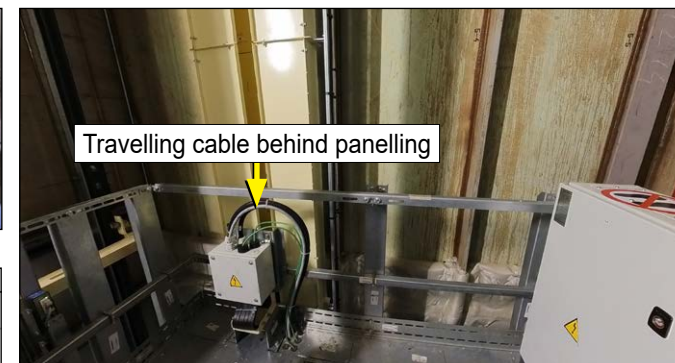
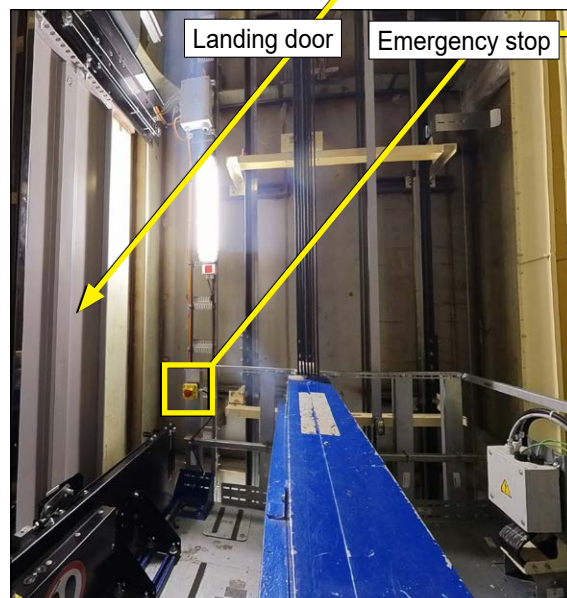
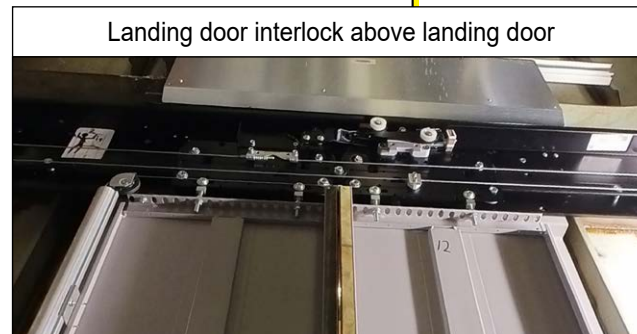
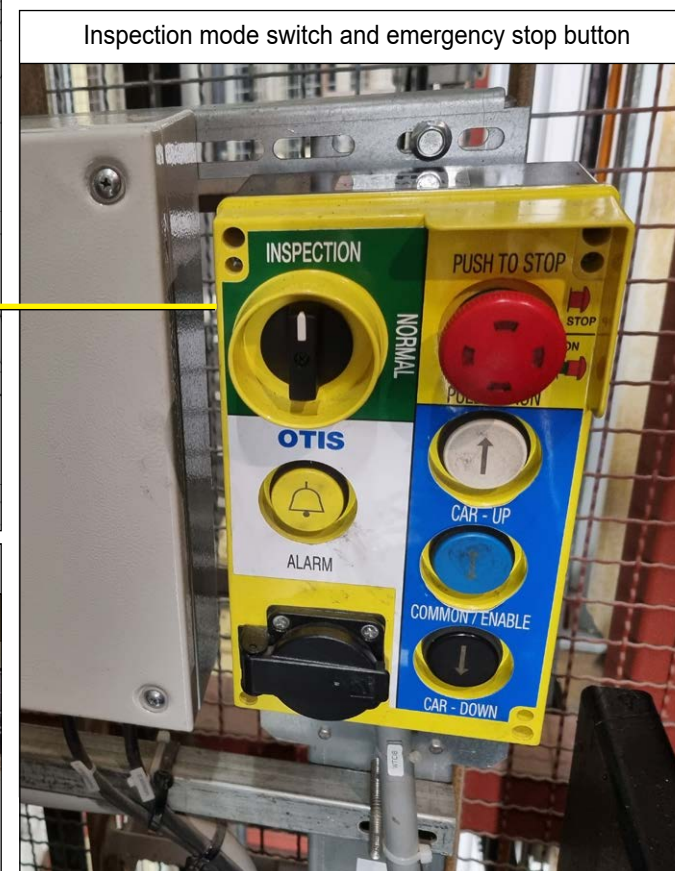
Figure 2: Lift car top

The ET and AET tried to access PL14 via the deck 12 landing doors. This was unsuccessful as the door release mechanism did not function and the door release key failed to open the landing doors. The ET then accessed the lift shaft from above the lift on deck 14<sup>2</sup> and used the shaft ladder to reach the lift car top. Once on the lift car top, the ET pressed the emergency stop button, switched the lift to inspection mode and opened the deck 12 landing doors from inside the lift shaft (**Figure 2**).

The ET and AET inspected PL14 and identified damage to the travelling cable supplying the lift car, which they rectified with a temporary repair after consulting with the 3ETO. The team then attempted to move the lift using emergency and manual controls on the lift car top and controls in the lift machinery room on deck 19. This was unsuccessful so the team then tried to move the lift by releasing the brakes using the manual rescue operation (MRO) control. This resulted in the lift raising slightly to a position halfway between decks 11 and 12 before stopping in the shaft. Work then stopped as the team neared the end of their shift.

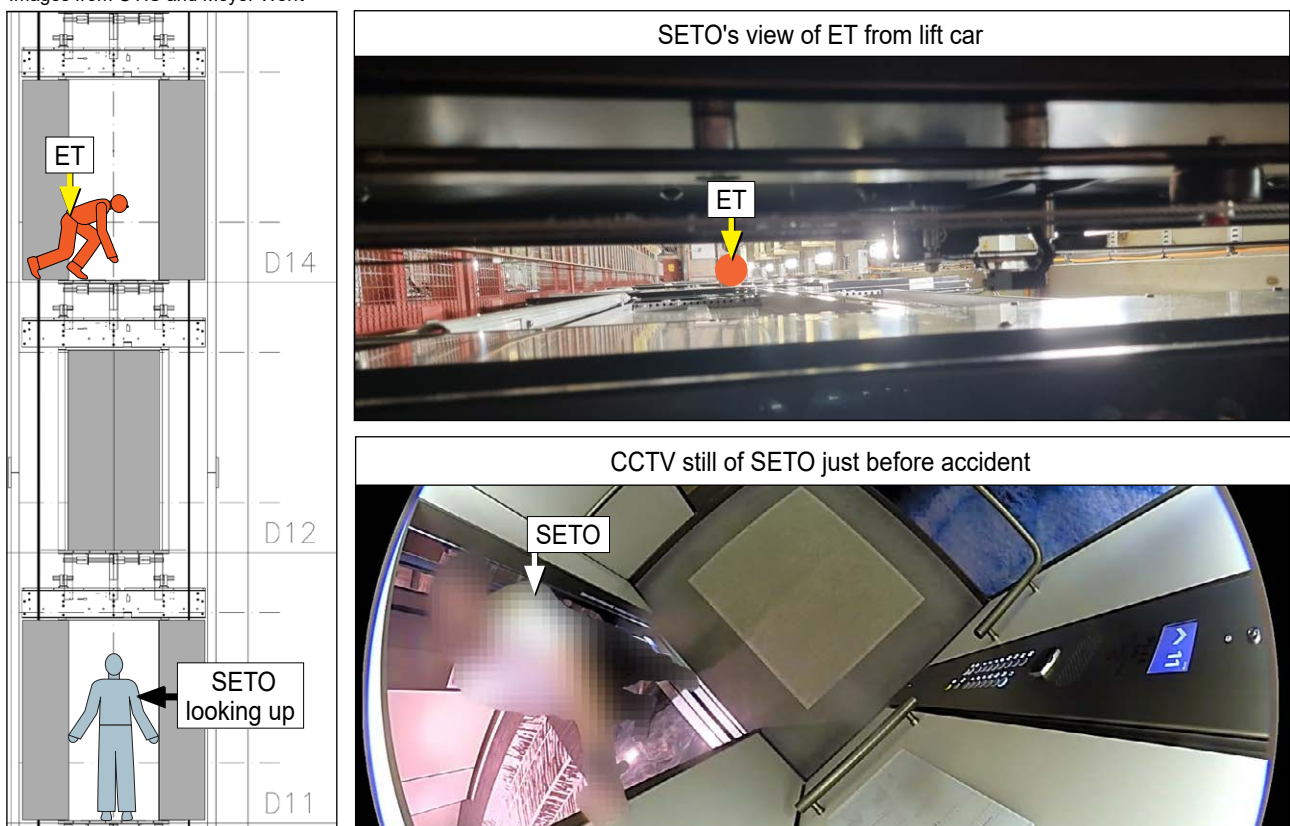
**Figure 3:** View looking up lift shaft from lift car

At 0601, the SETO, 3ETO, AET and a member of the ship’s medical team opened the deck 14 landing doors and observed that the ET was crushed between the side of the shaft and the lift car.

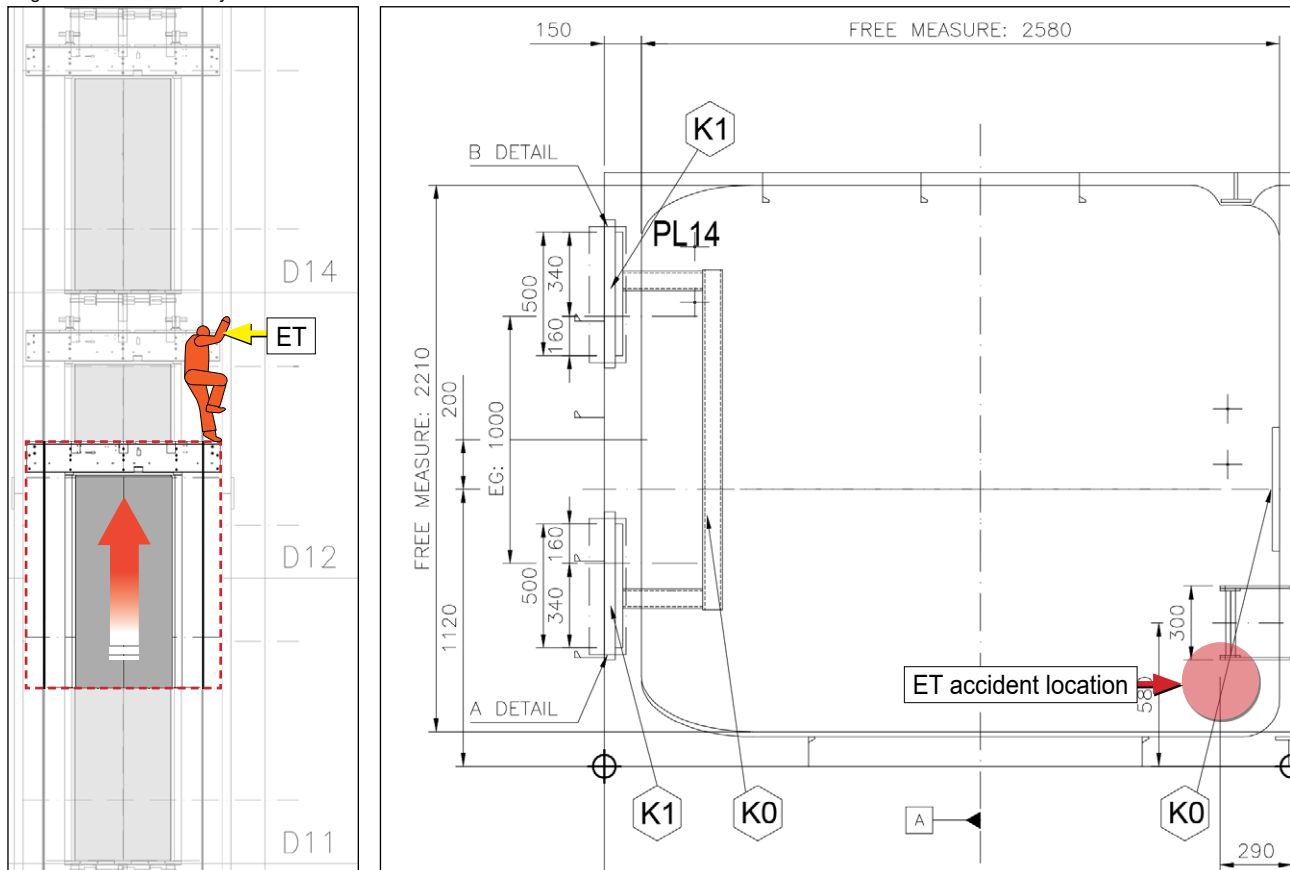
**Figure 4: Lift movement**

The lift reactivated because both sets of doors closed, restoring the safety circuit and allowing the lift to move. This exposed the ET to the hazard of the moving lift and resulted in the fatal accident.

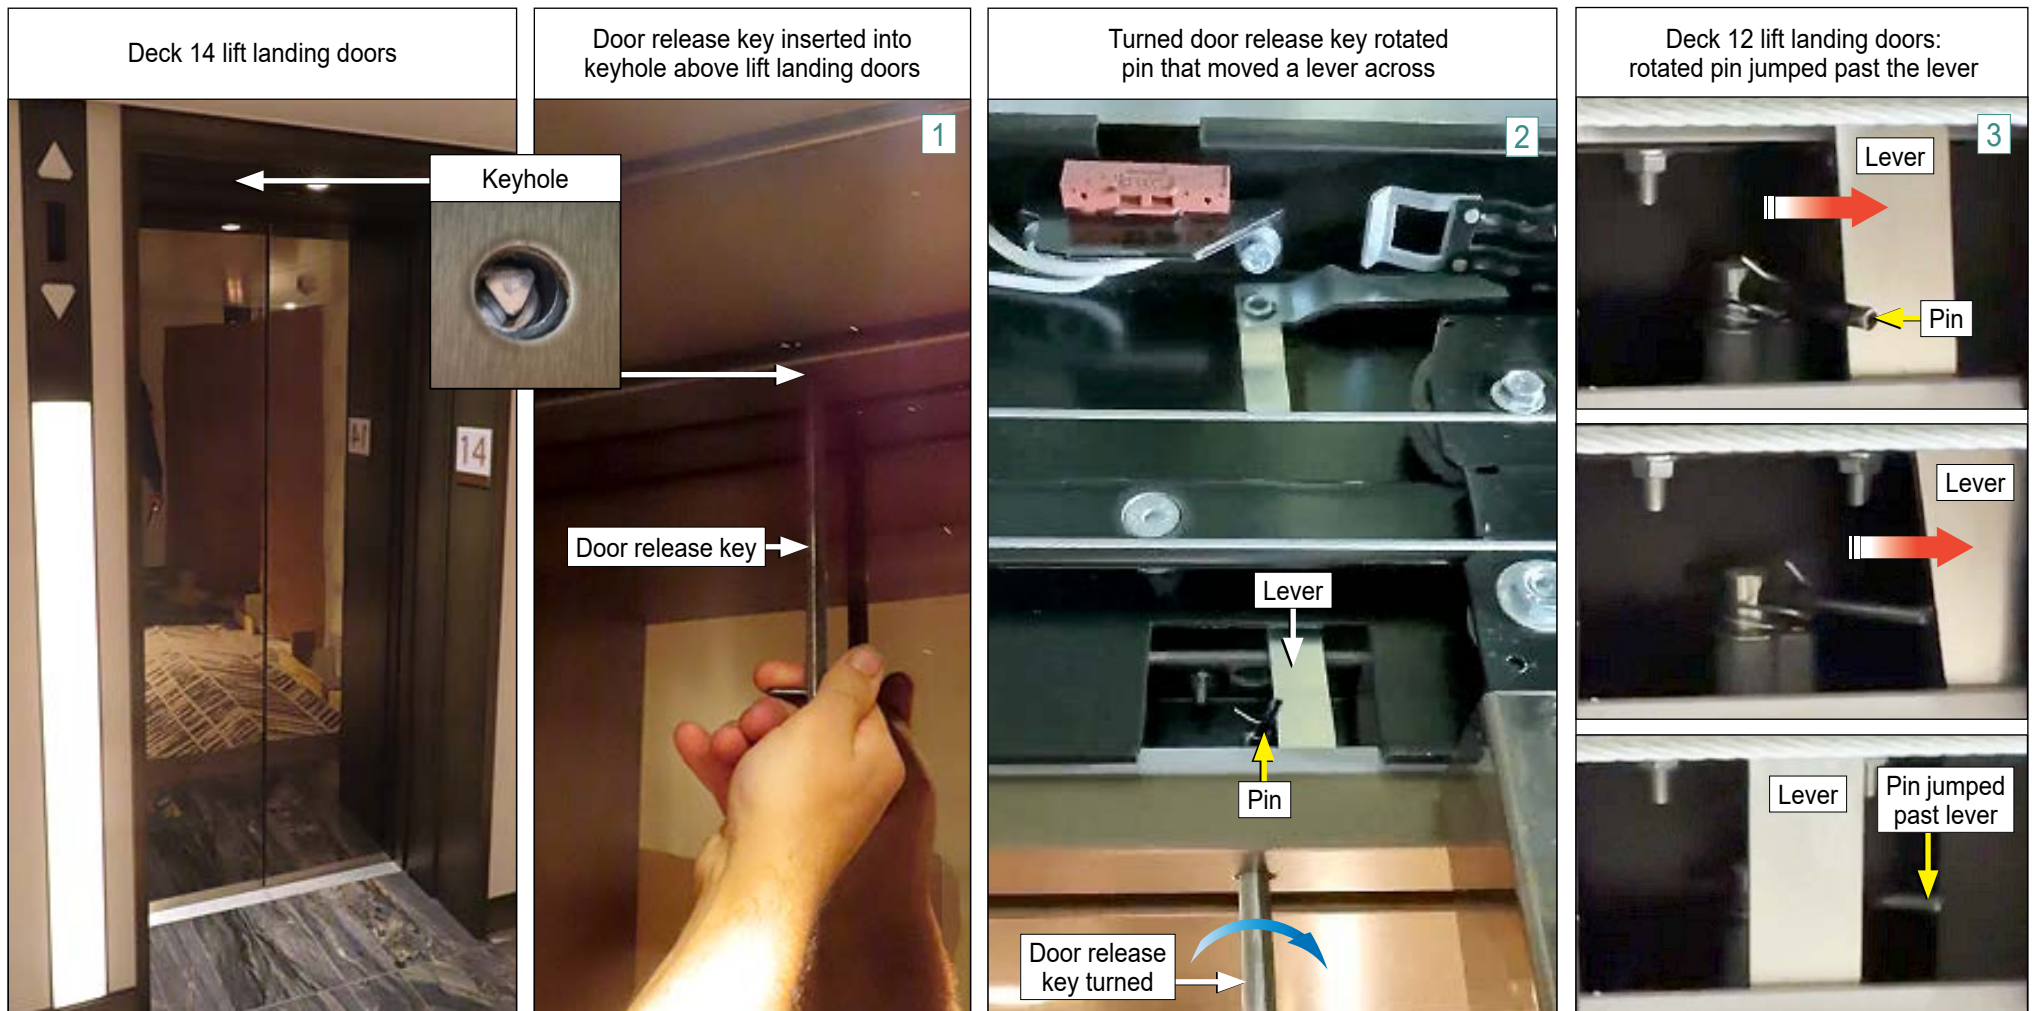
**Figure 5: Door release mechanism**

The mechanism on the deck 12 landing doors for PL14 was tested after the accident. The pin jumped past the lever as it was rotated with the door release key, preventing the movement that would allow the safety circuit to be broken and the doors to be opened, and the doors remained shut (**Figure 5**).

The deck 12 landing door release mechanism for PL14 did not operate when the release key was used and post-accident testing confirmed that the mechanism was defective. Access to the lift car top from deck 12 was therefore not possible and the ET instead used the lift shaft's fixed ladder to access the lift shaft from the deck above. The ET had used the lift shaft ladder several times during the preceding troubleshooting work to gain access to the lift car top. Initially, this was probably because the lift was stuck at deck 11 so moving it to facilitate access was not an option. However, the lift was able to move freely by the time of the accident so it was therefore possible to move it to another deck with a working door release.

The defective landing door release mechanism changed the lift car top access arrangements. This indirectly contributed to the circumstances of the accident by prompting use of an alternative access route before the lift had been placed under positive control.

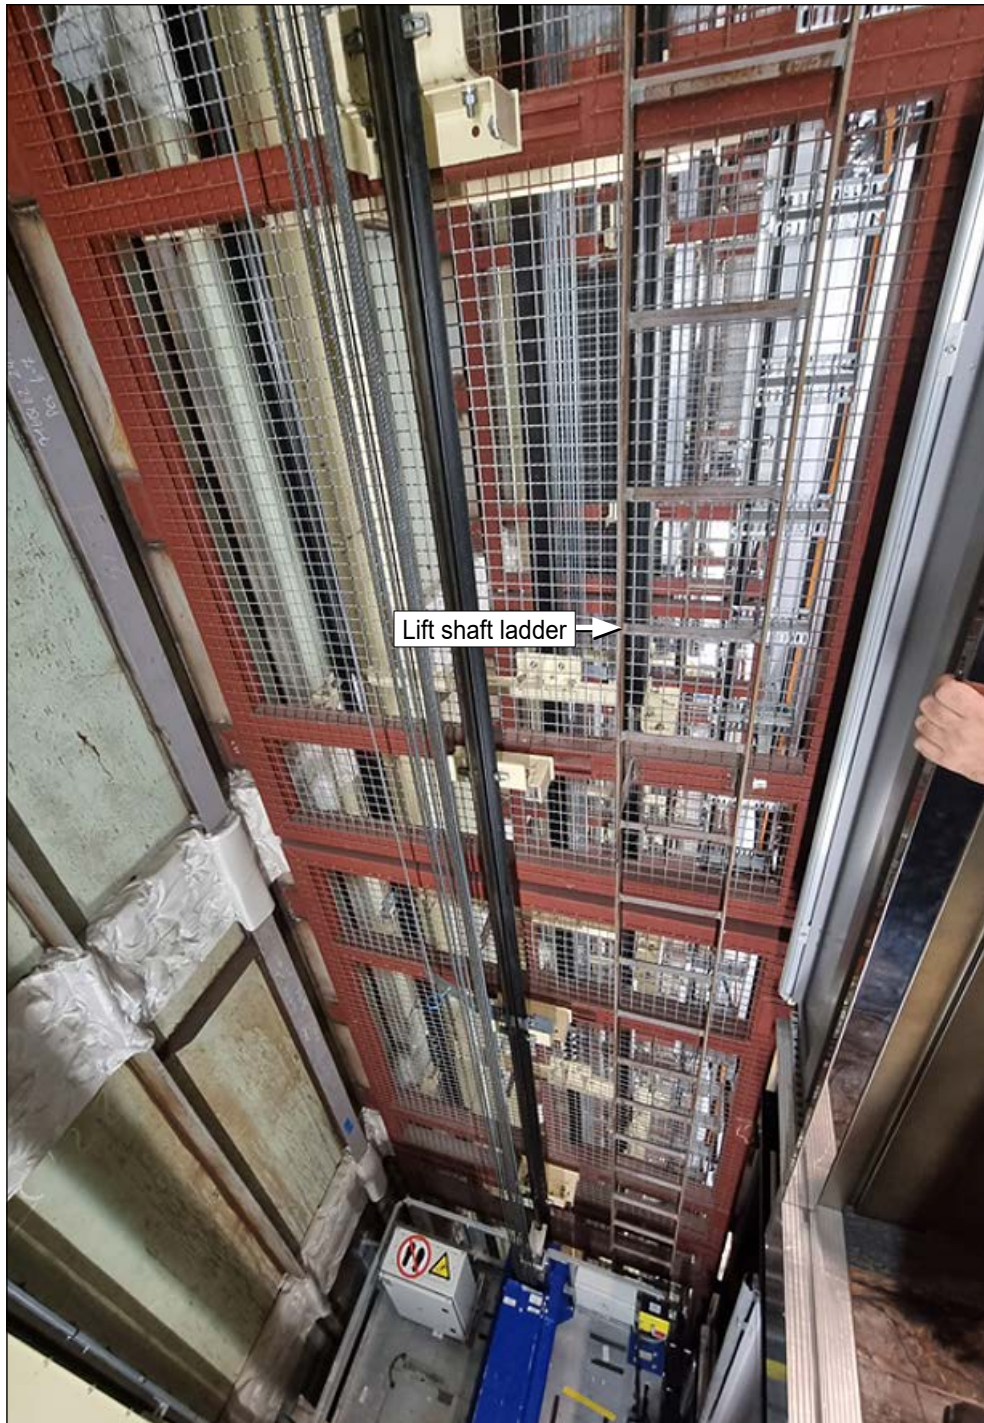
**Figure 6:** Lift shaft ladder viewed from deck 14

The lift shaft was fitted with a fixed ladder that was intended for emergency evacuation (**Figure 6**).
