# Rail Accident Report

## Unsafe movement of locomotives being coupled on the Bluebell Railway, East Sussex 9 August 2025

Report 11/2026  
October 2026

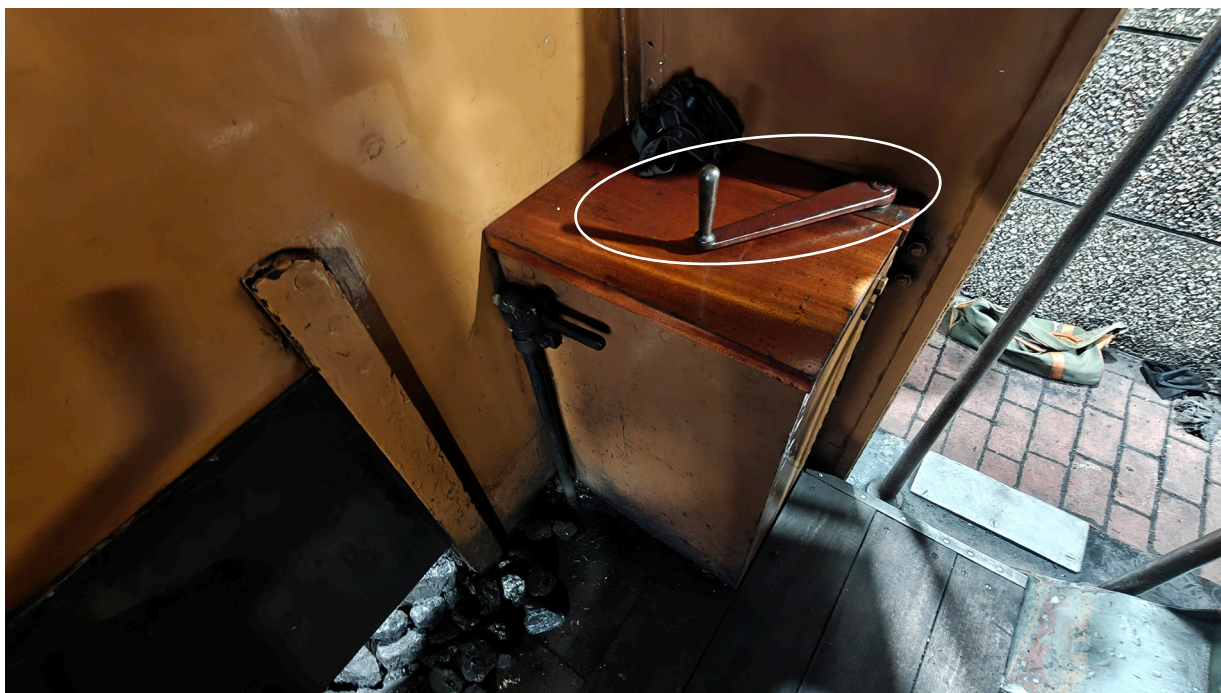
Figure 7: Drain cock operating handle on Fenchurch.

- 59 To avoid damage to the cylinders (paragraph 38) it is considered good practice to open the drain cocks when the locomotive is stationary. However, the Bluebell Railway's processes at the time of the incident did not require this to be done during coupling and the driver had not opened the drain cocks when they positioned Fenchurch next to Stepney ready for coupling.

- 61 Opening the drain cocks has the by-product that if there is steam entering the cylinders (either through a leak, or the regulator not being closed) then a cloud of steam may emerge from the front of the engine. Although not intended to act as a warning system, the visible steam cloud and the sound of steam escaping from the drain cocks may have alerted the driver and the shunter that the regulator was not fully closed, and that Fenchurch was at risk of moving, before the shunter went between the locomotives.

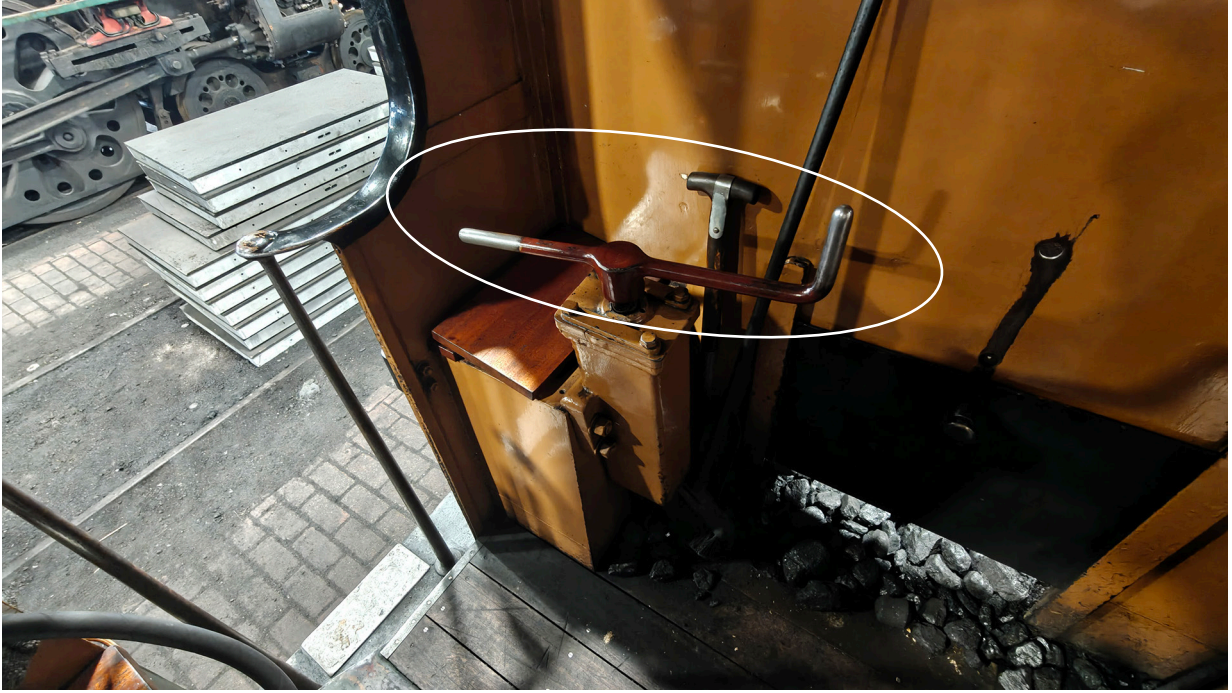
*Figure 8: Handbrake on Fenchurch (circled).*

- 44 Steam locomotives are normally provided with a handbrake. On locomotives such as Fenchurch and Stepney, the handbrake control is a simple mechanical system (figure 8), using a vertical handbrake column in the cab. Operation of the handbrake applies the locomotive's brake blocks to the wheels through a system of mechanical linkages. The braking force exerted by the brake blocks when using the handbrake depends on the torque applied to the handle. The torque that can be applied is inherently limited by the physical capacities of the person using it.

- 45 Handbrakes are intended to prevent the locomotive rolling away on shallow gradients and are not designed to resist it being moved by another vehicle under traction power.

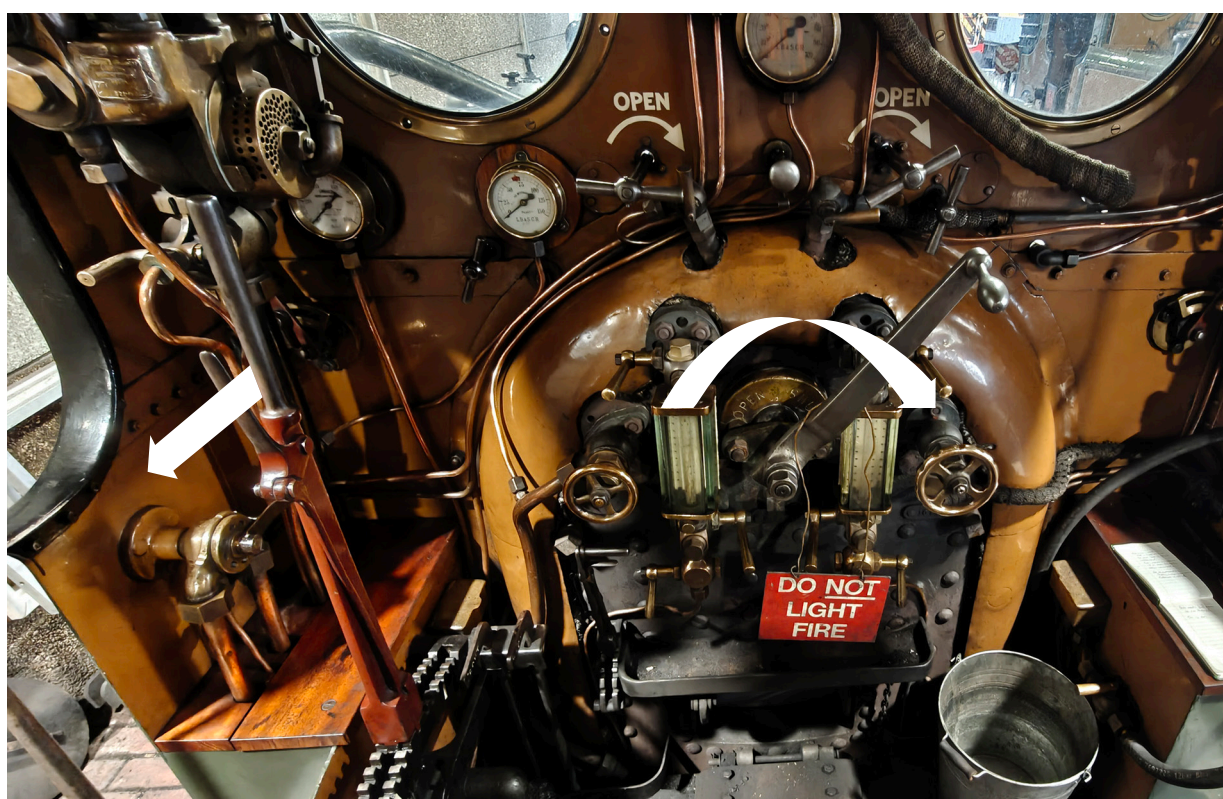
Figure 9: The regulator (right) and reverser (left) on Fenchurch.

**53 The driver had not ensured the regulator was fully closed, which admitted steam to the cylinders.**

54 The regulator controls the rate at which steam is admitted to the cylinders, which in turn generates the force needed to move the locomotive (paragraph 36). To prevent any steam being passed to the cylinders, the regulator must be in the fully closed position. On Fenchurch, to reach the fully closed position, the driver must push the regulator lever all the way to the right. Since the driver is positioned to the left of the lever, this motion pushes it away from them (figure 9). The driver believed they had fully closed Fenchurch's regulator, but immediately after the incident found that they were able to move it a little further towards the fully closed position. This indicates that it had not actually been fully closed and that steam had been able to pass to the cylinders.

55 At the time of the incident, the reverser (paragraph 37) was pulled all the way back into the full reverse position (figure 9). The driver was positioned to the left of the cab, so in this position the reverser was partially blocking the drivers access to the regulator and therefore restricting the driver's range of movement when closing it. This also made it more difficult to see the regulator's position when closed.

- 56 The regulator can get stiffer to operate the longer a locomotive is used during a shift due to the effects of heat, steam pressure and thermal expansion increasing friction within the regulator mechanism. The driver had noticed that this was the case as the day went on. The driver also stated that the regulator can be quite difficult to control when trying to move the locomotive at slow speeds. A report commissioned by the Bluebell Railway after the incident found that the regulator was operating as it should, and although it was stiff to operate, this was consistent with other locomotives, and there were no faults present. However, the report stated that stiffness near the end of the regulator's travel may make drivers think it is closed when it is not.

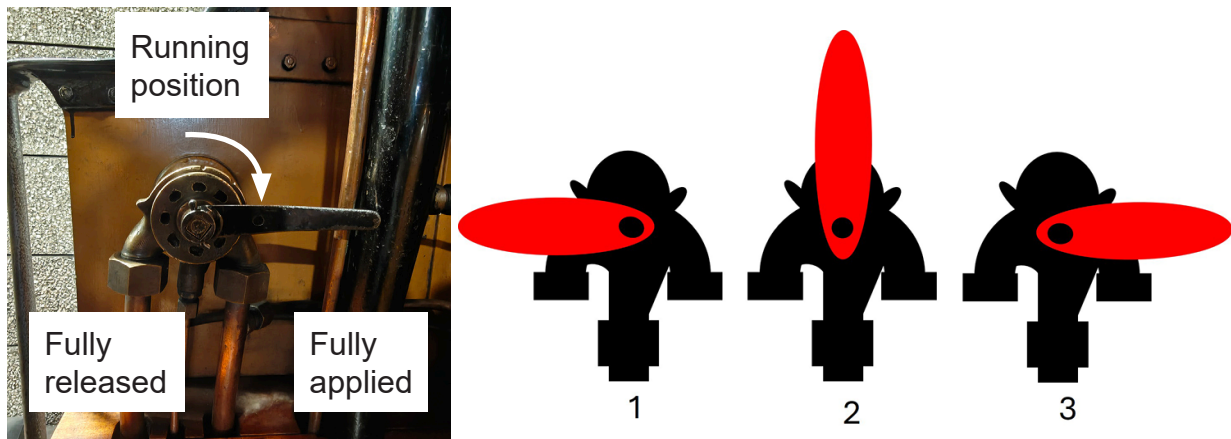
- 69 Fenchurch is one of only two air-braked locomotives in the operational Bluebell Railway fleet. Fenchurch has an air brake valve separate to the combining valve used to control vacuum-braked rolling stock (paragraph 43). When used by the driver, the air brake valve will apply the air brakes on Fenchurch only, and not any other vehicles connected to the automatic vacuum pipe. It is primarily provided to hold the locomotive stationary, for example, when coupling and uncoupling, or when operating as a light locomotive, without any rolling stock attached.

- 70 Testing of Fenchurch commissioned by the Bluebell Railway after the incident found that the locomotive did not move when the air brake was fully applied, even with the regulator fully open.

- 71 The driver did not check the angle of the air brake valve when they applied it (figure 10). After the incident, the driver concluded that they had not fully applied it, stated that they could not understand why, and speculated that they might have applied it, but it had then somehow been knocked.

- 72 When the fireman noticed that the locomotives were moving, they reached into Fenchurch from the platform and operated the air brake valve to check it was fully applied (paragraph 29). This action stopped the locomotives from moving any further during the incident indicating that the air brake had not been fully applied at the time of the incident.
