## Accident

| <b>Aircraft Type and Registration:</b> | Zenair CH 601HDS, G-CHZS | |
| <b>Location:</b> | Tatenhill Airfield, Staffordshire | |

## Synopsis

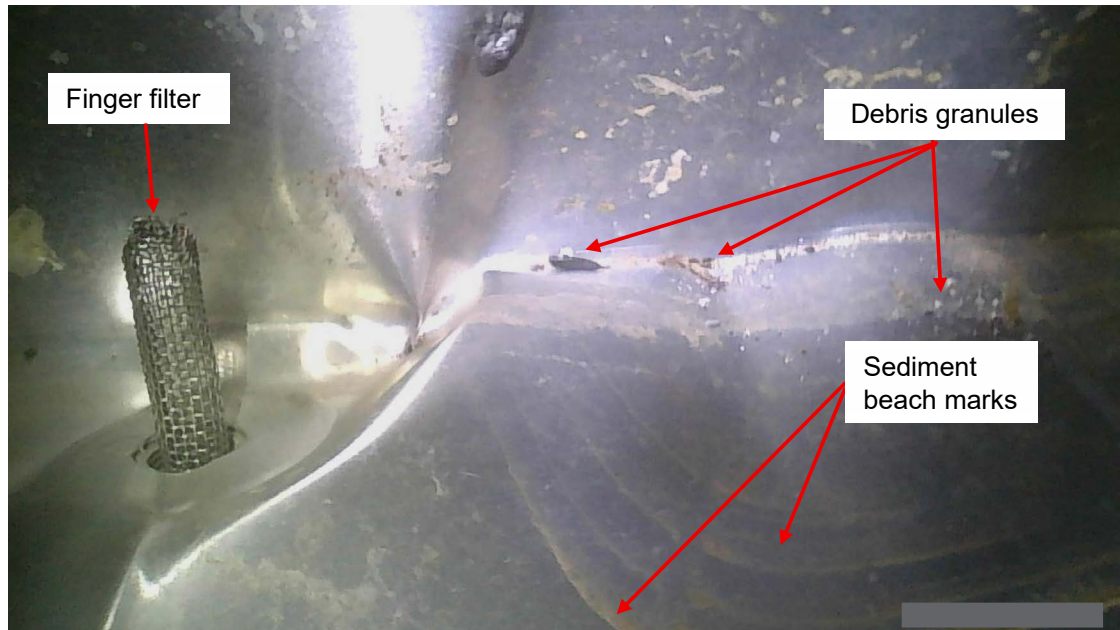
**Figure 1**

Examination of the main fuel tank revealed buckling of the tank structure, beach marks from sediment and the presence of larger granules of debris deposited throughout the tank's internal lower surfaces (Figure 1).

View inside the buckled main fuel tank showing sediment marks, debris, and finger filter

The presence of sediment and debris in the main fuel tank and gascolator, showed that the aircraft side of the fuel system was contaminated. The first opportunity to screen out these particles would have been the finger filter located in the fuel tank; however, this filter may not have been fine enough to prevent some of the debris from migrating to filters downstream. A filter screen in the gascolator should have provided a second barrier but it was missing, allowing debris to continue travelling through the fuel system. The presence of blue sealant around the rim of the bowl which had also migrated inside the bowl, may also have resulted in some of the material flowing into the fuel pipes, increasing the potential of a fuel blockage.

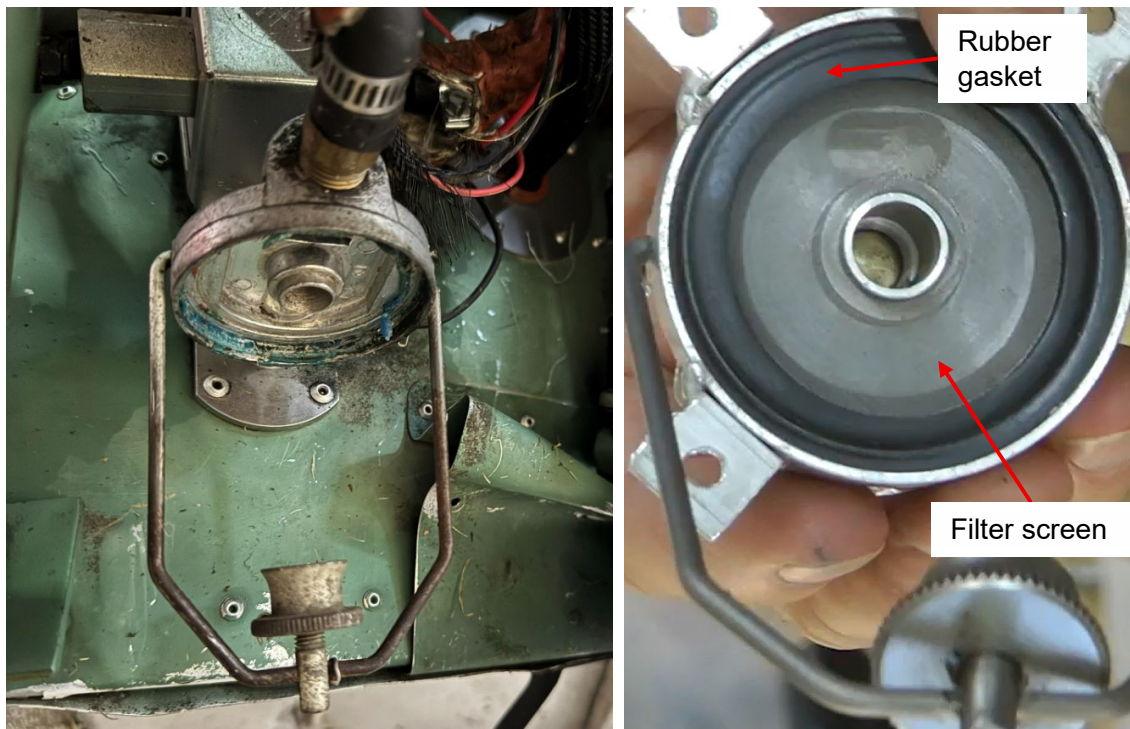
**Figure 2**

When the gascolator bowl was removed, the fine debris filter screen and rubber gasket were missing (Figure 2, left). The screen removes particles from the fuel whilst the gasket seals the bowl to the lid of the gascolator.

Gascolator lid showing filter and rubber gasket missing (left) and an example with the filter screen and rubber gasket fitted (right)

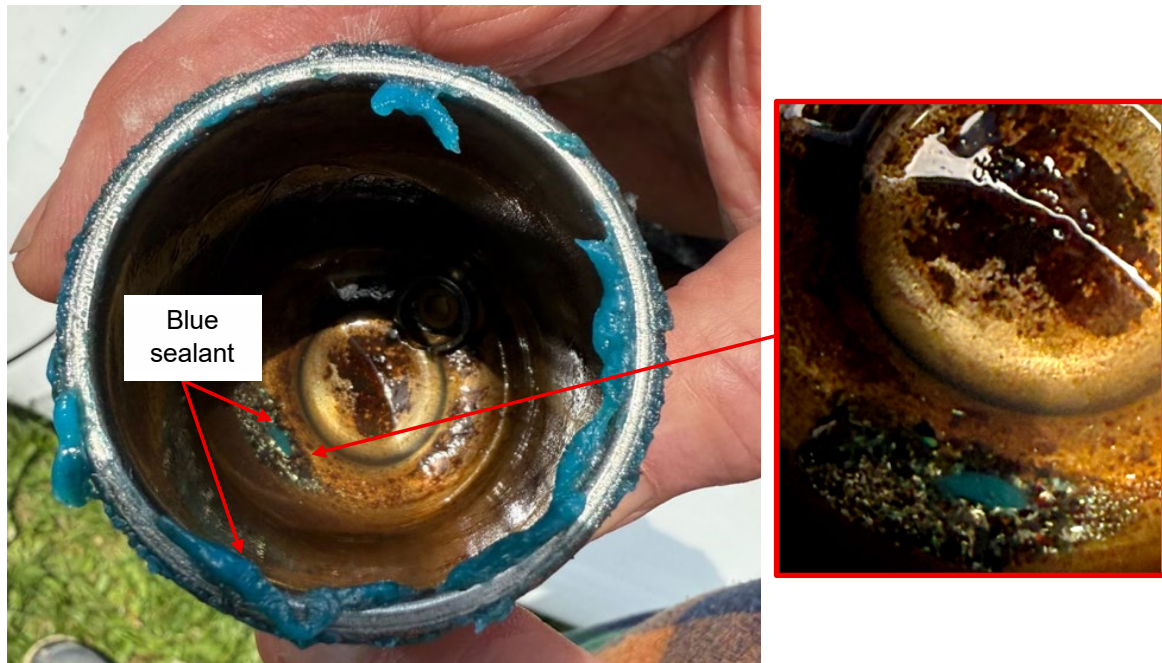
**Figure 3**

Inside the bowl, there was evidence of debris like that found in the main fuel tank, and blue gasket jointing sealant was found around the edge of the lid, the edge of the bowl and inside the bowl. The blue sealant appeared to have been used to seal between the bowl and the lid of the gascolator in place of the rubber gasket (Figure 3).

Gascolator bowl showing blue sealant and debris in the bowl

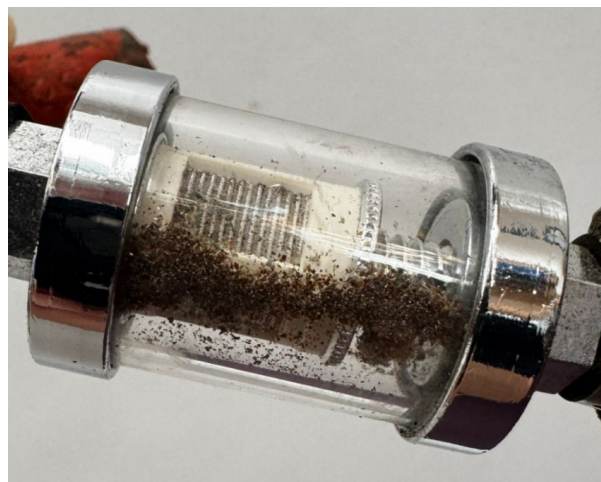
**Figure 4**

Examination of the in-line fuel filter revealed significant debris was present (Figure 4) which included clusters of granules (Figure 5).

Debris present within the in-line fuel filter

Downstream, the substantial number of granules found in the in-line filter could have caused a fuel blockage before fuel could even reach the carburettors. The considerable number of granules attached to the filter element could have reduced fuel flow below the amount the engine needed to keep running, particularly during high fuel flow demand.

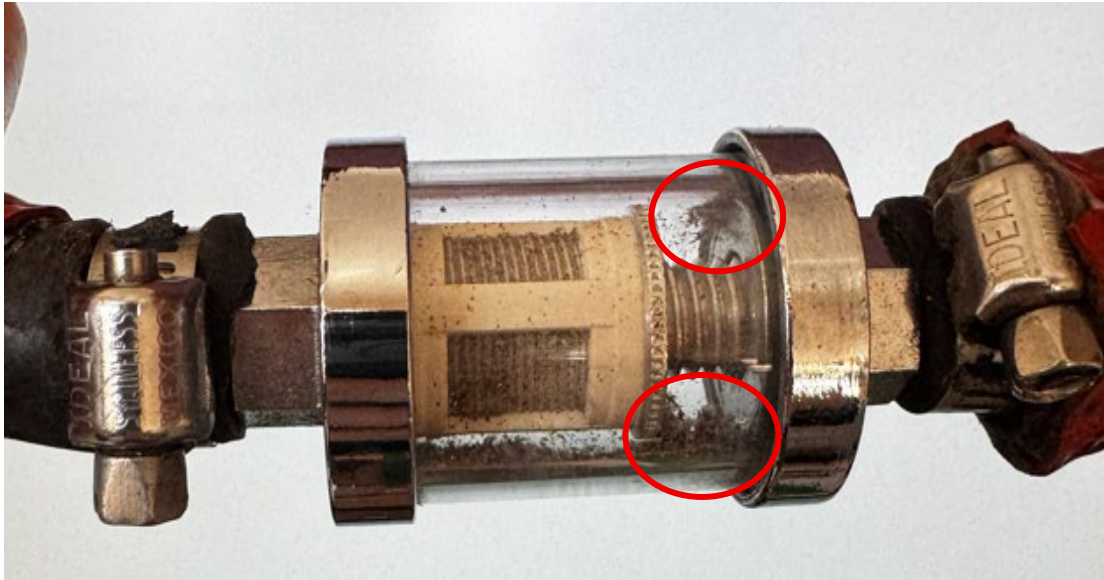
**Figure 5**

In-line fuel filter showing clusters of debris

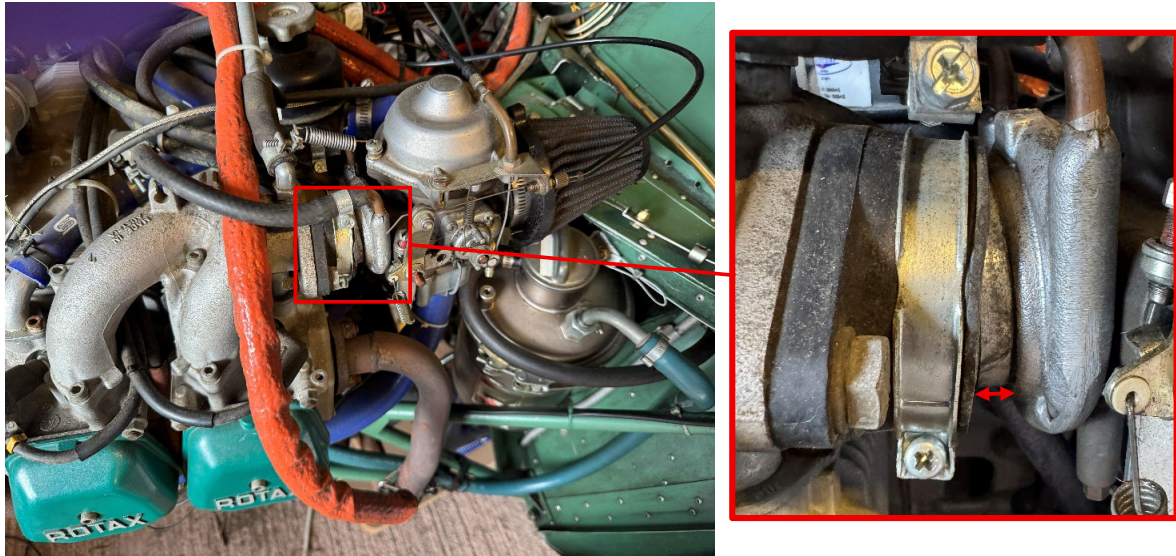
**Figure 7**

The left carburettor was not tightly secured to the engine inlet manifold (Figure 7) and appeared dislodged. It was not difficult to pull the carburettor away from the manifold because the securing buckle was loose. The right carburettor by comparison, was tightly secured. Air leaking at the inlet manifold can cause the engine to run with a lean fuel/air mixture.

Left carburettor dislodged from inlet manifold

If ambient air was able to leak through the loose seal between the carburettor and the manifold during engine vibrations, this could have affected the pressure in the manifold and resulted in a lean fuel mixture. This could have contributed to the engine failure.

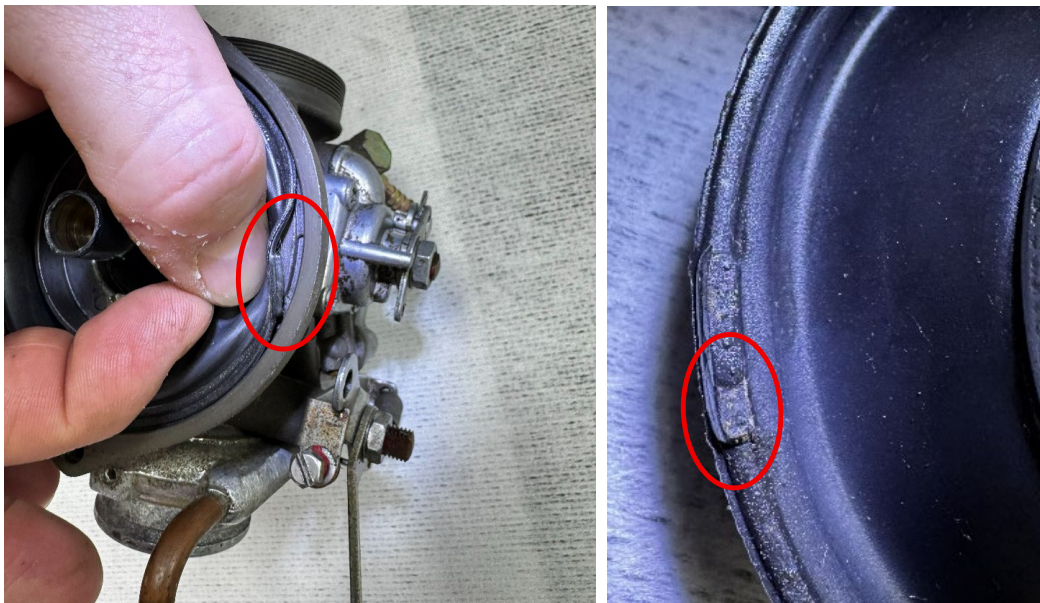
**Figure 8**

Both carburettors were removed from the engine and sent to a Rotax specialist workshop for examination. The results revealed that the left carburettor diaphragm was not correctly positioned because the locator tab, which fits into the recess in the rim of the carburettor housing, was displaced (Figure 8). The tab was partially compressed indicating that it had been damaged when the chamber top was refitted. As a result, it was possible there was a small gap between the top and bottom of the diaphragm. This may have affected the pressure differential across the top of the piston which can result in the piston not lifting correctly, restricting the cross-sectional area of the venturi. The amount of mixture drawn in by the engine and, therefore, its performance is determined by this cross-sectional area.

Misplaced diaphragm (Left) and damaged locator tab (right)

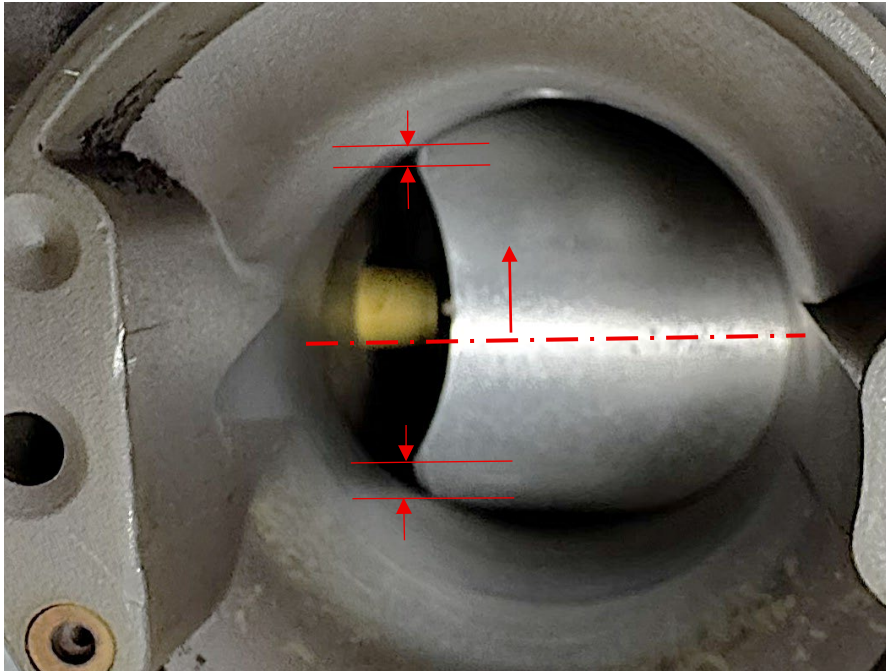
**Figure 9**

The carburettor piston was found slightly rotated (Figure 9) which would also have affected the cross-sectional area of the venturi.

Carburettor piston rotated

The rotated carburettor piston would have adversely affected the venturi cross-sectional area, reducing the efficiency of the carburettor. The potential compromise of the seal between the upper and lower surfaces of the diaphragm could have also affected the piston operation and only increased the carburettor's inefficiency. The leaking float bowl needle valve would have increased fuel flowing into the venturi causing a rich fuel mixture thereby reducing the engine performance even more.

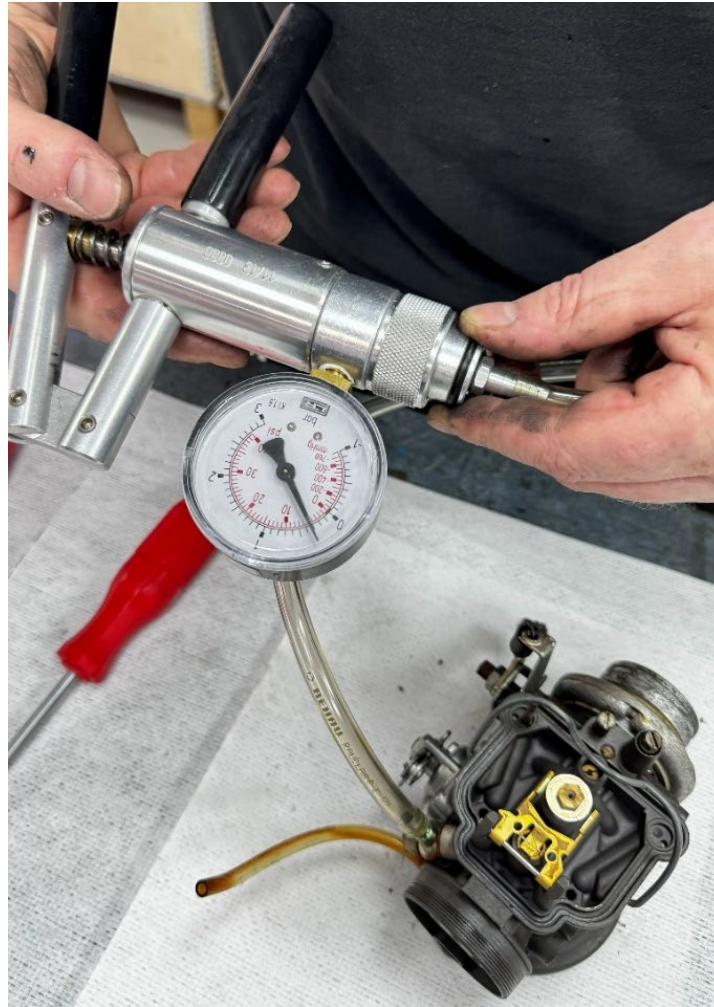
**Figure 10**

The carburettor float needle valve was leak tested in accordance with the BRP Rotax Maintenance Manual Heavy (MMH)-912<sup>2</sup>. The pressure reading did not hold for the required 5 seconds and started to dissipate immediately when pressure was applied, (Figure 10). This fault causes an increase in the fuel ratio resulting in a rich running engine. According to the maintenance manual, *'the pressure drop indicates leakage which may cause fuel overflow and in consequence engine damage due to hydraulic shock.'* Often this fault is caused by wear on the surface of the needle valve. It can also be caused by debris caught between the needle valve and the valve wall if the fuel is contaminated.

Pressure test of the left carburettor float chamber needle valve (Figure 11)

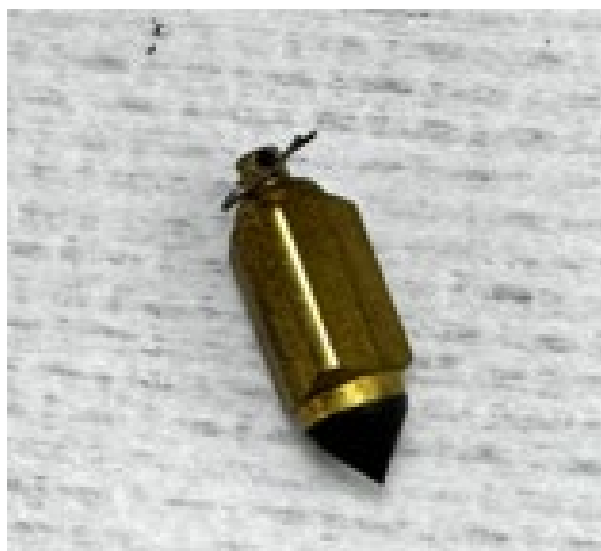
**Figure 11**

Left carburettor float bowl needle valve

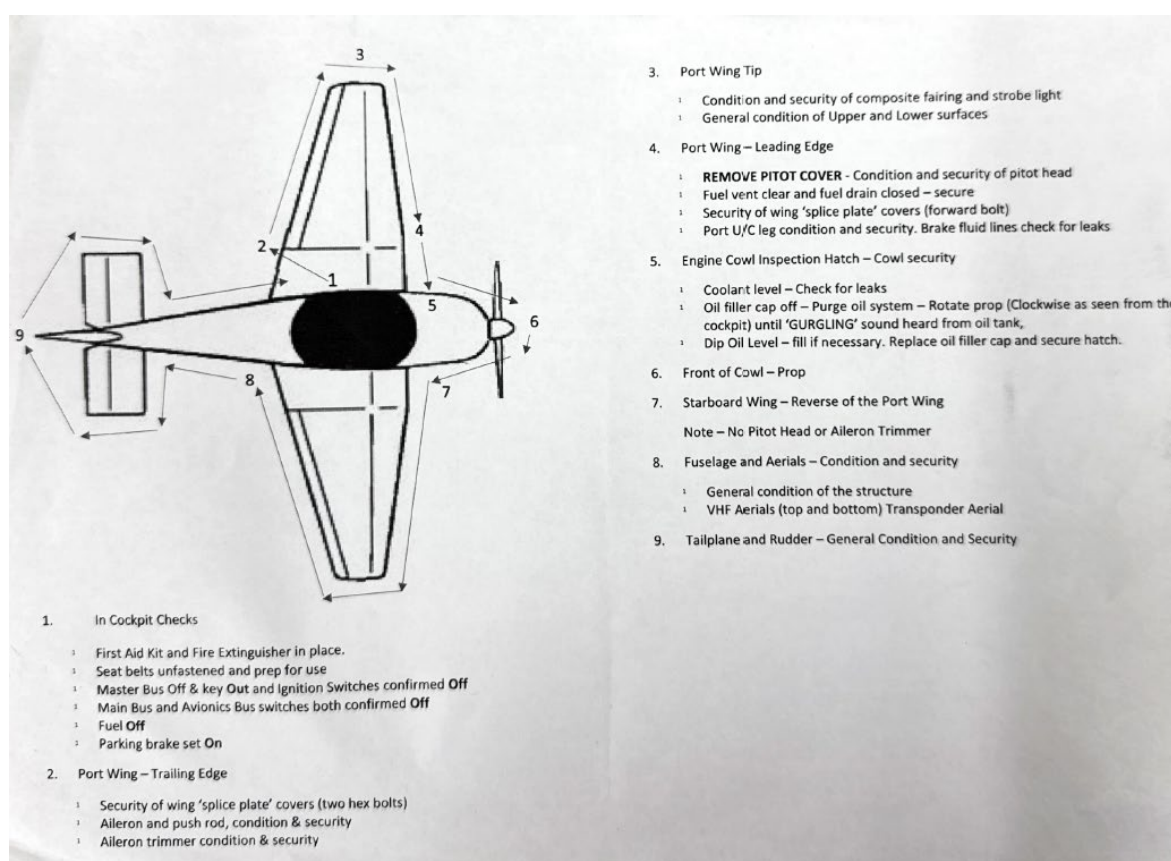
**Figure 12**

The walk around list provided with the aircraft paperwork (Figure 12) was the previous owner's mind-map of the pre-flight checks he needed to conduct. It did not reflect the Zenair CH 601 Pilot's Operating Handbook pre-flight inspection 'walk around' (Figure 13) and omitted the requirement to check the fuel drains and gascolator for the presence of water.

Bespoke pre-flight checklist intended for personal use only

The new owner stated that fuel drain checks had not been conducted before both flights on the day of the accident. Even if the owner had used the walk-round guide provided with the aircraft when it was purchased, there was no entry requiring fuel drain checks. Had the pilot located the Zenair CH 601 operating handbook and found the walkaround guide, the checklist may have prompted her to ask where the gascolator and its fuel drain were located to allow the check to be undertaken.
