Report on the investigation into the  
partial collapse of an  
**inflatable migrant boat**  
resulting in the loss of one life in the English Channel  
on 9 September 2025

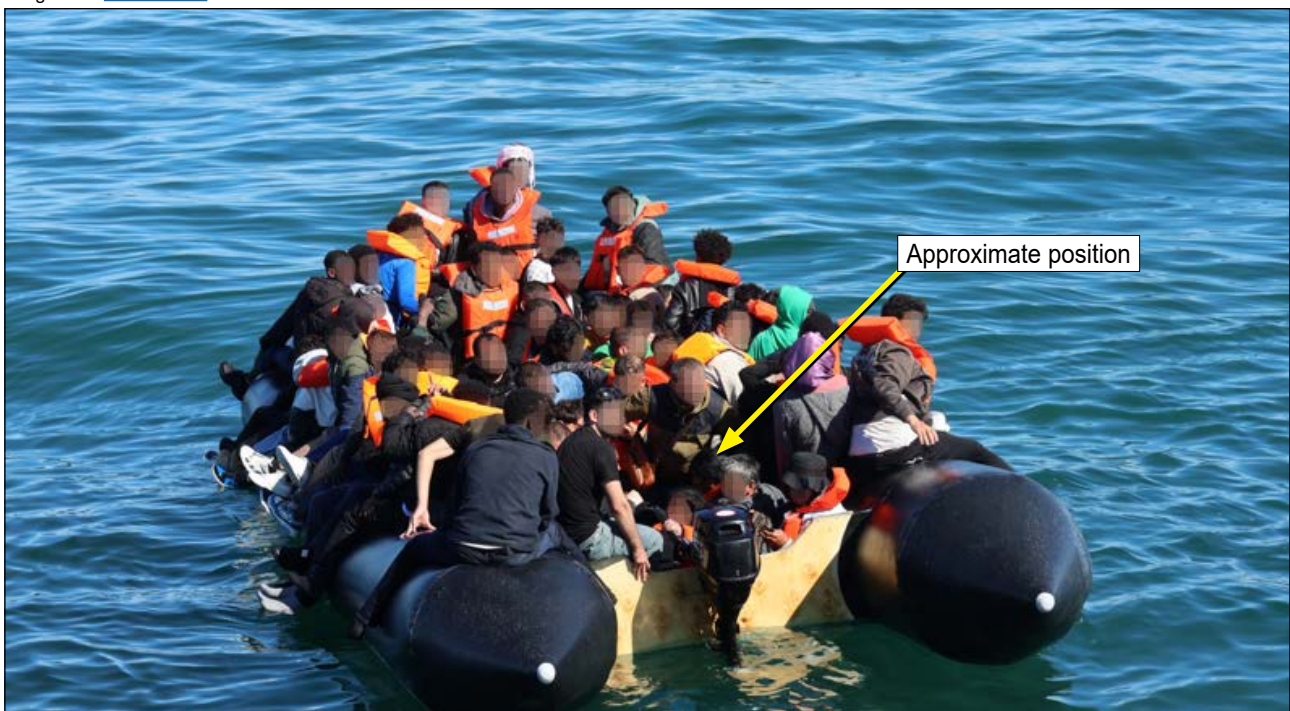
**Figure 2:** Manpreet Kaur's approximate position on board the boat

During the passage Manpreet Kaur was seated aft, on the deck and away from the sponsons, in confined conditions alongside other occupants (**Figure 2**). As the voyage progressed, the boat began to take on water, resulting in a significant accumulation on the deck. Occupants attempted to bail out the water using small containers such as plastic bottles. The sponsons progressively lost buoyancy, and repeated reinflation of the deck was required as the pump became detached allowing air to escape under pressure. The engine required refuelling on at least four occasions, during which petrol was spilled into the bottom of the boat.

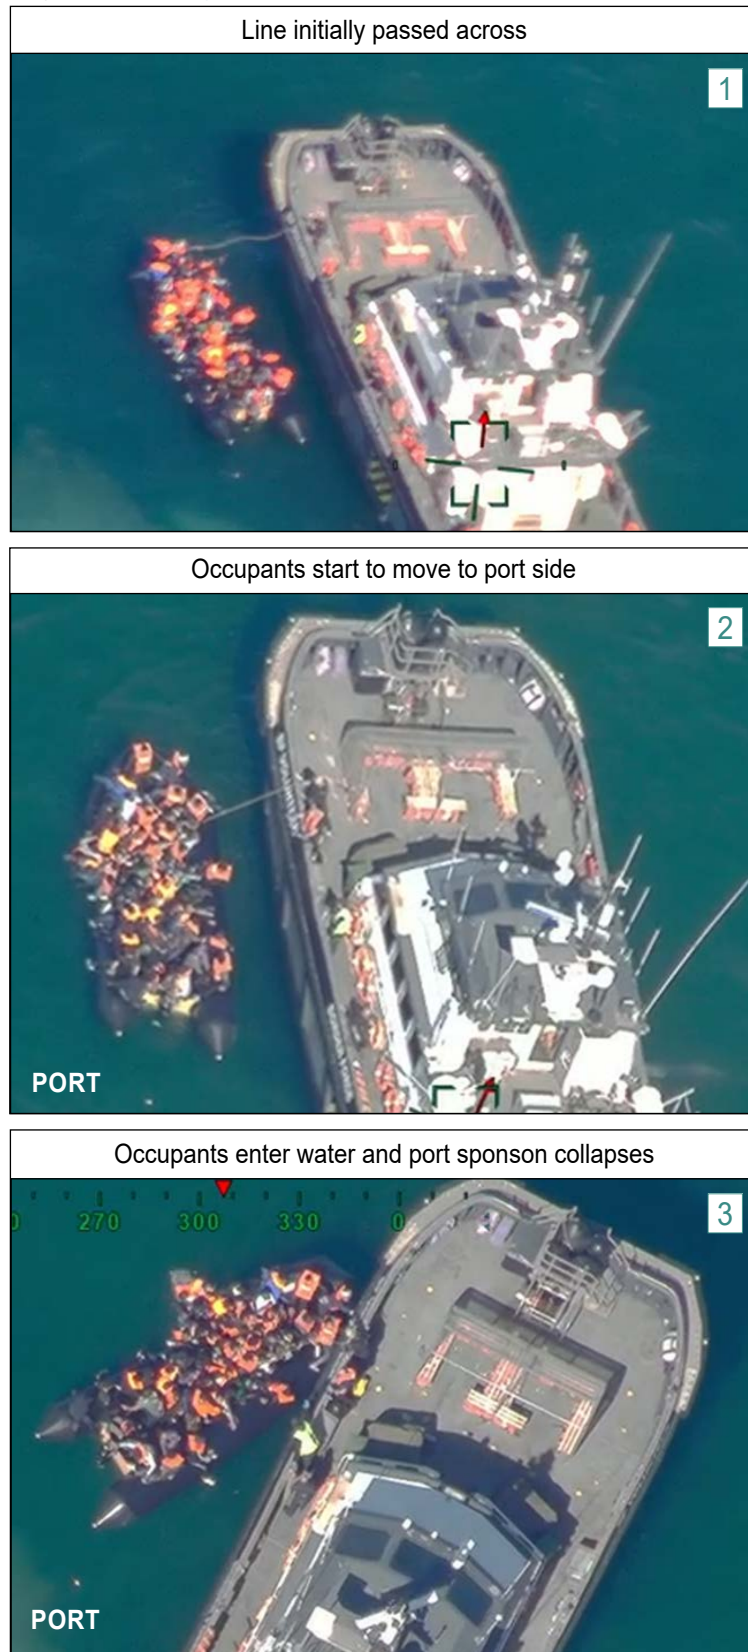
**Figure 3:** The movement of the boat's occupants during the rescue operation and the subsequent sponson collapse

At 1108, *BF Volunteer* passed a line to *migrant boat 512* to bring it alongside in accordance with standard operating procedures (SOPs). This action precipitated a mass movement of the occupants (**Figure 3**), resulting in the collapse of the port sponson, the ingress of significant quantities of water into the boat and multiple occupants entering the water.

As the occupants began to panic and move around the boat its structure collapsed further, causing more people to enter the water. Manpreet was trampled into the bottom of the boat, where she ended up face down in a mixture of water and fuel. A fellow occupant noticed her and attempted to pull her up by her lifejacket, which slipped off in the upheaval. At about the same time, the boat's deck flipped up, and Manpreet fell face down back onto the flooded polyvinyl chloride (PVC) floor (Figure 4).

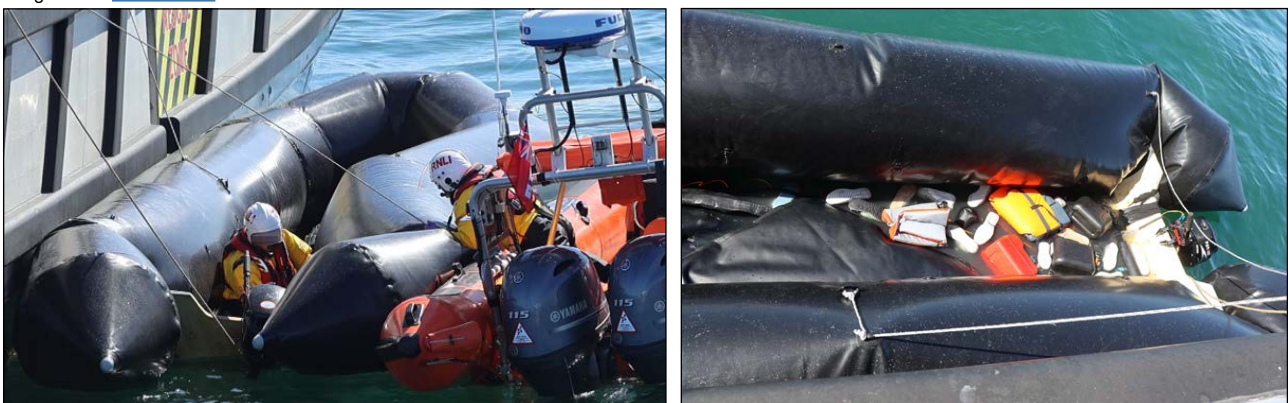
**Figure 5:** *Migrant boat 512* condition and partially collapsed state during rescue and post-recovery

*Migrant boat 512* was in a severely degraded state by the time it entered UK waters. The inflatable sponsons were partially deflated, the deck had lost rigidity, and a significant volume of water had accumulated on board. Air leakage from both the sponsons and the inflatable deck required repeated attempts at reinflation during the voyage, and the boat was likely to have departed France underinflated. *Migrant boat 512* was not constructed to any recognised design or safety standard: its inflatable floor was not structurally connected to the boat, deck pressure could not be maintained once the pump was removed, its seams and transom had been taped and glued rather than welded, and no strong points were fitted for securing or recovering it. The shaft length of the 9.9 hp outboard engine was incompatible with the depth of the transom, causing continuous contact with the hull and progressive deterioration of the PVC structure, allowing water to enter the boat.

*Migrant boat 512* was a rudimentary craft produced from low-cost materials outside recognised safety and quality standards. Its poor construction, overcrowding, low freeboard, air leakage, water ingress and incompatible outboard engine arrangement meant that it was wholly unsuitable for crossing the English Channel. By the time the boat entered UK waters it was in a compromised condition and vulnerable to structural collapse.

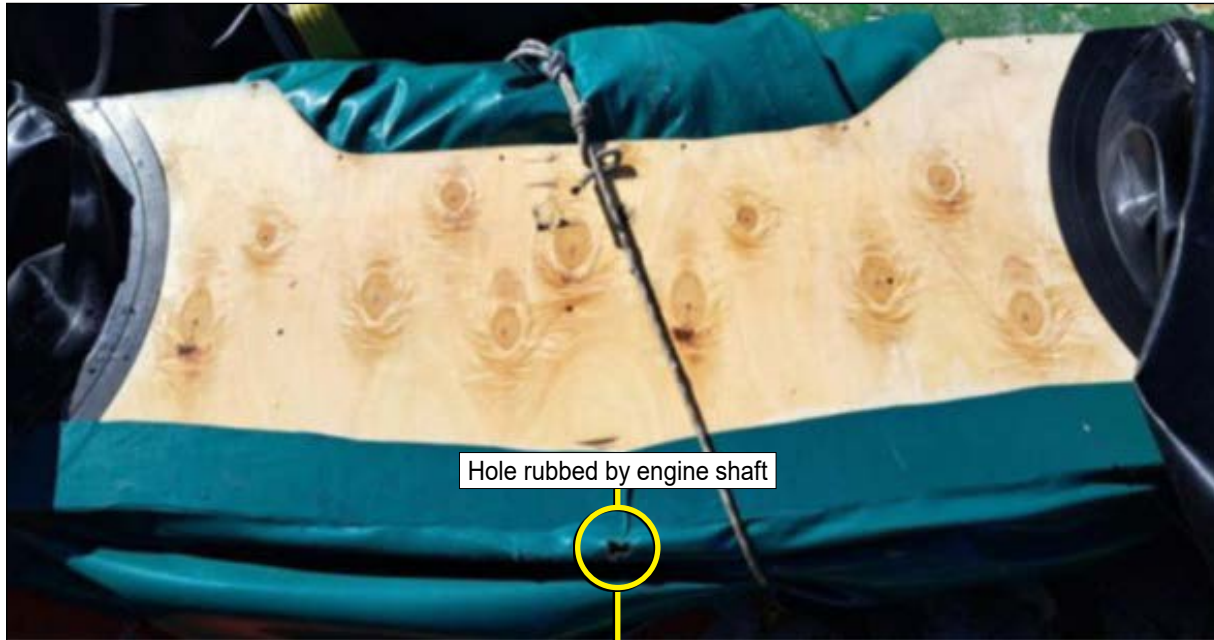
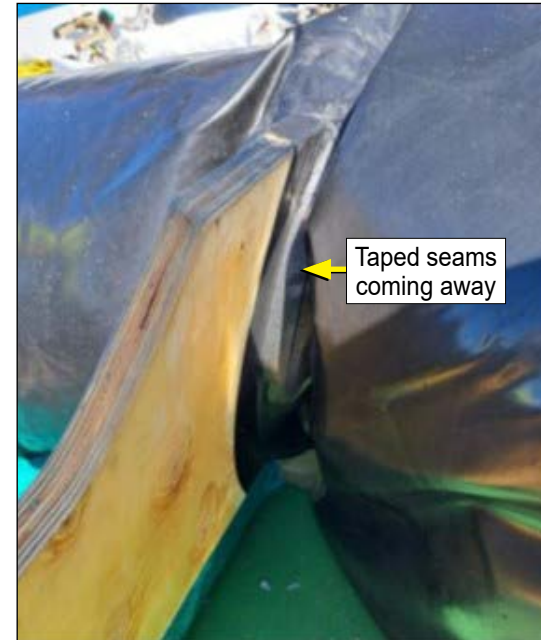
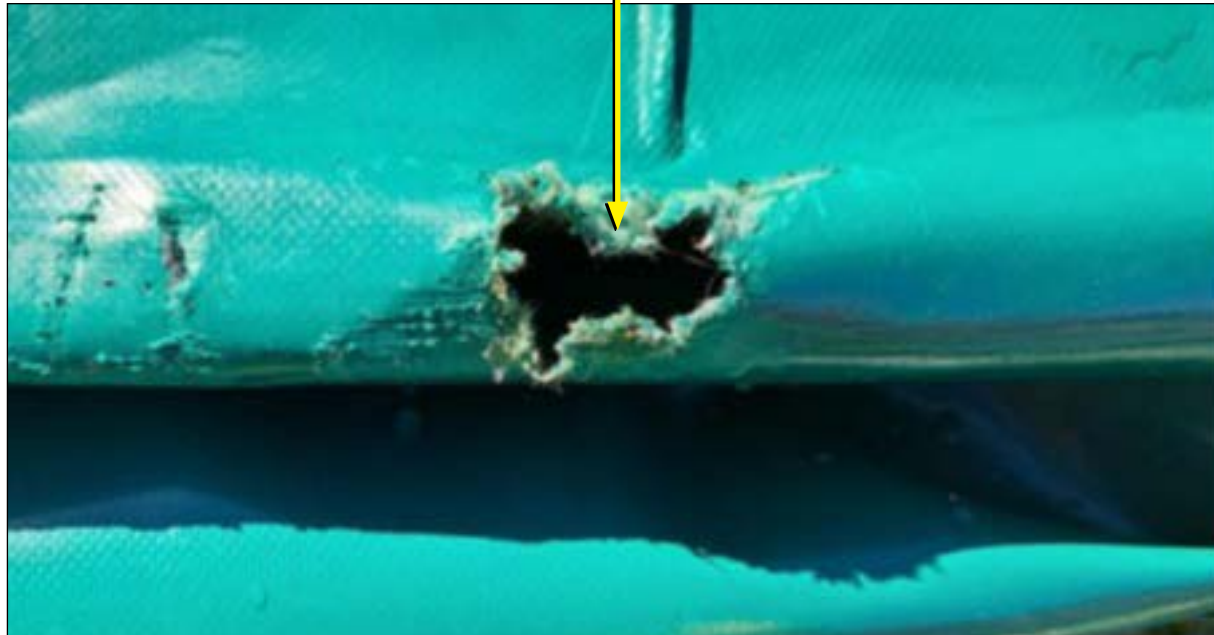
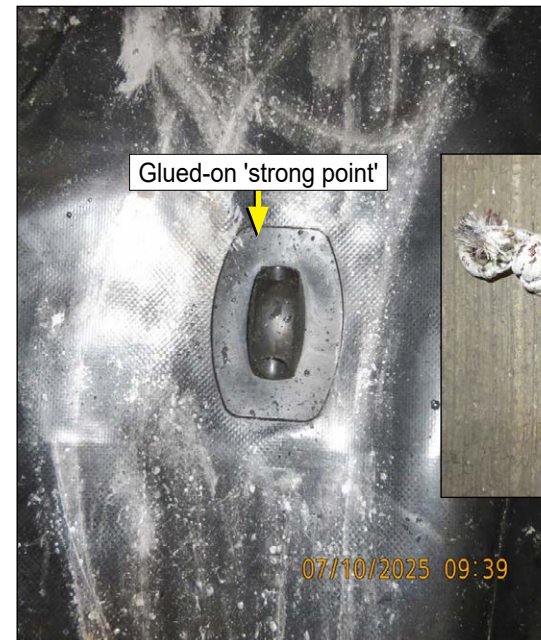
**Figure 6:** The boat's construction and defects

The deck valve leaked during inflation unless the pump remained connected. The MAIB tested the boat's valves and found no obvious defects, although the deck valve could not be tested under pressure because the boat was no longer airtight at the time of inspection. Several glued-on securing points had detached from the sponsons (**Figure 6**). The sponsons lost air during the voyage, with small tears reported in the boat.

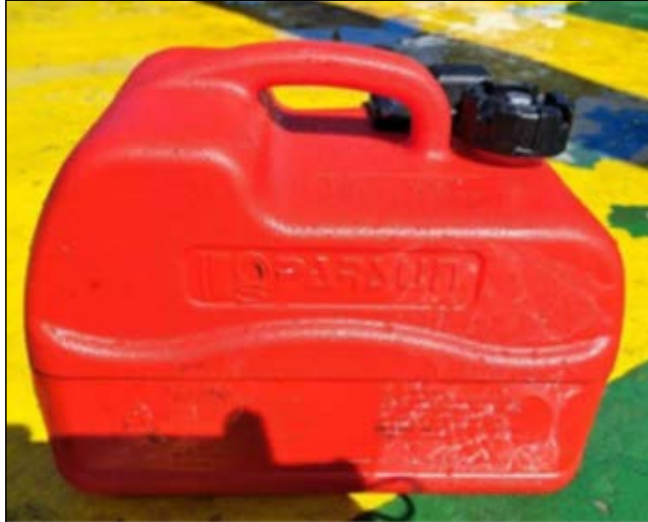
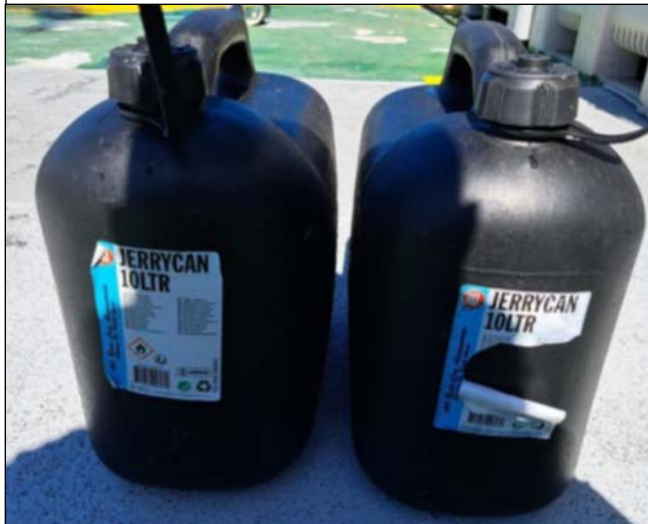
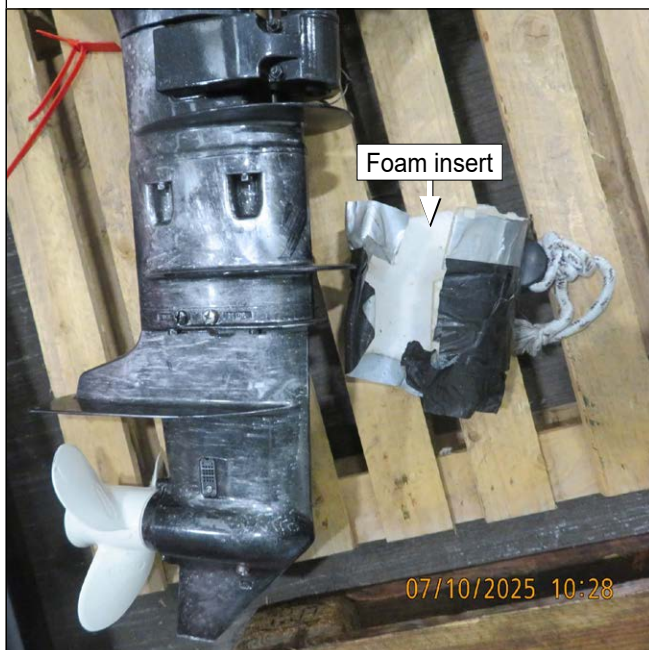
**Figure 7:** Engine and fuel arrangements for  
*migrant boat 512*

*Migrant boat 512* was fitted with a 9.9 horsepower (hp) four-stroke outboard engine connected to a 12-litre external fuel tank. The engine consumed about 3.5 litres of fuel per hour. Two additional 10-litre jerrycans were also carried on board (**Figure 7**). No refuelling equipment was provided, and fuel was spilled into the boat each time the tank was replenished. The lower section of the engine shaft was in contact with the base of the transom at a point where the PVC had been taped, resulting in abrasion and a hole in the structure (see **Figure 6**). A foam insert had been taped to the underside of the shaft in an apparent attempt to reduce this contact.

The boat's engine was refuelled at least four times during the voyage. The occupants were neither equipped nor trained to carry out refuelling safely and, as a result, fuel handling was poor and petrol was spilled into the bottom of the boat. The presence of petrol increased the risk to occupants through exposure to vapours and contact with fuel mixed with seawater, creating a corrosive mixture that caused skin burns to Manpreet and several other occupants. For those sitting low down in the centre of the boat, like Manpreet, vapour concentrations were likely to be particularly high due to the lack of air circulation caused by their proximity to the deck, the overcrowded conditions, and low wind speeds. This effect was likely to have been exacerbated when the boat stopped before being intercepted by *BF Volunteer*.

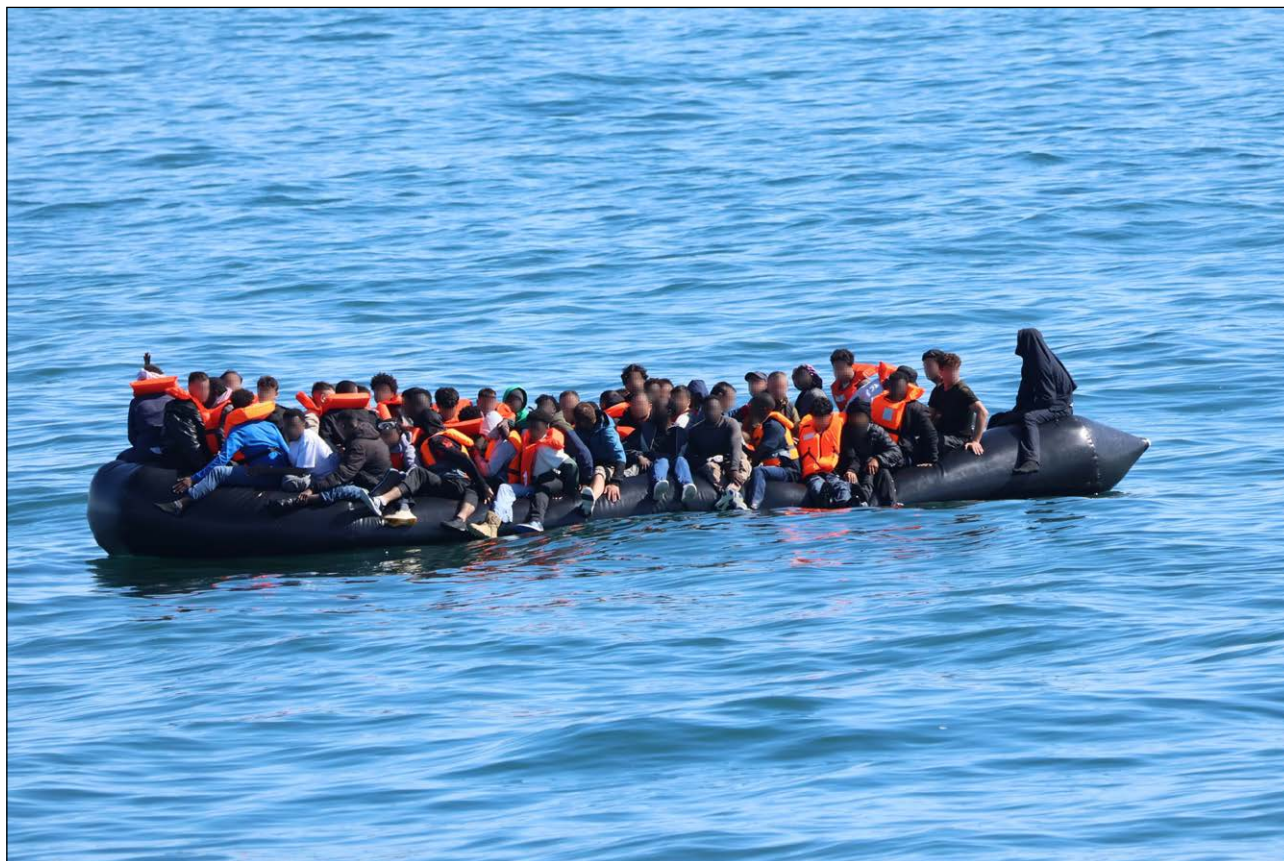
**Figure 8:** *Migrant boat 512* during the initial approach, showing deflation and low freeboard

*Migrant boat 512* did not have an established loading capacity, although comparable military commando raiding craft of a similar size and design were typically rated to carry no more than 12 people when fitted with a 50hp to 80hp outboard engine. The boat had a low freeboard, which allowed water over the sponsons throughout the voyage (**Figure 8**).
