**Accident**

| <b>Aircraft Type and Registration:</b> | DG Aviation LS8-e, G-CMMG | |

**Synopsis**

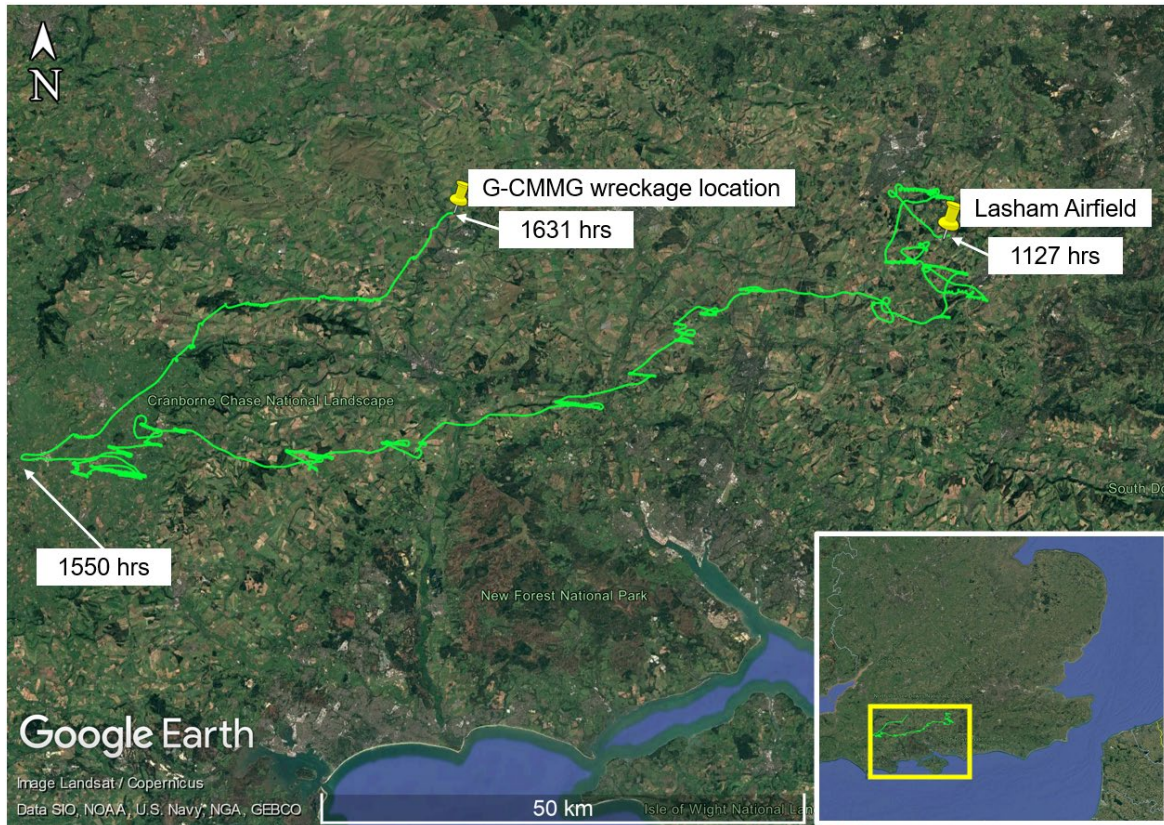
**Figure 1**

His initial routing took him south-west, routing to the north of Winchester and to the south of Salisbury (Figure 1). His height along the route was between 5,600 ft amsl and 1,000 ft amsl. He reached Henstridge (within the first task area) at around 1550 hrs at a height of 2,800 ft amsl where he turned to the north-east. At around 1607 hrs, having descended to about 1,100 ft amsl, the pilot turned onto a more easterly heading following the Great Ridge towards Salisbury. He gained height by thermalling along the ridge, increasing to about 1,500 ft amsl. At about 1627 hrs, having descended to about 800 ft amsl, he gained about 100 ft in two 360° turns in a thermal before he passed over the A303. As he approached the end of the ridge at 1628 hrs, around 4 nm north-west of Salisbury, he turned to the north-east and passed between Stonehenge and Amesbury at 900 ft. Shortly afterwards as he headed north-east, he entered the Salisbury Plain Danger Areas.

Track of the accident flight, recorded by the onboard avionics  
© 2025 Google, Image © Landsat / Copernicus

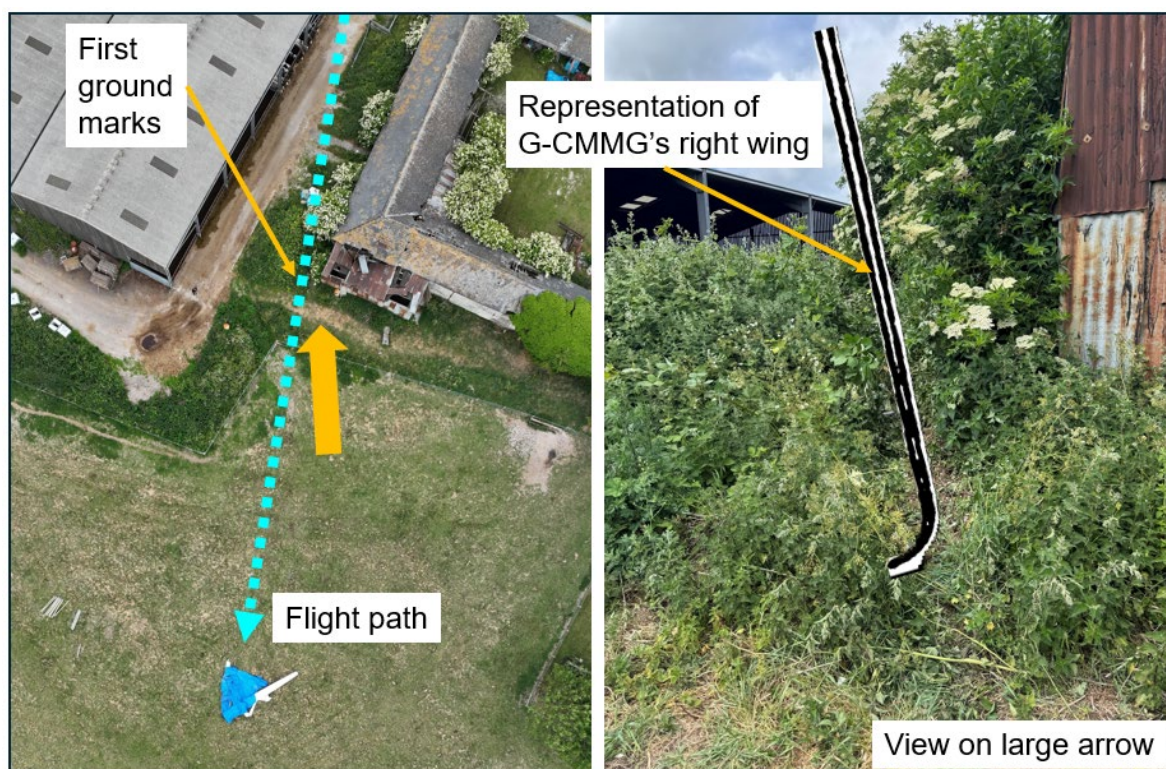
**Figure 2**

The accident site was in a field adjacent to some farm buildings. The first ground marks were from the right wingtip striking the ground close to one building and pieces of the wingtip were caught in the vegetation. The shape and proximity of the marks to the building indicated that the glider was approaching from the north and banking steeply with the wings almost vertical (Figure 2). The next ground marks into the field indicated various impacts suggesting a cartwheeling motion with the glider coming to rest in the middle of the field. The tail had become detached; the left wing structure had fractured and there was extensive damage to the nose and cockpit area. When the AAIB arrived at the scene, some of the glider's parts had been collected by the pilot and placed in a pile near the main wreckage. Further debris was still scattered about the field.

Accident site and the gliders attitude at first ground impact

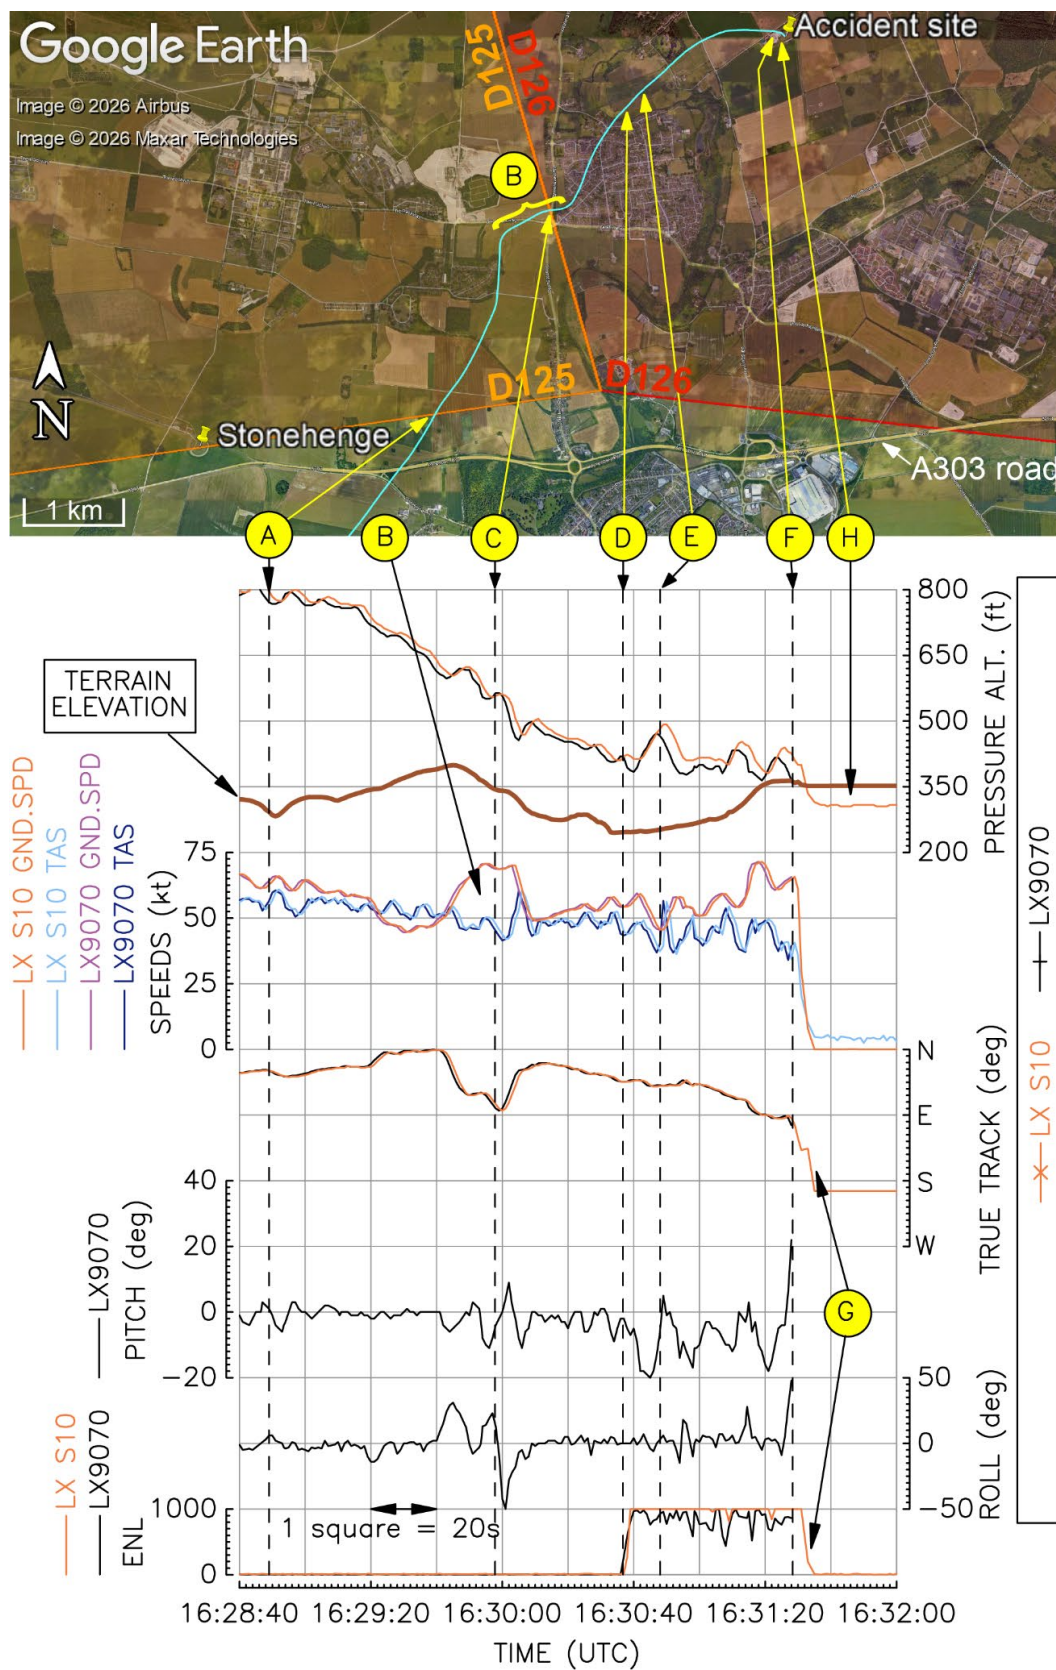
**Figure 3**

Figure 3 shows a composite illustration of the GNSS ground track for the last 2 minutes of the flight, with logged flight data parameters recovered from the S10 and LX9070. The terrain elevation in the altitude plot is based on data available from the Department for Environment, Food and Rural Affairs (DEFRA)<sup>1</sup>.

- Point A: G-CMMG flies into the EGD125 (Larkhill) Danger Area at 1628:48 hrs.
- Area B: G-CMMG was flying with tailwind of about 20 kt whilst flying due east.

- Point C: G-CMMG crossed into the EGD126 (Bulford) Danger Area at 1629:58 hrs.
- Point D: At 1630:37 hrs, at about 170 ft agl, ENL rose from around zero, reaching a maximum 2s later, indicating that the FES was running. The descent appeared to cease. The TAS was 44 kt and the groundspeed was 55 kt.

- Point E: Vertical speed increased sharply and G-CMMG gained about 100 ft, followed by a reversal into a descent and drifting to an eastward track.
- Point F: The LX9070 stopped recording at 1631:28 hrs. The last data point logged was a 48° right roll, 22° nose-up attitude, 3 m/s sink rate, and TAS of 40 kt. The S10 recorded a TAS of 34 kt and 4 m/s sink rate. The data indicated a tailwind of about 25 kt.

- Point G: The S10 continued recording. The data indicated a sharp track change towards the south, a sink rate of -16 m/s, and ENL going to zero.
- Point H: The S10 logged pressure altitude settles at 308 ft amsl and sink rate settled to zero. The accident site elevation was 351 ft amsl.

Composite of the gliders track and Danger Areas overlaid on satellite imagery (top), and pertinent parameters recorded by the onboard avionics (bottom)

On the accident flight, the recorded ENL parameter rose from a low level to its maximum at about 1630:39 hrs (Point D in Figure 3) as the glider descended below about 410 ft amsl, which corresponded with a height of about 180 ft agl.

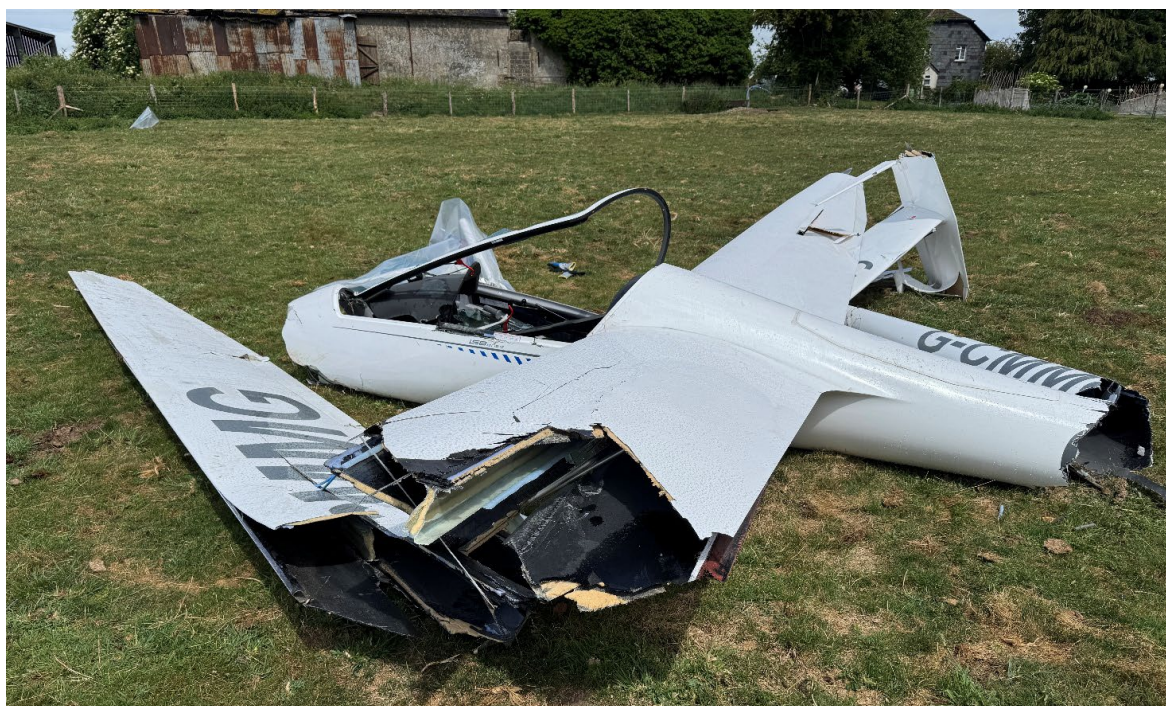
**Figure 4**

The preliminary examination of the glider at the accident site identified that the tail and left wing had suffered major structural failure from striking the ground (Figure 4). There was further damage to the horizontal stabiliser, and both wingtips had detached. The cockpit was extensively damaged, and the canopy had detached with the transparency shattered. Control surface continuity checks verified that all the surfaces were still connected.

G-CMMG at the accident site

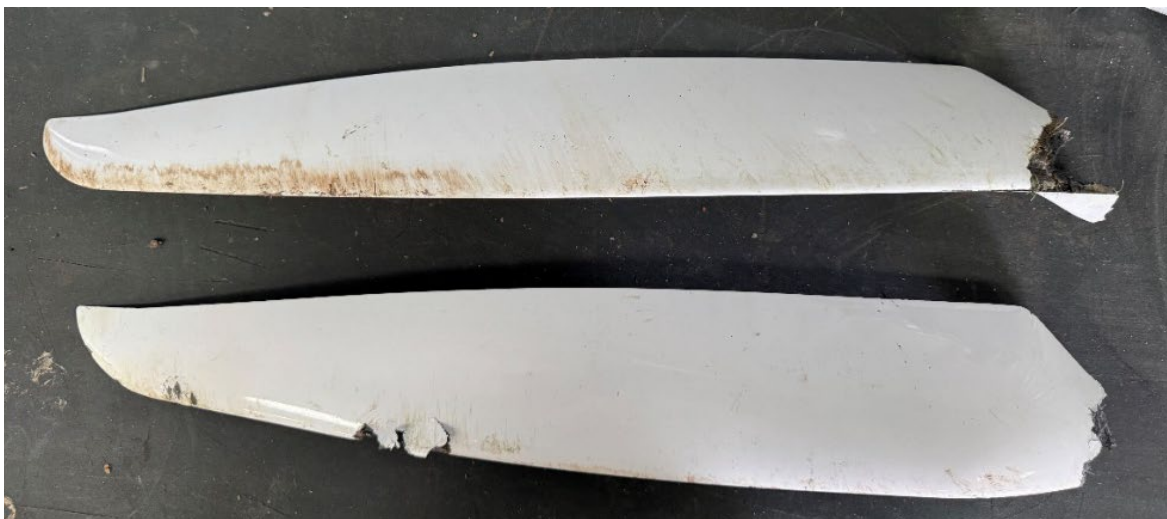
**Figure 5**  
FES Propeller blades

A detailed inspection of the structure revealed that the cockpit had sustained a heavy impact on the front right side which had detached the FES motor. The motor had been retained by the large diameter electrical cables. The remaining cockpit structure was predominately intact with evidence at the top of the rear left side that a significant injury had been sustained by the pilot. The tail section had detached approximately 30 cm behind the trailing edge of the wing, with the fracture showing tension overload on the left side and crushing with buckling on the right side. The horizontal stabiliser was damaged on both ends with significant sections detached. The fuselage water ballast tank was empty. The left wing had failed inboard of the airbrake, and the outer section was retained by the control surface cables. The evidence suggested that it failed by downward bending. Both wingtips were damaged with the right side showing abrasion in the direction of flight. The left had been predominantly removed. All wing water ballast tanks were empty with their integrity comprised by the damage sustained. The blades of the FES system were examined and there was evidence of dirt and staining on the leading edge of the blades that suggested that the FES was operational when it struck the field (Figure 5). The investigation did not establish the remaining power of the battery packs.
