# ***AAIB Bulletin***

# ***10/2026***

Published: 8 October 2026.

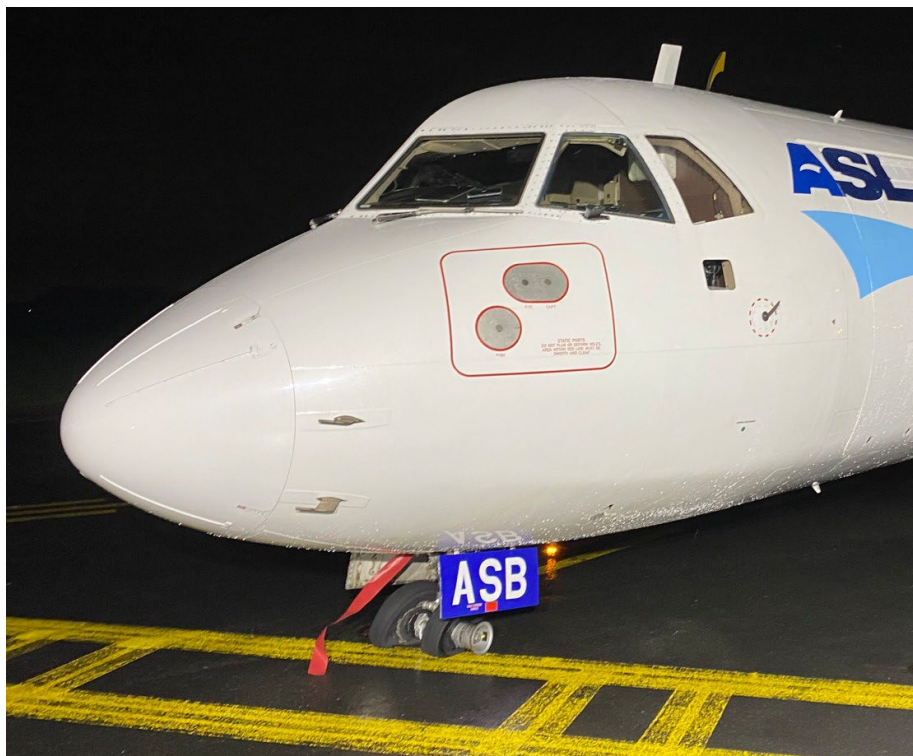
**Figure 3**  
Damage to nose landing gear after landing

Both nose landing gear wheels were fractured during the landing, causing the tyres to deflate and difficulty for the flight crew in steering the aircraft from the runway. Figure 3 shows the damage to the nose landing gear after the aircraft stopped on Taxiway S.

The aircraft manufacturer assessed the loading sustained during the heavy landing and determined that the nose landing gear leg, drag brace, right main landing gear leg and shock absorber required replacement due to exceeding their design load capacities. The manufacturer also required the left main landing gear shock absorber to be removed and inspected to determine whether it remained in a serviceable condition.

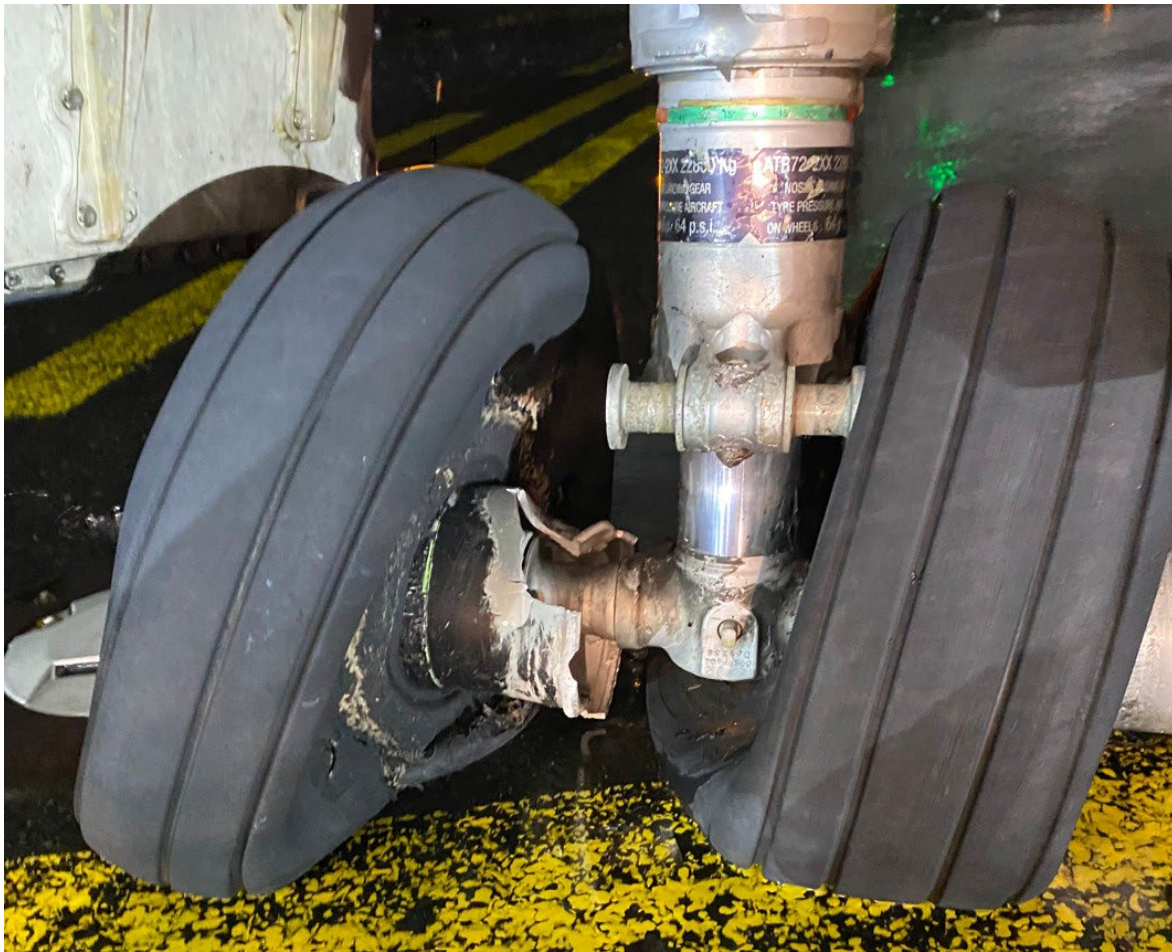
**Figure 4**

The wheel hub fractures were visually examined and the failures were determined to be due to mechanical overload (Figure 4).

Overload fracture of right nose wheel (left nosewheel similarly damaged)

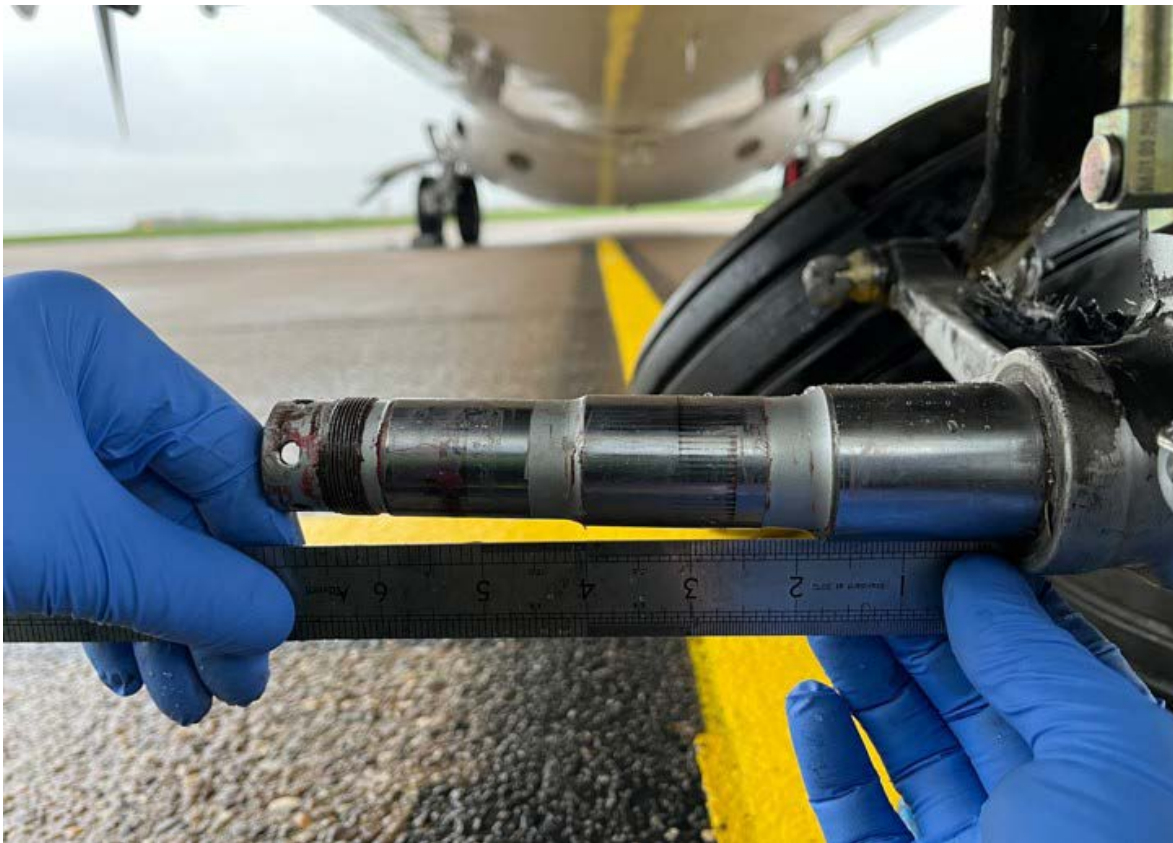
**Figure 5**

The damaged nosewheels were removed and serviceable wheels installed to permit the aircraft to be towed to a parking apron. Subsequent examination of the nose landing gear axle revealed that it had been bent upwards during the landing (Figure 5).

Upward bend evident in right nosewheel axle (left axle similarly damaged)

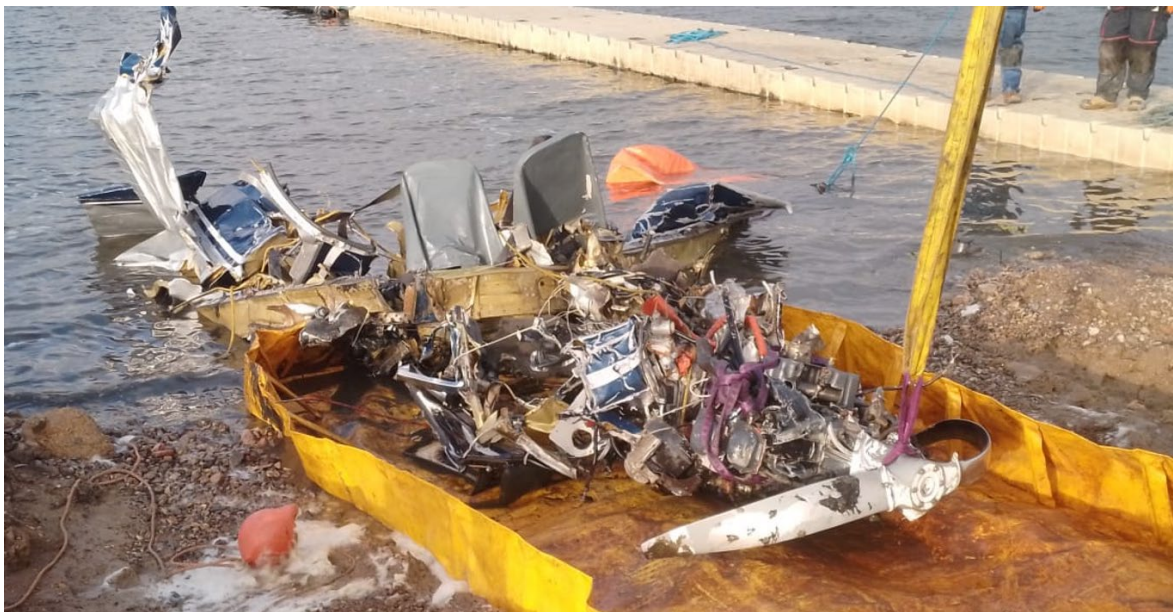
**Figure 3**  
G-AZDG aircraft wreckage

The aircraft wreckage was severely broken up (Figure 3) indicating a high-speed impact. The wreckage was found in a relatively small compact area which was consistent with a steep impact. One of the propeller blades was curled backwards which often occurs in steep impacts and makes it difficult to determine if the propeller was being driven by engine power at the time. The left horizontal tail and left elevator were attached, while the right horizontal tail and right elevator had partially detached in a manner consistent with impact forces. The elevator control cables were attached to the elevator bellcrank, but the cables had failed due to overload consistent with the airframe break-up. The elevator was in a neutral position and could be actuated via the cables. Due to the circumstances leading up to the accident no further wreckage examinations were carried out.

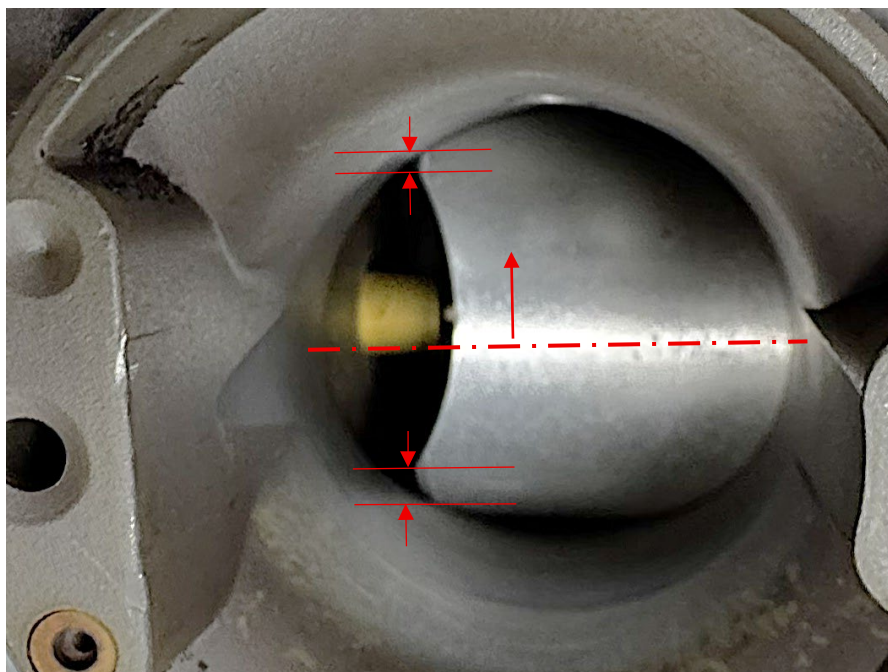
**Figure 9**

The carburettor piston was found slightly rotated (Figure 9) which would also have affected the cross-sectional area of the venturi.

Carburettor piston rotated

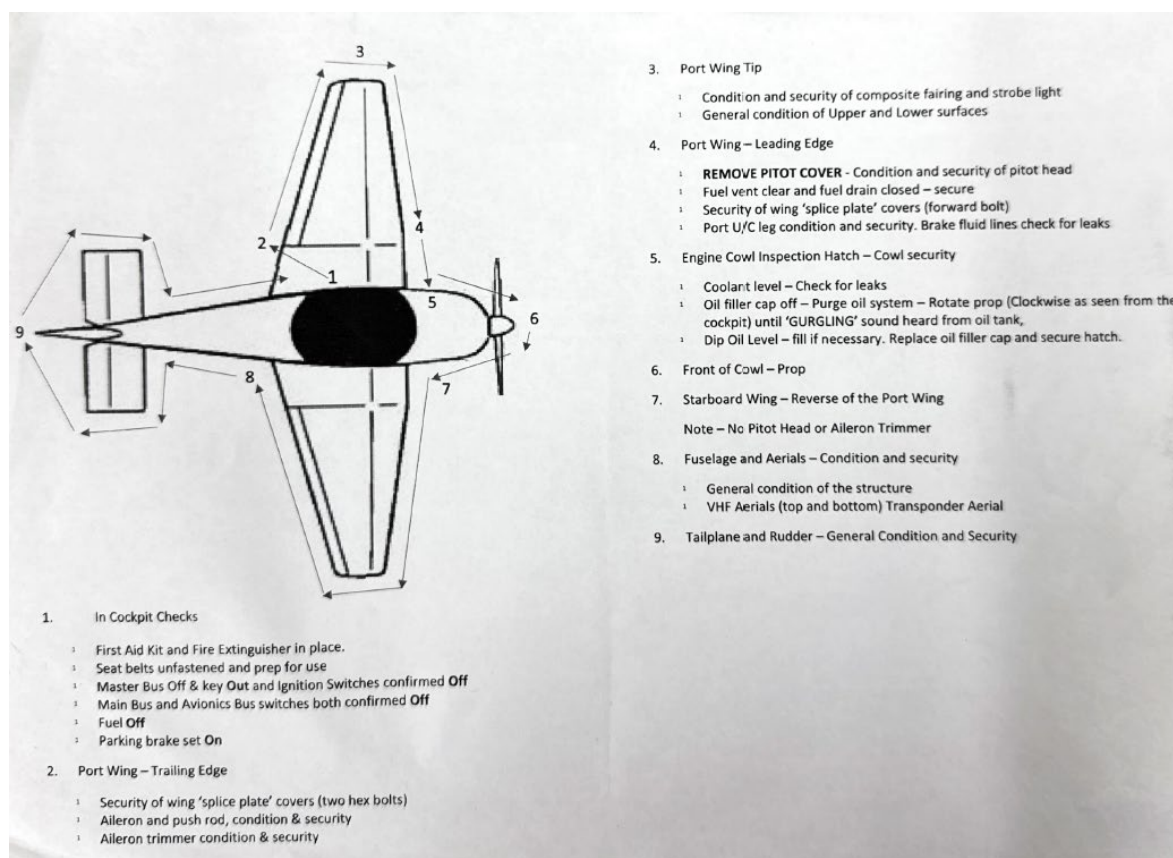
**Figure 12**

The walk around list provided with the aircraft paperwork (Figure 12) was the previous owner's mind-map of the pre-flight checks he needed to conduct. It did not reflect the Zenair CH 601 Pilot's Operating Handbook pre-flight inspection 'walk around' (Figure 13) and omitted the requirement to check the fuel drains and gascolator for the presence of water.

Bespoke pre-flight checklist intended for personal use only
