APPENDIX B

PHOTOGRAPHS

Boeing 747 - 121 Leading Dimensions

Figure B-1

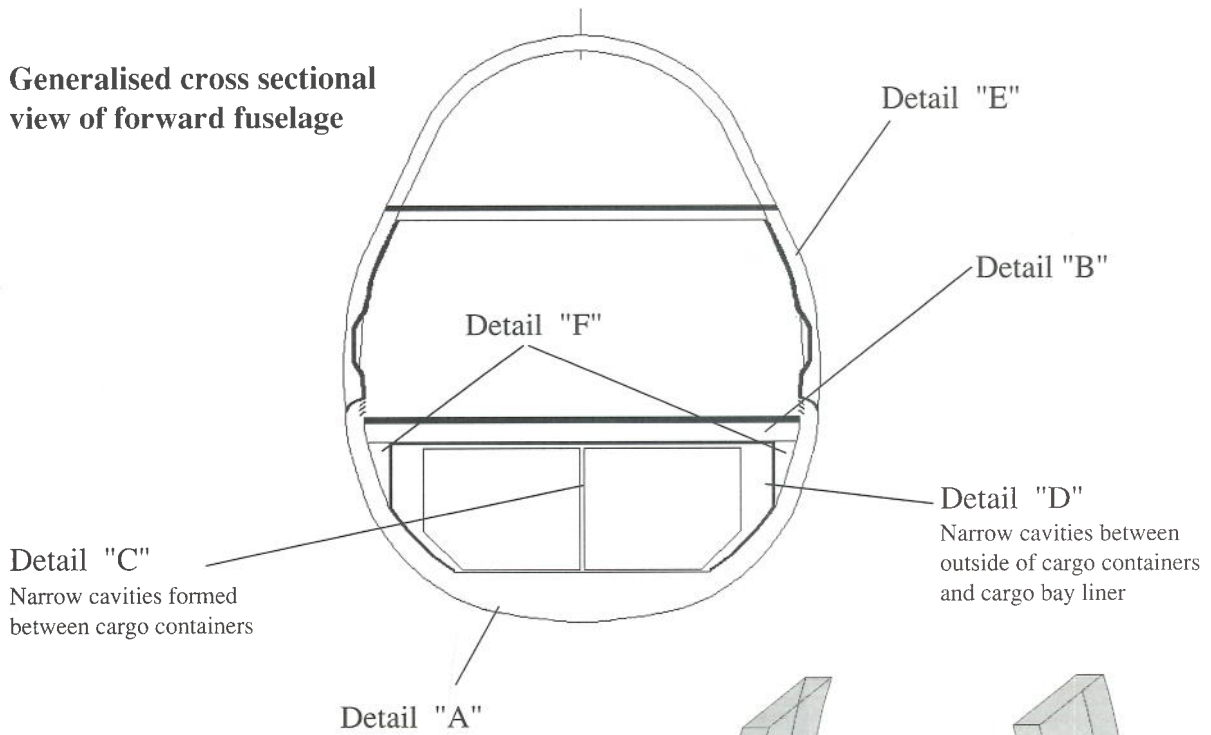
Figure B-3

Detail "C"
Narrow cavities formed between cargo containers

Detail "D"
Narrow cavities between outside of cargo containers and cargo bay liner

Detail "E"
Vertical cavities between frames, bounded by fuselage skin and cabin side liner panel. Top of cavity largely blanked by upper deck floor panels

Detail "F"
Longitudinal 'manifold' cavity, formed in space between container side and curved fuselage side

Detail "A"
Semi-circular cavity between fuselage frames in fuselage lower lobe, bounded by fuselage skin and cargo bay

Detail "B"
Horizontal cavity between floor beams, bounded by cabin floor panels and cargo bay liner/top panels of cargo containers

Network of Interlinked Cavities
formed within forward fuselage structure and baggage hold
(schematic representation)

Indirect explosive damage (channelling or ducting of explosive energy in the form of both shock waves and supersonic gas flows) is likely to occur because of the network of interlinked cavities which exist, in various forms, in all large commercial aircraft, particularly below cabin floor level. This channeling mechanism can produce critical damage at significant distances from the source of the explosion.

To prevent the 'ducting' of any blast which does enter the fuselage cavities, either because of partial penetration of the containment barriers or leakage at the vent duct interfaces, the scheme requires the provision of lightweight energy absorbing material within the cavities to limit reflection and propagation of pressure waves within the cavities, and radiation of shock waves into the cabin from the conditioning air vents. Materials such as vermiculite, which are of low density yet have excellent explosive energy absorption properties, may have application in this area, perhaps in lieu of the existing insulation material.

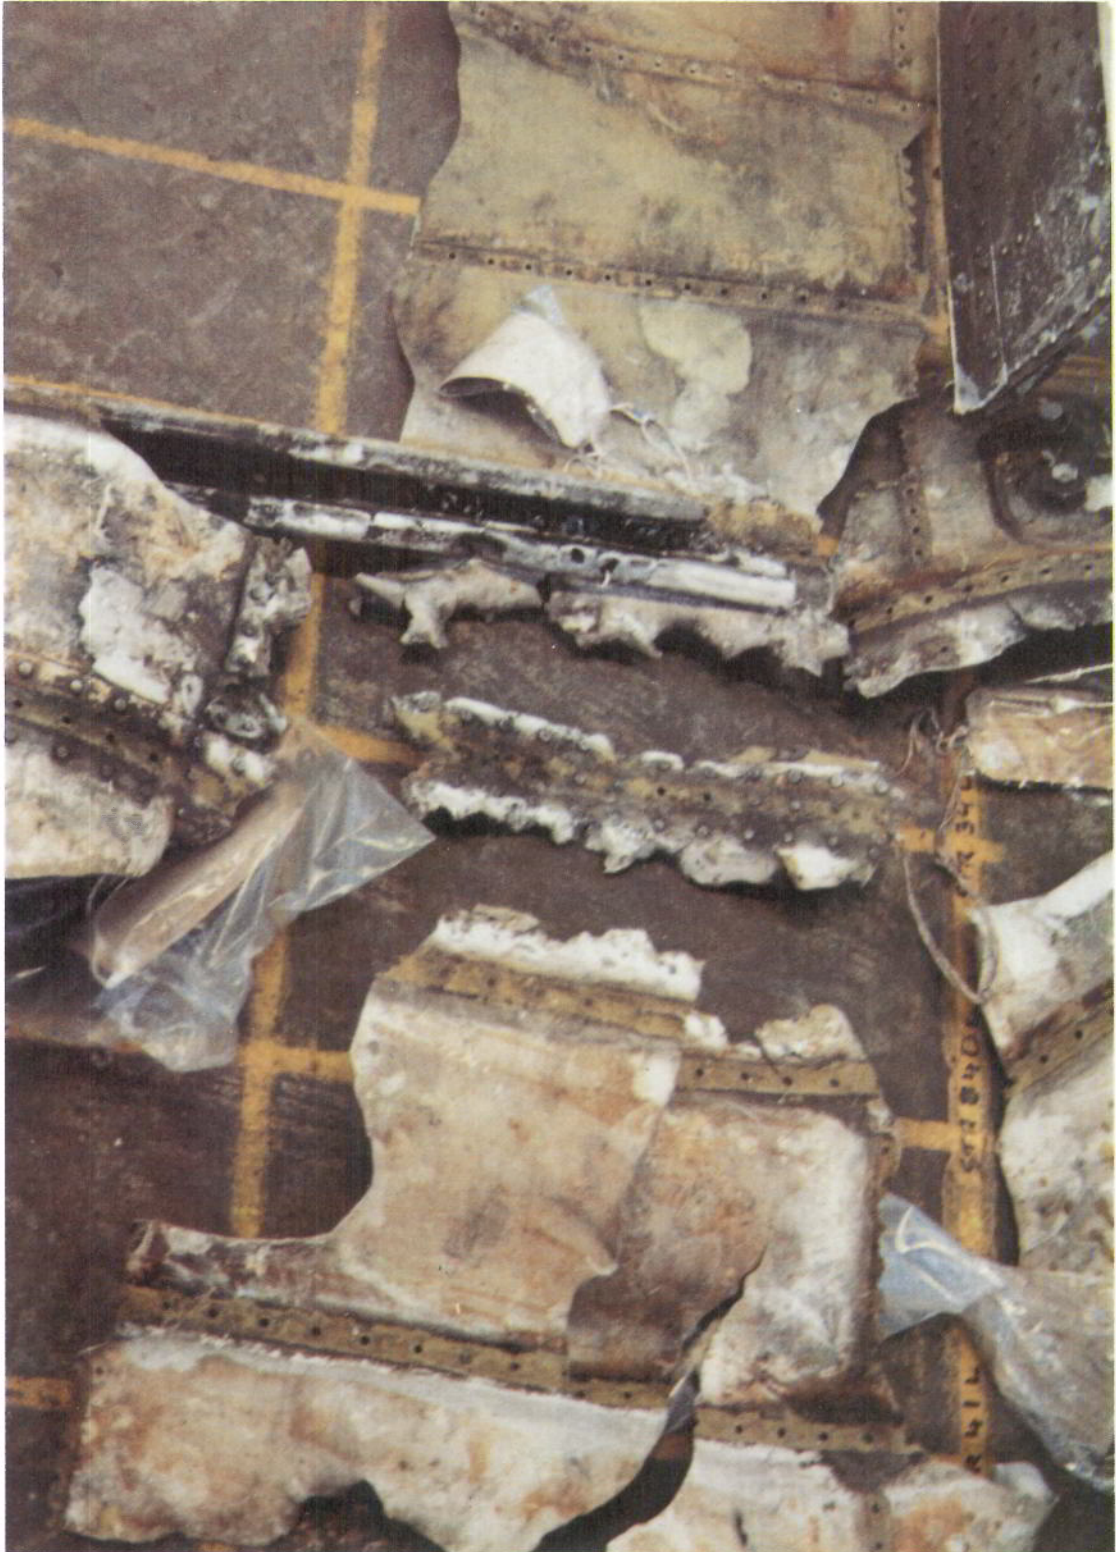
Figure B-15

Detail of shatter zone of fuselage

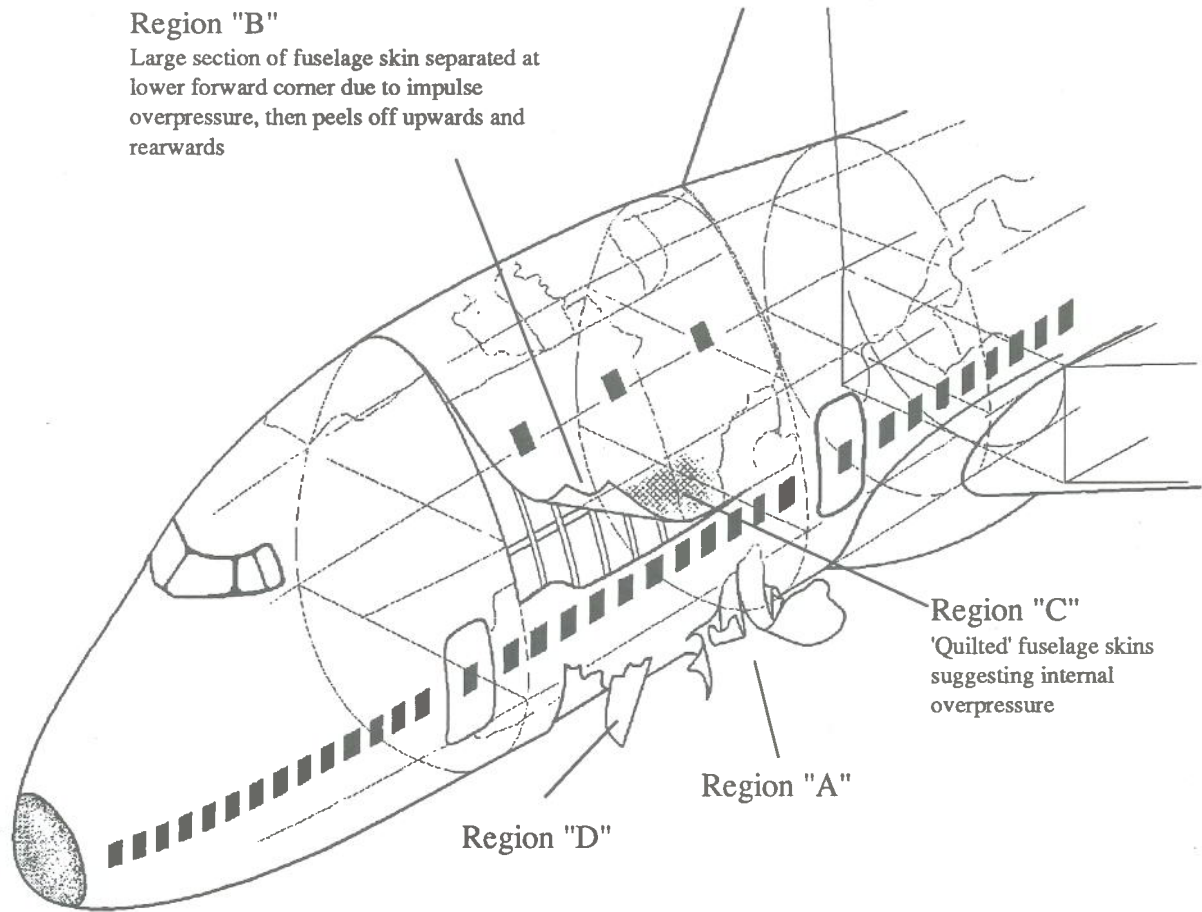
Figure B-19

Large section of fuselage skin separated at lower forward corner due to impulse overpressure, then peels off upwards and rearwards

Region "C"
'Quilted' fuselage skins suggesting internal overpressure

Region "A"
'Star-burst' fracture and petalled fuselage skins

Explosive Damage - left side
(schematic representation)

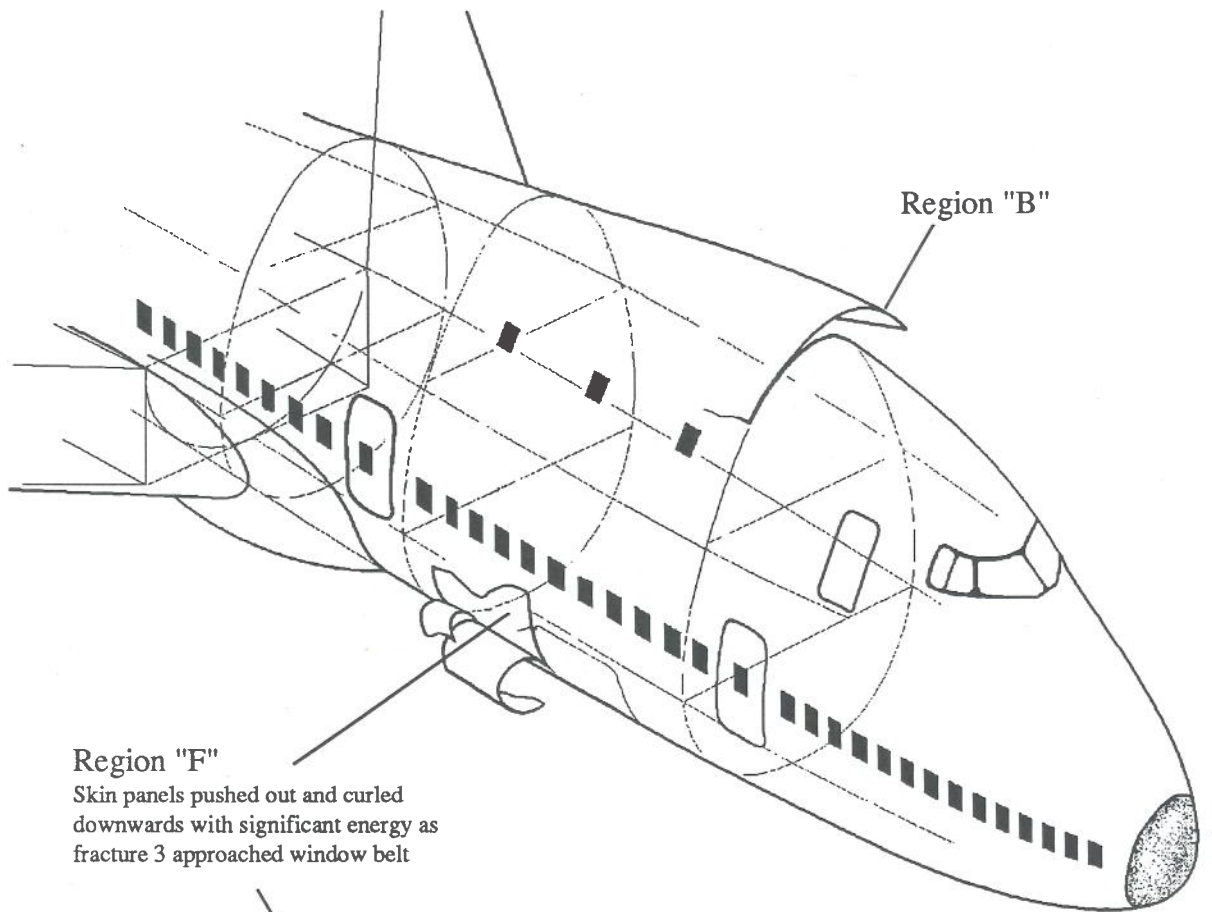
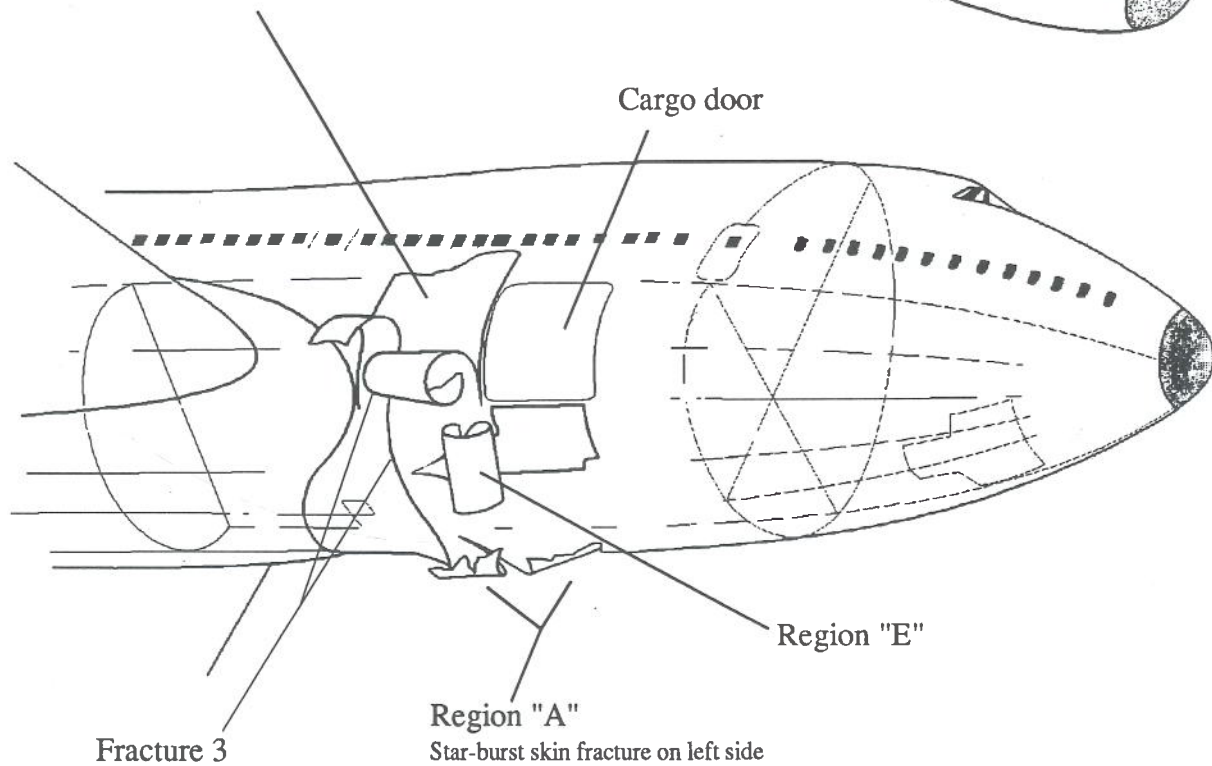
Figure B-20

Explosive Damage - right side
(schematic representation)

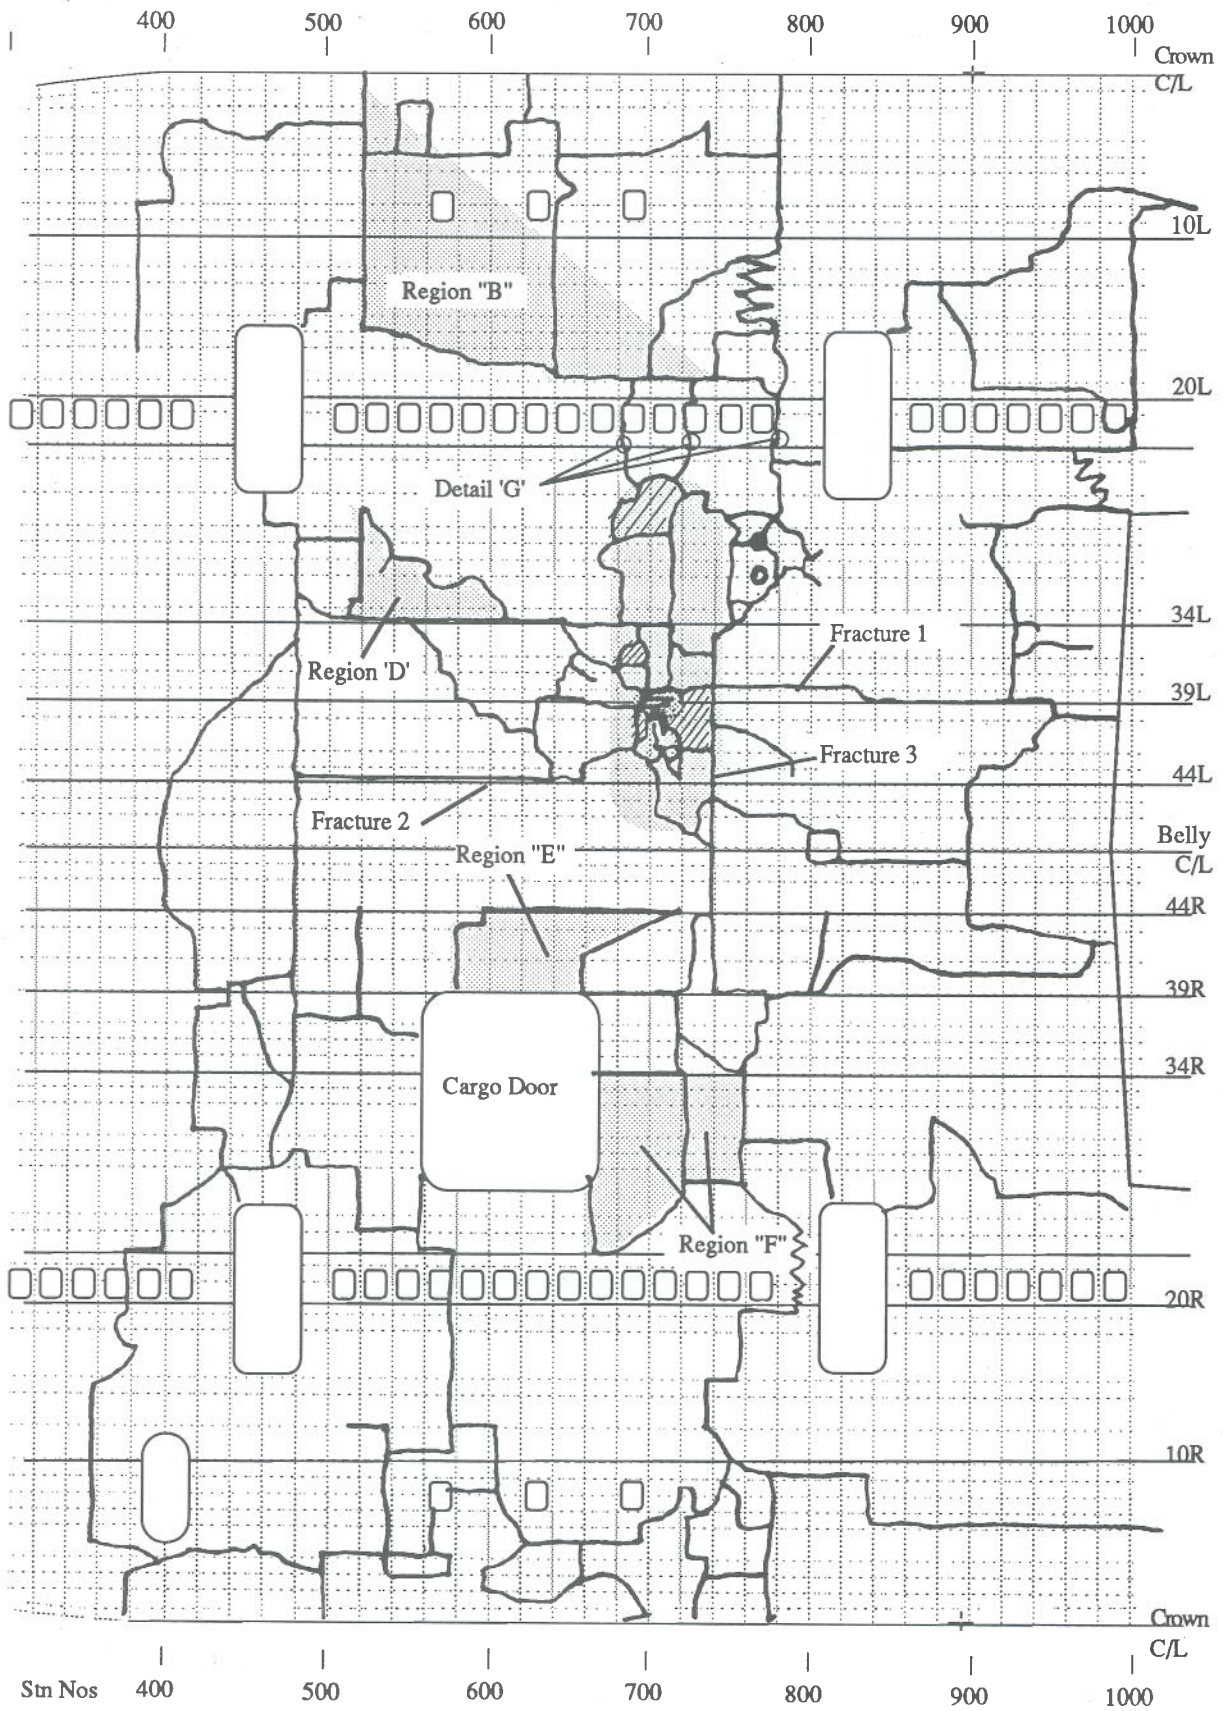
Figure B-21

Skin Fracture Plot

The results of the analysis indicated that, once the large petalled hole had been produced by explosive gas overpressure, the hoop stresses generated by fuselage pressurisation loads acting alone would have been sufficient to drive cracks longitudinally for large distances beyond the boundaries of the petalled hole. Thus, with residual gas overpressure acting as well, the 43 feet (total length) longitudinal fractures observed in the wreckage are entirely understandable. The calculations also suggested that the hoop fractures, due to longitudinal stresses in the skins, would have extended beyond the boundary of the petalled hole, though the excess stress driving the fractures in this direction would have been much smaller than for the longitudinal fractures, and the level of uncertainty was greater due to the difficulty of producing an accurate model reflecting the diffusion of longitudinal loads into the skins. Nevertheless, the results suggested that the circumferential cracks would extend downwards just beyond the keel, and upwards as far as the window belt - conclusions which accord reasonably well with the wreckage evidence.

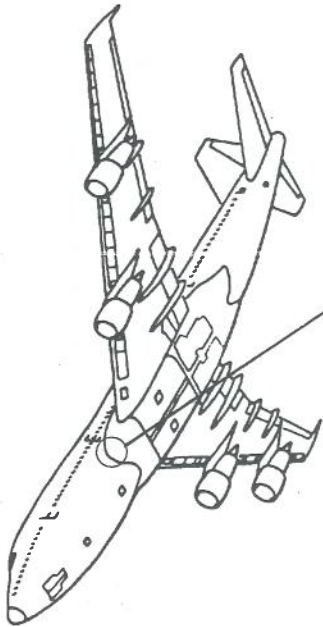
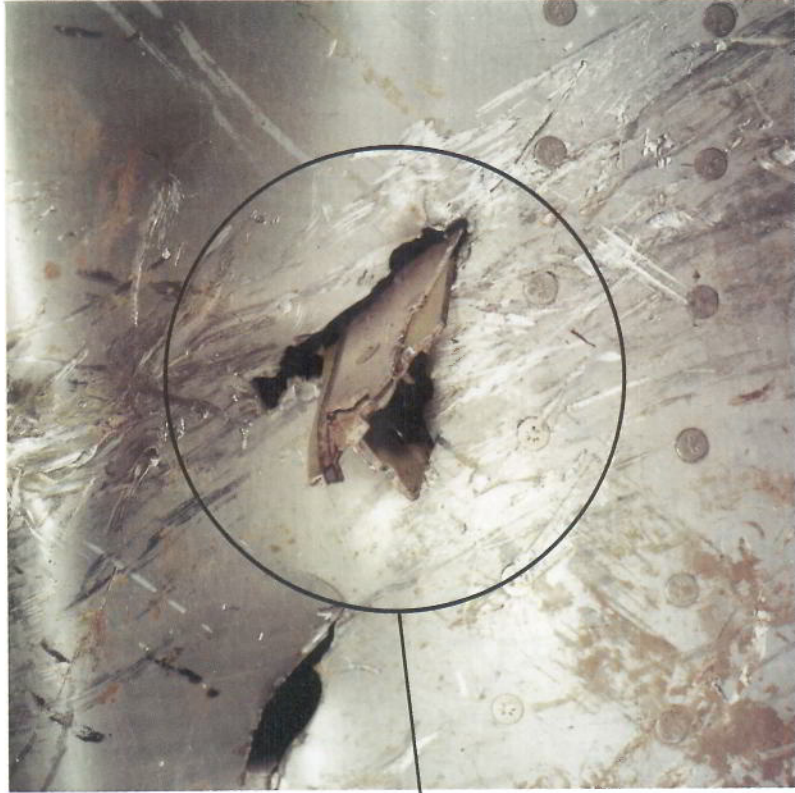
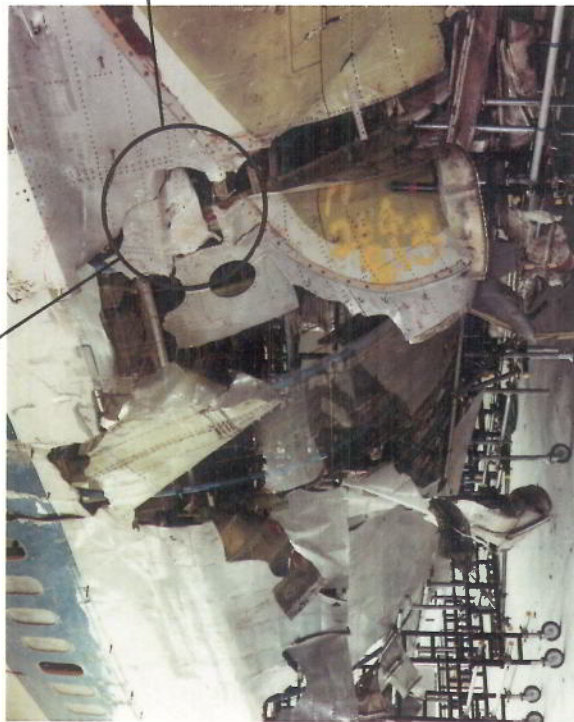
Figure B-22

Spar cap embedded in fuselage

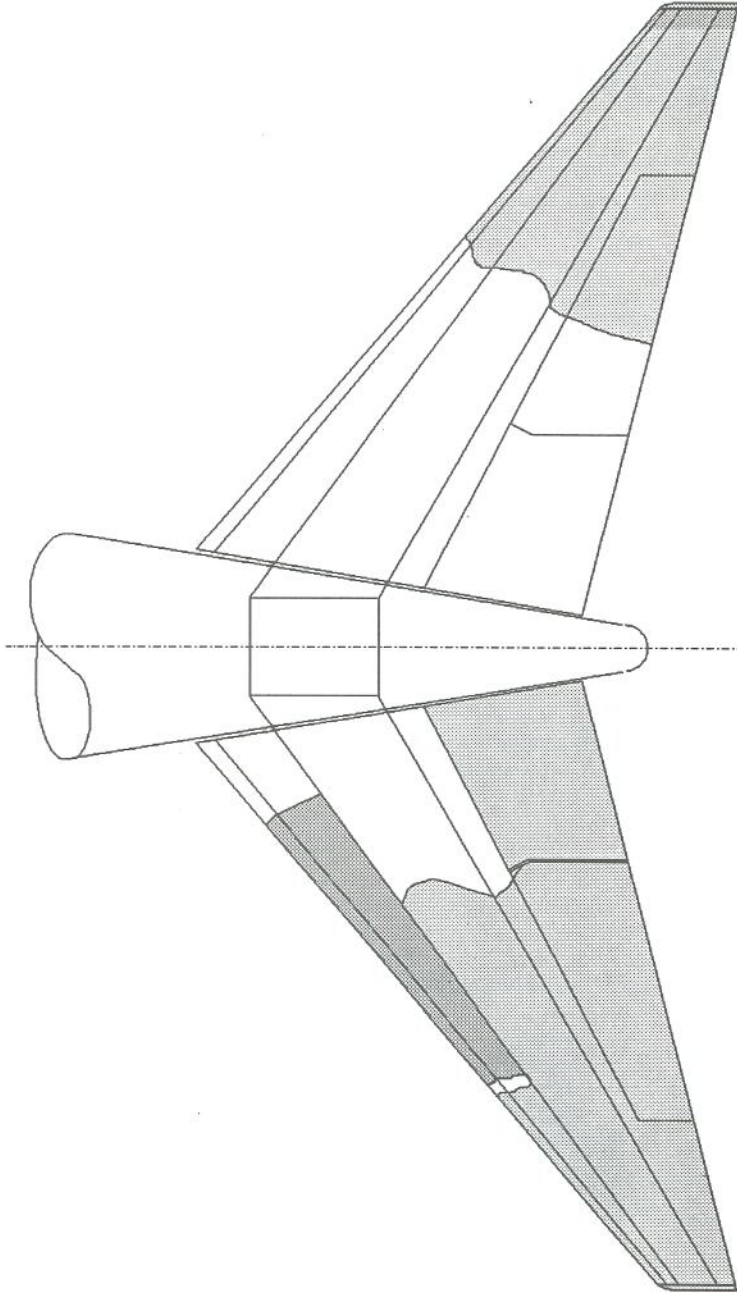
Figure B-23

Initial Damage to Tailplanes

(shaded areas denote wreckage recovered from southern wreckage trail)

A further complicating factor is that the size of this aperture is likely to be sufficiently large to allow complete cargo containers and other debris to be ejected into the airstream, with a high probability of causing catastrophic structural damage to the empennage.

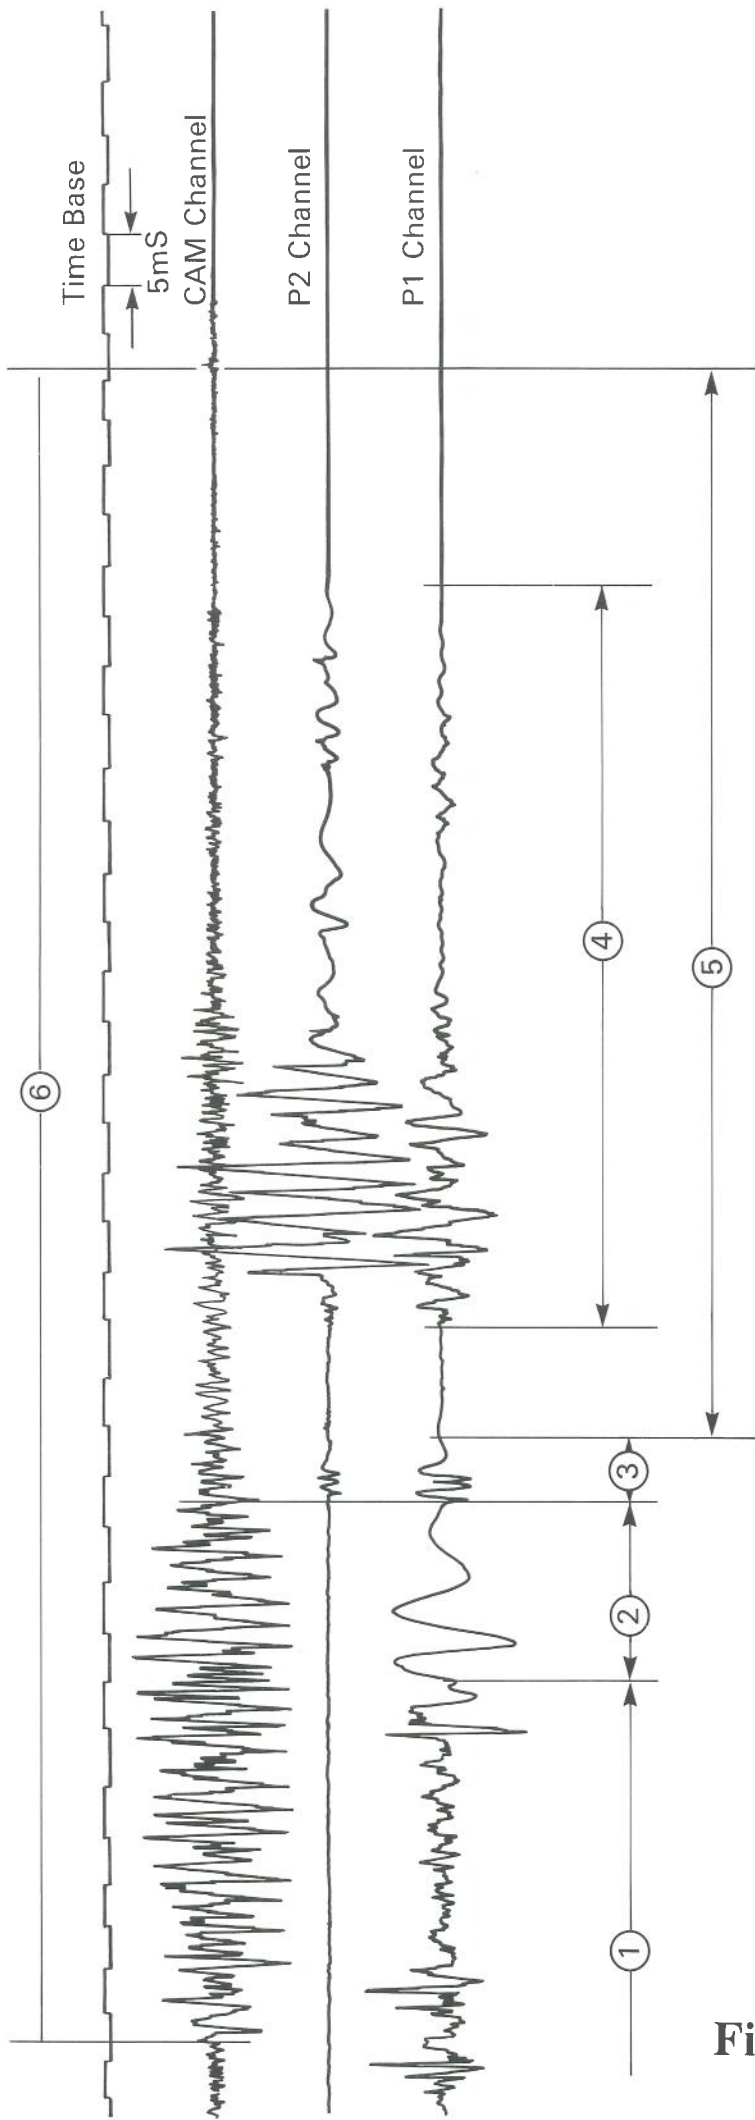
Figure C-8 is an expanded UV trace of the final milliseconds of the CVR record. Three tracks have been used, the flight engineer's RTF channel which contained similar information to the P2's channel has been replaced with a timing signal. Individual sections of interest are identified by number. On the bottom trace, the P1 RTF track, section 1 is part of the Shanwick transatlantic clearance. During this section the loud sound on the CAM channel is evident.

The CAM unit is of the old type which has a frequency response of 350 to 3500 Hz. The useable duration of the signal is probably confined to the first 60 milliseconds of the final 170 milliseconds and even during this period the AGC is limiting the signal. In the remaining time the sound is being distorted because power to the recorder has been disconnected. The ambient cockpit noise may have been high enough to have caused the AGC to have been active prior to the event and in this event the full volume of the sound would not be audible. Distortion from the incomplete erasure of the last recording may form part of the recorded signal.

The end of the recorded signals from the CVR of the final flight of N739PA

In order to respond to events that result in the almost immediate loss of the aircraft's electrical power supply it was therefore recommended during the investigation that the regulatory authorities consider requiring CVR systems to contain a short duration (i.e. no greater than 1 minute) back-up power supply.

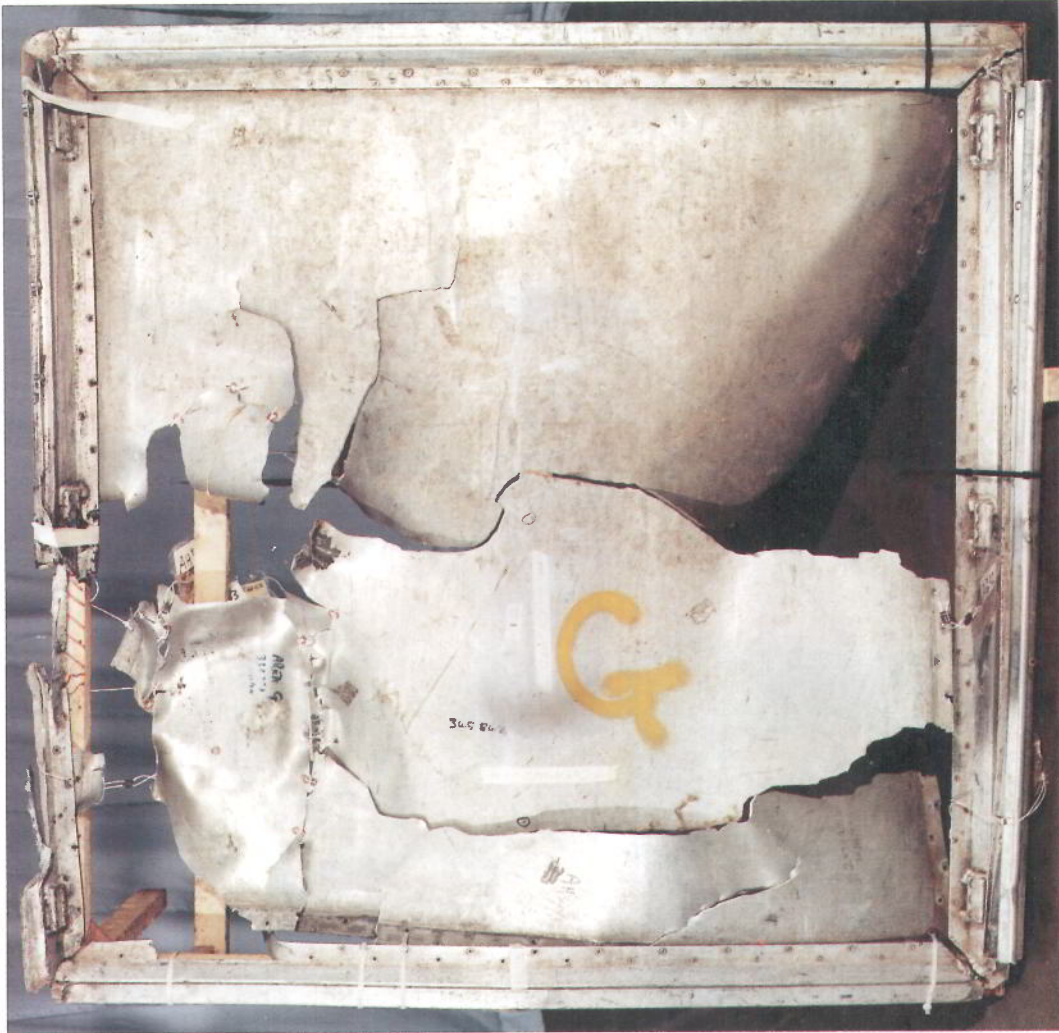
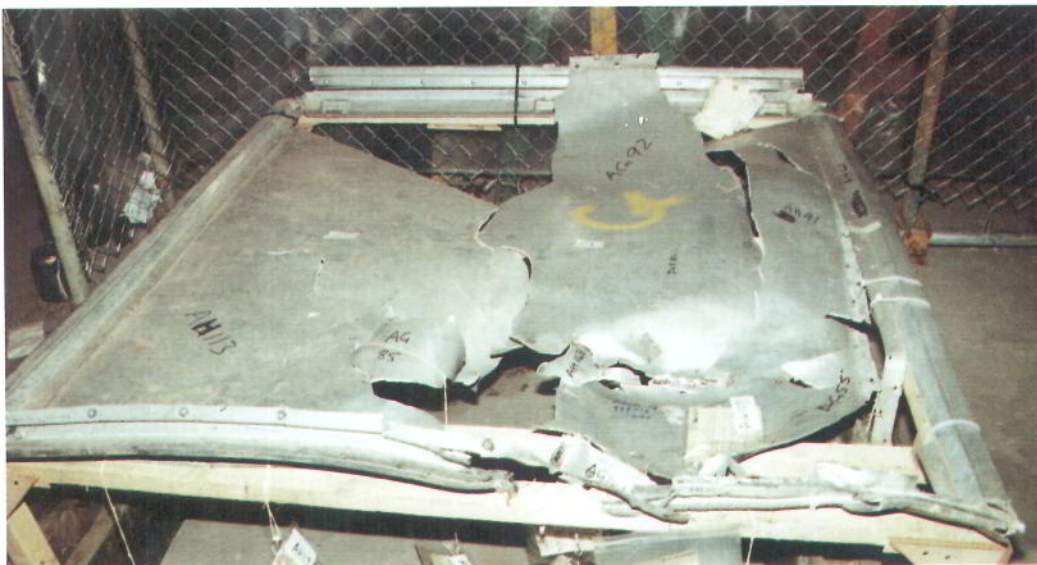
Figure F-3

Detail of Damage to Container Floor

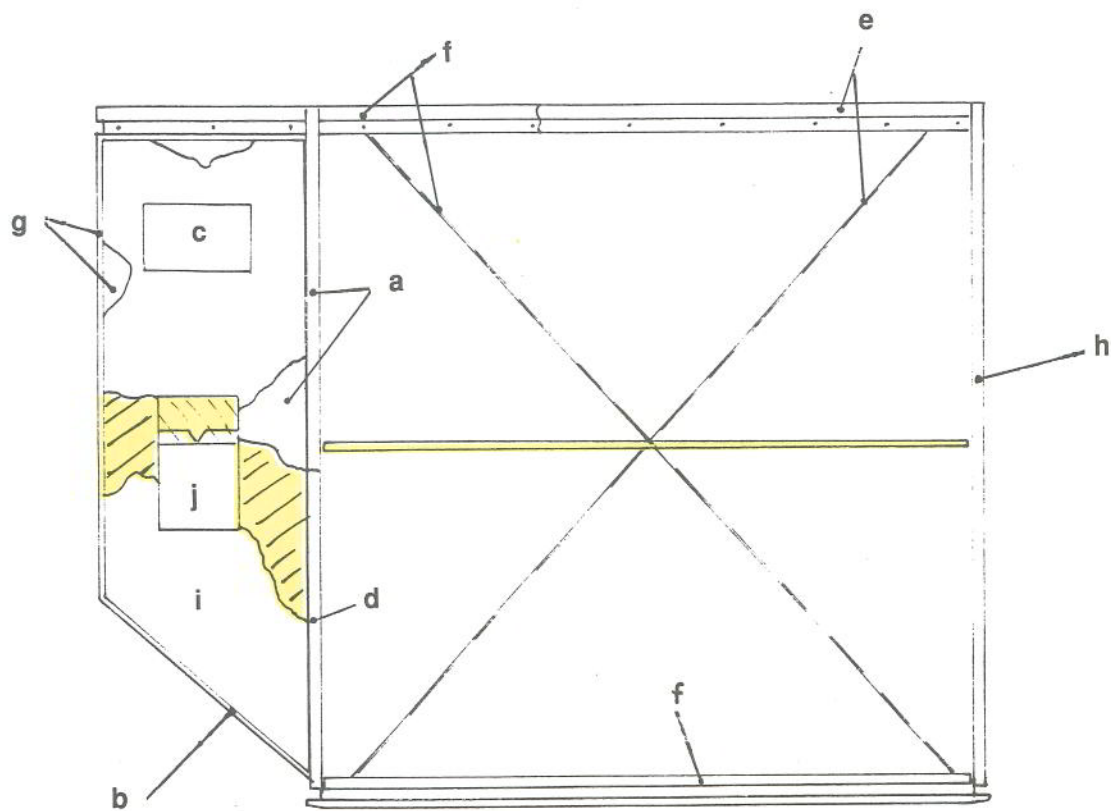
Figure F-5

Blast damage to the forward face of container 7511 was as a direct result of hot gases/fragments escaping from the aft face of container 4041. No evidence was seen to suggest that more than one IED had detonated on Flight PA103.

- a Curtain aperture left side vertical edge member, upper half
- b Sloping face edge member
- c Container manufacturer's data plate containing burnt piece of material which itself contained a fragment of circuit board
- d Curtain aperture left side vertical edge member, lower half
- e Upper edge member, right half, attached to roof edge member and one curtain bar
- f Upper edge member, left half, attached to roof edge member, cutrain wire and lower curtain bar
- g Left edge vertical member
- h Curtain aperture right side vertical member
- i Left side lower skin section adjoining sloping face
- j Soot stained plastic sheet

**Aft face of container AVE 4041 PA, view
looking forward**

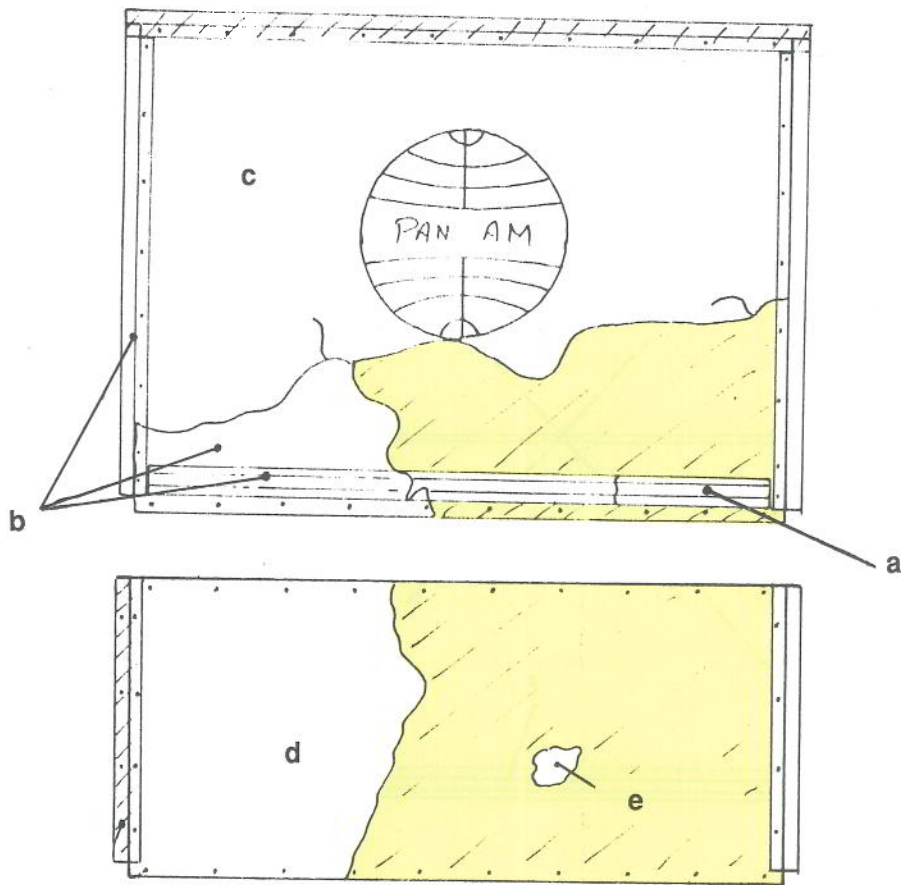
Figure F-6

- a Stiffener section from base of vertical face
- b Vertical face forward edge member, lower stiffener section and skin fragment
- c Distorted upper section of vertical face skin
- d Forward section of sloping face skin, severely distorted
- e Fragment of container skin, provisionally thought to be part of sloping face skin.

Outboard faces of AVE 404

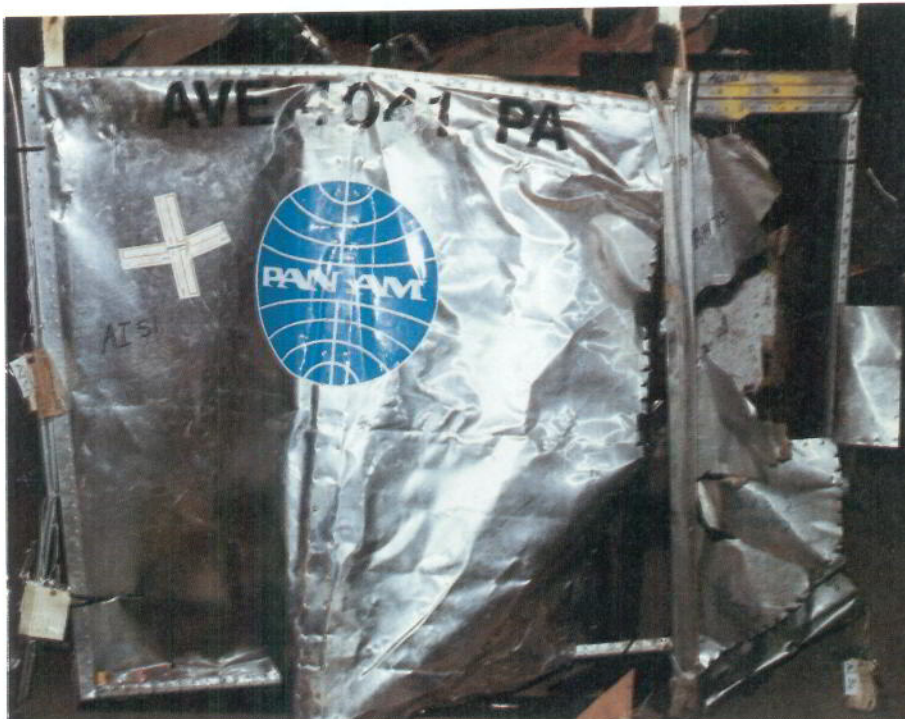
Figure F-7

Forward face of AVE 4041 PA

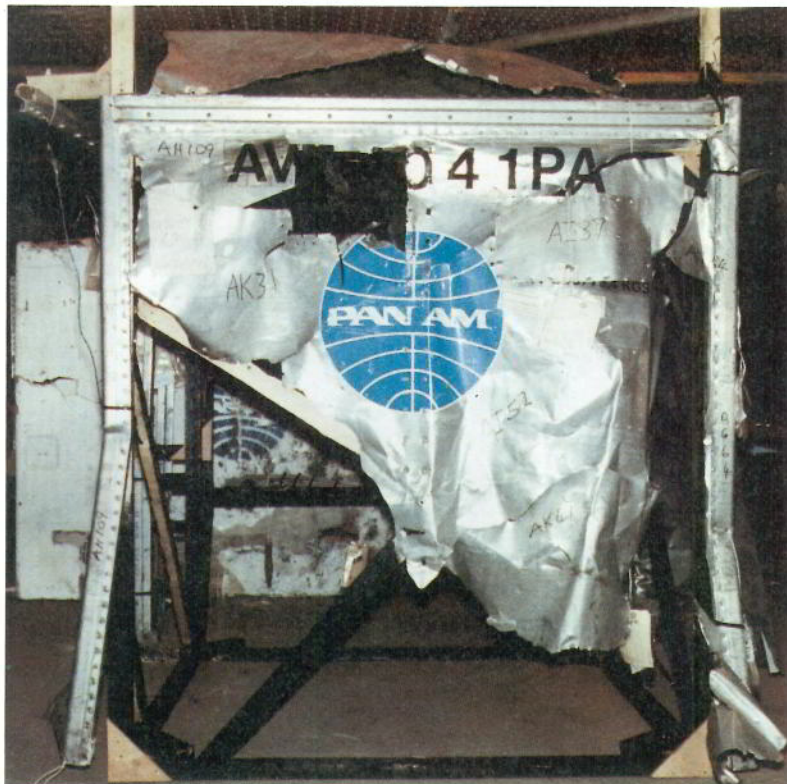
Figure F-8

- a Aft, top and roof edge members including upper section of skin
- b Repair patch from upper right side
- c Mid section of skin including stiffener section
- d Upper skin section
- e Lower skin section
- f Right side vertical edge member attached to lower piece of skin

Inboard face of container AVE 4041 PA

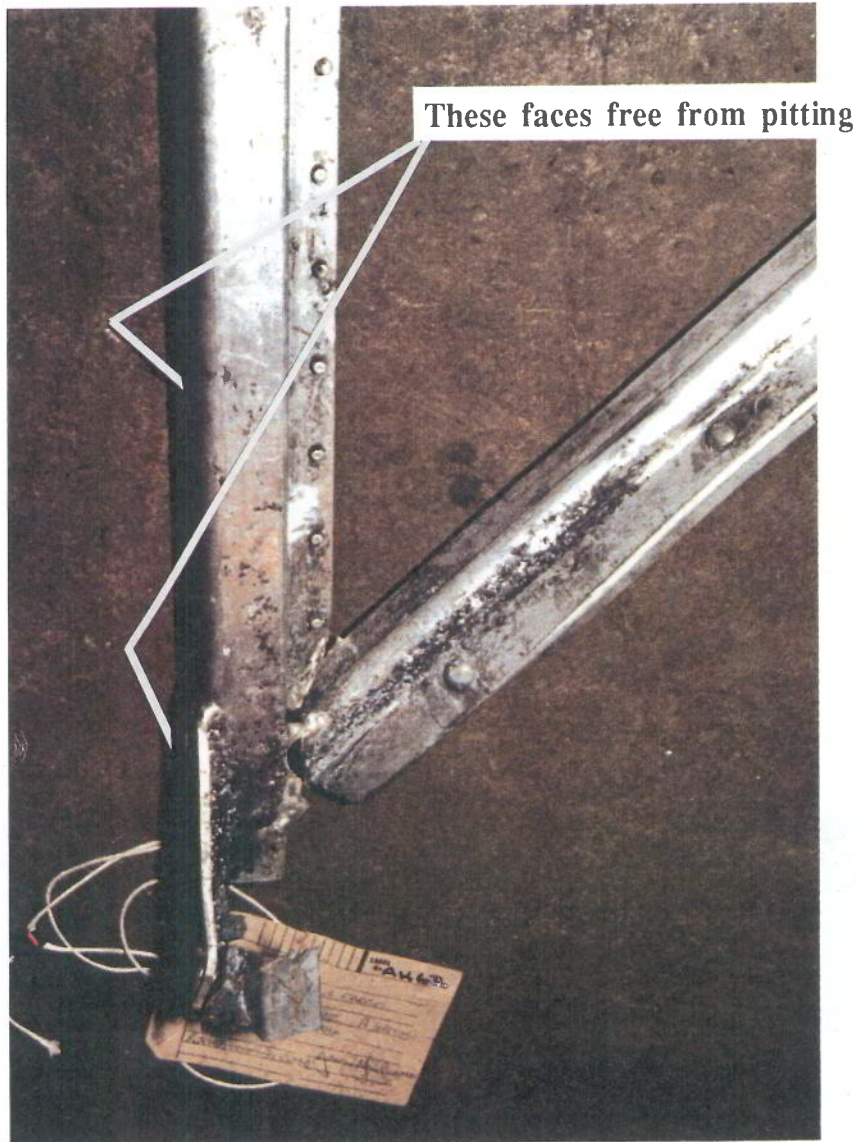
Figure F-9

**Detail of items from aft face of container
AVE 4041 PA showing evidence of blast
damage**

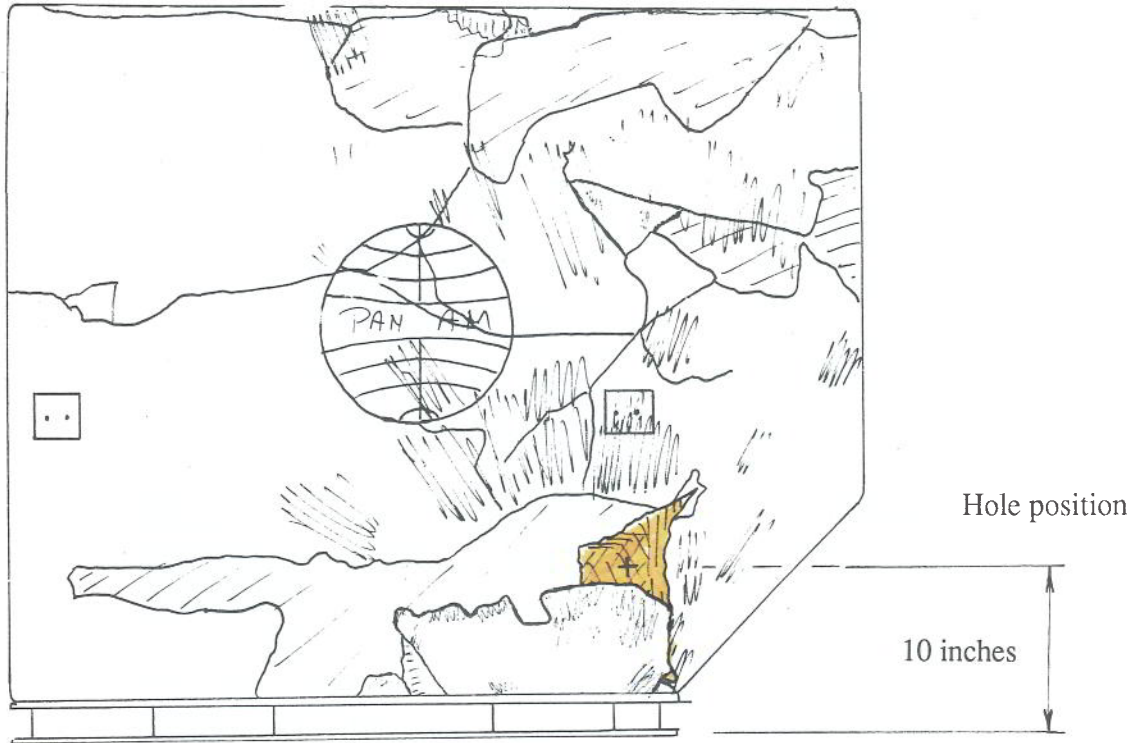
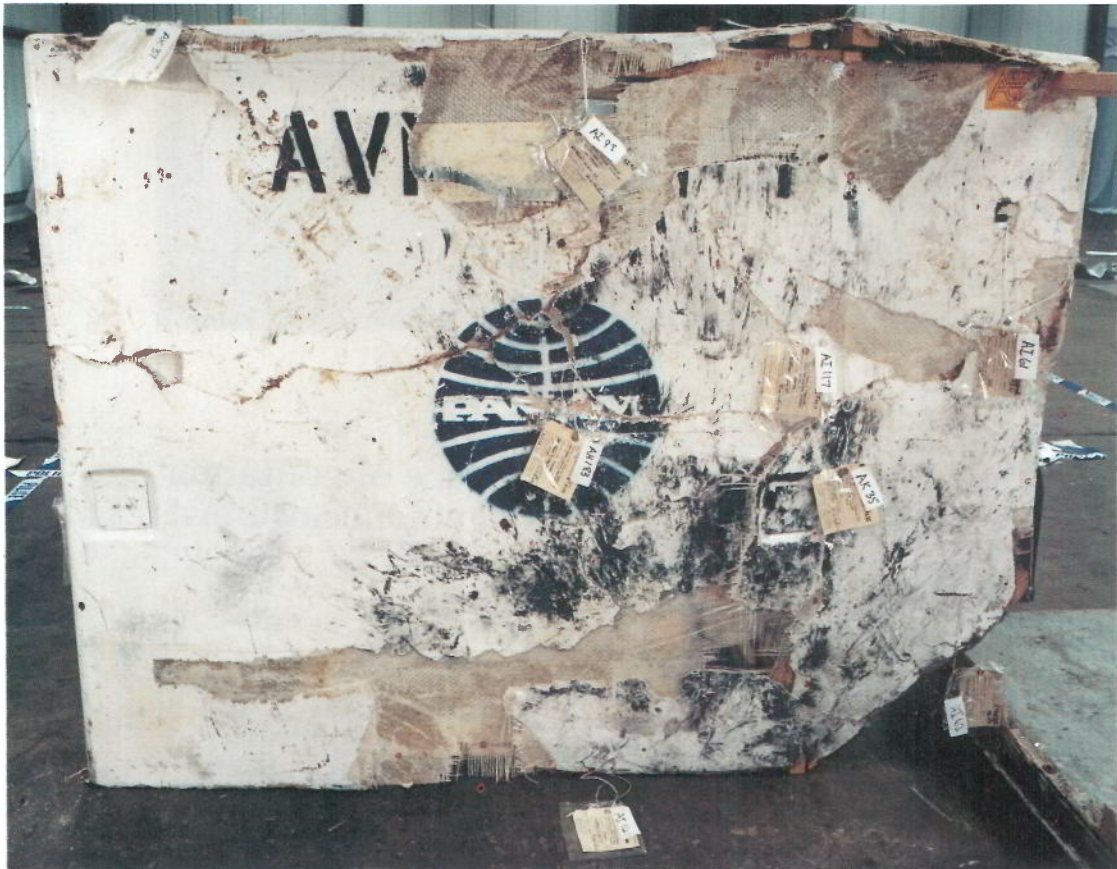
Figure F-10

**Forward face of container AVN 7511 PA,
view looking aft**
