Rail Accident Investigation Branch

Rail Accident Report

Autumn Adhesion Investigation Part 1: Signals WK338 and WK336 Passed at Danger at Esher 25 November 2005

Signals WK338 and WK336 Passed at Danger, Esher, 25 November 2005

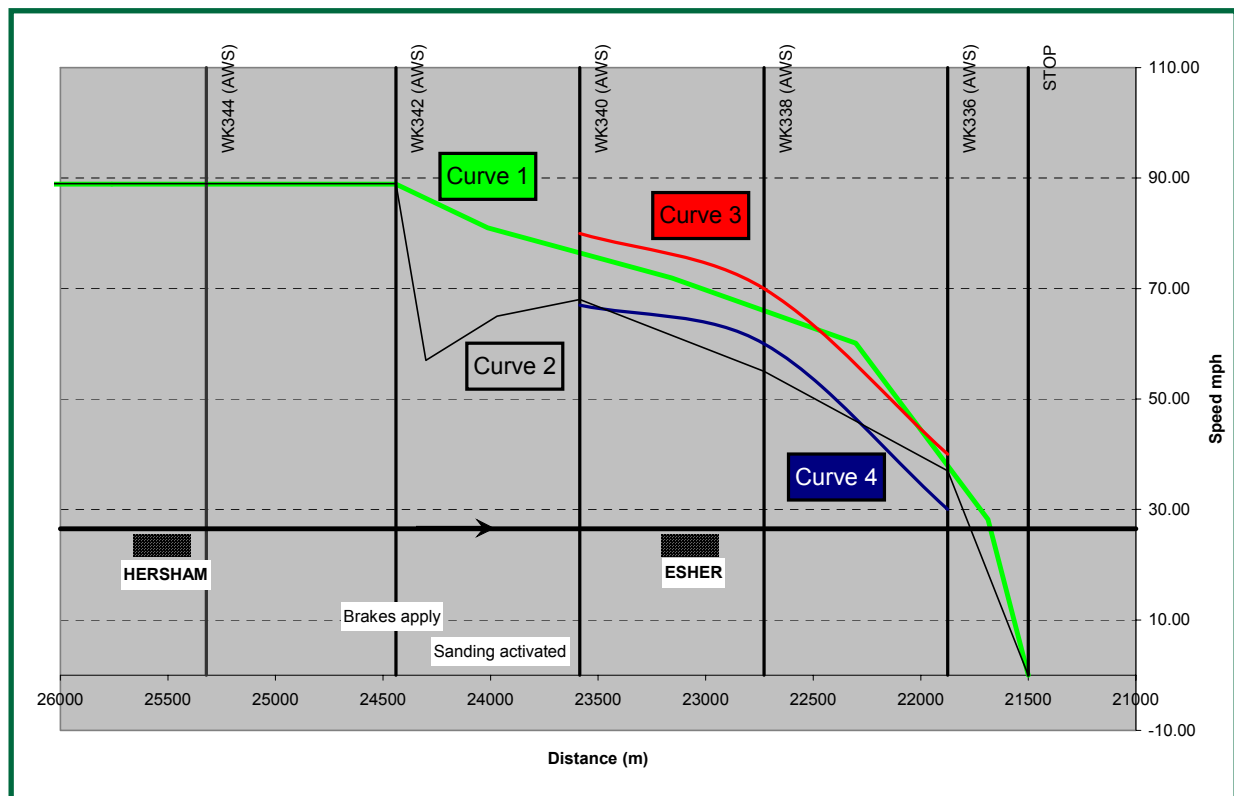
Figure 3: Distance speed graph depicting the events at Esher on 25 November 2005.

67 The OTMR download for unit 450 022 indicates that WSP activity commenced from the moment the brake was applied and continued throughout the duration of the slide until the train stopped. The OTMR download does not identify how many of the four vehicles on the train experienced WSP activity, but confirms that it happened continuously on at least one of the four vehicles.

68 Figure 3 shows train and wheel rotational speeds derived from the following sources:

69 Figure 3 shows that:
