Rail Accident Investigation Branch

**Annual Report  
2013  
Section 2:  
Reported Status  
of RAIB's  
Recommendations  
2013**

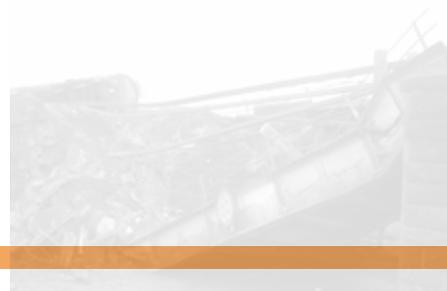
**Annual Report 2013 Section 2:  
Reported Status of RAIB's  
Recommendations 2013**

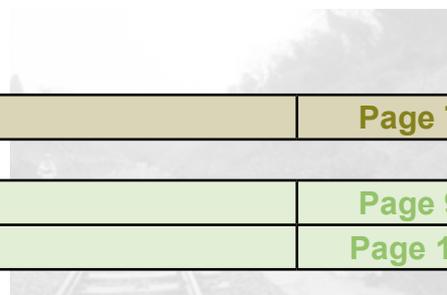
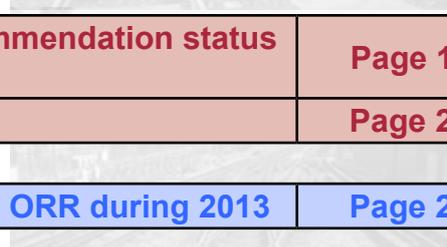
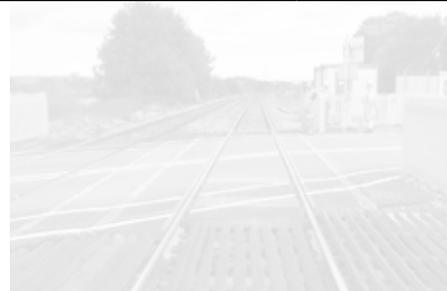
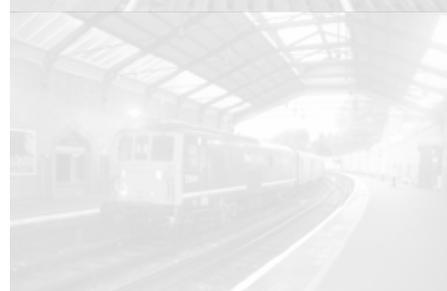
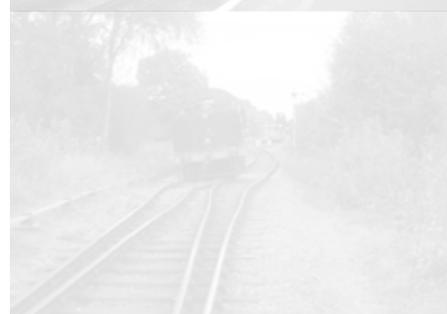
This page is left intentionally blank
