# Frigg Field Cessation Plan Close Out Report

## Close Out Report

Stavanger 12 May 2011

TOTAL E&P NORGE AS

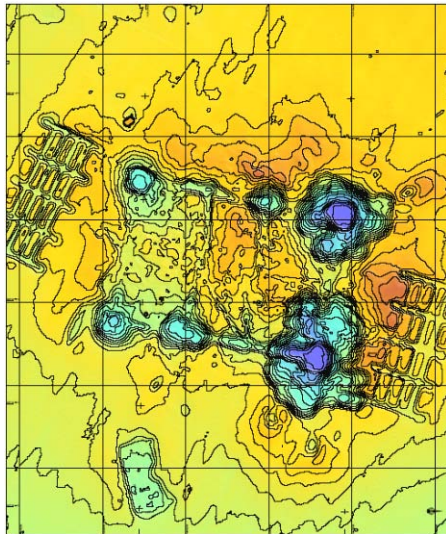
Figure 18 shows the foot prints of the DP1 jacket after the jacket had been removed but before the removal of the debris. These footprints have been filled with gravel in line with the recommendation given in the EIA [1].

**Figure 18.** Foot print of DP1 Jacket after removal showing the debris which have been removed

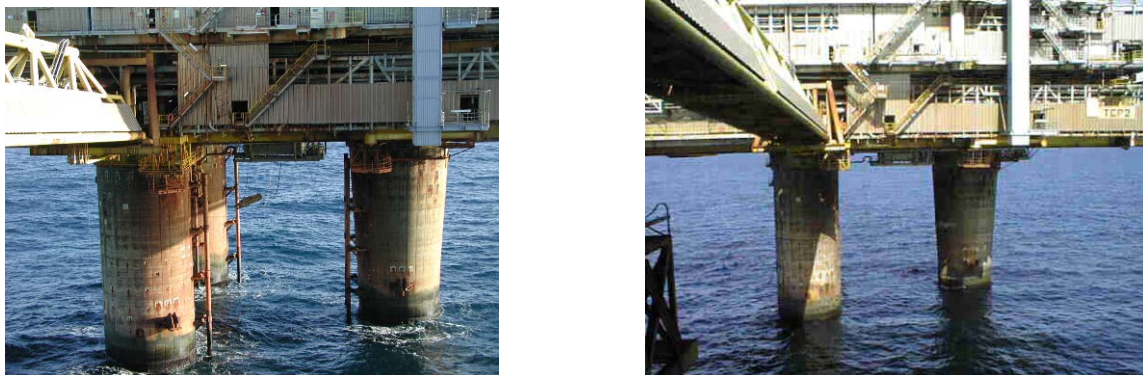
All the identified steelwork above and below water has been removed except for three items. The 5.8 tonne pull-in sheave located on concrete base slab next to the seabed turned out to be impossible to remove despite applying a force of 50 tonnes after all the bolts were cut. As this item would not represent any obstructions to fishing, MPE has agreed to TOTAL Norge's recommendation to leave it in place.

Figure 25. Before and after the removal of utility risers and ladders on one of the TCP2 concrete columns.

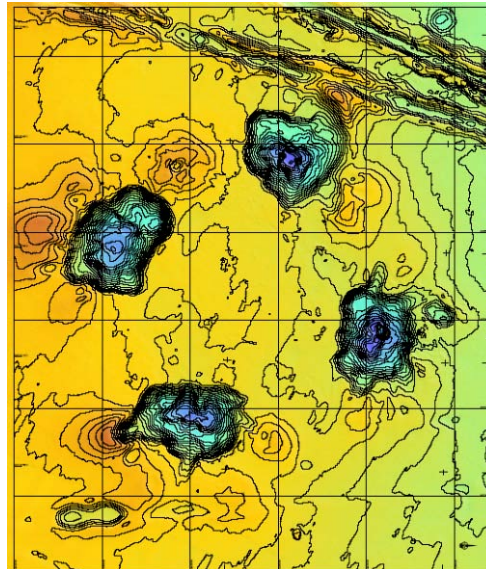
The Environmental Impact Assessment in the Frigg Field Cessation Plan [1] defined the need to cover the remaining sections of the QP jacket piles in the dredged areas as they could represent a potential obstruction to future bottom trawl fishing. Consequently, gravel has been placed where the seabed have been dredged to allow the cutting of the jacket piles.

**Figure 32.** Foot print of QP Jacket after removal

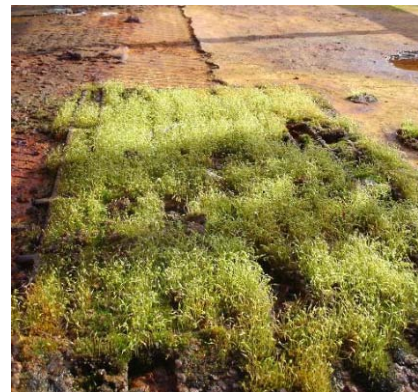
No general maintenance was carried out during the following years. As a result, the removal of the topside facilities was very challenging with specific access concerns in many areas. More than one month was spent in making the platform safe before commencing actively the preparation work required before removal of modules could commence. Safety nets were put in place under the deck which enhanced the safety precautions by providing a second barrier to prevent personnel falling into the sea within the moonpool (inside the outer concrete wall). This was particularly important as the offshore work was undertaken during the winter period when rough weather prevented effective rescue from the moonpool.

**Figure 40.** Grass found growing on the steel deck

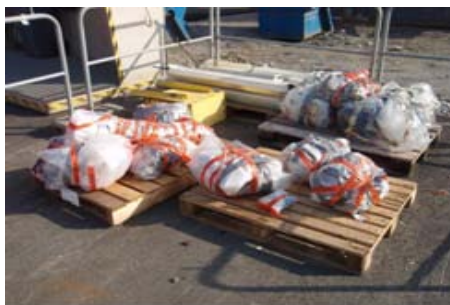
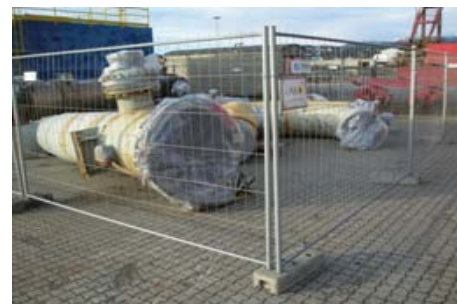
**Figure 51.** Material containing Asbestos which have been isolated before transport to final disposal site
