BRE Global Client Report

BS 8414-1:2015 + A1:2017 test referred to as DCLG test 6.

Prepared for: DCLG
Date: 25th August 2017 (Issue 1.0)
12th September 2017 (Issue 1.1)
Report Number: B137611-1037 (DCLG test 6) Issue 1.1

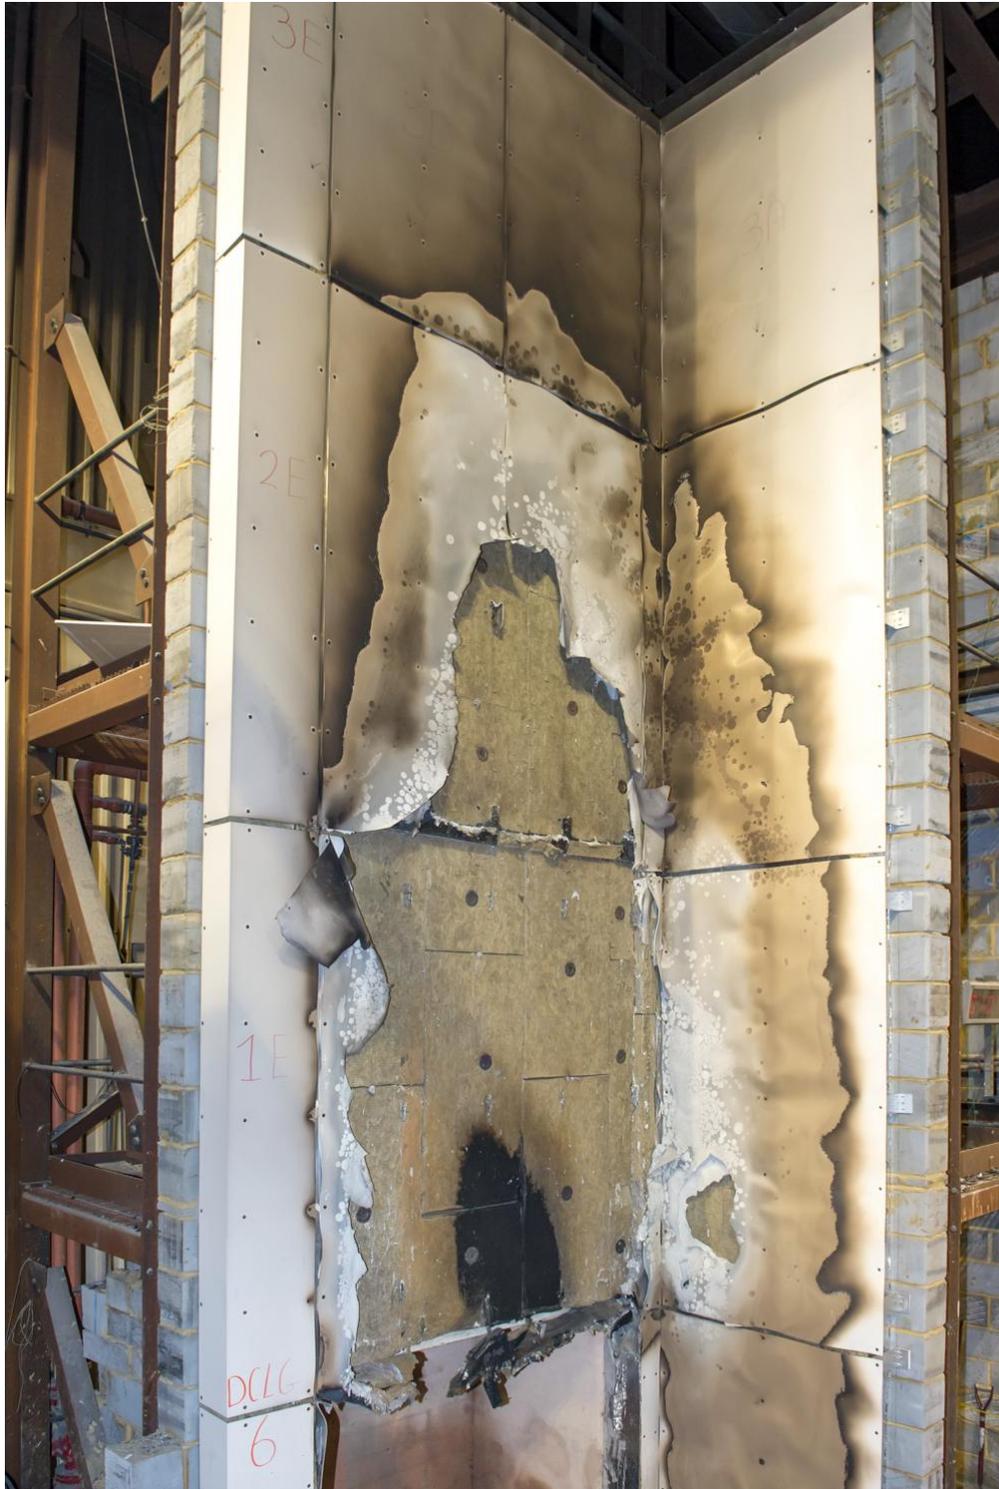
Figure 19. Full height photograph of system post-test.

The cladding system was damaged across the full height – see *Figures 19-25*. The extent of the damage increased from black discolouration of the ACM panels at the edges of the flame damage zone to complete consumption of panels, rail substructure and substantial discolouration of the insulation directly above the combustion chamber opening up to a height of approximately 5000mm above the combustion chamber.

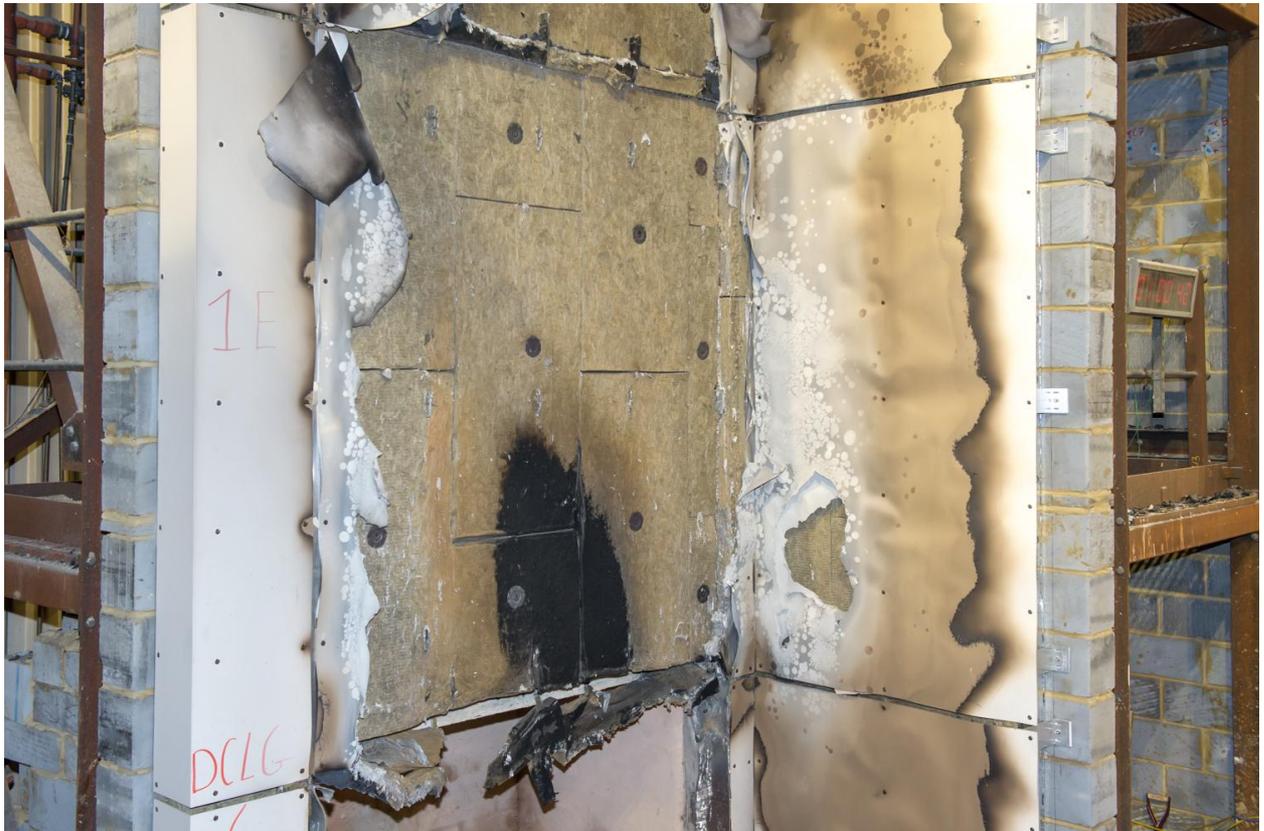
Figure 20. First row ACM panels (directly above combustion chamber).

Panel 1D - Extensive damage to the panel. Approximately 90% of the panel was consumed during the test. A section of the panel adjacent to panel 1E remained attached to the frame.

Panel 1C - The panel was fully consumed.

Panel 1B - The panel was extensively damaged and approximately 40% of the central section of the panel had been consumed during the test. Two sections of the panel at the top and base remained attached to the framing system.

Panel 1A - The panel distorted and was discoloured across approximately 80% of the surface. The panel remained in place. An opening in the panel, approximately 400mm x 400mm (0.16m²), exposed the stone wool insulation beneath.

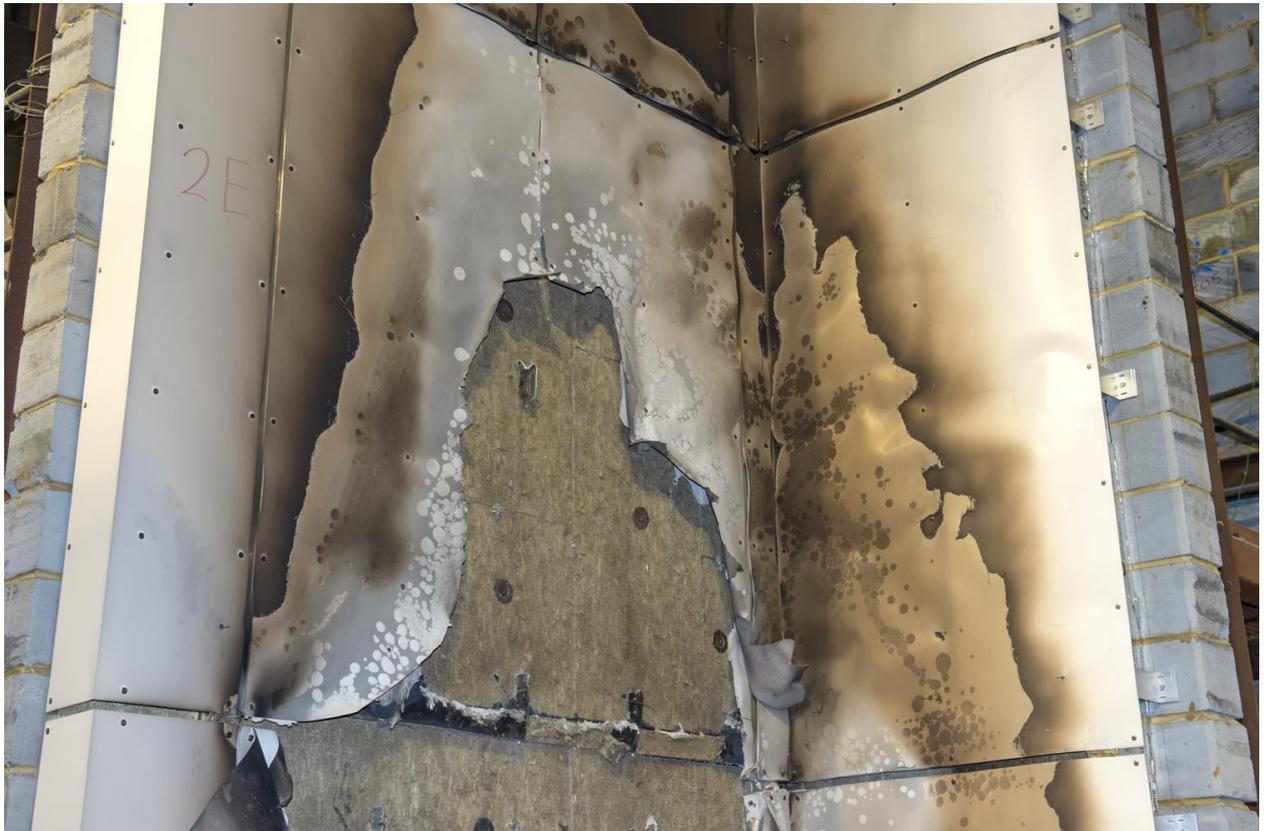
Figure 21. Second row ACM panels (approximately 2300mm-4600mm above combustion chamber).

Panel 2D - The panel was extensively damaged. A section of panel, 1600mm-high x 500mm-wide (0.8m²), had been consumed exposing the insulation beneath. The remaining panel was distorted and damaged.

Panel 2C - The panel was extensively damaged. A triangular section of panel, approximately 1600mm-high x 1200mm-wide (0.96m²), was consumed during the test. The remaining panel was distorted and damaged but remained attached.

Panel 2B – The panel remained intact. Damage and distortion was observed across the full height.

Panel 2A - The panel remained intact. Damage and distortion was observed across the full height. The area of damage was adjacent to panel 2B and approximately 900mm wide at the base, approximating a triangle, reducing to 20mm at the top of the damage. The main area of damage (approximately 0.97m²) stopped 150mm from the top edge of the panel.

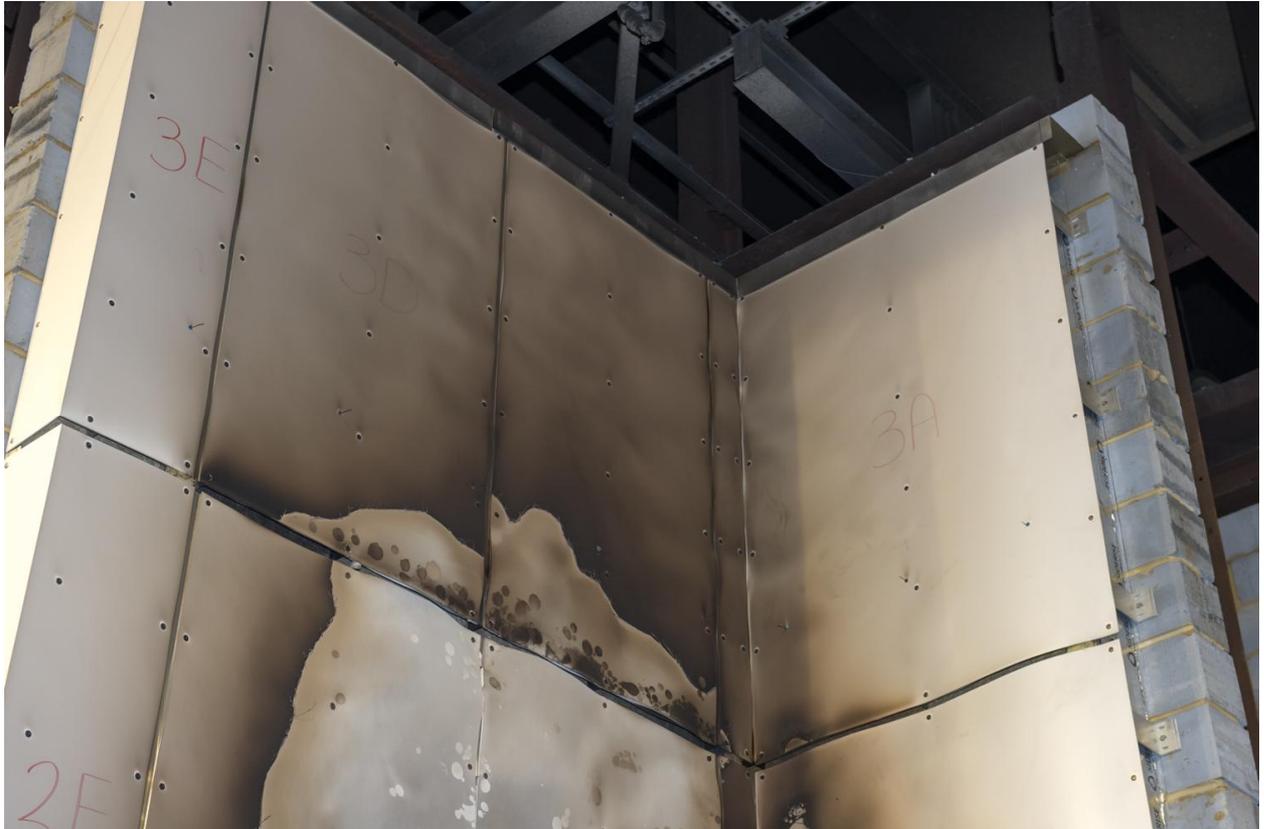
Figure 22. Third row ACM panels (approximately 4600mm-6500mm above combustion chamber).

Panel 3D - The panel remained intact but suffered distortion. There was an area of damage to the panel approximately 750mm-wide x 200mm-high (0.15m²).

Panel 3C - The panel remained intact but suffered distortion. There was an area of damage the full width of the panel with a maximum height of 400mm, adjacent to panel 3D, which tapered to 180mm at panel 3B (approximately 0.27m²).

Panel 3B - The panel remained intact but suffered distortion. There was a small area of damage on the bottom left hand corner of the panel.

Panel 3A - The panel remained intact but suffered distortion. There was a small area of damage to the bottom edge closest to the main wall (approximately 600mm-wide).

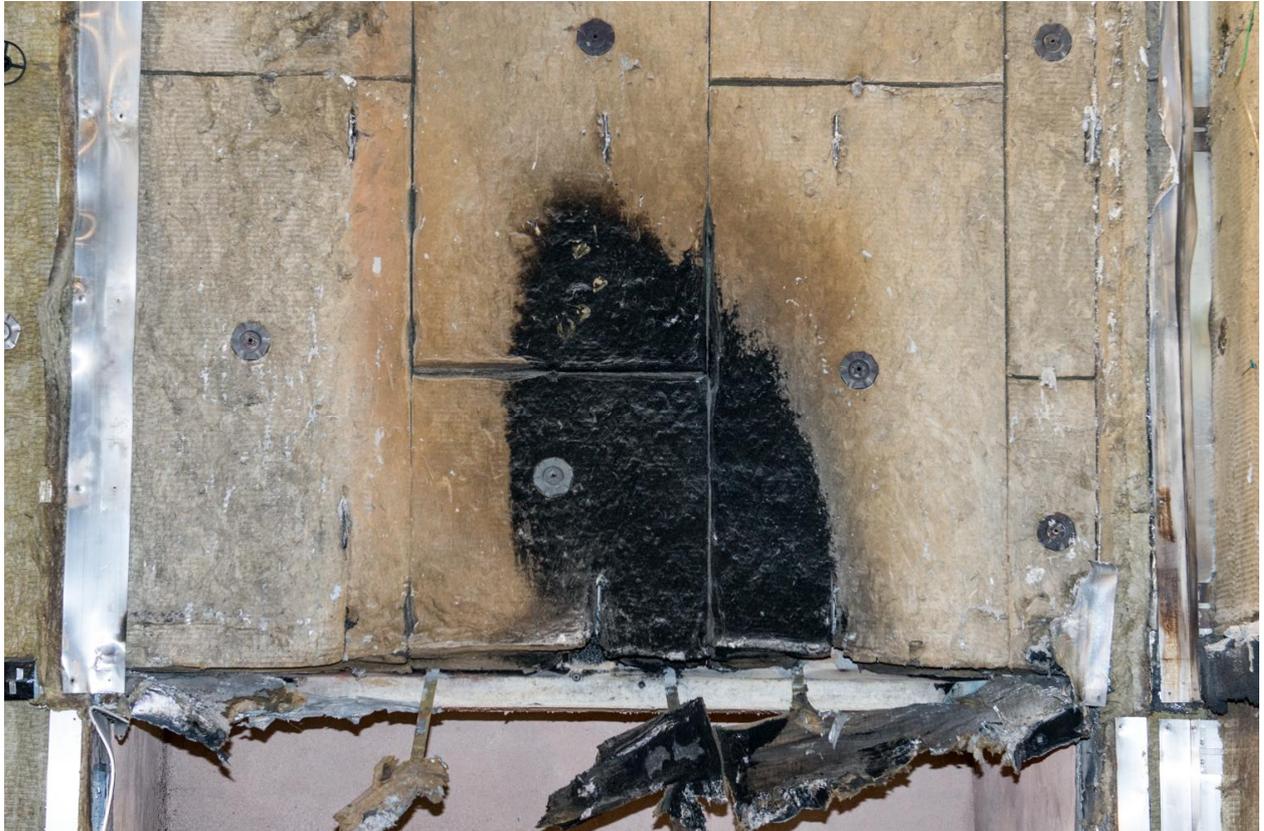
Figure 23. Close up of melted window pod and collapsed horizontal cavity barrier directly above the combustion chamber.

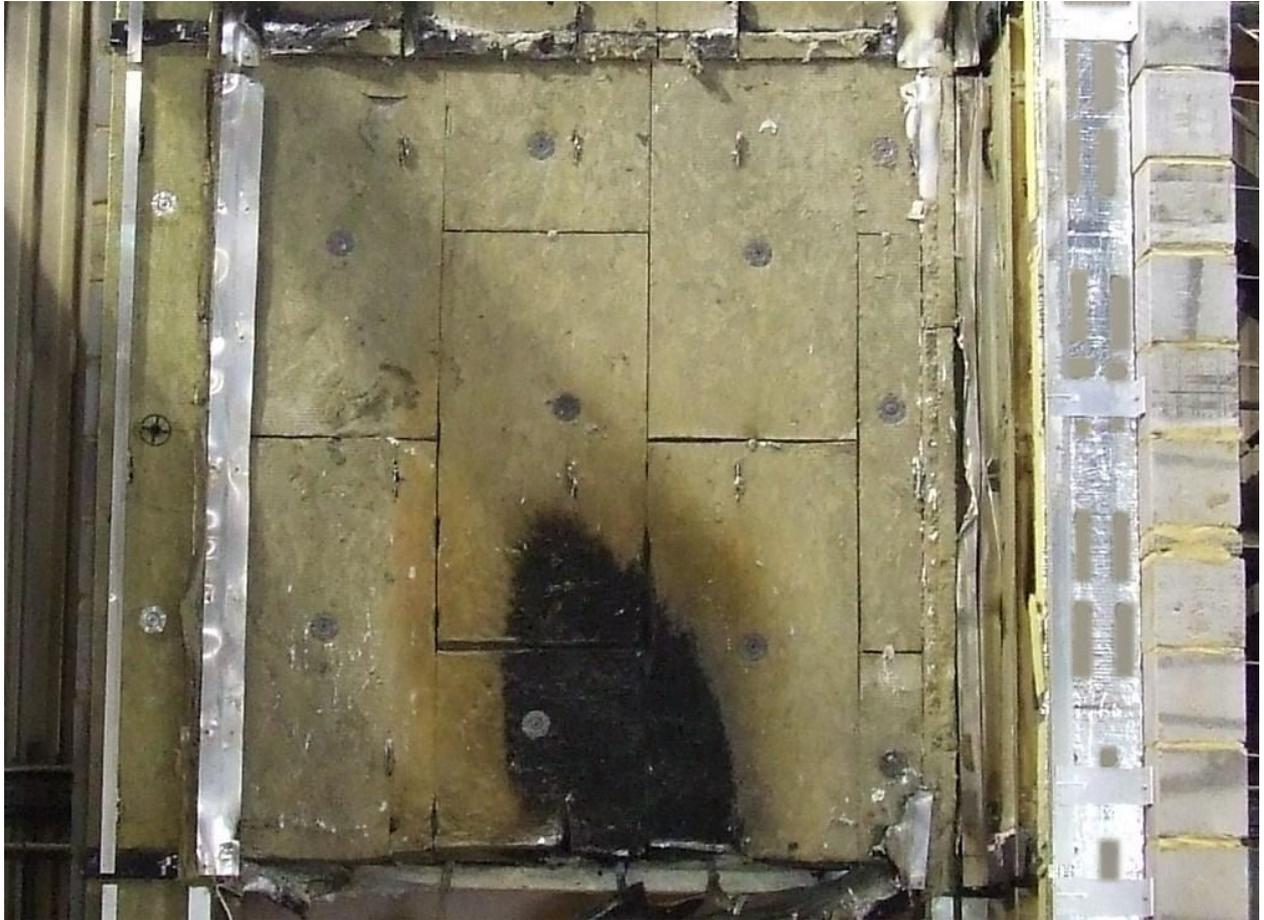
Figure 24. Close up of charred section of stone wool insulation directly above the combustion chamber.

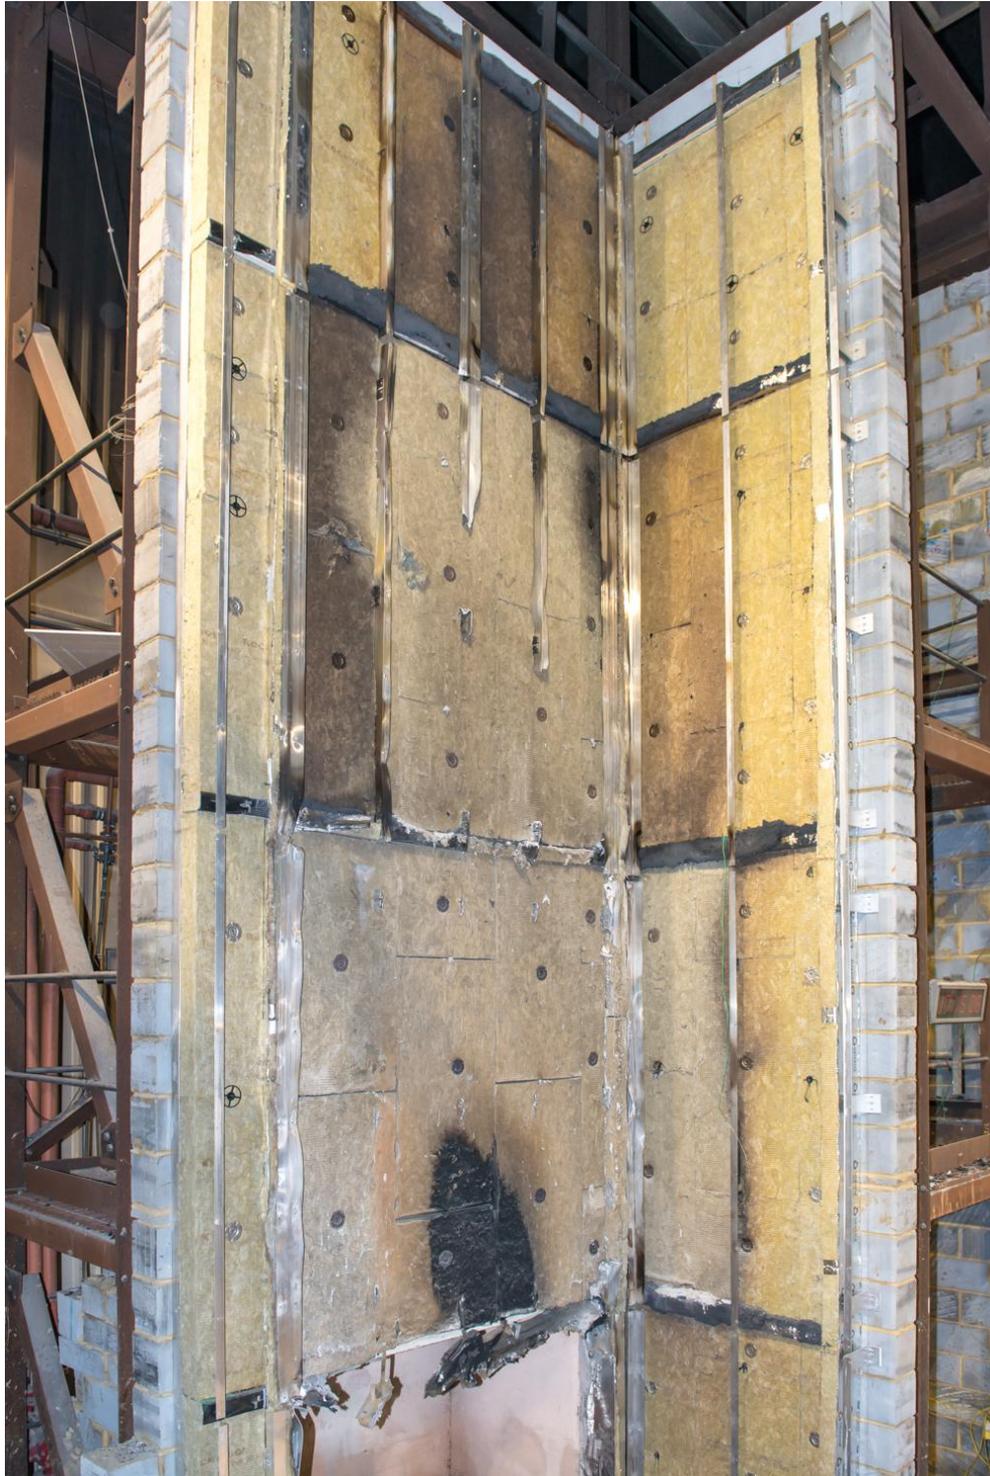
Figure 25. Full height photograph of cladding system following removal of ACM panels.

The wing wall was less severely damaged than the main wall with one area of panel consumption located on panel 1A. There was ACM panel discolouration up to panel 2A and distortion of the panel above this. Beneath the ACM panels on the wing wall, insulation discolouration (concentrated in the region of panel consumption) was limited to below the height of the third cavity barrier.

Panels 2C&2B - the insulation remained intact and appeared pale and bleached of its original colour. There was an area of soot staining in the top right hand corner. No plastic fixings remained.
