SS Richard Montgomery

Background

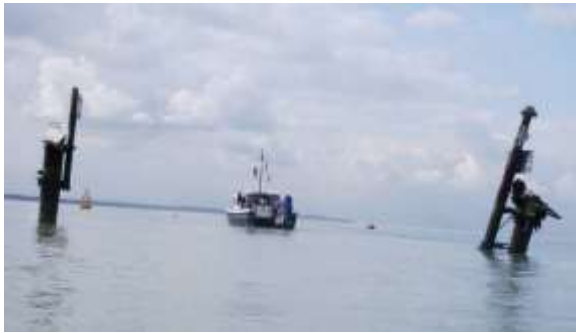
Photograph of the wreck during 2013 hull thickness survey.

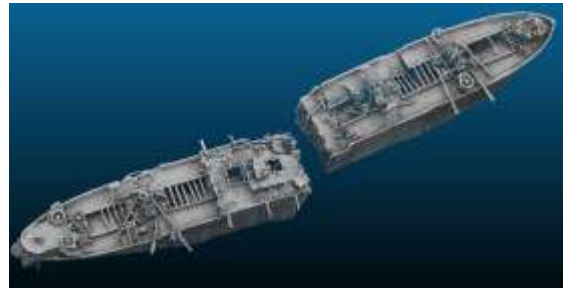
Multibeam sonar image of the wreck, 2012
