MARINE ACCIDENT INVESTIGATION BRANCH

1/2011

SAFETY DIGEST Lessons from Marine Accidents No 1/2011

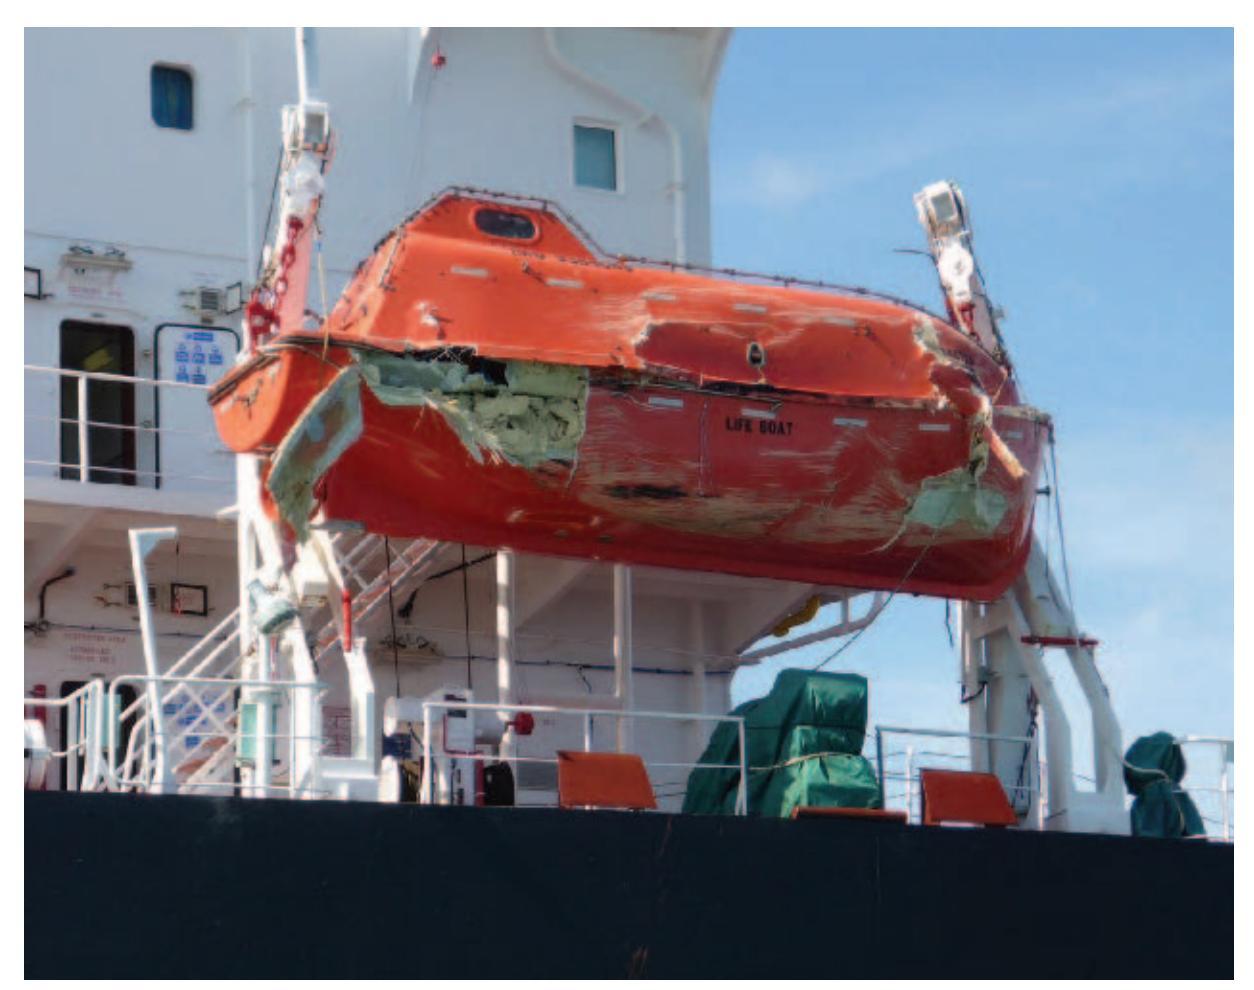
Figure 1: Damage caused to the lifeboat

As the manoeuvring vessel's bow swung very slowly to port towards the other vessel, the superintendent ordered 'slow astern'. This time, the engine started and the superintendent immediately ordered full astern followed by a series of engine and helm orders given in rapid succession. Seconds later, the manoeuvring vessel's port anchor struck the starboard lifeboat on the other vessel (see figure). The manoeuvring vessel's engine failed to start because a dirty air start pilot valve had not allowed starting air to pass into the cylinder.

- 1. When manoeuvring in close proximity to another vessel or navigational hazard the possibility of something going wrong must be carefully considered. In such situations, bridge and MCR teams need to be trained and ready to respond quickly and effectively to engine and steering failures.

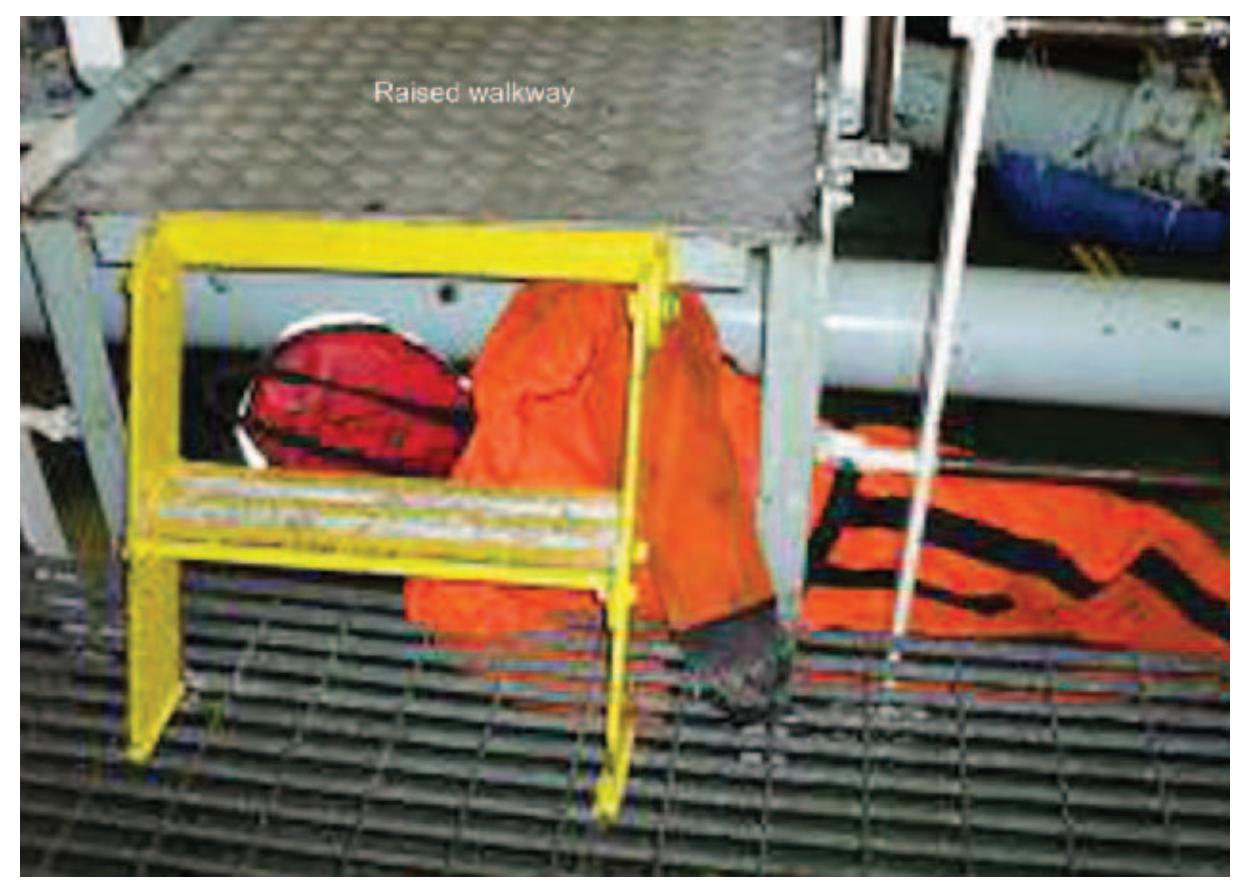
Figure 1: A demonstration of where the motorman was pinned

A short while later, the chief engineer went to the steering gear flat to check on the motorman's progress. When he arrived there, he found the motorman pinned between the steering gear connecting rod and a raised walkway frame (Figure 1). The coastguard was alerted and the motorman was airlifted to the nearest hospital, where he received medical treatment for crush injuries to his vertebrae and pelvic region. As he had leant through the gap in the rails (Figure 2), the motorman's high visibility jacket had become snagged on a connecting rod coupling. At the same time, a hard-over rudder movement was executed which resulted in him being dragged in between the connecting rod and the raised walkway frame, where he became trapped.

- On this vessel, the railings around the steering gear were not sufficient to protect anyone from inadvertently being dragged into a dangerous position. Areas around moving machinery should be securely guarded to prevent such accidents.

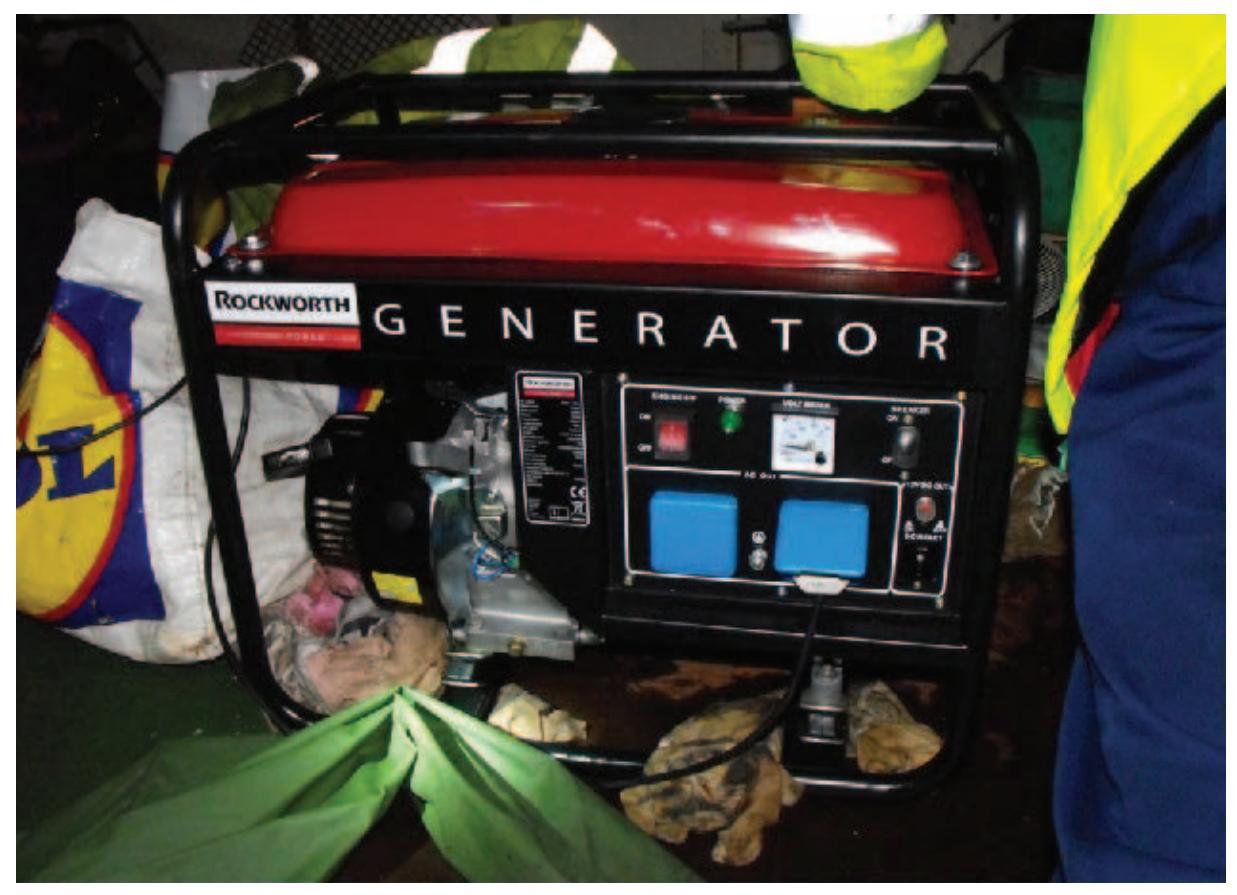
Figure 1: The portable generator involved in the incident

Ventilation openings to the forward store were still closed in the seagoing position, and although the hatch was partially open, carbon monoxide in the exhaust fumes built up quickly and overcame the crewman when he attempted to run the generator.

- 1. Carbon monoxide is a silent killer. It has no smell or taste and works by stopping oxygen from being carried in the blood stream. Even very small amounts can be fatal.
- 2. The exhaust from small petrol-driven engines and faulty heaters is the most common cause of accidents involving carbon monoxide. Petrol-powered bilge pumps and generators should only be used in well ventilated areas – and beware of the exhaust drifting away and collecting in the bottom of holds, or being sucked up by ventilation fans.
- 3. If you suspect an area has been contaminated with carbon monoxide, ventilate it thoroughly, preferably using a fan, before you put your life at risk by going in.
- 4. Simple carbon monoxide alarms are cheap to buy and easy to install. They may be the only warning you get.

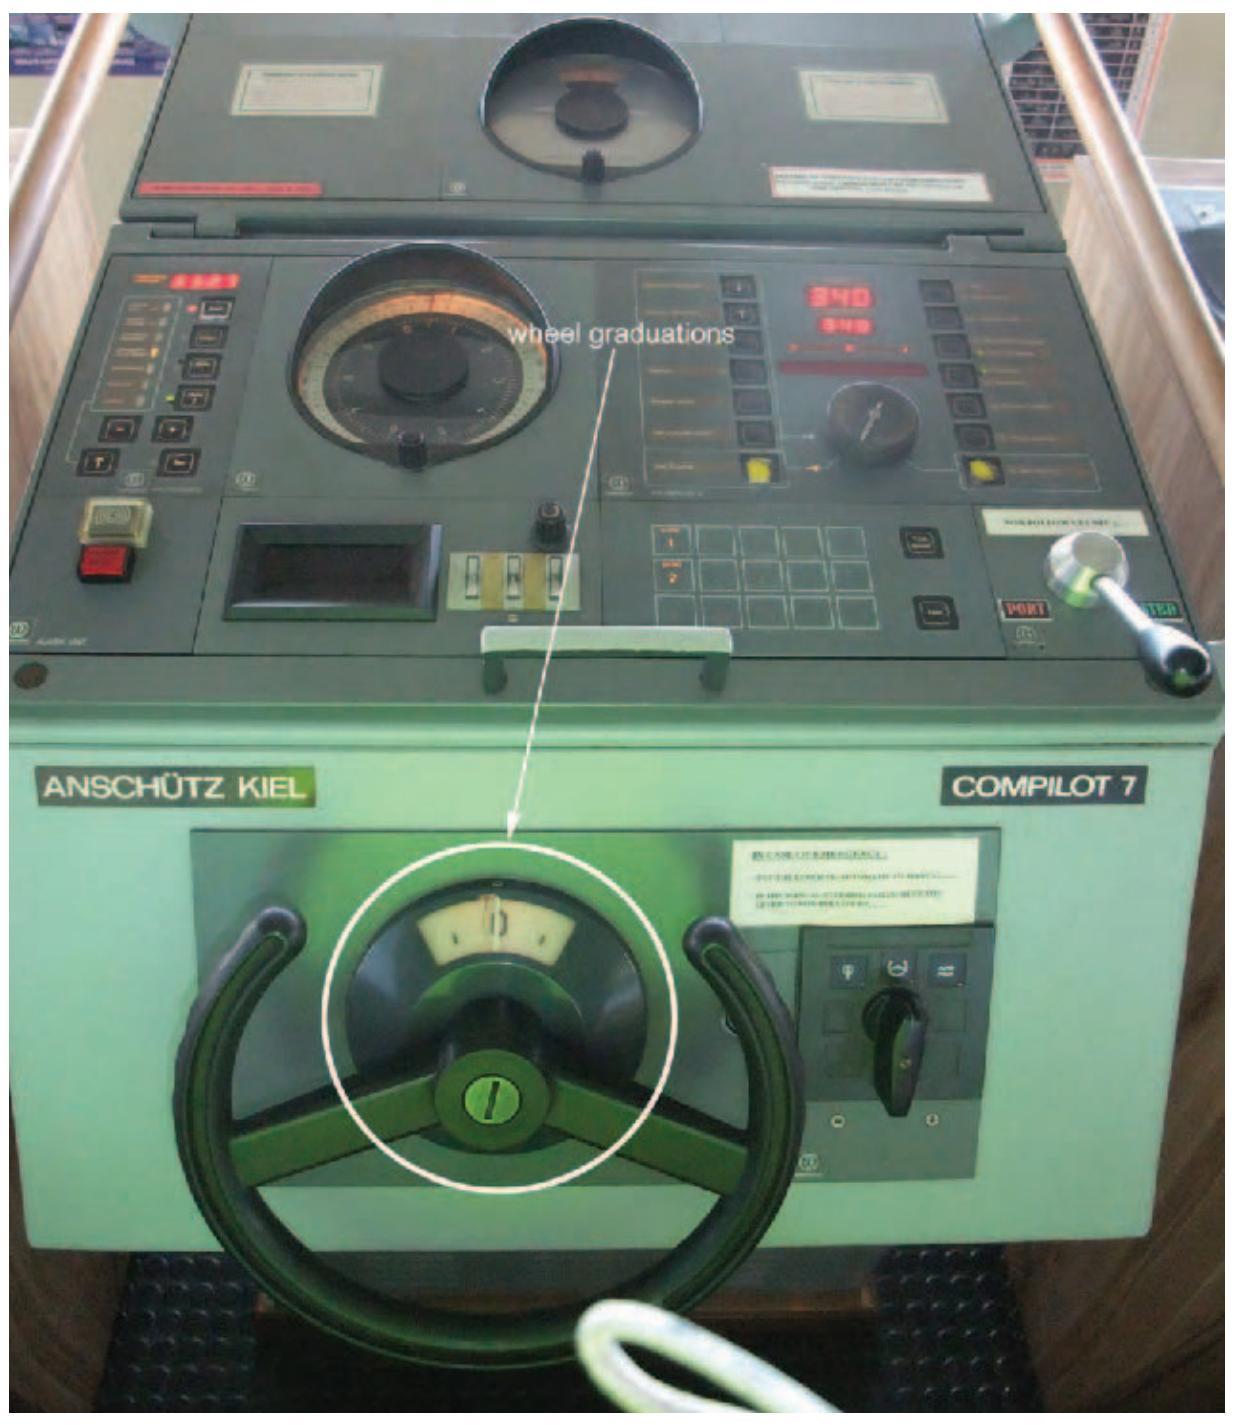
Figure 1: Bridge steering console

The superintendent then ordered the helm to "starboard 20" and then to "hard to starboard", and an increase in speed, but the rate of turn to port increased. Realising that something was wrong, the master repeated the orders to the third officer and helmsman. The bridge wing indicator was checked at this time and found to be reading "port 20". The helmsman then applied starboard helm and the rate of turn to port decreased, stopped and then the ship began to swing to starboard. However, after having made an alteration of course of nearly 30 degrees to port, the port side of the fo'csle inevitably collided with the other ship, causing structural damage. Fortunately, there were no resulting injuries or pollution.

Despite the superintendent's actions the two ships collided, causing structural damage in way of both vessels' boat decks.

- 1. In the first case, the helmsman had been concentrating for $1^{1/2}$ hours on steering ordered courses, and it was increasingly important to keep these as accurate and steady as possible as the ships approached each other. When the superintendent's instructions changed from courses to steer to specific helm orders, the helmsman was relatively able to relax as he had only to move the wheel to the desired graduation on the wheel's boss (see photograph). This led to a lapse in concentration and resulted in him mistakenly applying opposite helm. It is necessary to change the helmsman at frequent intervals so that concentration is maintained.

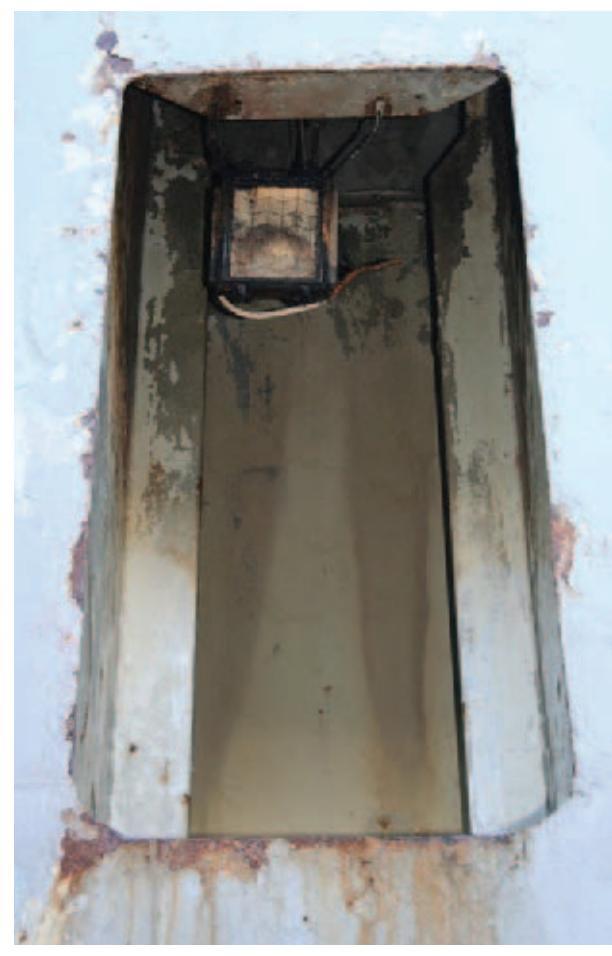
Figure 1: Cargo hold light

The chief officer switched on the cargo hold lights (Figure 1), which had been fitted inside the lower end of the hold's port forward (which was forward of the moveable hold bulkhead) and starboard aft ventilation trunkings by the previous owners. These gave sufficient light to assist the cargo surveyor with his hold inspections.

The smouldering was caused by the wheat pellets covering the hot halogen lamp, which had been left on because of inattention to the basic post-loading checks to confirm the vessel was safe to proceed to sea.

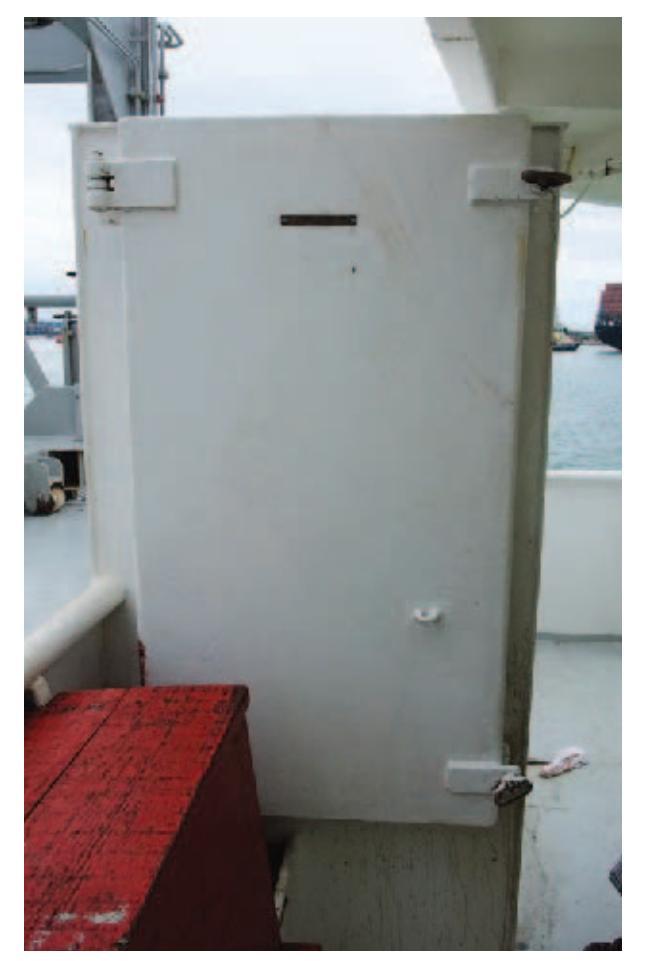
Figure 2: Ventilation terminal

The hold was cleared by the surveyor and the wheat pellet cargo was loaded. In doing so the pellets migrated up inside the after ventilation trunking and covered the starboard halogen light. Crucially, the hold lights were left on throughout loading and after the hold hatches were closed.

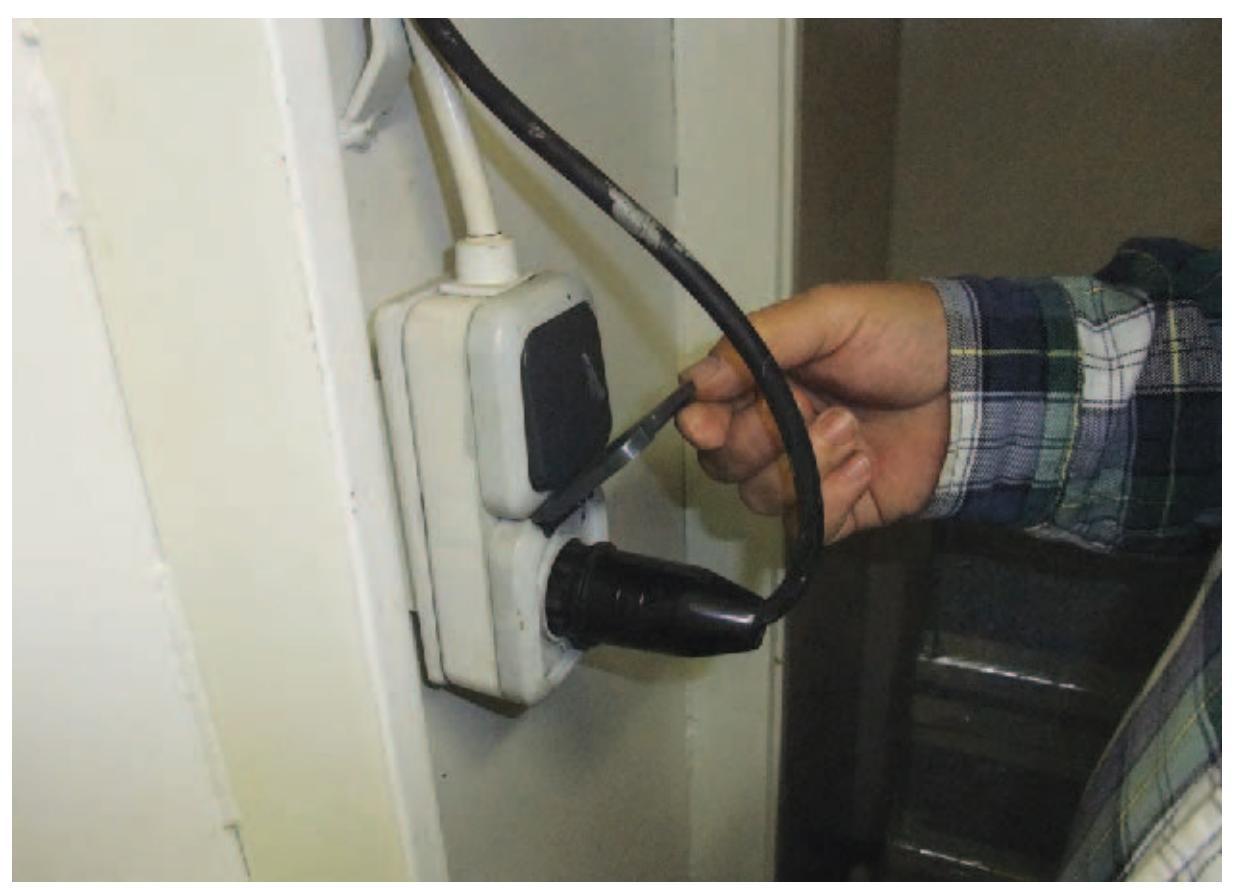
Figure 3: Hold lighting switch

No checks had been carried out on the hold lighting system to ensure the lights were turned off, and there were no indicators in the wheelhouse to alert the OOW that the lights were still burning.

The terminal's cover was immediately closed, and the master was alerted. The crew remained calm and carried out a search for hot spots around the hold, and of the adjacent compartments. None were found. The crew had exercised for a cargo hold fire, and immediately laid out the fire hoses for boundary cooling as the master contacted the coastguard. One of the ABs checked the hold lighting switch and found it still switched on (Figure 3), so he switched it off.

On investigation it was also found that the hold lighting arrangement was not approved by the classification society, and that the electrical supply cable bulkhead glands did not conform to the rules, which compromised the ability of the bulkhead to prevent the spread of fire.

- The rationale for fitting the hold lights was to aid hold inspections and to check break cargo securing arrangements. When carrying break cargo (such as steel rolls), there was no risk of any cargo covering the lights. However, the fluid nature of the wheat pellets meant that it was easy for them to migrate into the ventilation trunking, and cover the hot halogen lights. Had a more flammable cargo been carried, the outcome could easily have been far worse.
- 2. When considering additions or modifications to equipment, do seek professional advice, especially from classification societies, to ensure that the proposal is safe and within the rules.

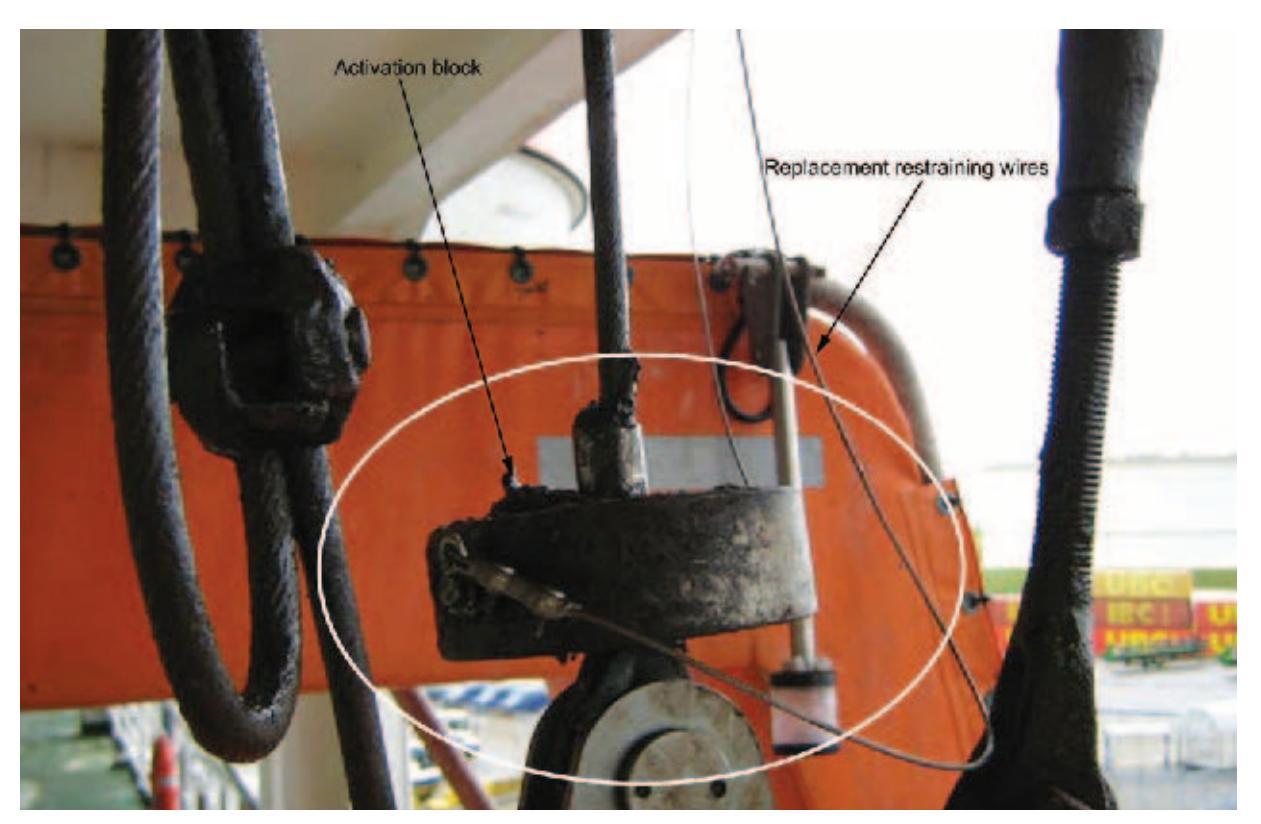
Figure 2: Limit switch activation block and replacement constraining wires

The cause of the failure was initially believed to have been a faulty limit switch which had been recently adjusted by a member of the crew. The limit switch itself was activated by a circular block which was lifted when in contact with the davit hook (Figure 2). On lowering, the block was constrained by two chains which held it at about 0.5m below the limit switch. The design of this particular davit arrangement meant that there was still inertia in the winch drum that allowed it to continue to rotate for a very short time after the control lever was set to the stop position. The correct adjustment of the limit switch allowed for this, and was designed to prevent over tensioning and stretching of the wire, which would inevitably lead to its failure. However, the person who adjusted the limit switch did not seem to have been aware of this although it was stated in the operation and maintenance manual.

Unfortunately there have been a number of accidents, some fatal, resulting from a misunderstanding of the functionality of elements of rescue boat and lifeboat hoisting and lowering equipment. In this case maladjustment of the limit switch caused the fall wire to fail. However, the design of the circular block constraining chains had also occasionally caused the wire to snag before the limit switch operated. To prevent this happening, the manufacturer replaced the chains with stiff wires (Figure 2).

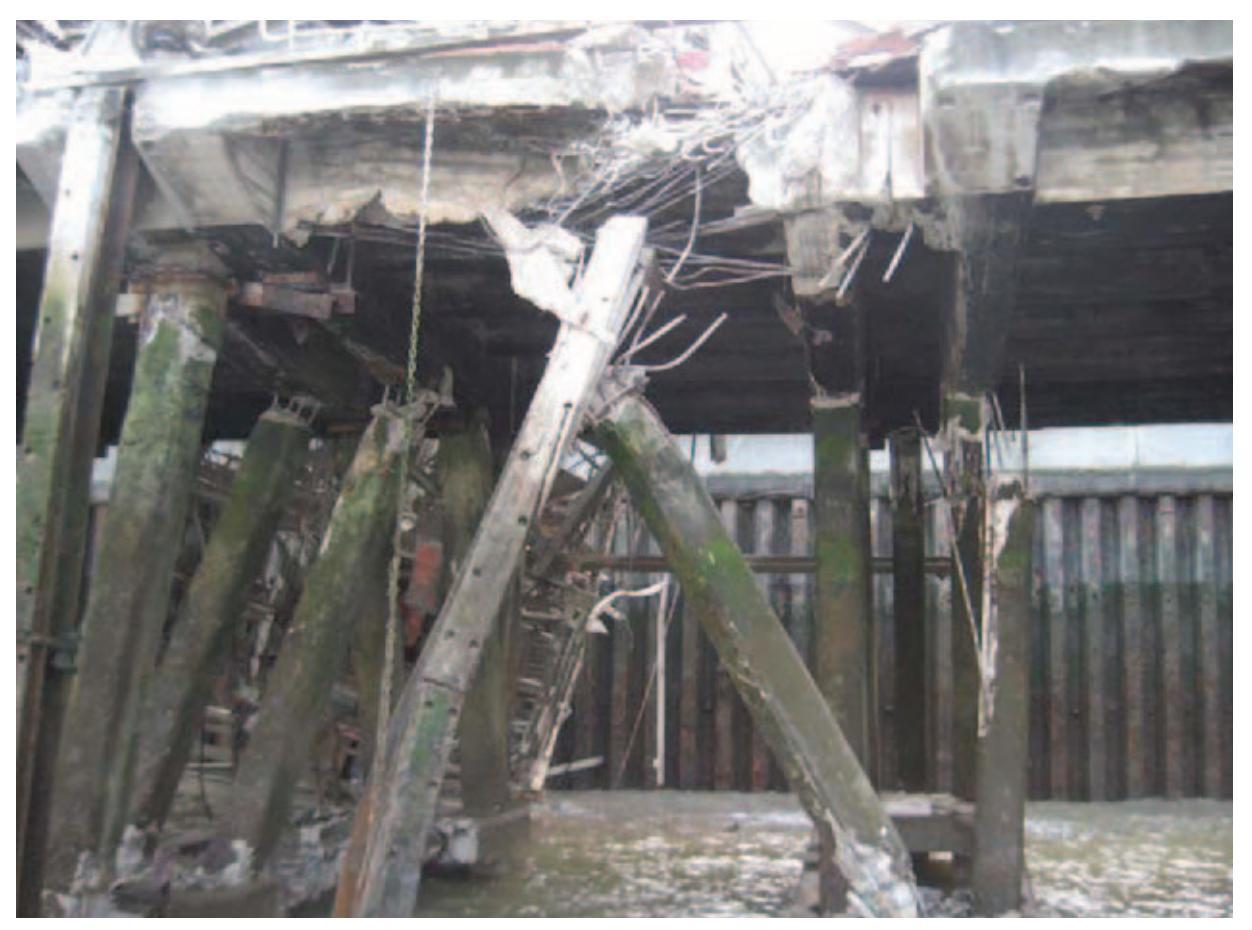
Figure 2: Damage caused to the jetty

with the bow thrust. The forward tug was also requested to push on the starboard bow. However, this did not prevent the vessel from making contact with a disused jetty. The damage to the vessel was minor and she was able to continue on passage. The damage to the jetty, which was scheduled for demolition, was significant (Figure 2).

- 1. The state of the visibility is key in many operations, and where there are signs that it might reduce considerably, it is frequently better to abort a manoeuvre early rather than risk being caught out half way through.

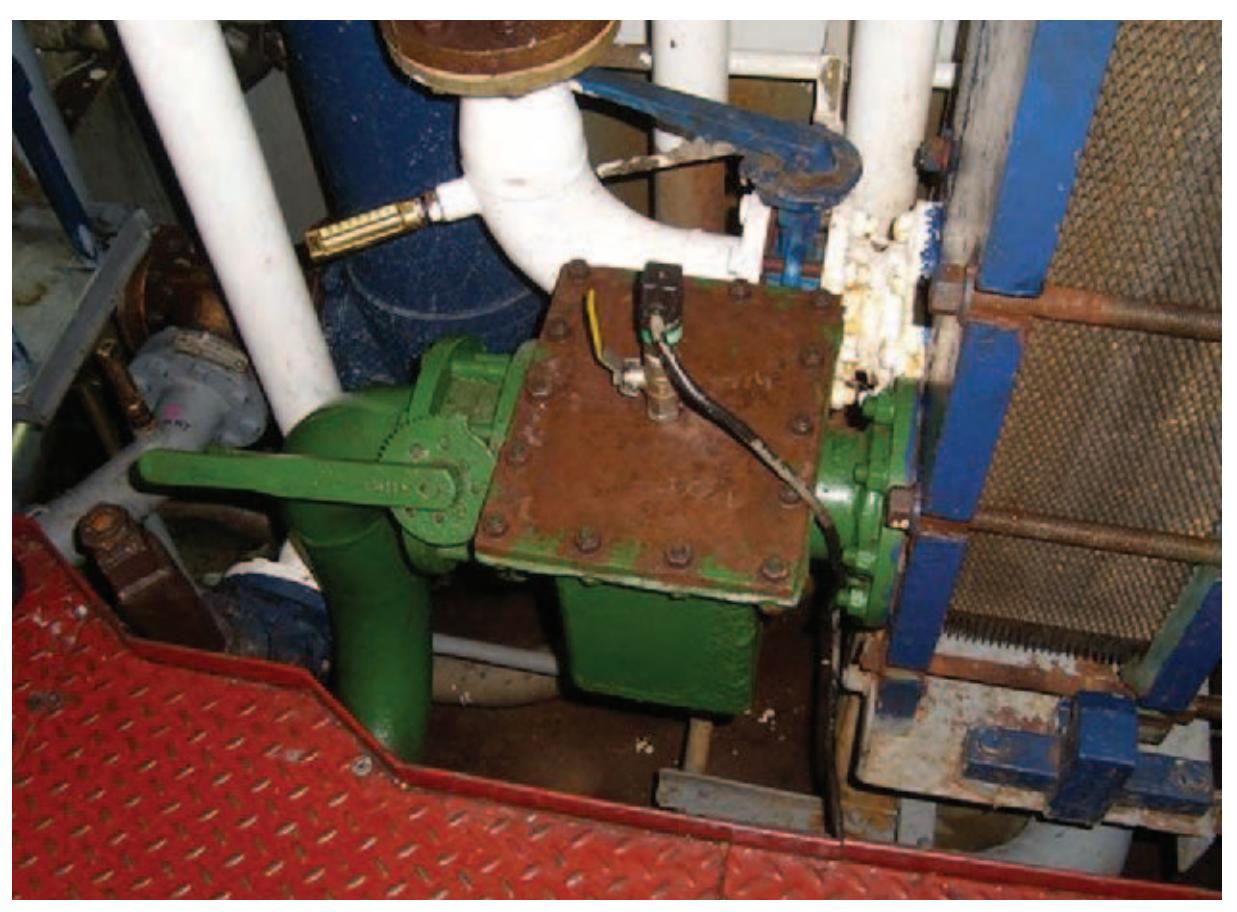
Figure 1: Freshwater cooling system

The new filter was not a duplex type, nor was it fitted with a by-pass valve. There was no high temperature alarm at the fresh water cooler outlet, and the low sea water pressure alarm switch fitted at the inlet to the cooler was defective. When the chief engineer received the high temperature alarm at the fresh water inlet to the main engine, it was already too late.

- 1. The sea water filter installed at the inlet to the fresh water cooler functioned as intended by preventing weeds from fouling the cooler. However, there was no means of by-passing the filter if it became blocked. As the entire fresh water system relied on a single cooler, the loss of sea water to this cooler resulted in the ship losing its main engine. When implementing an improvement, it is imperative that all possible knock on effects are considered.

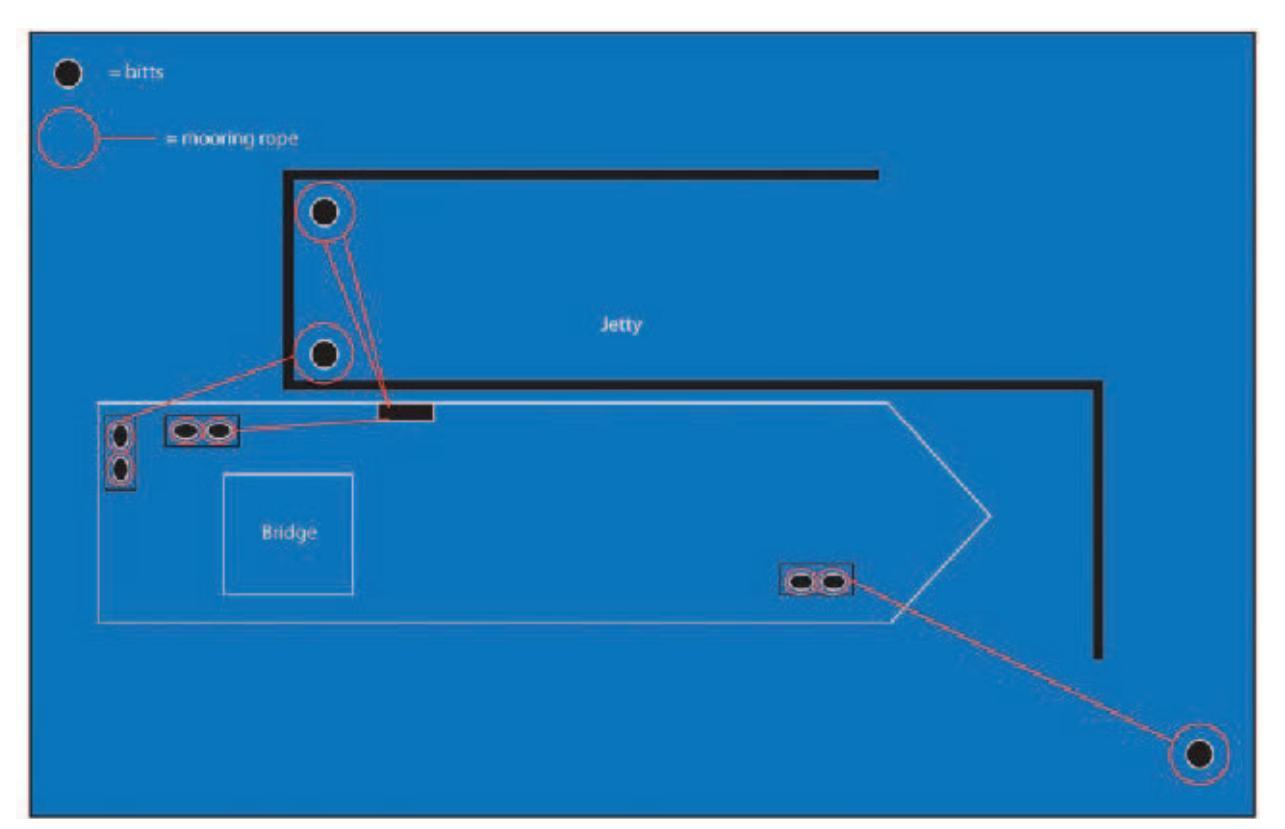
Figure 1: Mooring arrangements

The terminal remained shut for 18 hours due to the damage to the support structure of the oil pipelines on the jetty roadway.

- 1. The mooring ropes used to tie up the vessel were in very good condition, but the vessel had not been secured effectively. Pre-planning of such operations should be undertaken, especially in cases where the vessel will remain unmanned and/or has to use an unusual or non-standard mooring arrangement.

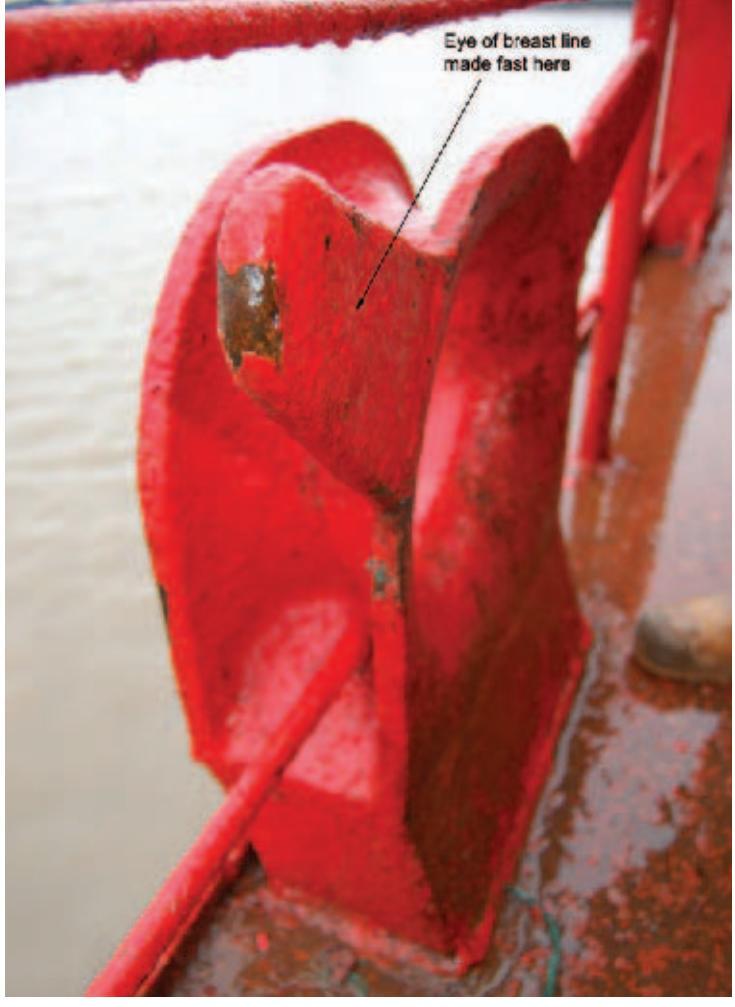
Figure 2: Fairlead with cleats

- 3. Careful thought should be given to the lead of the lines so as to avoid creating sharp angles. In this case, the eye of the breast line was secured to a cleat forming part of the fairlead (Figure 2). A sharp edge on the fairlead effectively cut through the rope as the vessel oscillated alongside before breaking free.

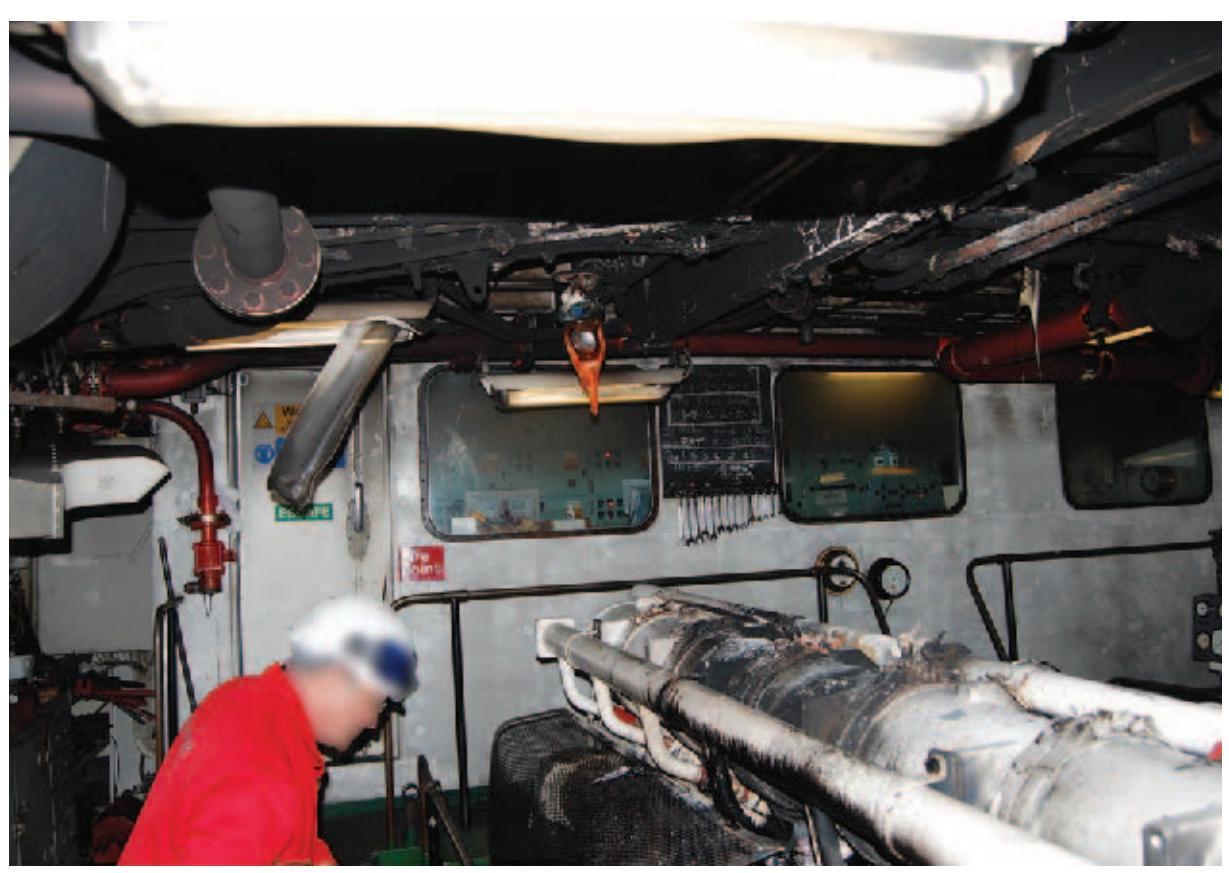
Figure 1: The view from ECR

Pre-sailing checks were completed and there was nothing to raise the concerns of either the tug master or chief engineer. About 20 minutes after the escort duties started, the fire alarm sounded and the detection panel indicated a fire in the engine room. The chief engineer looked into the engine room through the engine control room (ECR) windows (Figure 1) and saw diesel fuel being sprayed onto the deckhead and cascading down onto the hot exhaust in the vicinity of number 4 cylinder head of the port main engine. He immediately advised the tug master to break off escort duties. As he did so, the fuel spray ignited. The chief engineer attempted to fight the fire using an extinguisher, but was quickly driven back into the ECR. He then stopped the engine at the same time as the tug master advised the pilot and harbour authorities of the situation.

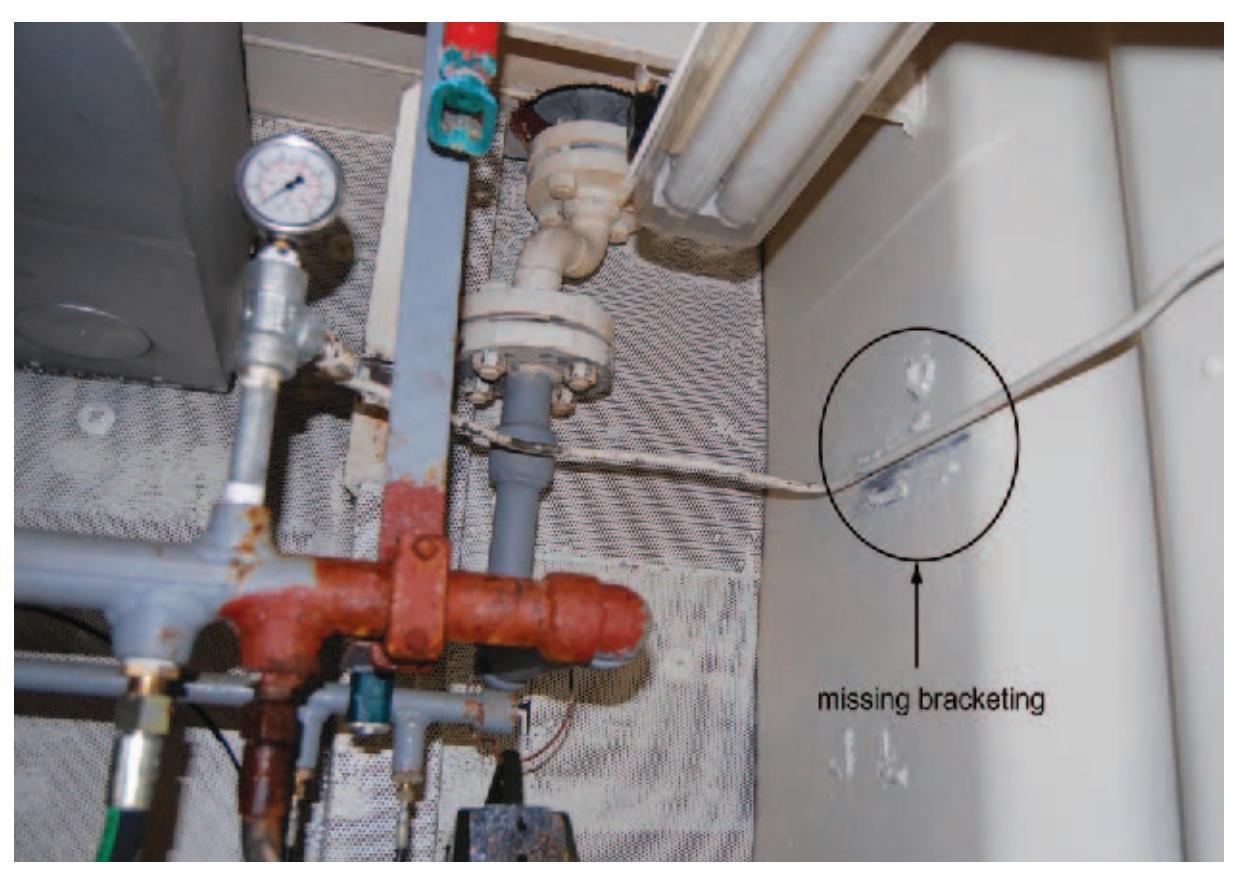
Figure 2: Failed CO₂ sensing pipe

The CO₂ flooded the hold when a pressure sensor pipe was pulled through a union (Figure 3) while the system was being pressurised. This was caused by missing support bracketing.

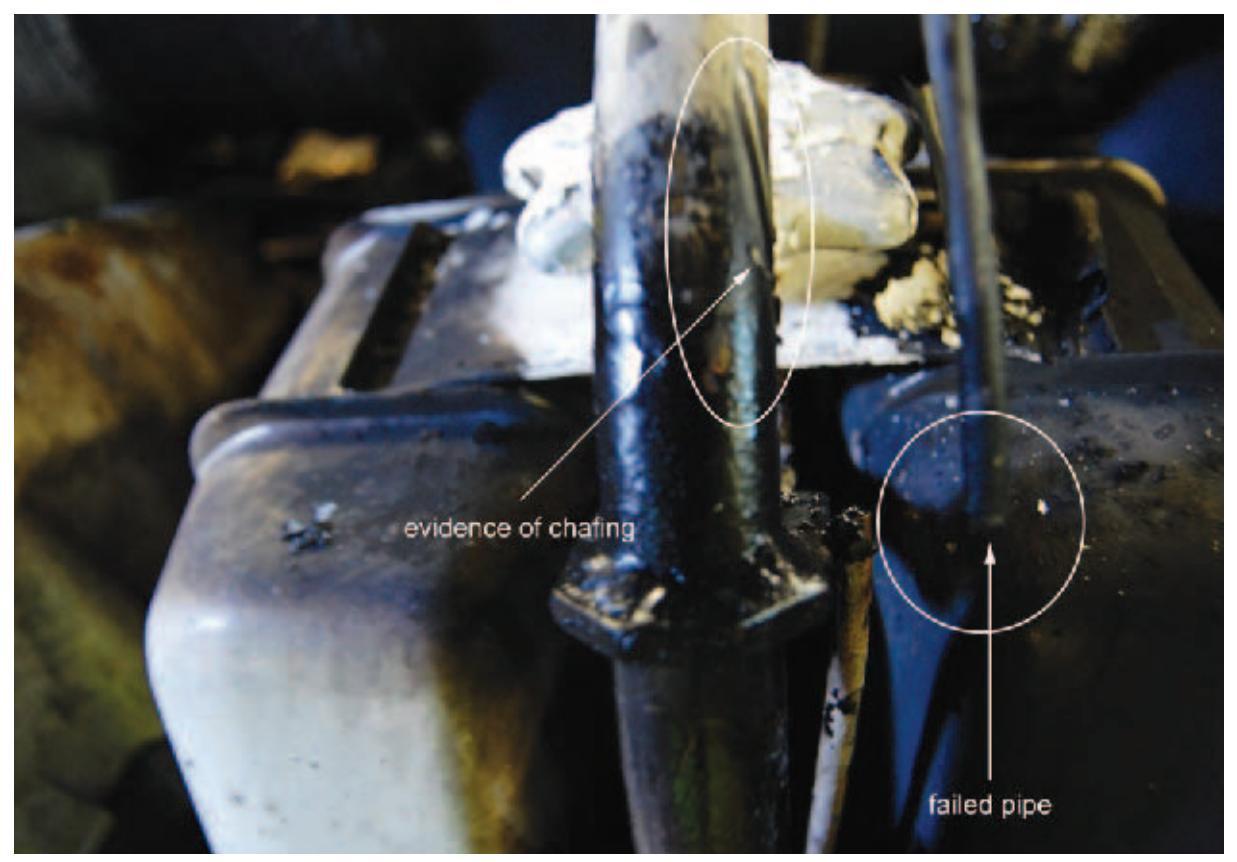
Figure 3: Failed leak-off pipe

The investigation found the port engine's number 4 cylinder fuel injector leak-off pipe had suffered extensive chafing (Figure 2) because of its inadequate bracketing arrangements. The pipe failed and sprayed diesel fuel onto the hot engine, where it ignited.

Disappointingly, most of the other leak-off pipes on the port and starboard engines, and others in the same vessel class, had also suffered from severe chafing. While some of the pipes had been braze-repaired, there was no evidence of the defect being reported to the company ashore, so no proper engineering solution was developed to prevent the fire risk.

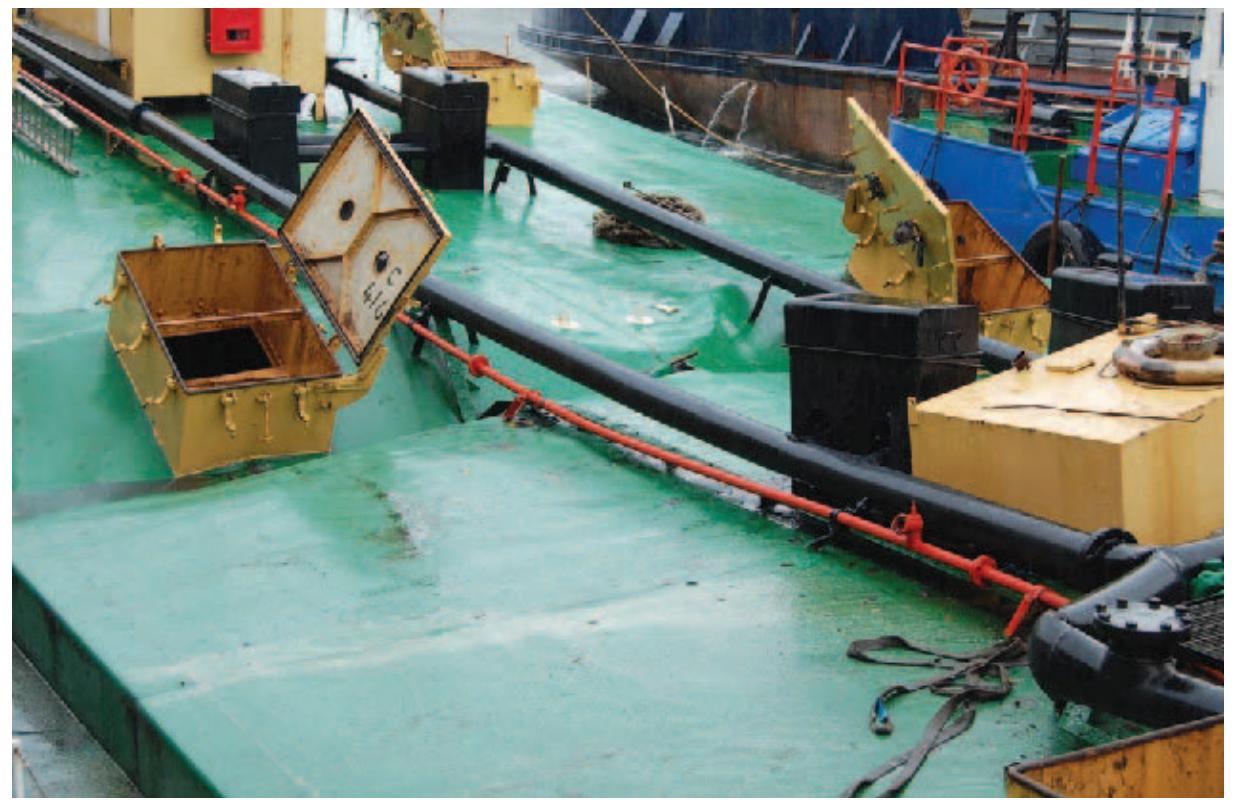
Figure 1: Hull failure

Cargo loading operations were controlled by the company's terminal staff, and discharge operations by the crew of vessels accepting the cargo. A lack of barge 'ownership' meant that operations had become disjointed. There were no written procedures for loading or discharge to ensure safe operation and that the vessel remained in a seaworthy condition.

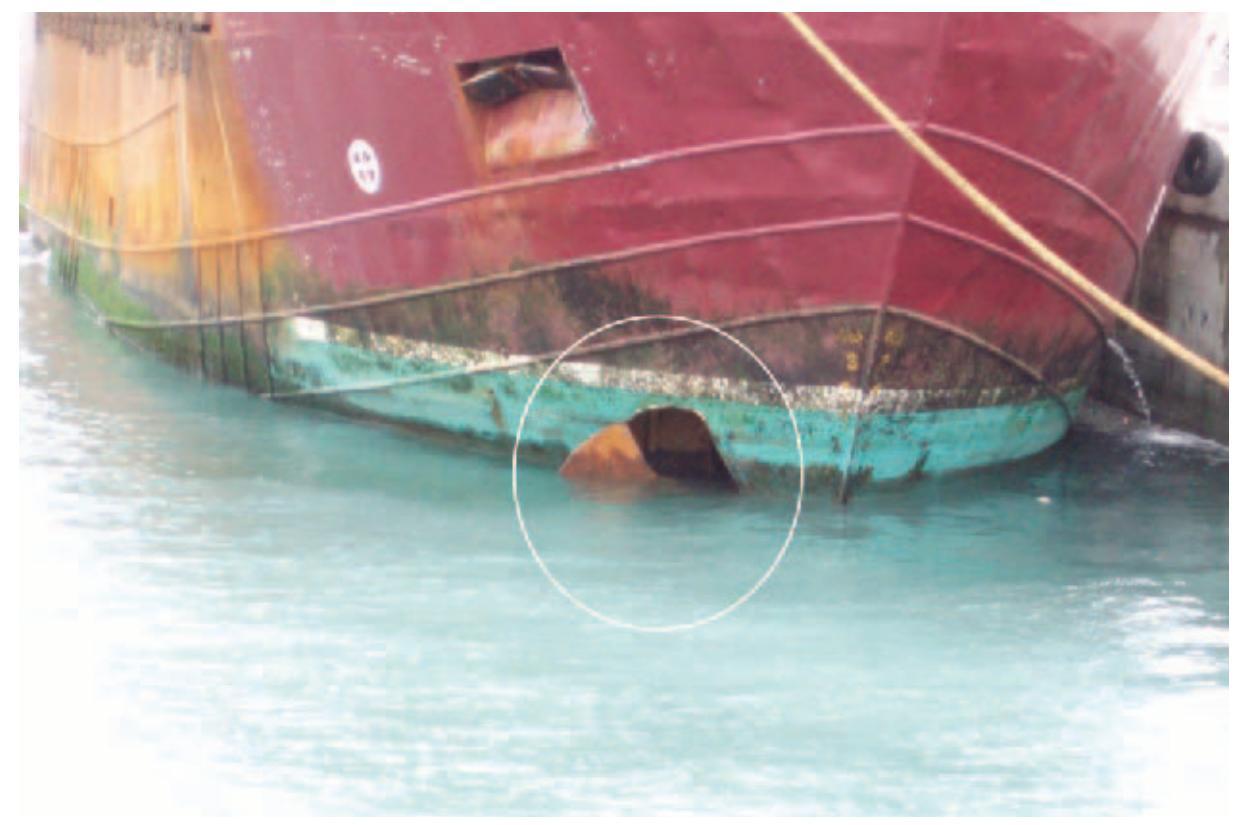
Shell plating damage

Detailed examination of the fore peak found that of the four frames, two had wasted and come away from the shell plating completely, and another was attached by only half its length. The shell plating had been unsupported and flexed as the boat moved through the sea. The plating was in good condition, but a crack had developed which had then spread, allowing the sea to leak in. The crack had then got bigger, until the force of the sea tore the plating open like a tin can. Fortunately, the collision bulkhead, at the aft end of the fore peak tank, was in good condition and saved the vessel from flooding uncontrollably.
