ACCIDENT

Aircraft Type and Registration:	Cessna 340A, N346DW	
No & Type of Engines:	2 Continental Motors Corp TCM TSIO-520-NB piston engines	
Year of Manufacture:	1979	
Date & Time (UTC):	15 July 2011 at 1156 hrs	
Location:	Fairoaks Airport, Surrey	
Type of Flight:	Private	
Persons on Board:	Crew - 1	Passengers - None
Injuries:	Crew - None	Passengers - N/A
Nature of Damage:	Damage to right main landing gear, right flap, right wingtip and right propeller, right engine shock-loaded	
Commander's Licence:	FAA Airline Transport Pilot's Licence	
Commander's Age:	72 years	
Commander's Flying Experience:	1,750 hours (of which 250 were on type) Last 90 days - 50 hours Last 28 days - 25 hours	
Information Source:	Aircraft Accident Report Form submitted by the pilot

Synopsis

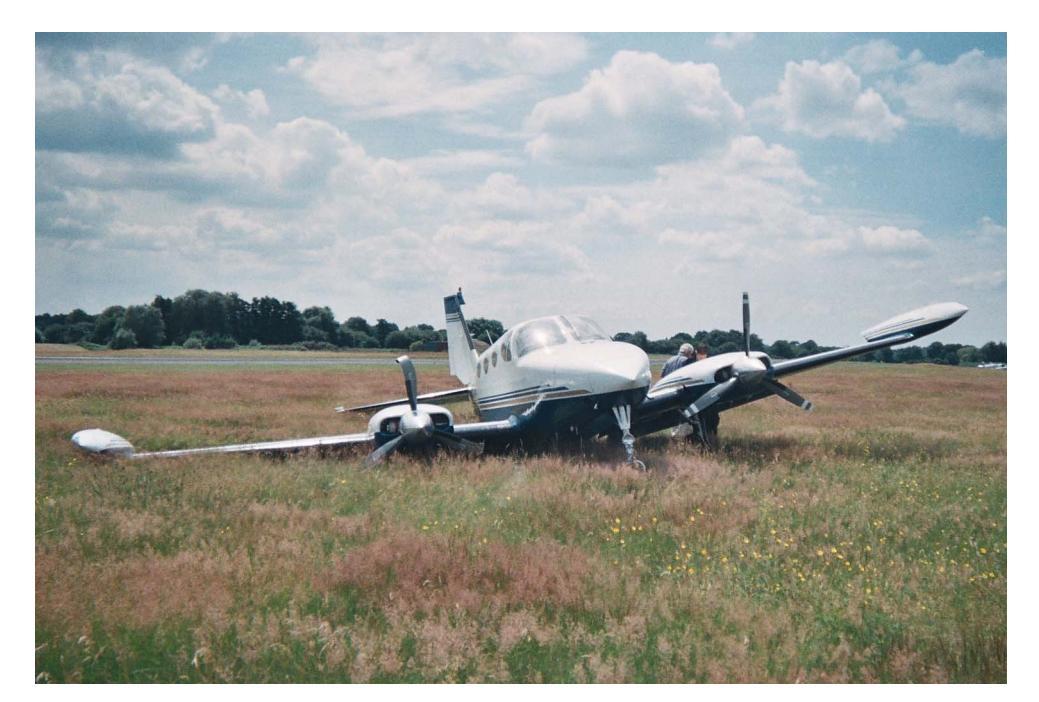
During the landing roll, the aircraft's right main landing gear retracted and the aircraft departed from the right side of the paved runway, damaging the aircraft. The damaged sustained by the landing gear components was consistent with the right main landing gear side brace folding, as weight was transferred onto the right main landing gear during the landing. The cause of the landing gear collapse was not positively identified.

Figure 1 The aircraft following the right landing gear collapse

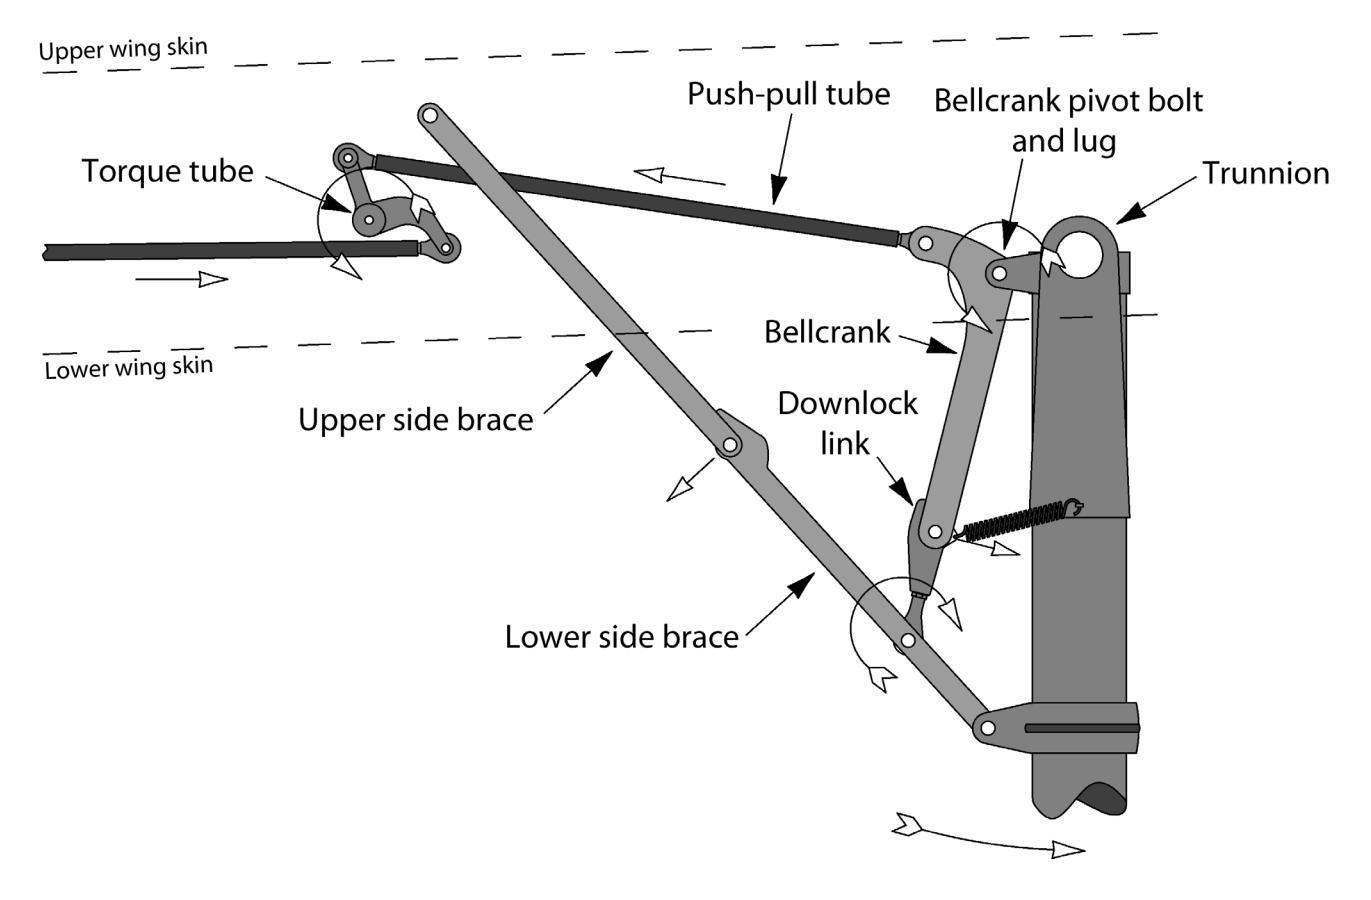
Figure 2

The landing gear retraction system is powered by an electric motor that drives, via a reduction gearbox, a series of rods, torque-tubes and bellcranks that move the landing gear legs. The main landing gear is held in the 'down and locked' position by a folding side brace. A downlock link, driven by a bellcrank, applies force to the side brace to keep it in an over-centre position when the landing gear is down (Figure 2).

When the main landing gear leg is down and locked, the downlock link and bellcrank should be in an over-centre position, to prevent the side brace from folding. A microswitch, mounted to the downlock link, closes when it is over-centre and illuminates the green DOWN instrument panel light for that landing gear leg.

Schematic of the right main landing gear downlock mechanism, showing direction of motion as the landing gear locks down

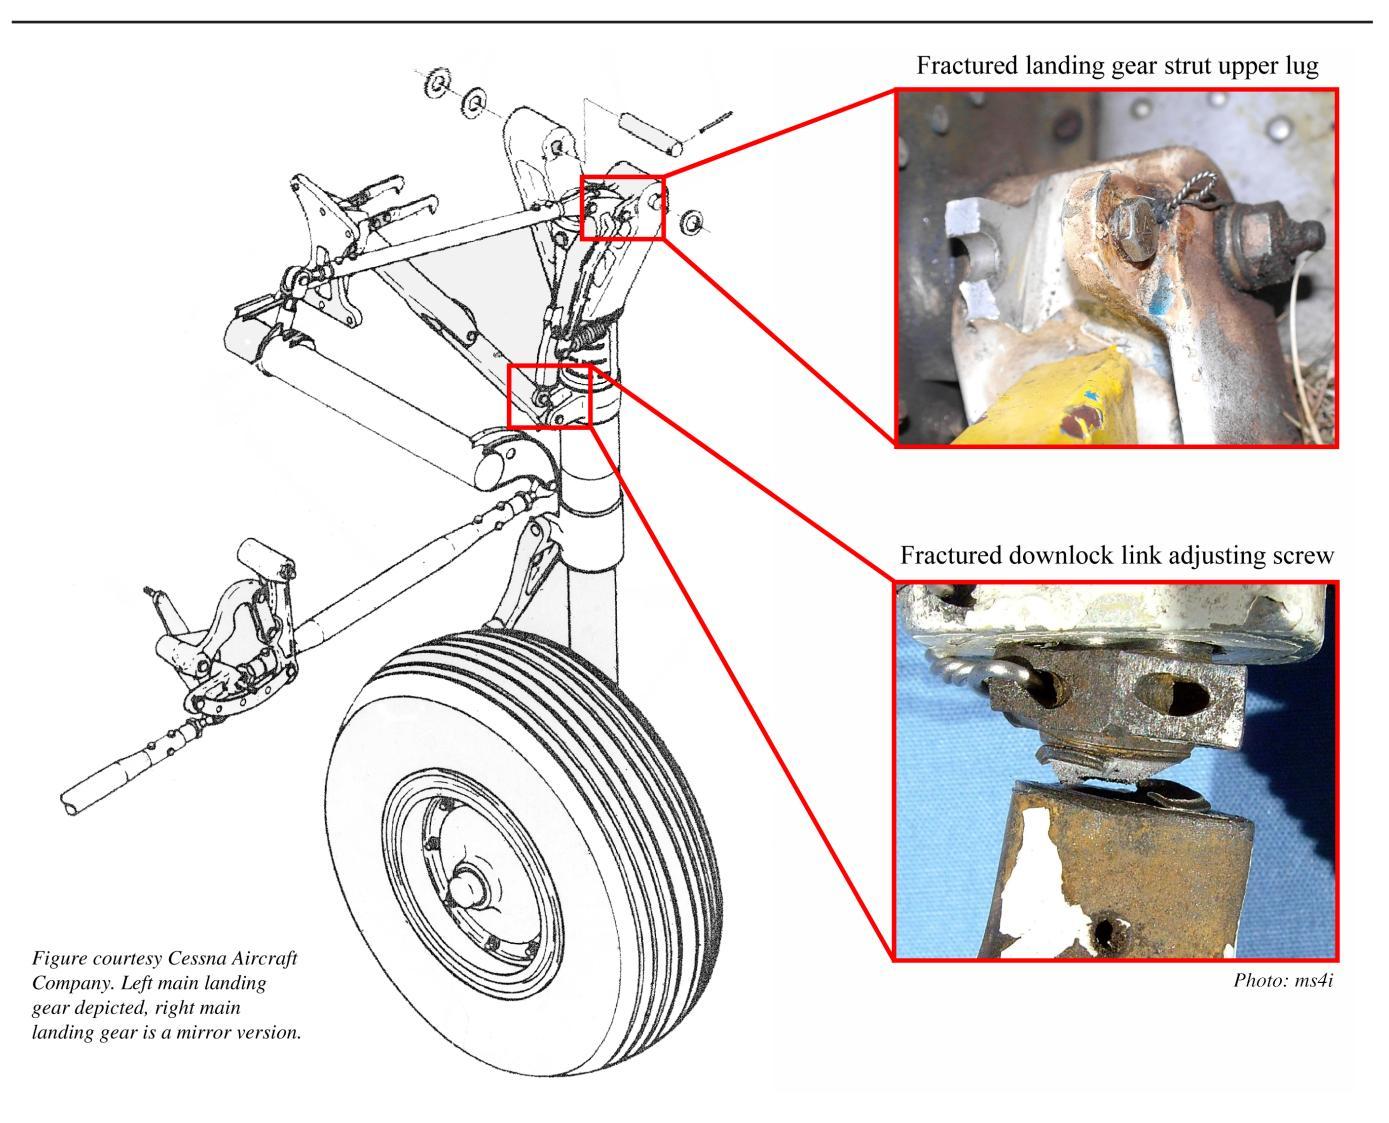
The aircraft sustained damage to its right wingtip and right flap as a result of the landing gear collapse, in addition to damage to the right propeller and shock-loading of the right engine. The right landing gear was inspected and it was apparent that the downlock link had separated from the lower side brace due to fracture of the downlock link adjusting screw (Figure 3). Additionally, the forward lug on the upper landing gear strut, at its attachment to the bellcrank pivot bolt, had broken off and the fracture surface was dull with a rough texture, indicative of tensile overload. The bellcrank pivot bolt had sheared, such that the bellcrank was no longer attached to the landing gear strut. The right main landing gear microswitch, mounted on the downlock link (Figure 4), was electrically tested and found to function correctly when the switch contacts were closed. However, due to the deformation of the microswitch mounting bracket sustained during the accident, it was not possible to determine the pre-accident alignment of the microswitch lever with respect to the bellcrank.

Figure 3 Location of right main landing gear leg broken components

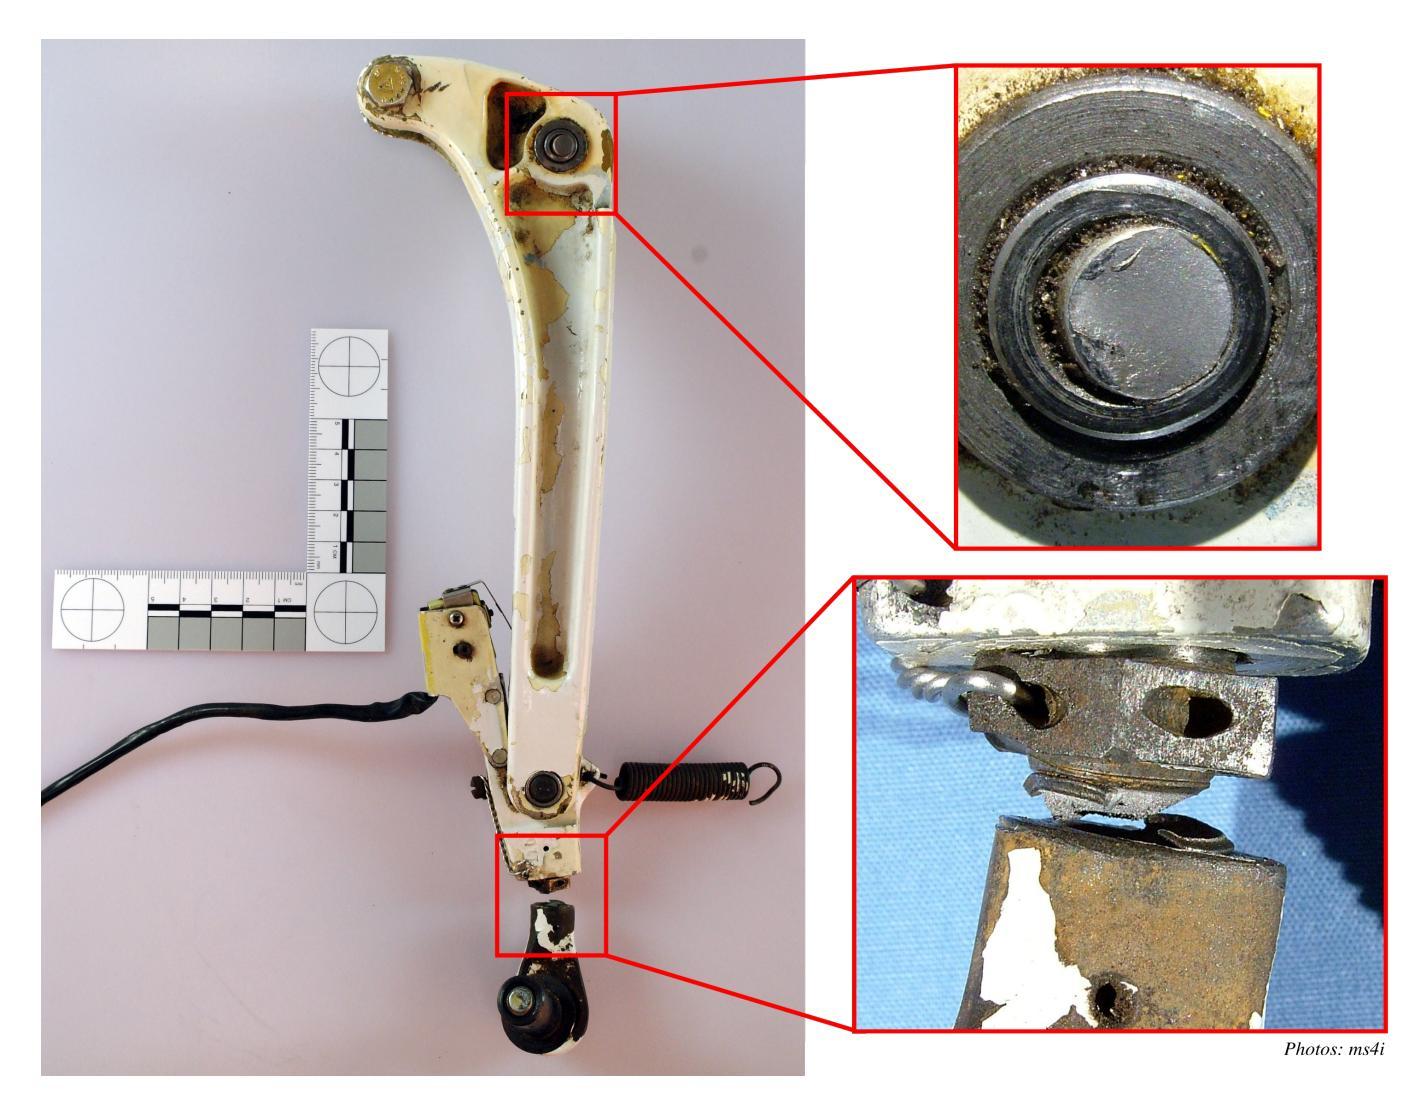
Figure 4

The metallurgist concluded that the downlock link adjusting screw had failed in a single, non-reversed, bending overload event. The fracture surfaces did not show any macroscopic evidence of pre-existing cracks, material defects or anomalies associated with crack initiation, and there was no evidence of slow crack growth mechanisms such as fatigue or stress corrosion cracking. The adjusting screw's material was found to

Fracture surfaces of the bellcrank pivot bolt and downlock link adjusting screw

The bellcrank pivot bolt was determined to have failed in single shear, resulting from a single overload event, and the fracture surface did not show any evidence of pre-existing cracking or material defects.

Based on the observed damage to the right main landing gear components, it is probable that the downlock link or side brace, or both, were not sufficiently geometrically over-centre at the point the aircraft landed. In this condition, any inboard side-load generated by the right landing gear would cause the side brace to begin to fold, leading to the observed bending overload failure of the downlock link adjusting screw. Further rotation of the right landing gear leg would have then loaded the push-pull tube in tension, resulting in the tensile failure of the pivot bolt lug and single shear overload of the pivot bolt.
