# **Air Accidents Investigation Branch**

Report on the serious incident to Airbus A319-131, G-EUOB during the climb after departure from London Heathrow Airport on 22 October 2005

This investigation was carried out in accordance with The Civil Aviation (Investigation of Air Accidents and Incidents) Regulations 1996

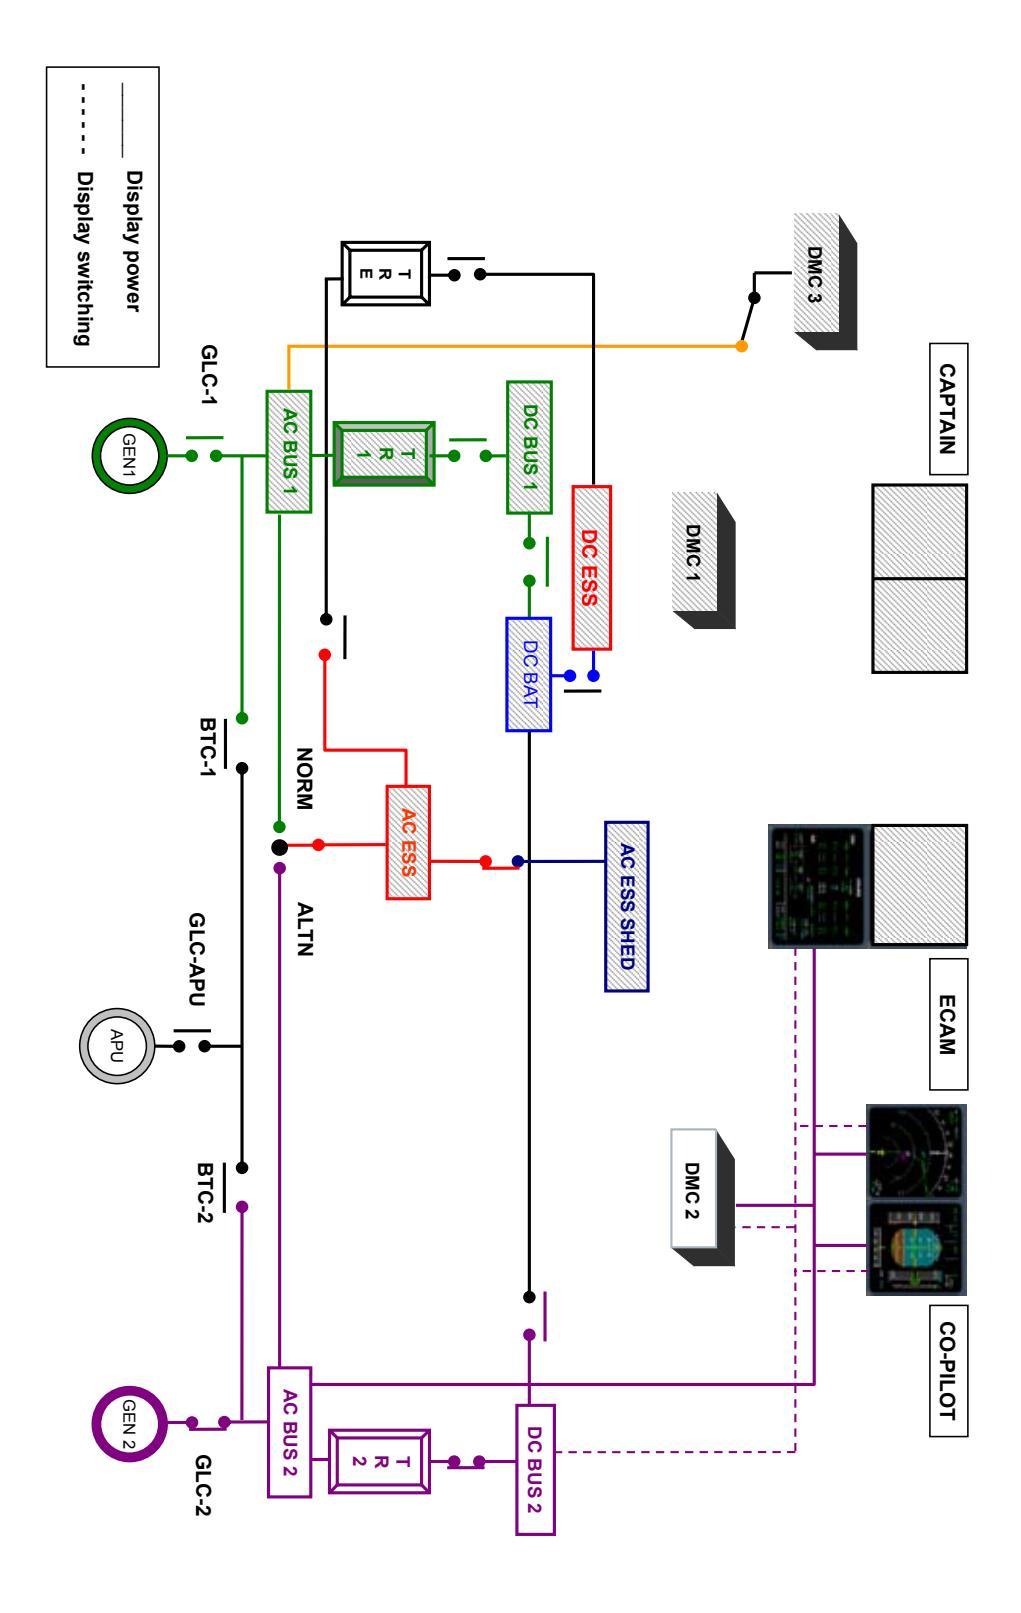
**Figure 6** EIS Effects following AC BUS 1 Failure

The normal EIS power supply configuration is shown in Figure 5. The expected effect on the EIS displays due to an AC BUS 1 failure is shown in Figure 6. Figure 7 shows the EIS power supply configuration after selection of the AC ESS FEED switch to 'ALTN'.

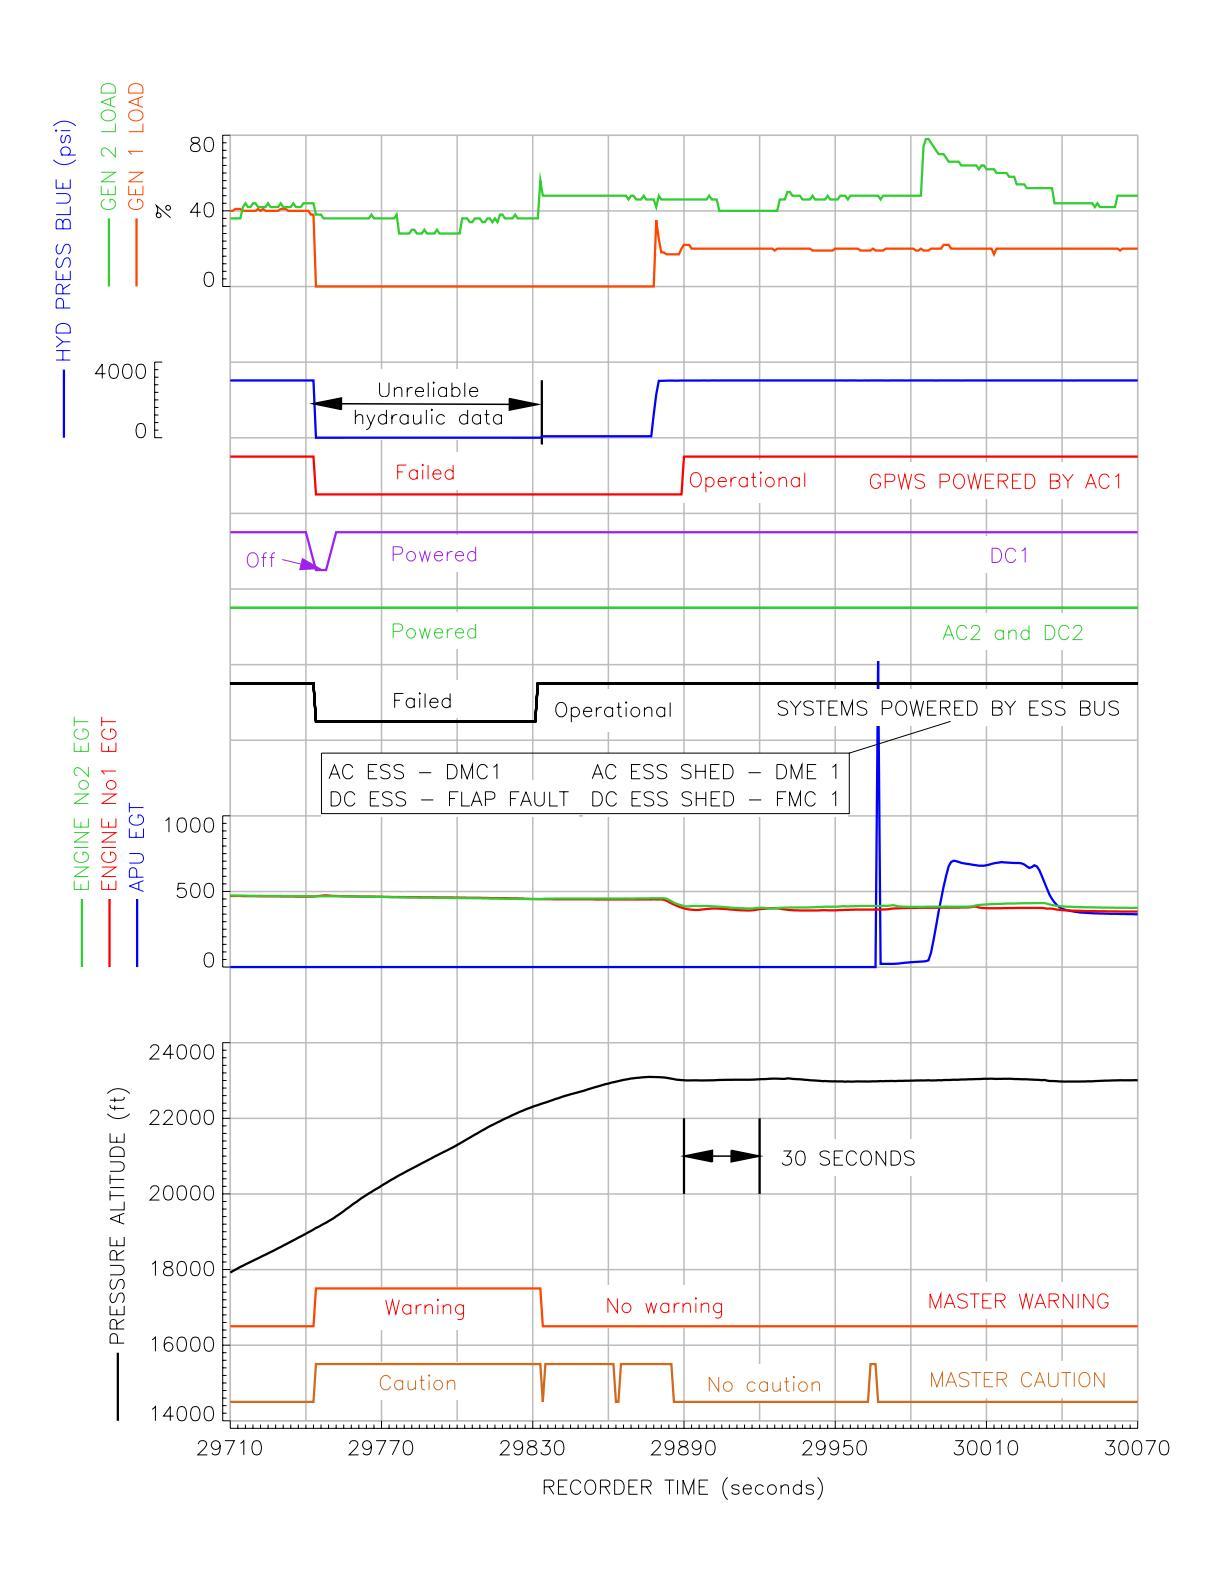
# Figure 9

The loss of Enhanced Ground Proximity Warning System (EGPWS) data, amongst others, indicates a loss of power to the AC BUS 1. The continued operation of the DAR shows that AC BUS 2 remained powered. The AC ESS SHED bus was reliably recorded as failed. The AC ESS bus parameter showed one sample of definite loss of power before becoming an unreliable parameter, however, parameter failures of systems powered by AC ESS point to the loss of this bus for the same period as the AC ESS SHED bus. Other parameters directly relating to power proved unreliable during this period.

The DC BUS 1 showed a temporary failure for between 4 and 12 seconds (this parameter is sampled every four seconds). The continued good FMC2 and accelerometer data indicate that DC BUS 2 remained healthy throughout. Loss of FMC1 data points to the loss of power on the DC ESS SHED bus. Flap parameters reported by the Slat Flap Control Computer (SFCC) 1 became invalid indicating that the DC ESS bus lost power.

DAR derived data showing the power available on the aircraft. Note: the yellow and green hydraulic systems were unaffected.

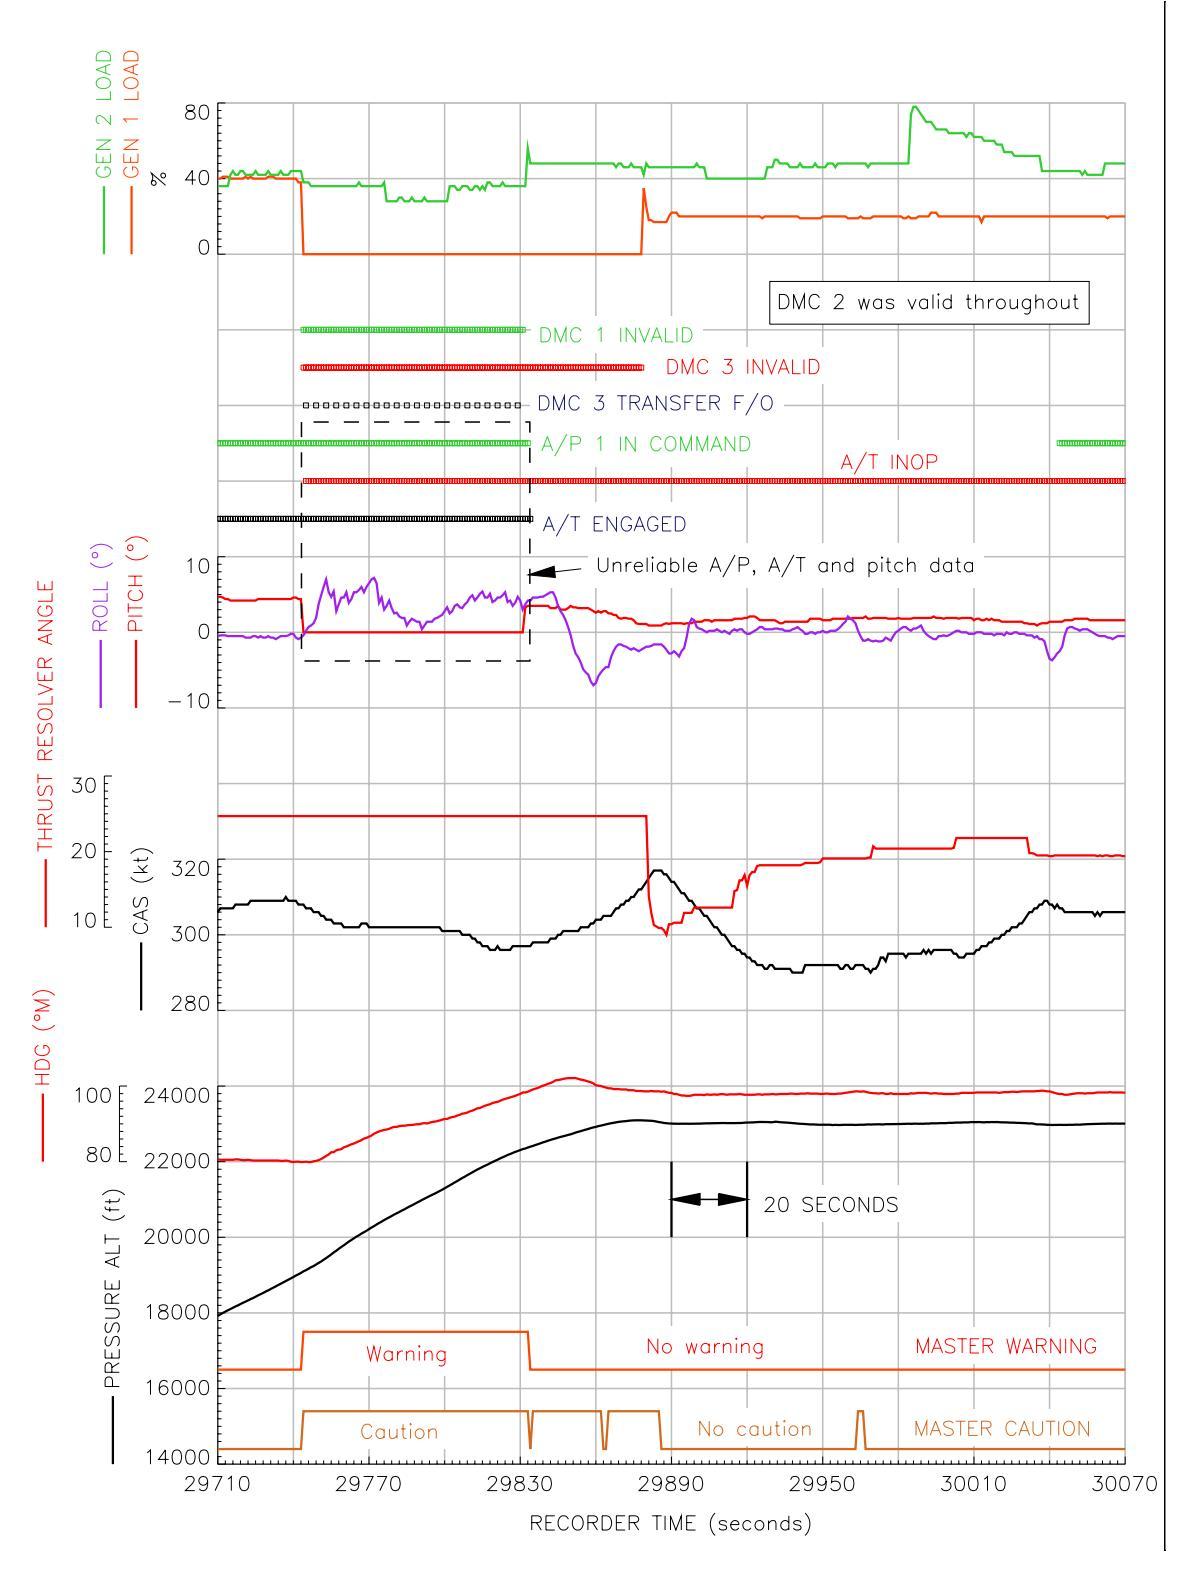
Figure 10

DAR derived data showing the parameters relating to the control of the aircraft.
