# **Air Accidents Investigation Branch**

Report on the incident to Airbus A321-231, registration G-MEDG During an approach to Khartoum Airport, Sudan on 11 March 2005

Aircraft Incident Report No:	5/2007	(EW/C2005/03/02)
------------------------------	--------	------------------

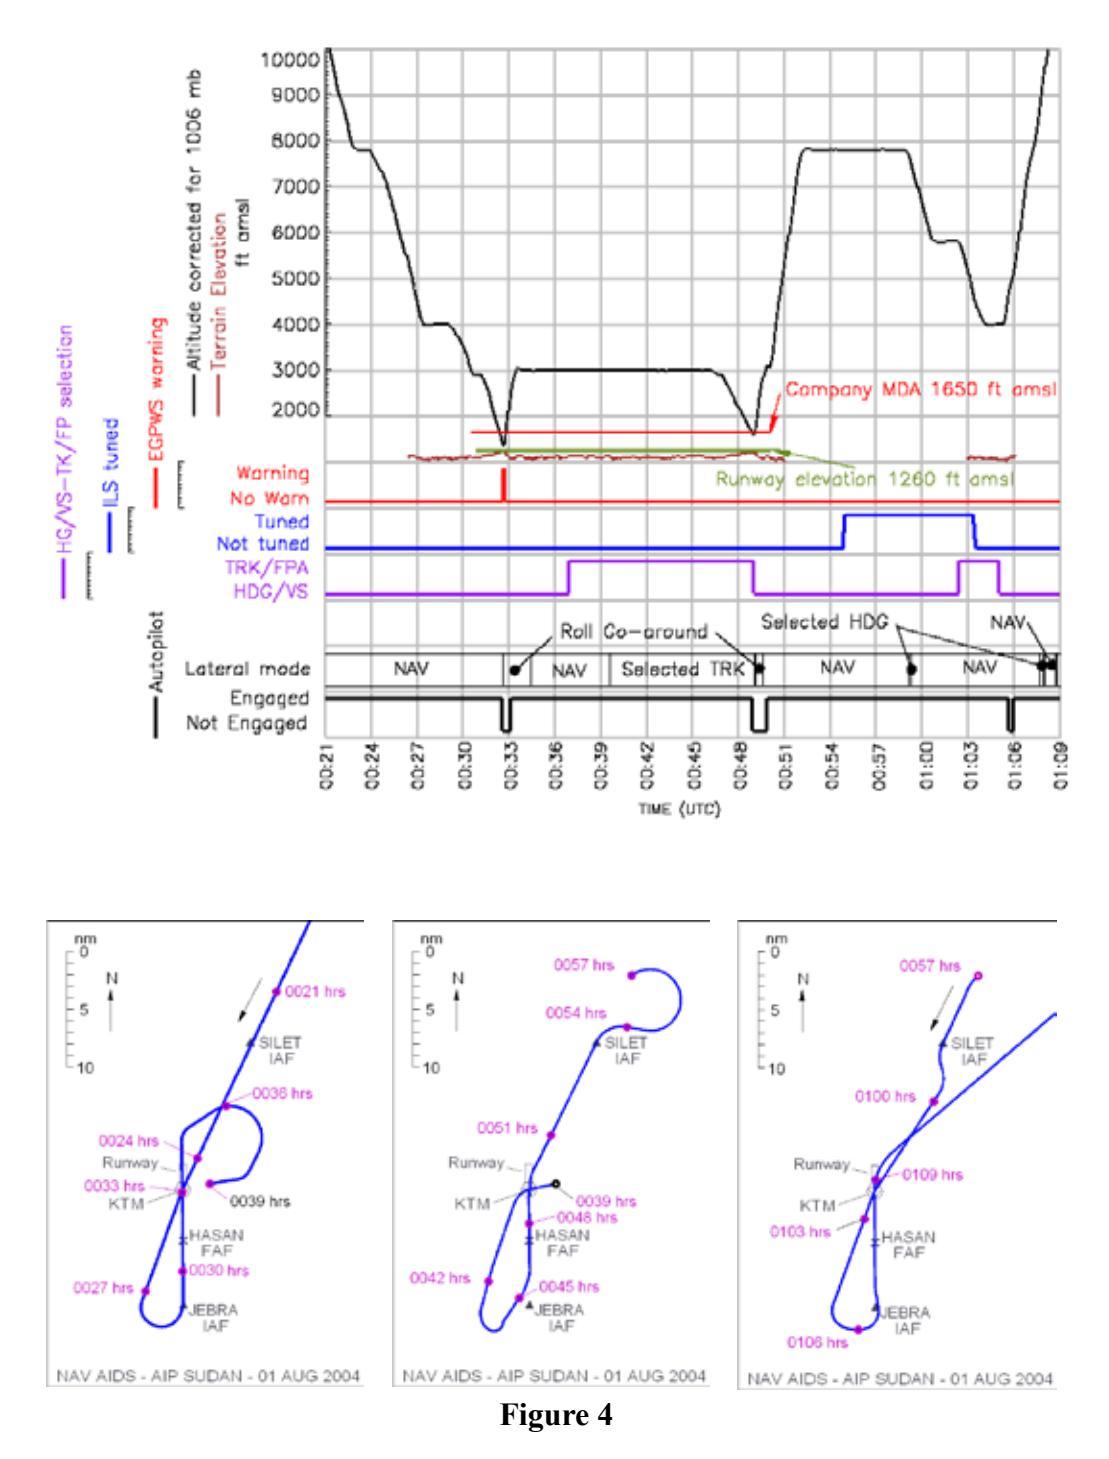
General overview of the flight path in the vicinity of Khartoum

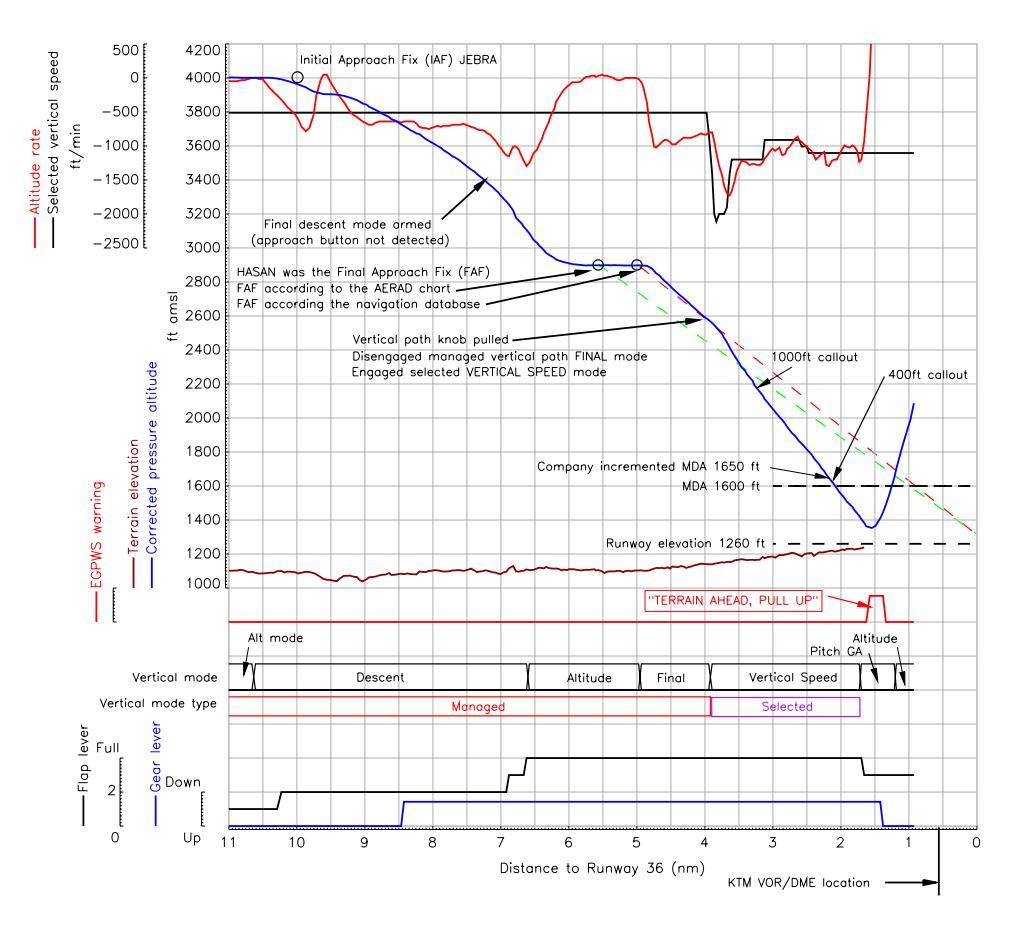
First approach shown relative to distance to the runway threshold, KTM VOR/DME and different reference points for the final approach fix

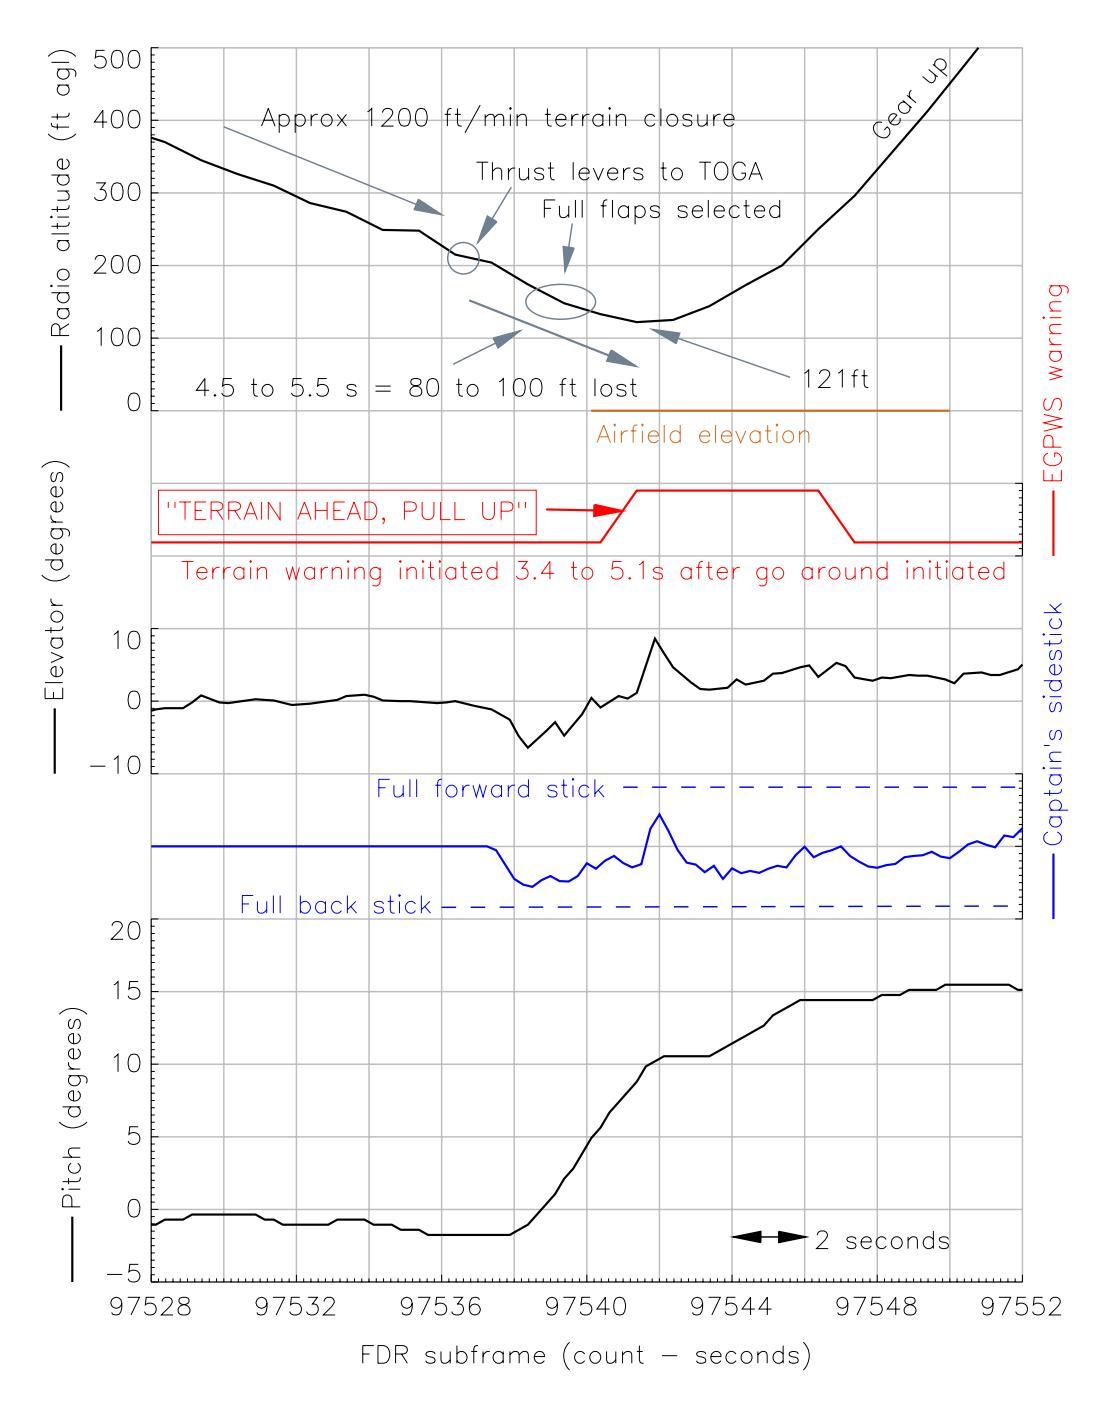
EGPWS warning during the first go-around

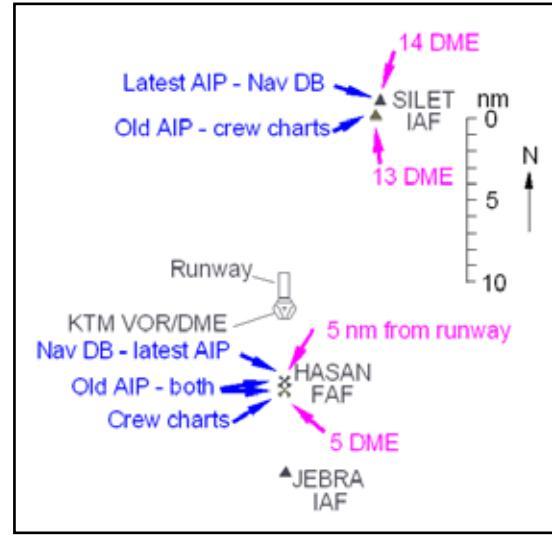
Figure 7

Comparison of waypoint locations as shown in the Sudanese AIPs, the Navigation database and the crew charts

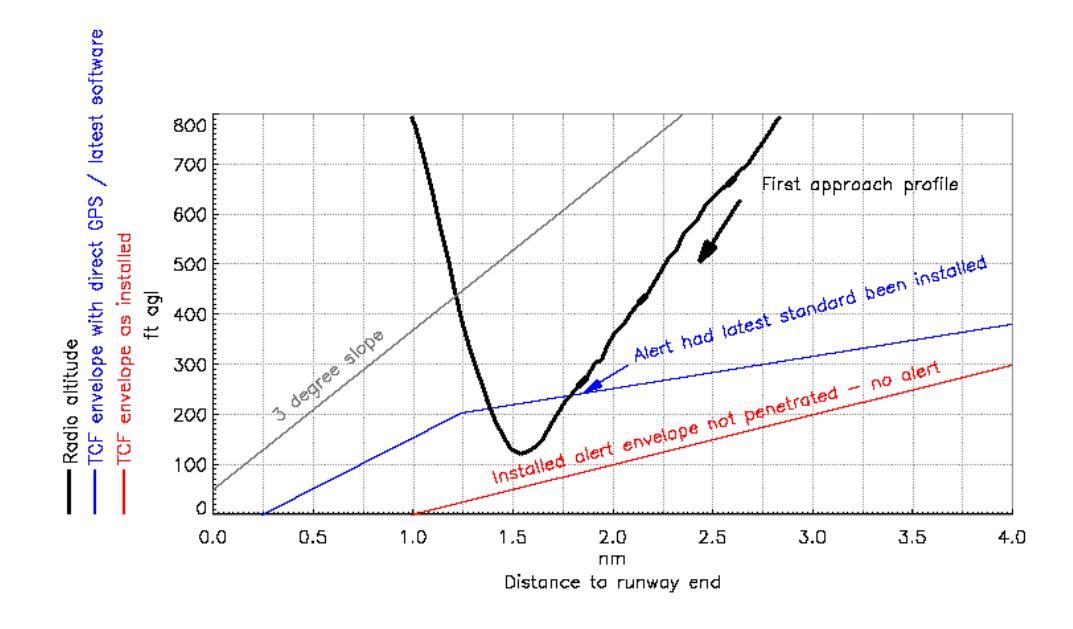
Figure 12

The fact that the GPS, GPIRS and FMC positions were close and correlated with the recorded DME distance showed that navigational accuracy was not a factor in the ineffectiveness of the EGPWS in this instance. No anomalies with other sources of data were identified and the EGPWS was fully operational as established by analysis by the manufacturer. The lack of a timely alert was a factor of the design of the system.

The navigation system as installed included a GPS source and so provided accuracy that exceeded the applicable TAWS requirements even though the GPS did not directly feed the EGPWS. Further manufacturer analysis of the data highlighted that had a direct link between the GPS and the EGPWS been installed and the latest software used, the TCF alerting envelope would have triggered a "TOO LOW TERRAIN" with a radio altitude of approximately 240 ft as show in Figure 12. The "PULL UP" warning trigger point would not have changed. The alert at 240 ft radio altitude would have served as an earlier, systematic alert whereas none was given by the system installed at that time.

The TCF alert envelope as fitted compared to the latest certified alert envelope with a direct GPS feed to the EGPWS

The European Aviation Safety Agency, in conjunction with industry, should review the current TAWS system design criteria (ETSO-C151a), and installation certification criteria, with particular emphasis on the timeliness of alerting when close to the runway. Revisions to these standards arising from this review should apply retrospectively to all aircraft currently covered by the TAWS mandate. (Safety Recommendation 2007-044)

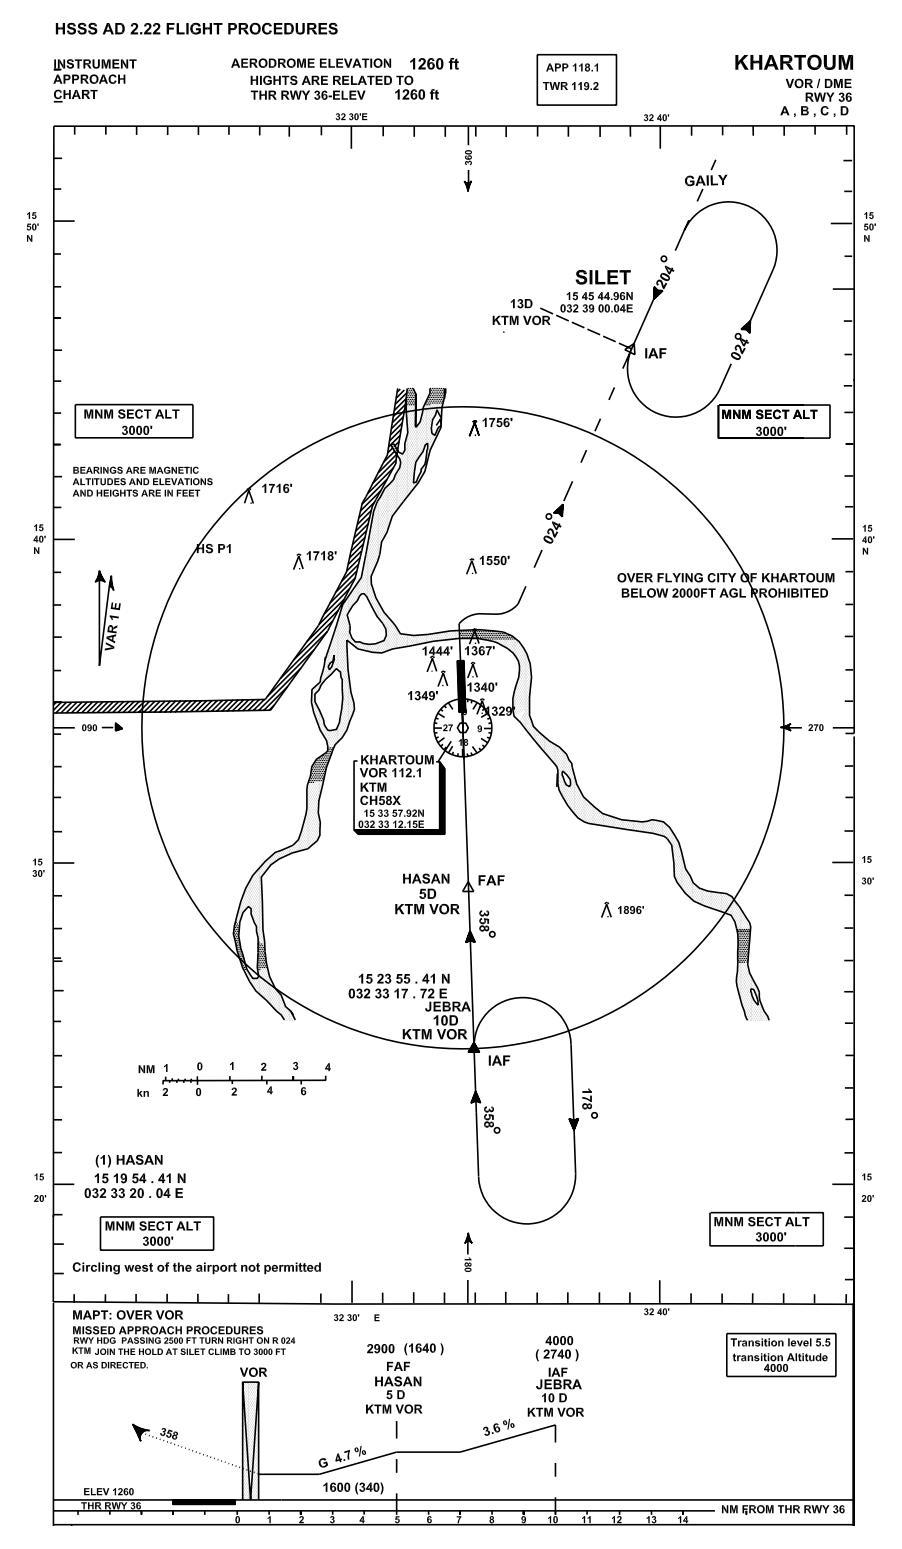
Extract from Sudan AIP 01 November 2002 for the KTM VOR/DME 36 approach.

Note that HASAN is shown 5 nm from the runway but also labelled as 5 nm from the DME, positions 0.6 nm apart
