ACCIDENT		
Aircraft Type and Registration:	Titan T-51 Mustang, G-MUZY	
No & Type of Engines:	1 Rotax 912 ULS piston engine	
Year of Manufacture:	2009 (Serial no: LAA 355-14831)	
Date & Time (UTC):	30 October 2012 at 1318 hrs	
Location:	Wellesbourne Mountford Airfield, Warwickshire	
Type of Flight:	Private	
Persons on Board:	Crew - 1	Passengers - 1
Injuries:	Crew - None	Passengers - None
Nature of Damage:	Damage to propeller and panels on underside of fuselage	
Commander's Licence:	Private Pilot's Licence	
Commander's Age:	52 years	
Commander's Flying Experience:	1,420 hours (of which 4 were on type) Last 90 days - 15 hours Last 28 days - 10 hours	
Information Source:	Aircraft Accident Report Form submitted by the pilot and further inquiries by the AAIB

AAIB Bulletin: 5/2013

EW/G2012/10/15

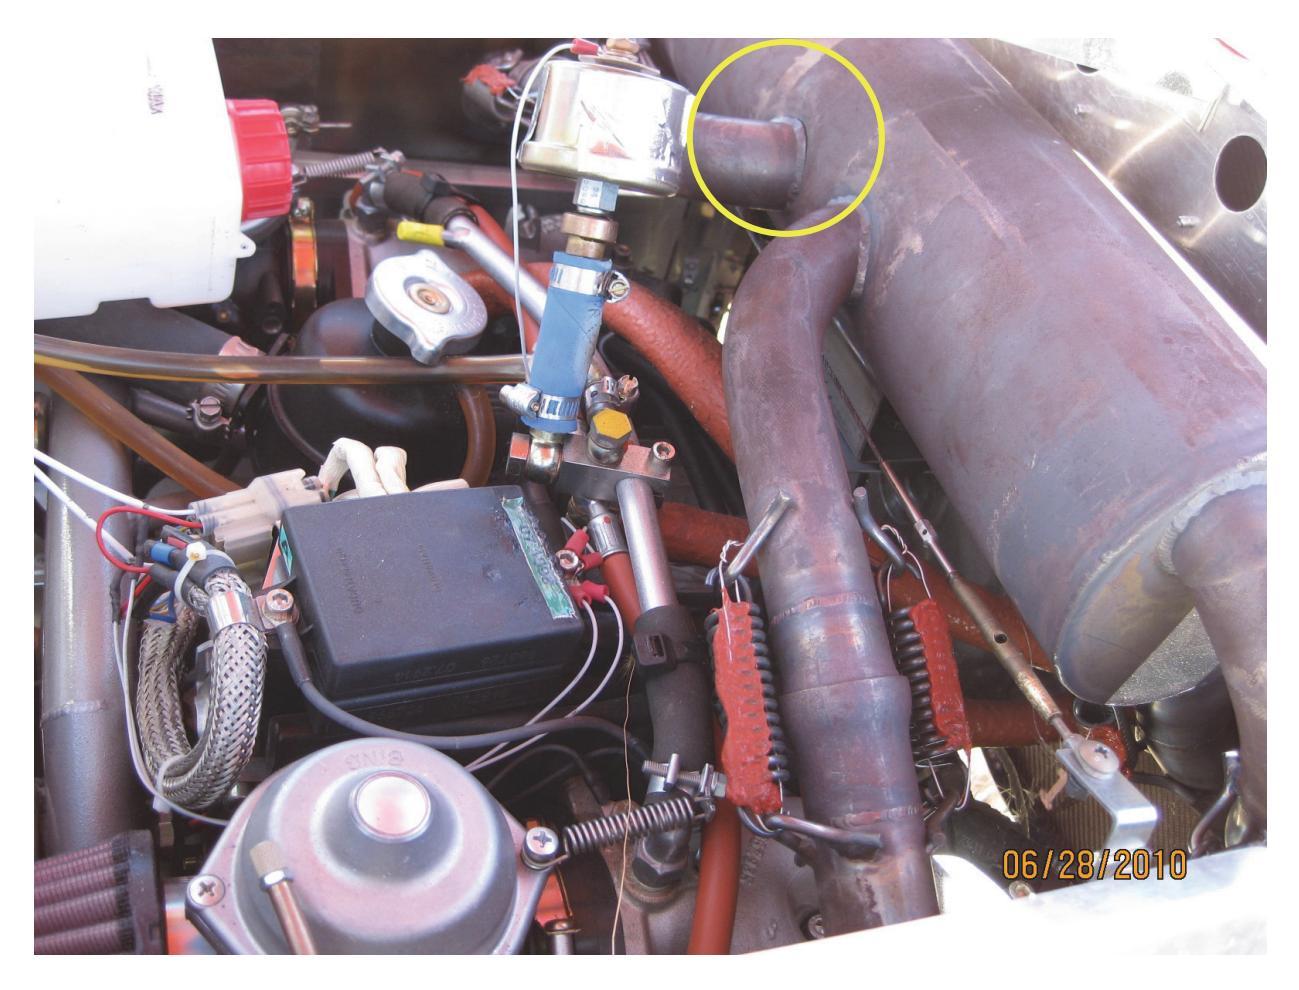
#### Figure 1

Upon examination, it was found that an exhaust pipe welded to the expansion box under the engine cowling had failed at the weld (Figure 1) and the hot gases thereby released had damaged several components in the area, including the throttle cable, and had partially melted the battery. It was clear that the throttle problems were caused by heat deterioration of the throttle cable and the landing gear system, which is electro-hydraulic, had been unable to function due to the battery damage. It should have been possible to actuate the standby free-fall landing gear extension, but this was not attempted by the pilot.

View of the engine compartment of a Titan T51 (not G-MUZY). Note presence of a crack (circled) in the exhaust similar to that thought to be responsible for the failure on G-MUZY

The LAA has advised that they intend to conduct a review of the design of the exhaust system, since it is thought that the failure probably occurred following a period of crack development. which went undetected. For the same reason they will also look at the ease of access to the area for frequent inspections for defects such as this. The LAA give the general advice to pilots about to fly an aircraft with which they are unfamiliar, that they receive a full briefing, and understand all the aircraft systems, before they take to the air.
