## ACCIDENT

Aircraft Type and Registration:	DA 42 Twin Star, G-SUEA	
No & Type of Engines:	2 Thielert TAE 125-02-99 piston engines	
Year of Manufacture:	2007	
Date & Time (UTC):	20 January 2009 at 1457 hrs	
Location:	Lands End Aerodrome, Cornwall	
Type of Flight:	Private	
Persons on Board:	Crew - 1	Passengers - 2
Injuries:	Crew - 1 (Minor)	Passengers - 2 (Minor)
Nature of Damage:	Substantial damage to forward fueslage and propellers	
Commander's Licence:	Private Pilot's Licence	
Commander's Age:	47 years	
Commander's Flying Experience:	1,315 hours (of which 62 were on type) Last 90 days - 38 hours Last 28 days - 10 hours	
Information Source:	AAIB Field Investigation

## Synopsis

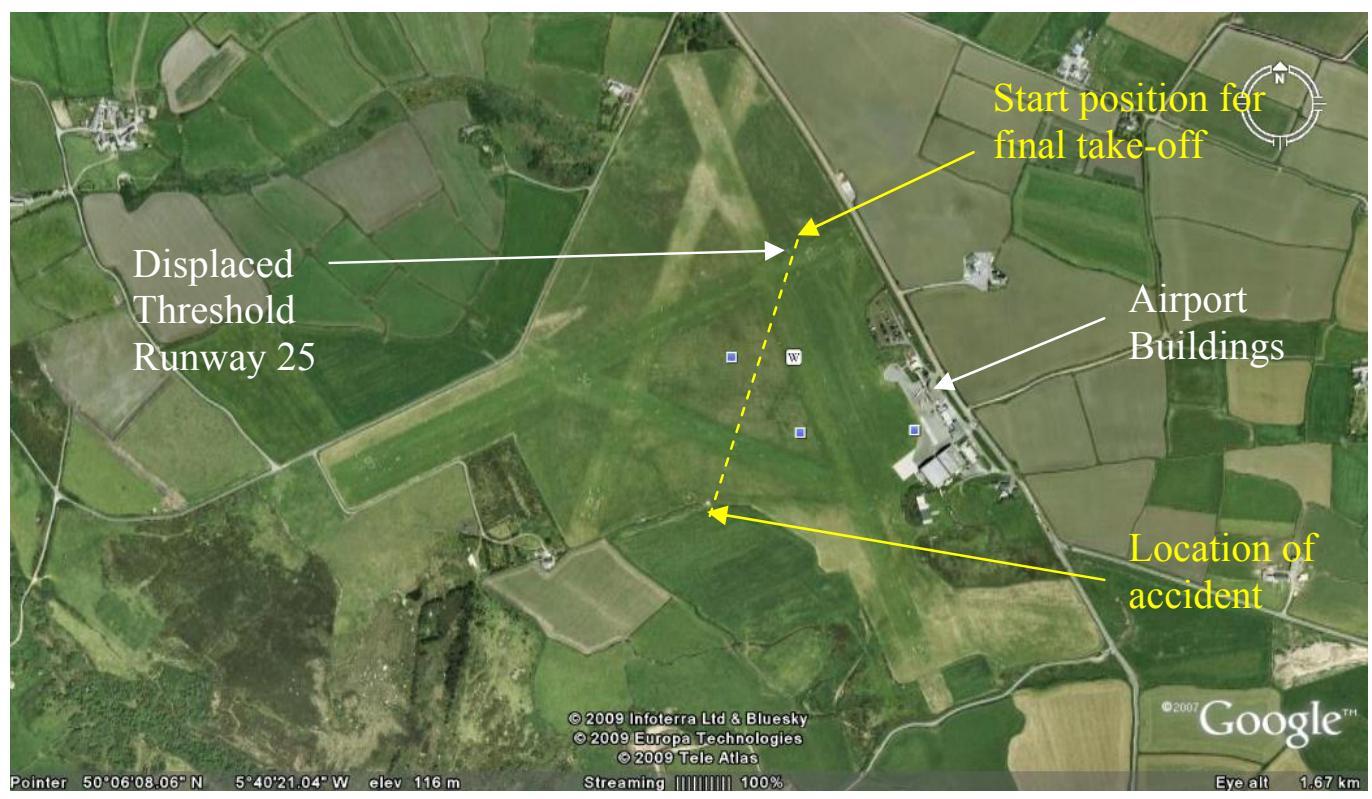
The AFS then towed the aircraft to the right side of Runway 25, adjacent to the normal threshold, Figure 1. The pilot reported that he thought his location was closer to the airport buildings and on the left side of Runway 25. He then attempted to take off. His plan was to track alongside Runway 25, displaced to the left, which he felt was firmer ground than on the runway itself. As power was increased, the aircraft accelerated. The pilot was closely monitoring the airspeed, hoping to reach 70 kt in order to be able to lift off. However, at around 46 kt he reported a "pull to the left" and became aware of the L ECU A FAIL caption being illuminated. He then retarded the throttles and aborted the takeoff.

**Figure 1** Lands End Airfield The wheel marks on the airfield indicated that the aircraft had followed a straight track in a direction of approximately 200° from its start location on the right side of Runway 25. It had covered approximately 350 m when it crossed the airfield boundary and entered a ploughed field. The aircraft immediately nosed over in the very soft ground, coming to rest inverted.
