## ACCIDENT

Glasair IIS RG, G-KSIR 1 Lycoming IO-360-B1E piston engine 1995 18 November 2008 at 1050 hrs Upfield Airfield, Whitson, Newport Training Crew - 2 Passengers - None Crew - None Passengers - N/A Nose landing gear collapsed, engine shock-loaded Private Pilot's Licence 69 years 1,100 hours (of which 99 were on type) Last 90 days - 8 hours Last 28 days - 1 hour

Aircraft Accident Report Form submitted by the pilot and additional AAIB inquiries

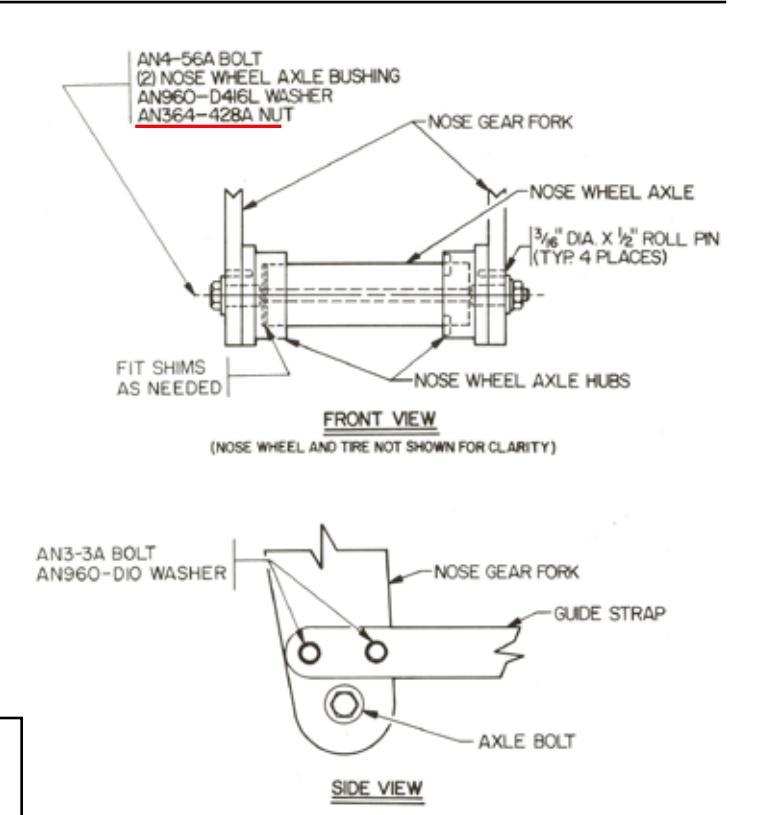
The Glasair IIS RG is a two seat retractable tricycle landing gear aircraft of composite material construction. After the accident it was apparent that the nosewheel had become partially detached from the nose leg fork, as a result of the loss of the nut that retains the wheel axle bolt. The bolt normally passes through the wheel hub and both halves of the fork and the loss of the nut had allowed it to migrate from its correct position. This allowed the wheel to tilt within the fork and also to move rearwards, so that it contacted a guide strap that passed around the rear of the wheel. This resulted in it becoming jammed and to effectively act as a locked wheel on touchdown; the consequent force on the nose leg, generated by friction between the surface and the tyre, caused the leg to collapse rearwards.

A drawing of the nosewheel fork and hub assembly is shown in Figure 1, and it can be seen that it specifies an AN364-428A nut to attach to the AN4-56A axle bolt. The nut is of the self-locking type in that it has a nylon thread insert.

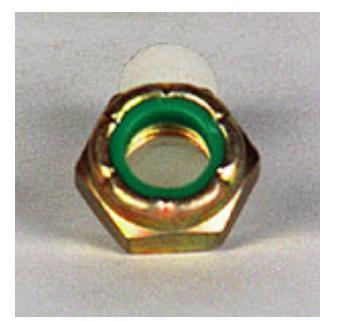
The owner of G-KSIR considered that his aircraft had been equipped with the shear nut; examples of both are shown in Figure 2.

<sup>&</sup>lt;sup>1</sup> A shear nut is intended to restrain a bolt in its installation where it experiences predominantly shear loading; it is not designed to resist any significant axial load in the bolt. Where such axial loads exists, a tension nut is used.

Notwithstanding, because nose gear shimmy can cause fairly severe side loads to the axle and fork assembly, replacement of the AN364-428A (shear) nut with an A365-428A (tension<sup>1</sup>) nut would be a prudent change.'

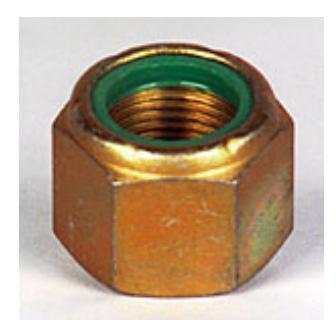
AN365-428A (tension)
Figure 2

The tension nut is deeper than the shear nut, which increases the overall width of the fork assembly, although in fact the SB does not specify a longer axle bolt. However it does advise that for retractable gear aircraft, such as G-KSIR, it may not be feasible to use the AN365 tension nut due to width constraints in the nosegear well. In such a case, it advises using a 'lower height' MS21042-4 steel self-locking nut, which offers high tensile strength.
